UNDERWATER BRIDGE INSPECTION REPORT

STRUCTURE NO. 7865

CR 315

MINNESOTA DEPARTMENT OF TRANSPORTATION  
UNDERWATER BRIDGE INSPECTION

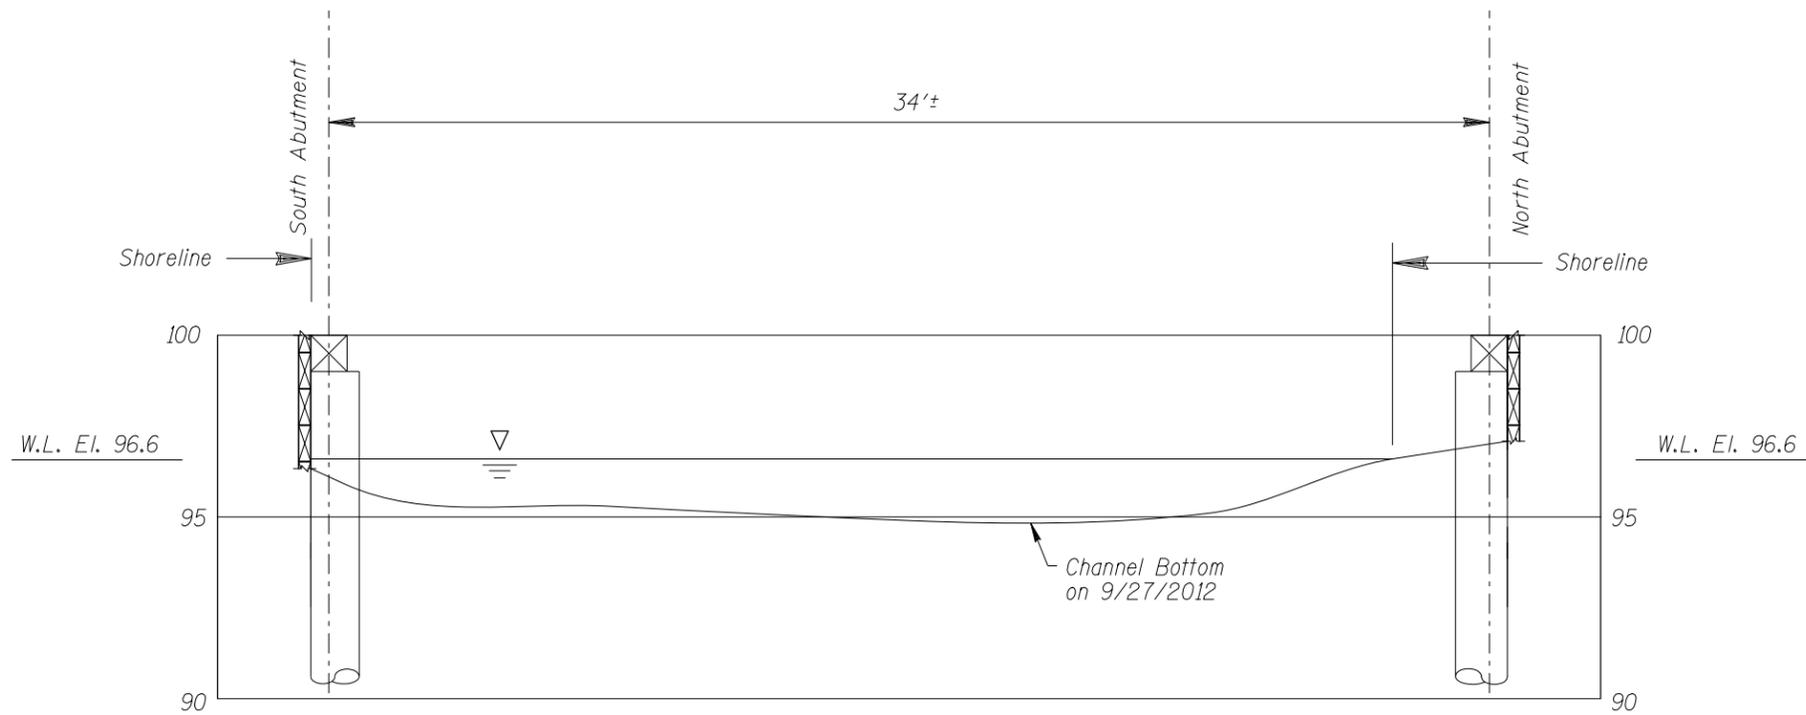
DOWNSTREAM FASCIA PROFILE

- ③ The timber piles were typically sound allowing a typical timber awl penetration of 1/8 inch. No significant decay, splitting or checking was observed.

- ④ The timber backwall at the both abutments was typically sound and in good condition. No significant gaps or loss of backfill was observed.
- ⑤ A gap, up to 1/4 inch wide, was observed between the top of the pile and the bottom of the pile cap at Piles A' and B at the North Abutment resulting in complete loss of bearing at both piles.

- ⑥ Vertical planking was observed along the length of both abutments extending from the channel bottom to roughly 2 feet above the waterline at approximately 2.5 feet off the backwall and running parallel to both abutments.

- ⑧ Scattered concrete rubble with reinforcing steel protruding was observed along both abutment faces.

- (A) Place shims between the top of Piles A' and B of the North Abutment and the pile cap to restore full bearing of both piles.
- (B) Reinspect the submerged substructure at the normal maximum recommended (NBIS) interval of sixty (60) months.
