UNDERWATER BRIDGE INSPECTION REPORT

STRUCTURE NO. 92277 H, I, J, and K

MILLER CREEK

JULY 26, 2012

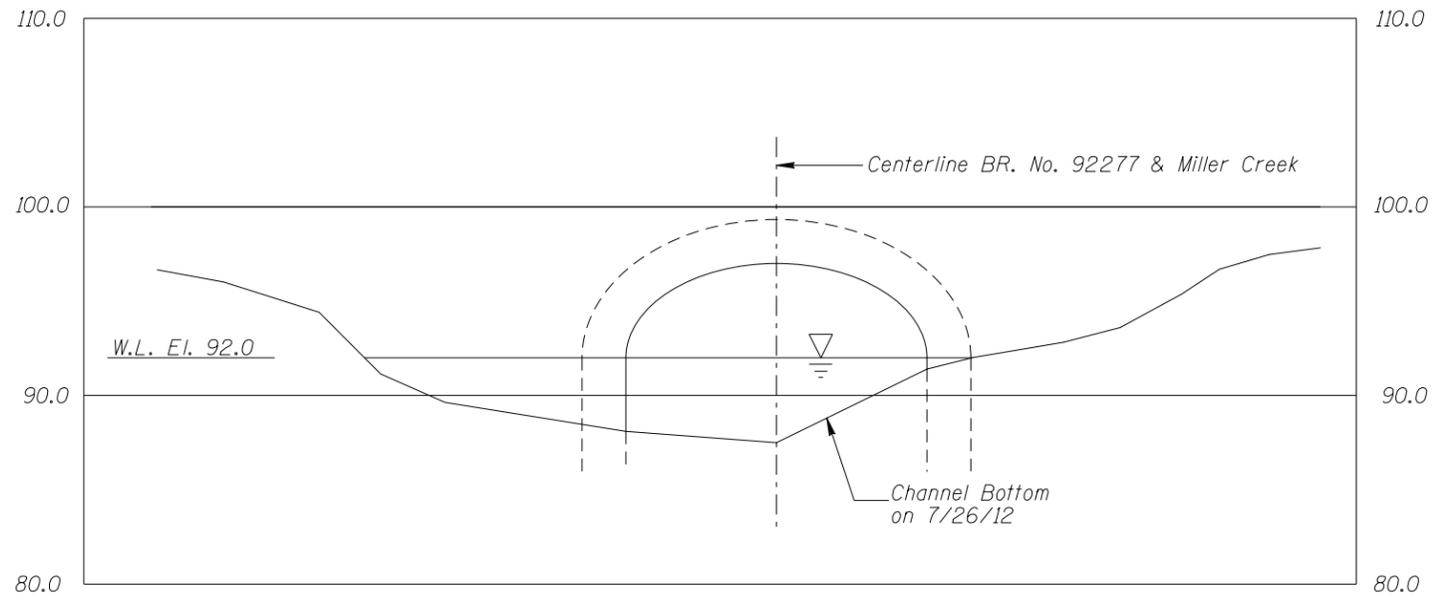
DOWNSTREAM OPENING PROFILE  
(Looking Upstream)

REMARKS: Overall, the concrete surfaces of the culverts exhibited minor scaling. The masonry of the culvert walls and ceilings was found to be in satisfactory condition with joint mortar typically intact. However, a significant extent of undermining was observed throughout the structure ranging from 4 to 14 inches vertically and up to 3 feet of maximum penetration.

Repair undermining throughout the structure.
