UNDERWATER BRIDGE INSPECTION REPORT

STRUCTURE NO. L9571

PELICAN RIVER

MINNESOTA DEPARTMENT OF TRANSPORTATION
UNDERWATER BRIDGE INSPECTION

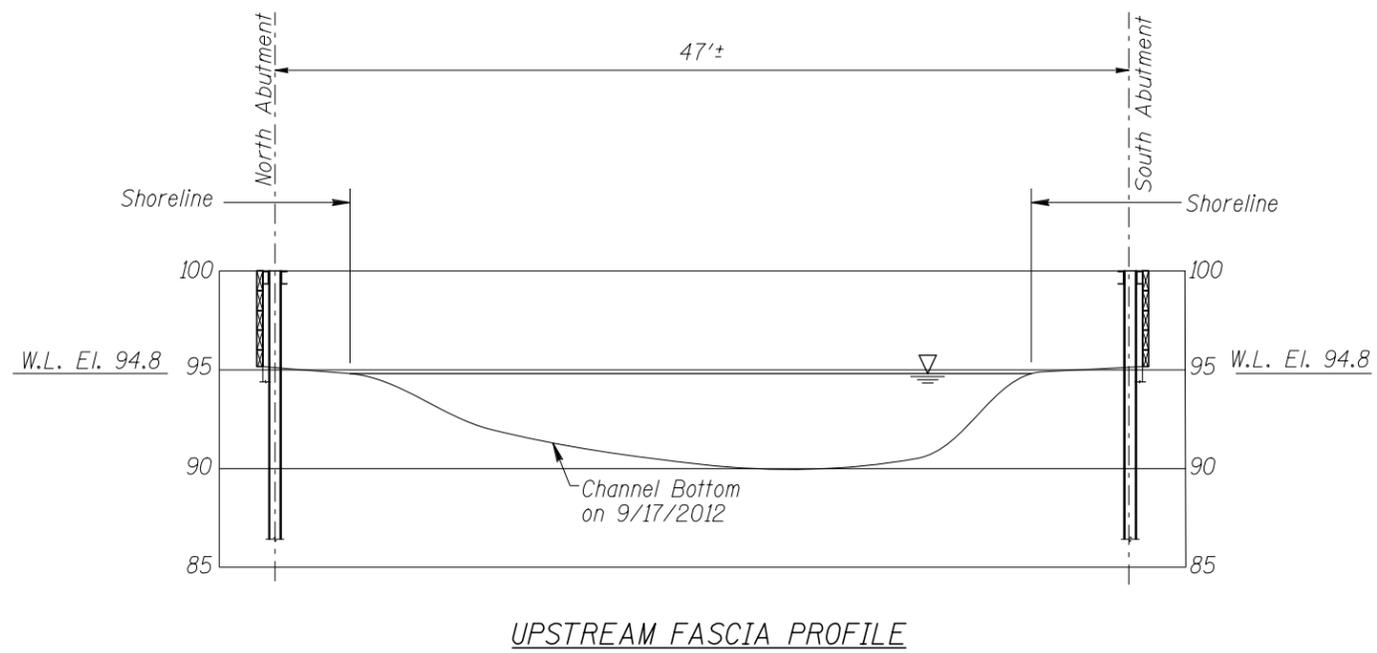
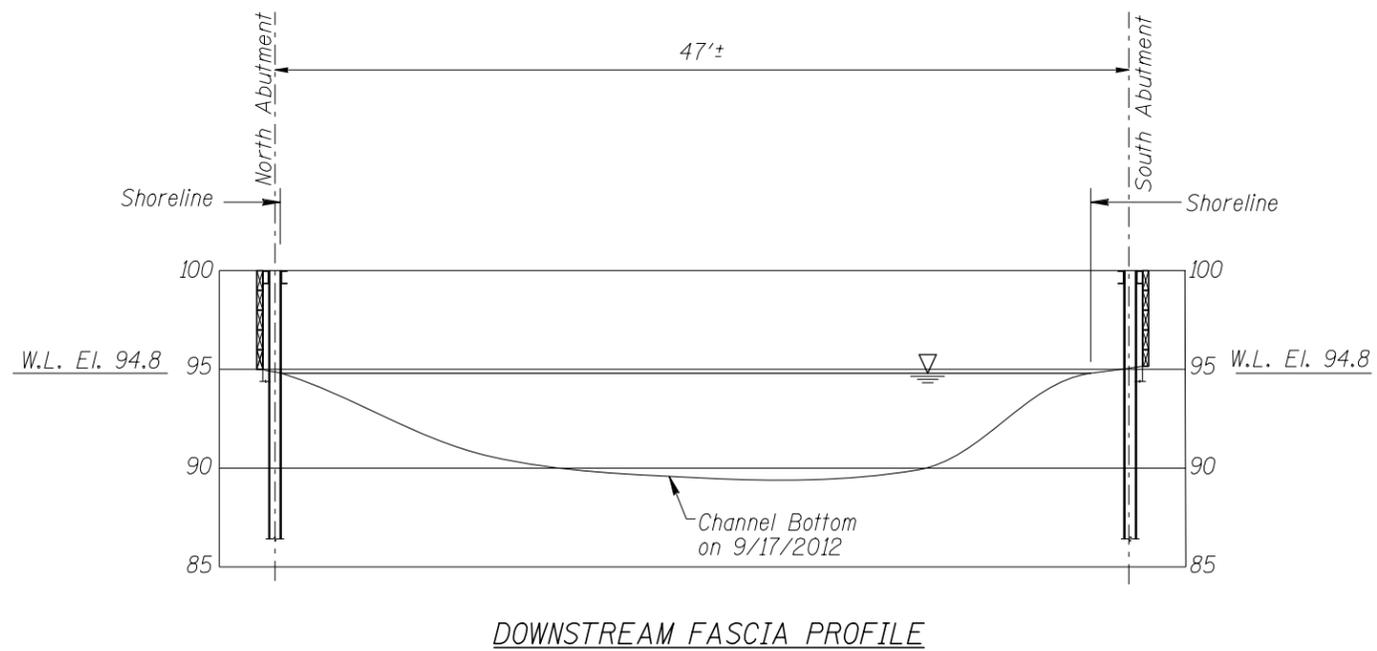
REMARKS: Overall, the North and South Abutments, were found to be in fair condition, with only minor defects of structural significance. The H-Piles exhibited light to moderate corrosion with pitting up to 1/8 inch deep. The timber backwall and wingwalls were sound and tight with no observed loss of backfill or structural deficiencies. The channel bottom appeared to be stable with no evidence of significant scour.
