# 2017 UNDERWATER BRIDGE INSPECTION REPORT

## BRIDGE # 58510 CSAH 61 over SNAKE RIVER

Date of Inspection: 09/22/2016

Contractor: Collins Engineers, Inc.

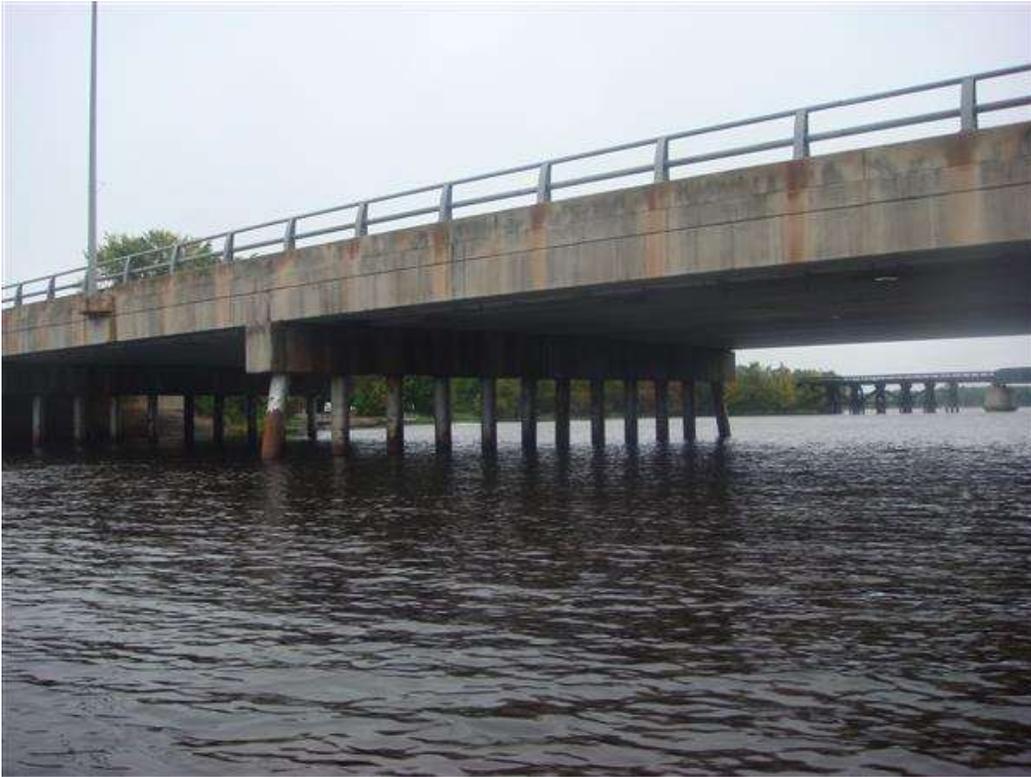
Photo 5 - View of Pier 3, Looking Northeast

- A. A light amount of scattered timber debris, 3 inch diameter and smaller, was observed along the south side of Piers 1 and 2. A light to moderate accumulation of timber debris, 6 inch diameter and smaller, was observed along the upstream half of Pier 3 extending from channel bottom to 3 feet below the waterline.

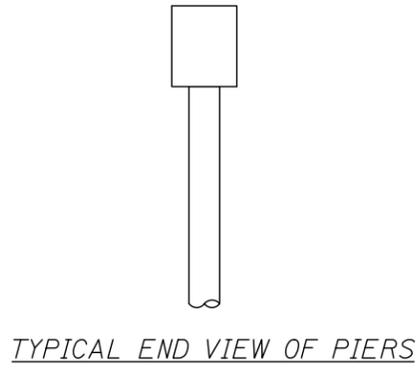
**TYPICAL END VIEW OF PIERS**

- ④ Channel bottom material consisted of gravelly sand with scattered riprap and cobbles allowing 2 inches of maximum probe rod penetration.
- ⑤ Light to moderate corrosion on all piles from bottom of cap to the channel bottom, with up to 1/2 inch diameter rust nodules below water covering up to 100% of the surface area of the piles, and with a maximum of 1/8 inch deep pitting from 1 foot below waterline to channel bottom.

- ⑥ Metal dock framing debris was observed around the two upstream piles of Pier 1.
