# 2017 UNDERWATER BRIDGE INSPECTION REPORT

## BRIDGE # 69592 CSAH 29 over WHITEFACE RIVER

Date of Inspection: 09/13/2016

Contractor: Collins Engineers, Inc.

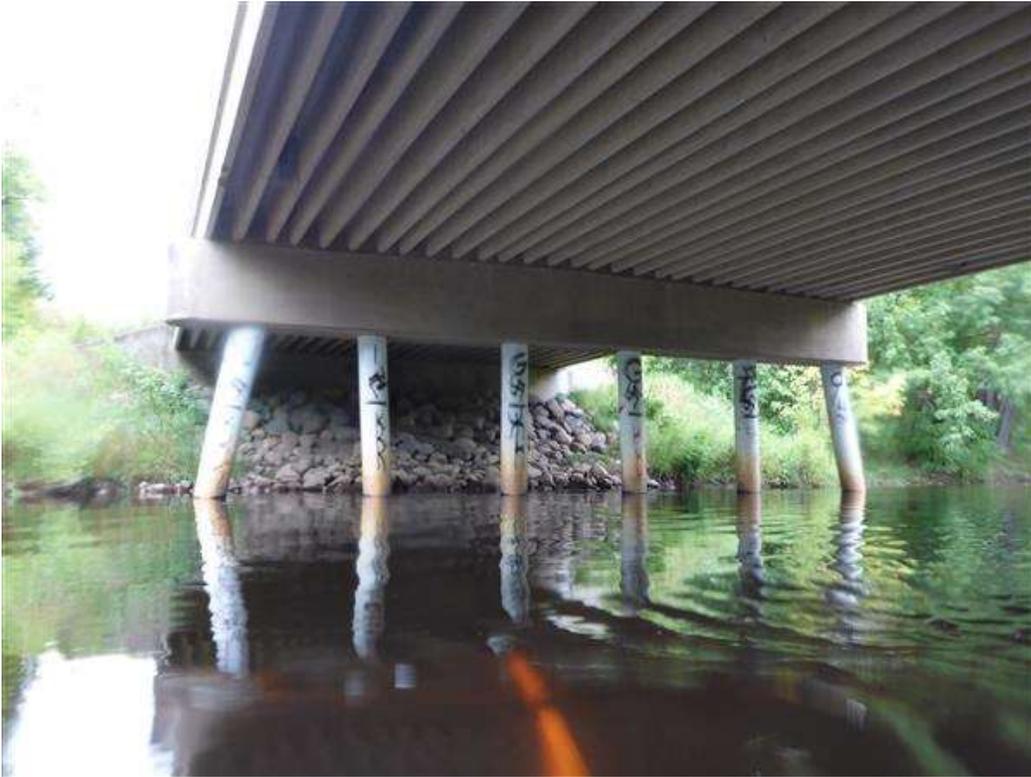
(C) A light accumulation of timber debris, consisting of logs and branches up to 12 inches in diameter, was observed extending from the west shore out 20 feet to the upstream nose of Pier 1, and along the east face of the pier, extending off the face up to 10 feet. The debris extended from the channel bottom to the waterline.

Photo 3 - Pier 2, Looking East
