2016 UNDERWATER BRIDGE INSPECTION REPORT

BRIDGE # 7836 CR 737 over HELLEWEGS CREEK

UNDERWATER INSPECTION

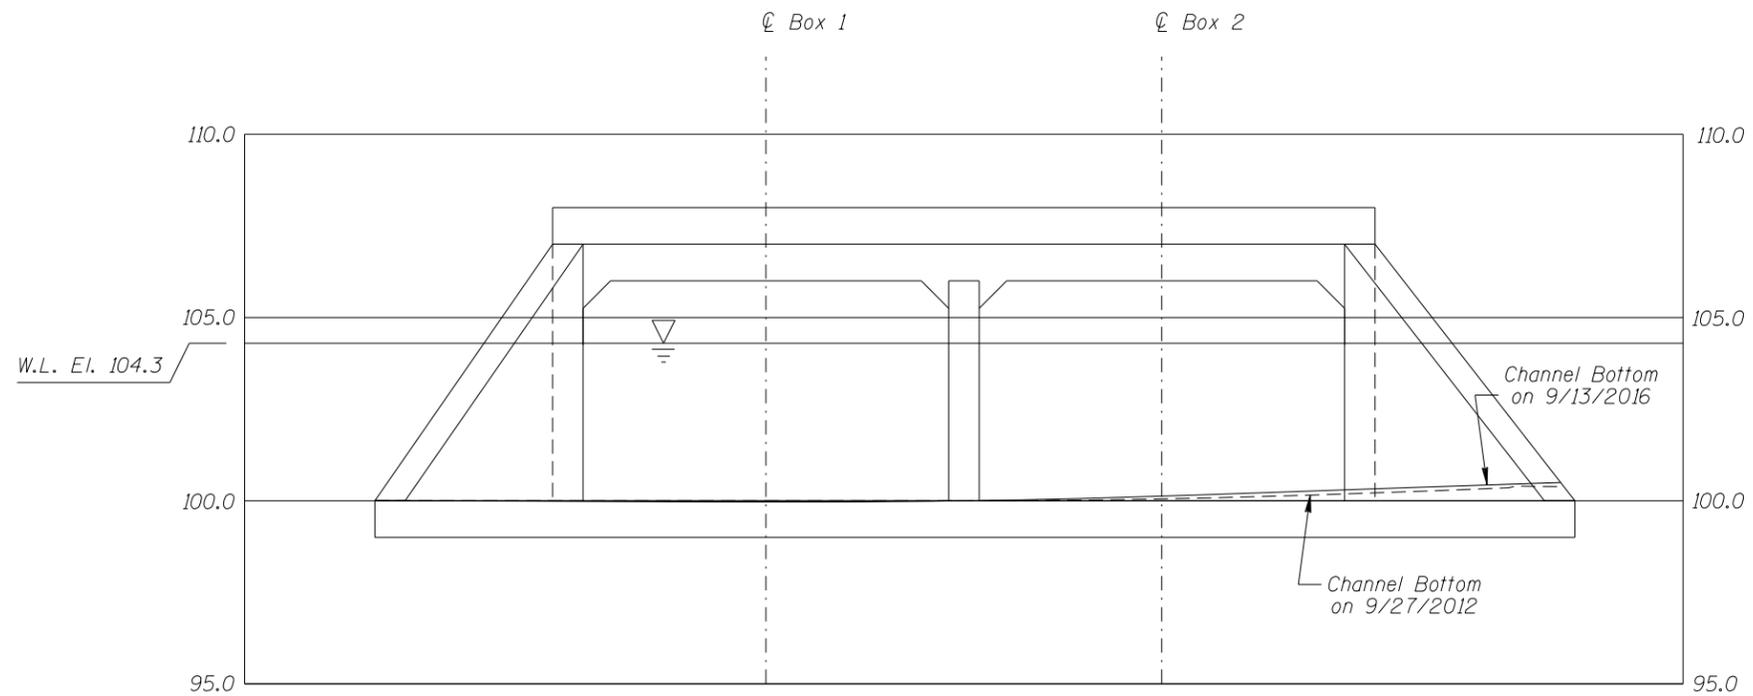
UPSTREAM OPENING PROFILE

- (A) The culvert floor was typically clear of any debris or silt build up. There was a layer of silty sand and gravel allowing up to 3 inches probe rod of penetration covering a portion of the concrete apron at the upstream and downstream openings of Box 2.

- (D) The apron floor was flush with the channel bottom at the upstream and downstream openings of Box 1 with no vertical face exposure.
- (E) A diagonal crack was observed on the northwest wingwall with a maximum width of 1/4 inch.
