2016 UNDERWATER BRIDGE INSPECTION REPORT

BRIDGE # 96224 CR 720 over BEAVER CREEK

Date of Inspection: 06/20/2016

Contractor: Collins Engineers, Inc.

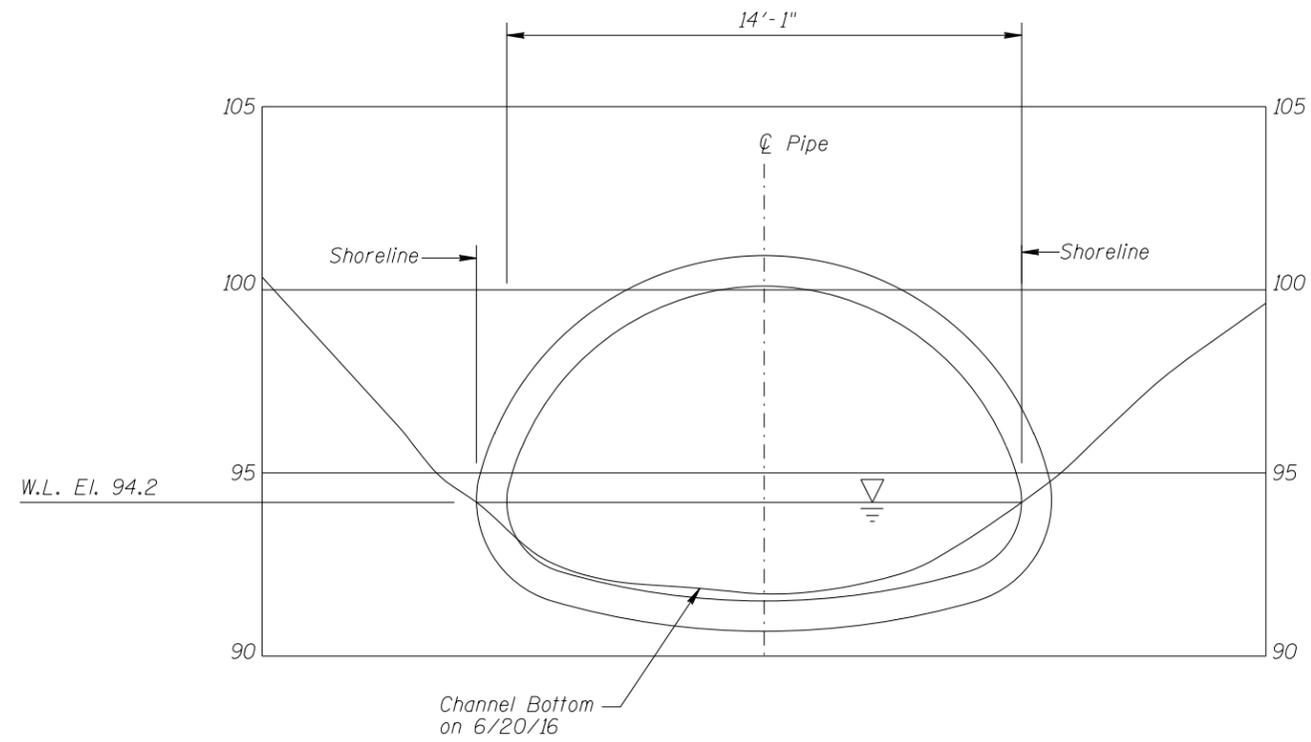
UPSTREAM FASCIA PROFILE

- ① Channel bottom material consisted of soft silt allowing 18 inches of probe rod penetration.
- ② Concrete floor was typically covered by 6 inches to 1.5 foot thick layer of silt infill.
- ③ Concrete was typically sound along the entire interior of the culvert. Light scaling with 1/16 inch of penetration extended from the channel bottom to 2.5 feet above the waterline.
- ④ Minor deterioration of concrete grout was observed along the seams of the individual culvert segments.
- ⑤ Minor erosion was present along the southwest bank with up to a 5 foot vertically cut bank.
