2020 HydInfra Discussion

Culvert Cost WIG on the Road to Drainage Asset Management

HydInfra - MNDOT's Culvert and Storm Drain Inventory and Inspection System

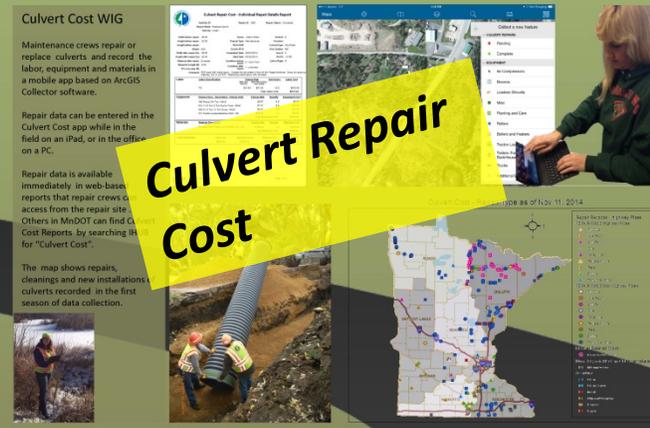
Culvert Repair Cost

The map shows repairs, cleanings and new installations of culverts recorded in the first season of data collection.

Maintenance crews repair or replace culverts and record the labor, equipment and materials in a mobile app based on ArcGIS Collector software.

Repair data can be entered in the Culvert Cost app while in the field on an iPad, or in the office on a PC.

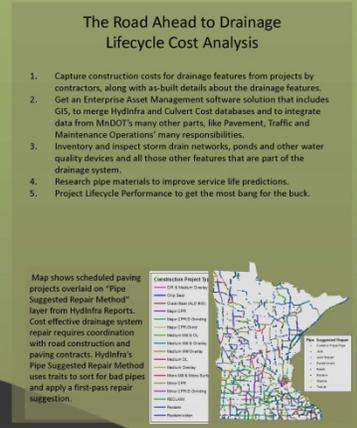
Map shows scheduled paving projects overlaid on "Pipe Suggested Repair Method" layer from HydInfra Reports. Cost effective drainage system repair requires coordination with road construction and paving contracts. HydInfra's Pipe Suggested Repair Method uses traits to sort for bad pipes and apply a first-pass repair suggestion.

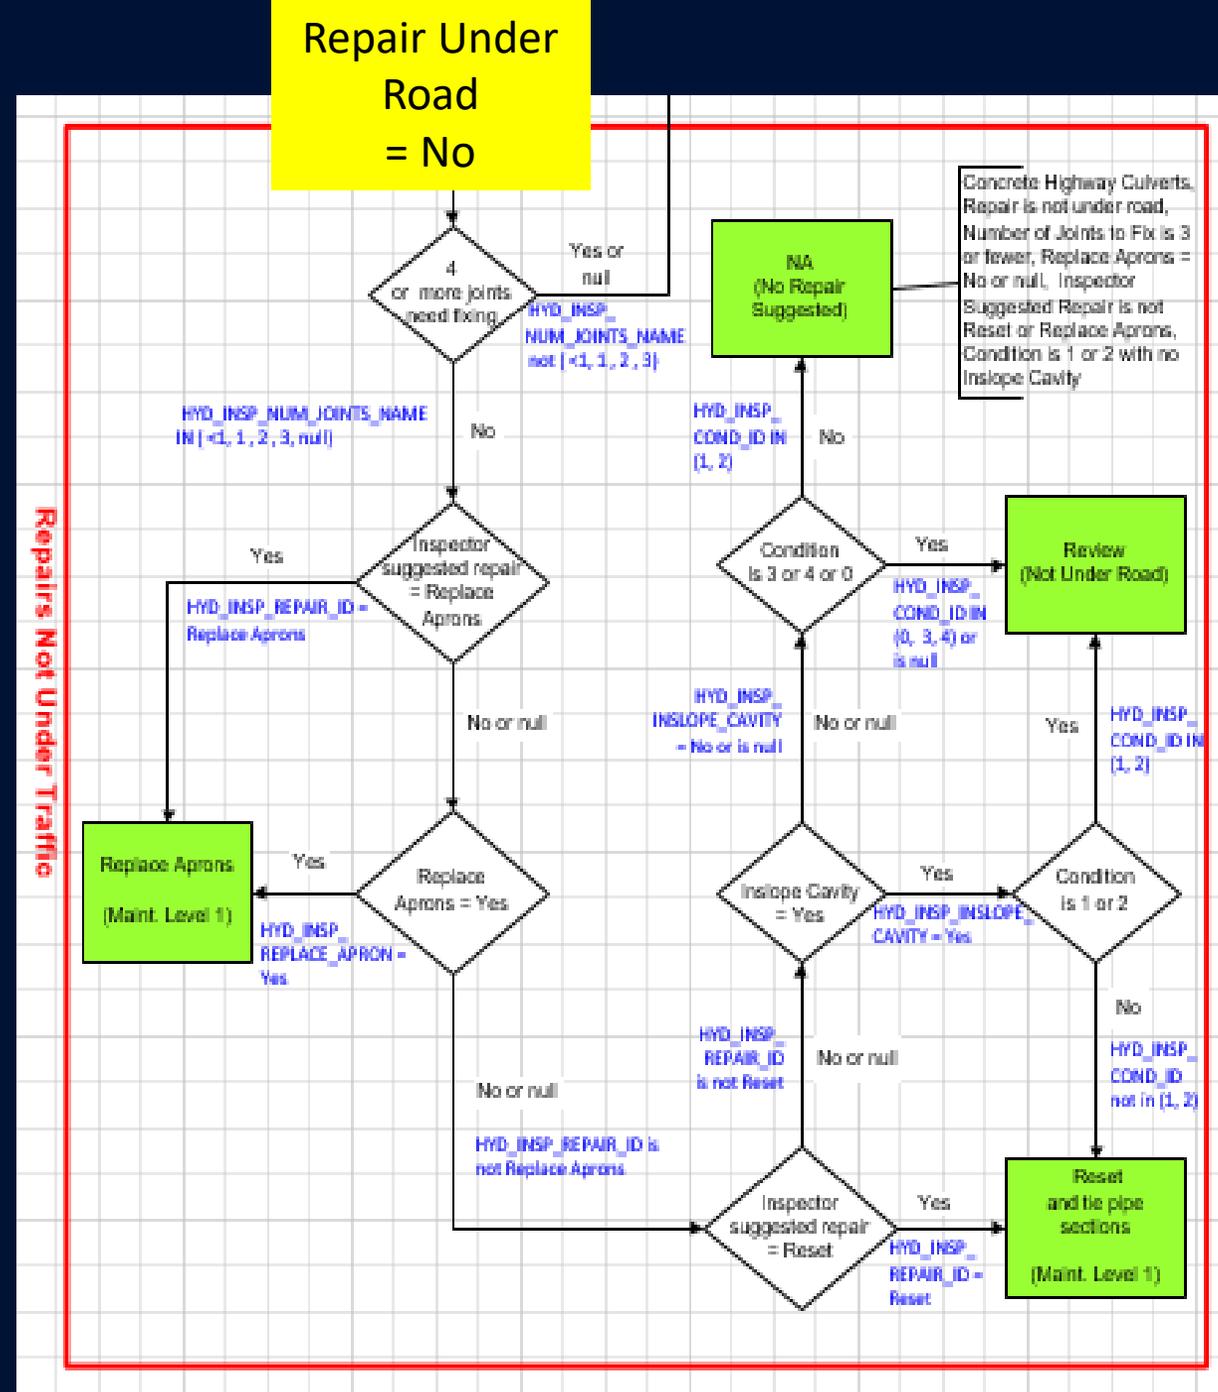
sorting process for **Concrete Highway Culverts**

Repair is needed but is not under traffic

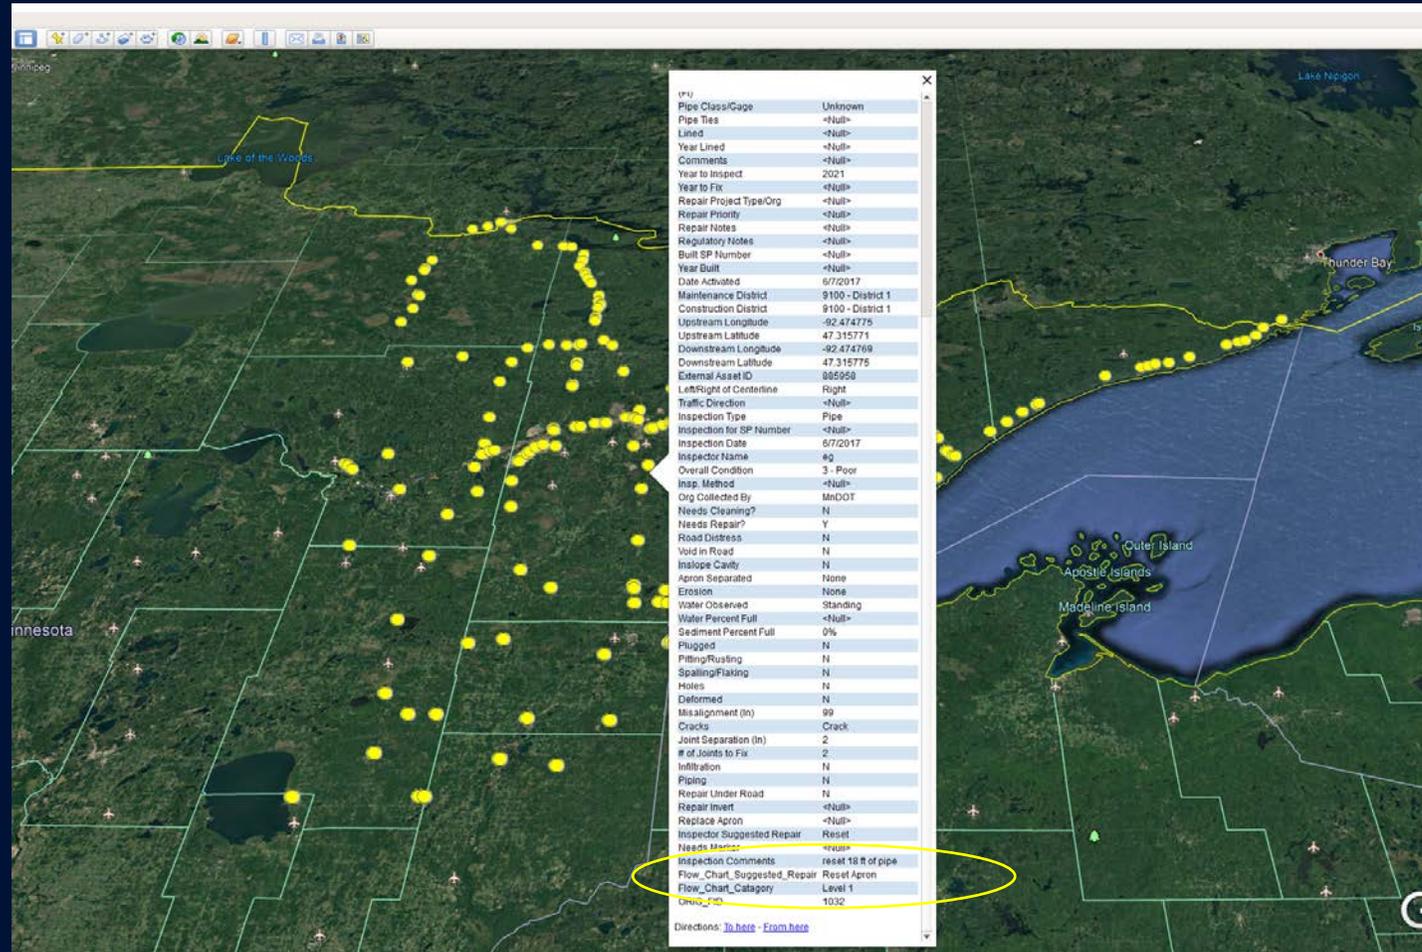
Flowchart Suggested Repair kml shows Highway Culverts to repair

TAMS HydInfra pipes are sorted into Suggested Repair by ArcMap model based on Suggested Repair Flowchart ([decision tree](#))

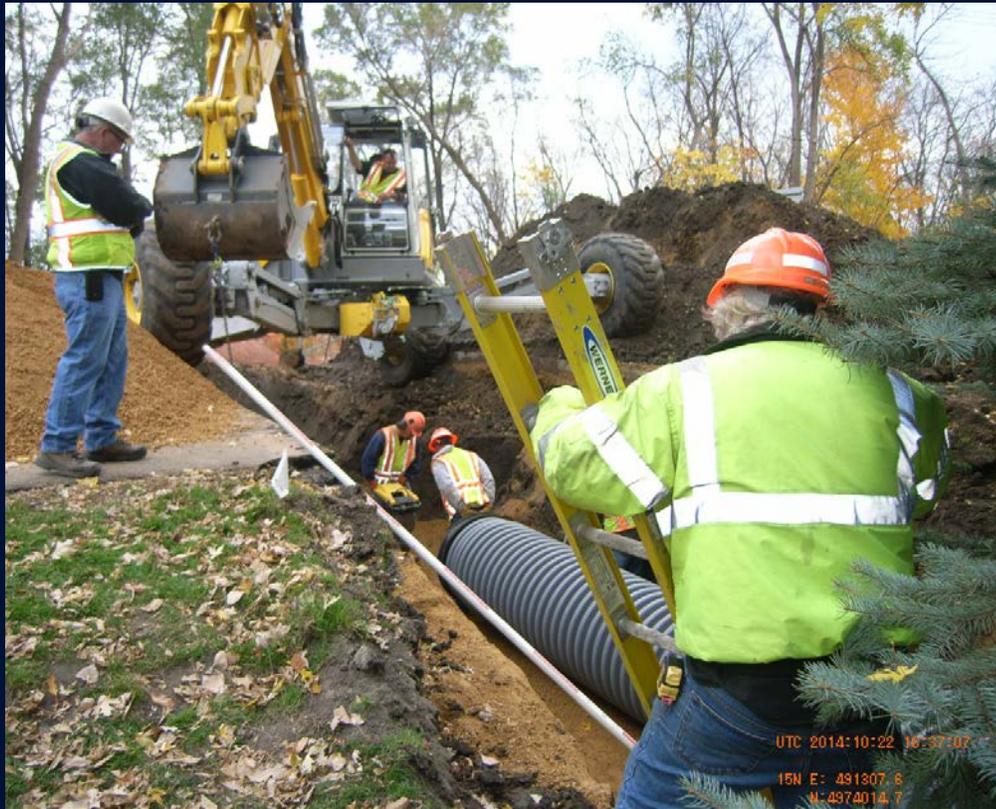
TAMS Work Order Management module does not change HydInfra asset record

- After repair, Insert a new inspection
- After replacement, change old pipe Inventory record to “Removed” and Insert a new pipe Inventory
- Metro District drainage repairs will be updated in TAMS-HydInfra by WRE.

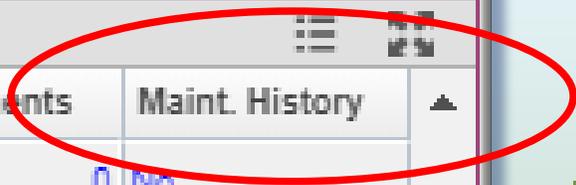
Scroll to far right in TAMS table to find linked work orders -- Yes

Record History	Documents	Maint. History
Yes	0	No
Yes	0	No
Yes	0	Yes
Yes	0	No
Yes	0	Yes

HydInfra Inventory > Maint. History field shows W.O.

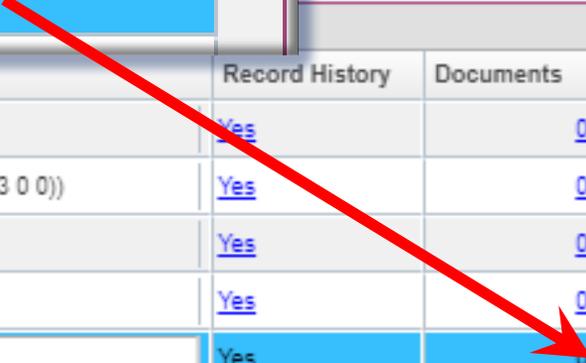
WO# 40691

Maintenance Management | Asset Inventory > Asset Performance > Pipe Inventory

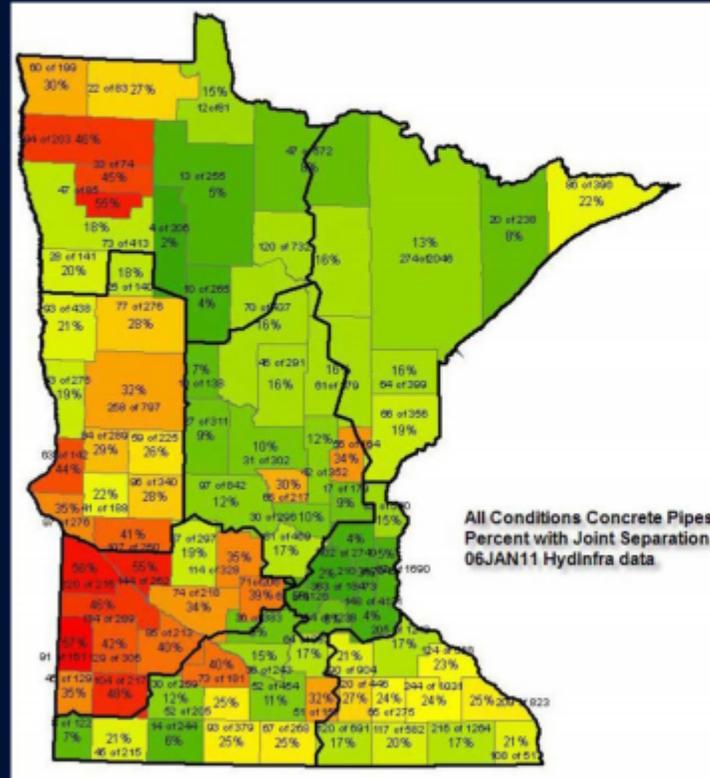
2011 All Concrete Pipes with **Joint Separation**

All Concrete Pipe Joint Separation 2011 vs Concrete Culvert Joint Separation 2017 - by County

- Concrete pipe joint separations are likely worse in fine soils (frost-heave) or steeper grades.
- Pipe Ties work to prevent some separation
- Inspector feedback furthers understanding of pipe defects

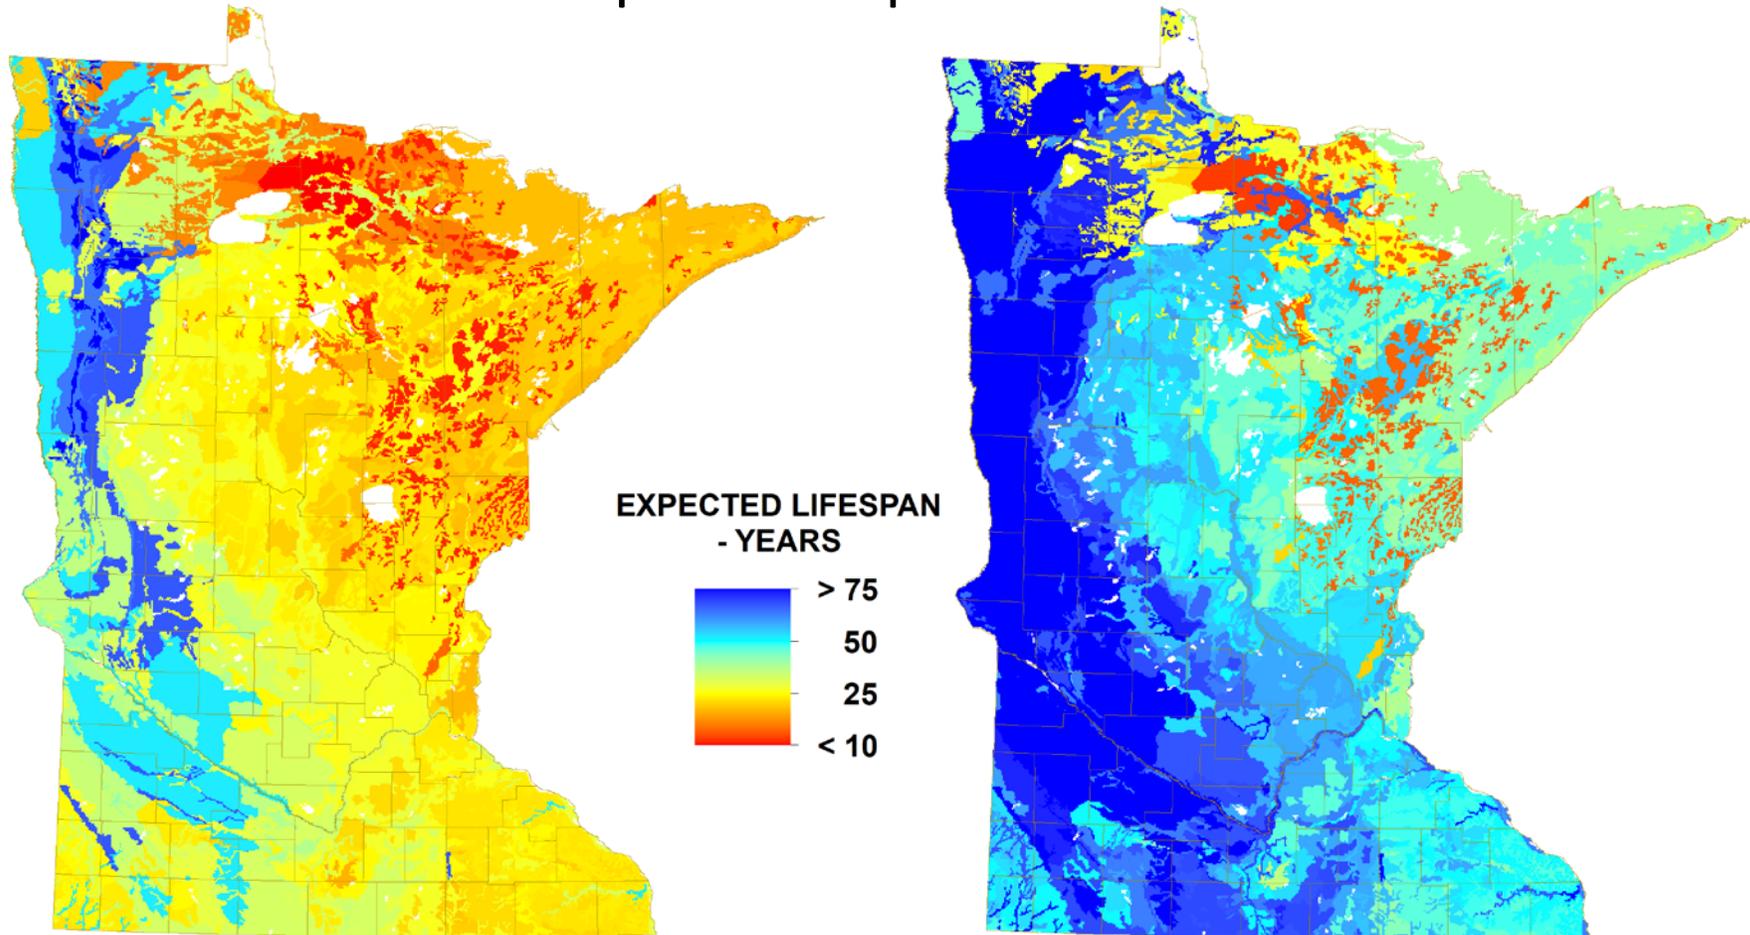
MnDOT Steel Pipe lifespan research-2015

16 Gage Galvanized Steel Pipe

16 Gage Aluminized Steel Pipe

Research focusing on the projected lifespan of steel pipe is underway. The map below shows roadside pH overlaid on NRCS pH data. Acidity, or low pH, is a factor in steel pipe deterioration rates. The research is being done by Barbara Burkholder Heikamp, U of M
