30 minute overview

HydInfra and Culvert Cost

MnDOT's version of
drainage asset management

Culvert and Storm Drainage System
Inventory and Inspection Program

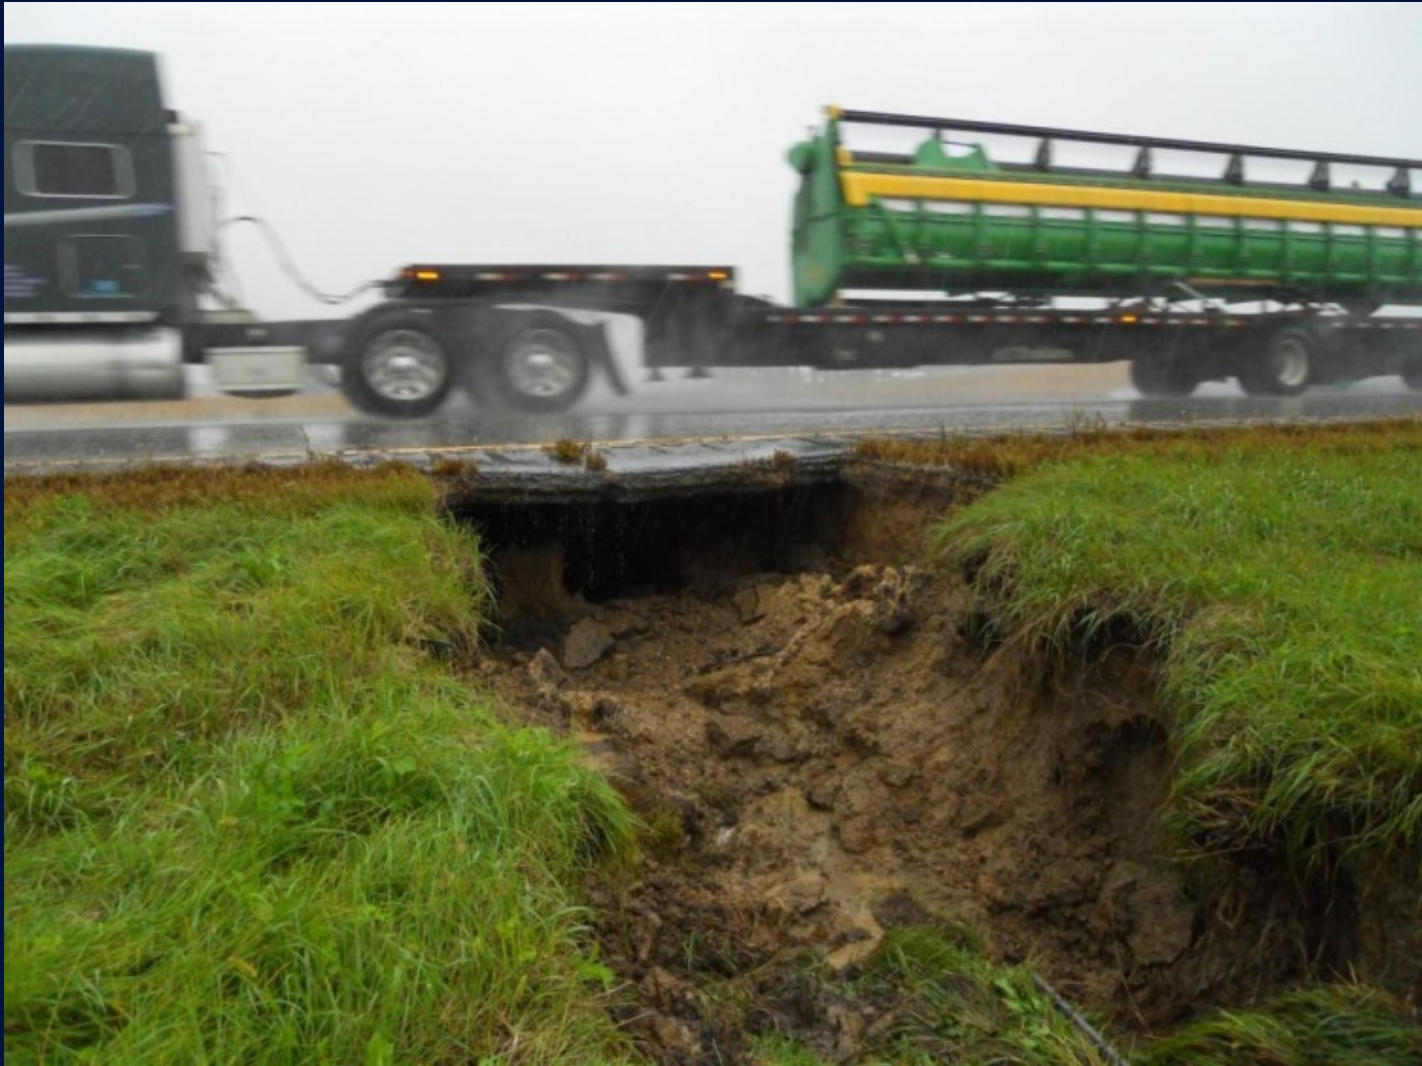
Big storm + bad pipe = wrecked road

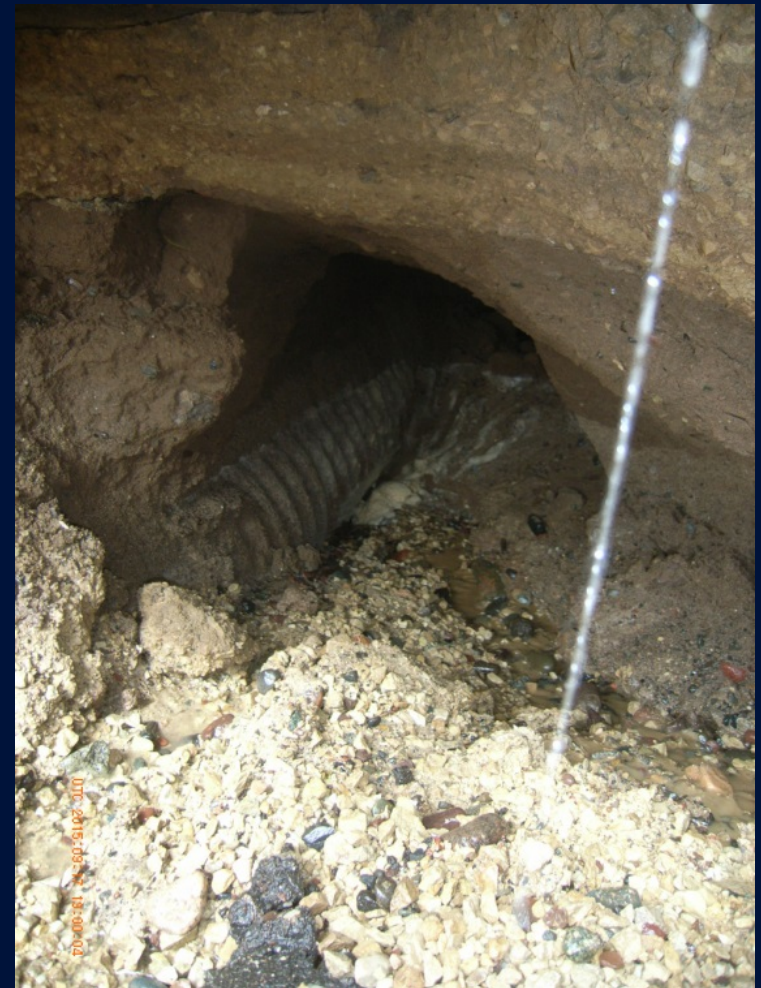
CMP Storm Drain at MnDOT Oakdale Office
in 2015

Pipe with Holes causes Piping and Road Void

Road fill washes out at each
burst of rain

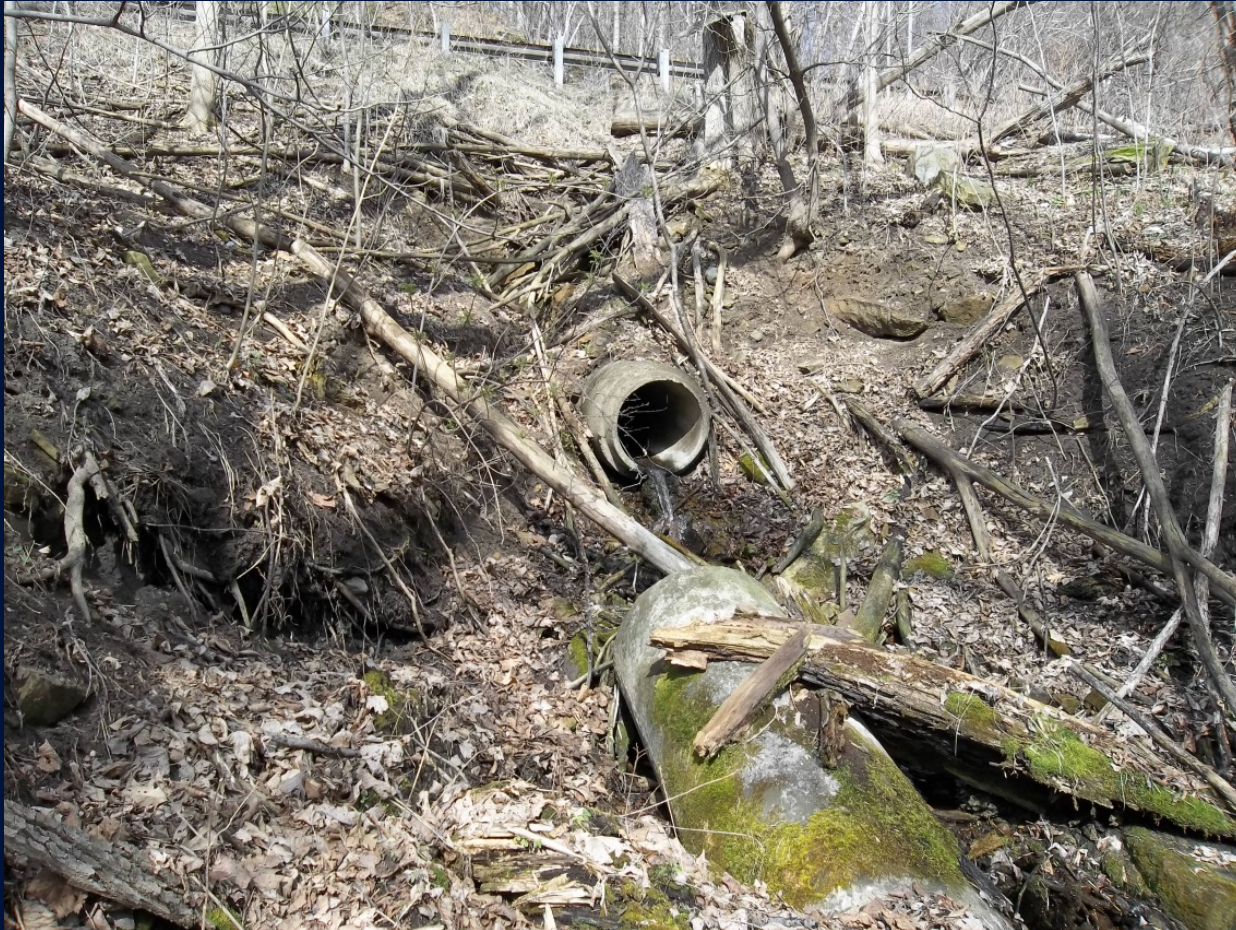
While some steep slopes are prone to failure
leaking pipes lubricate the slide

Soil crack to left of pipe end indicates slope failure.
US Highway 8, April 2016

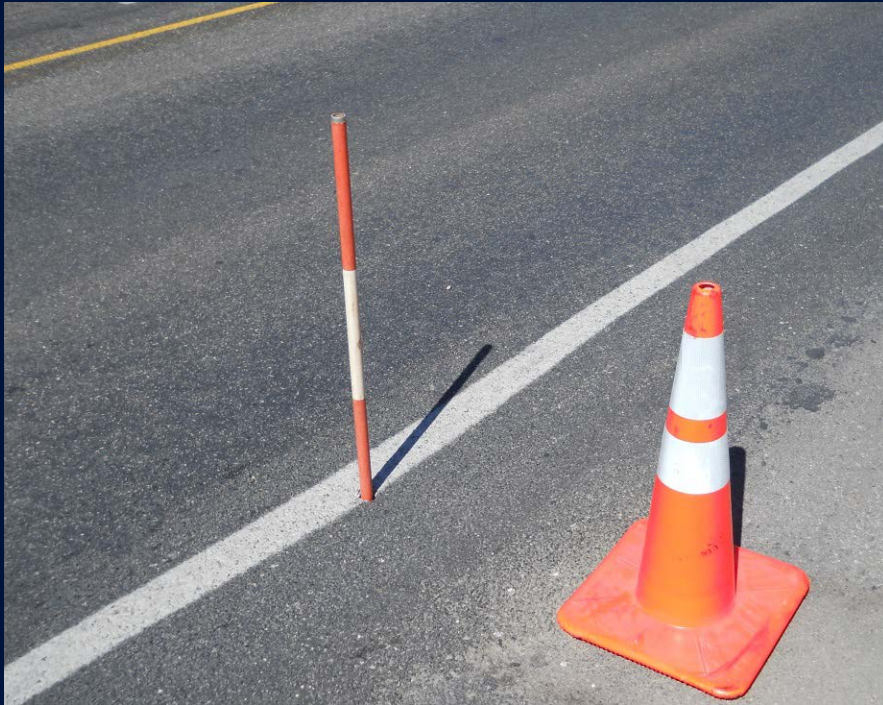
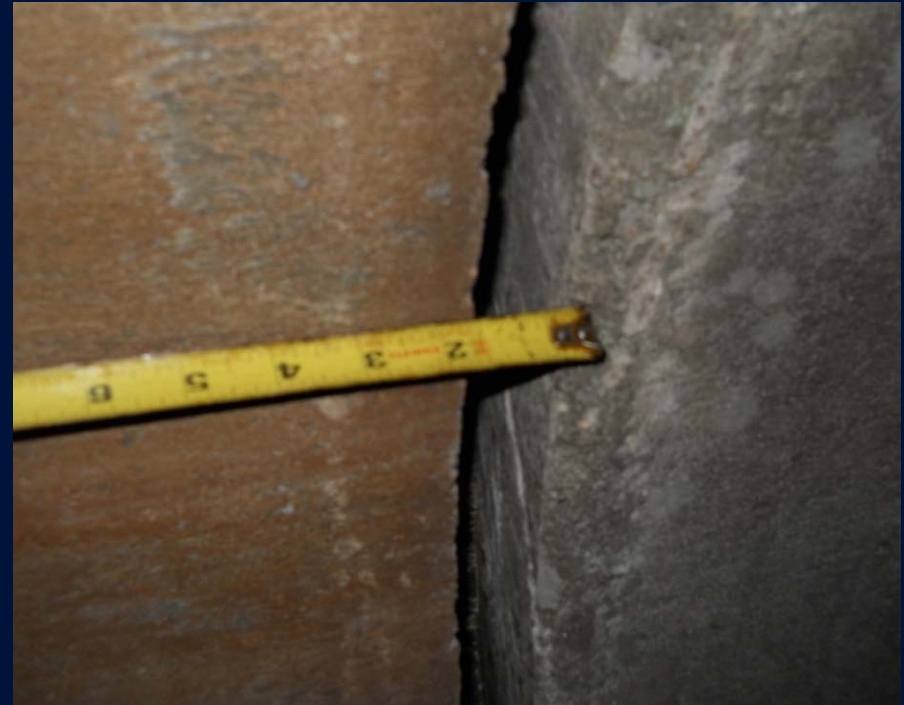
Void in Road – Evidence of a loss of soil from the road around or near the pipe or other feature.

D6 Jacked Pipe creates road void 27SEP2011 – Rob Coughlin

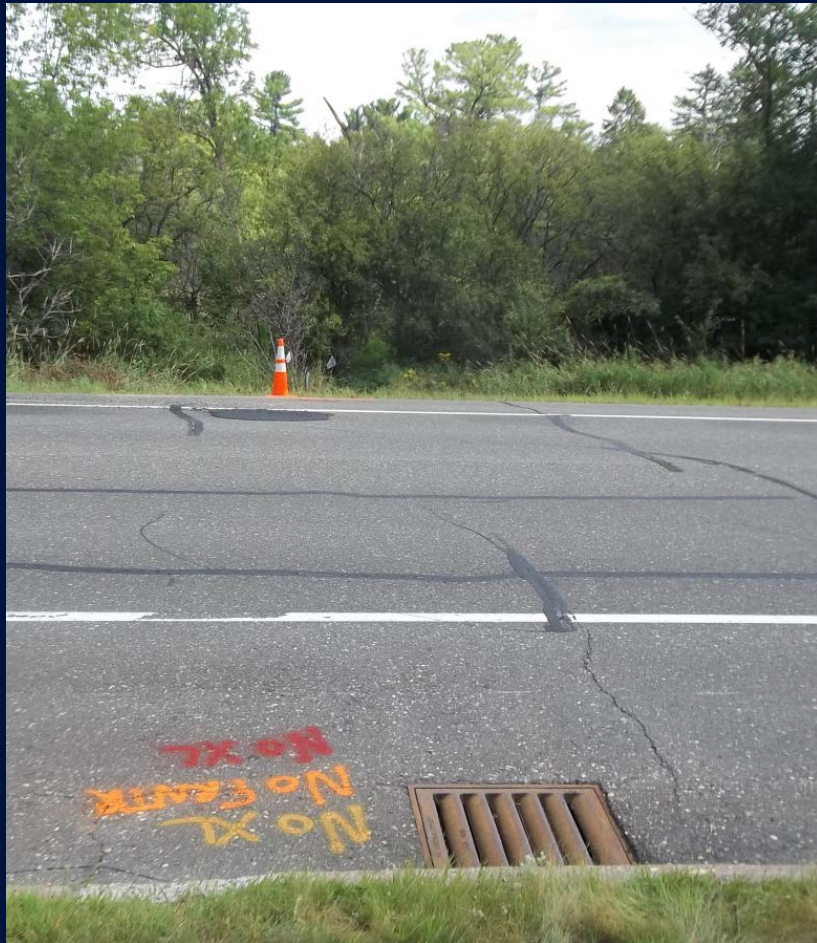
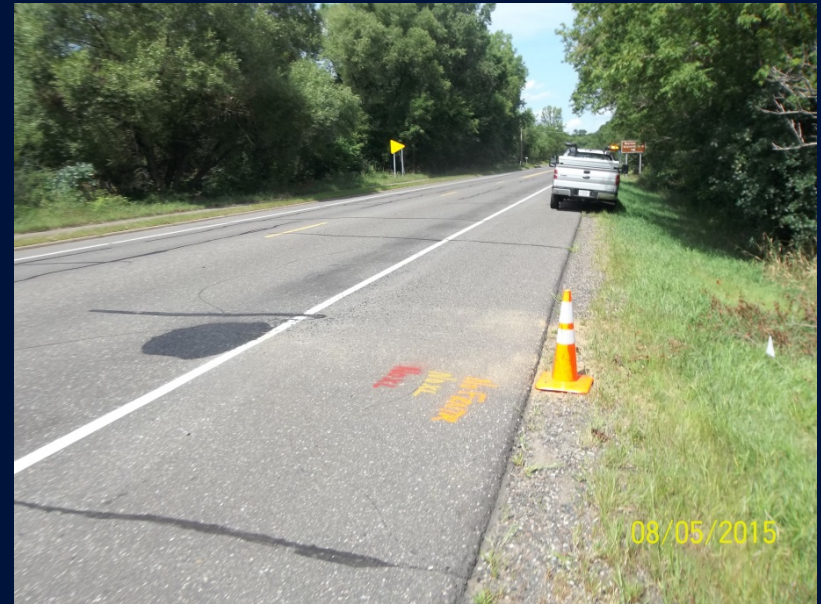
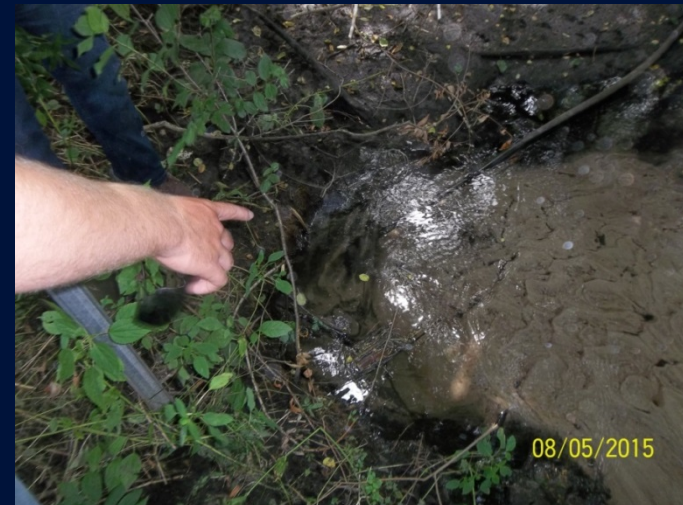
MN 95 2015 Eric Brenna

Typical Culvert Failure has a pavement patch

Water flows along the outside of pipe carrying road fill away.

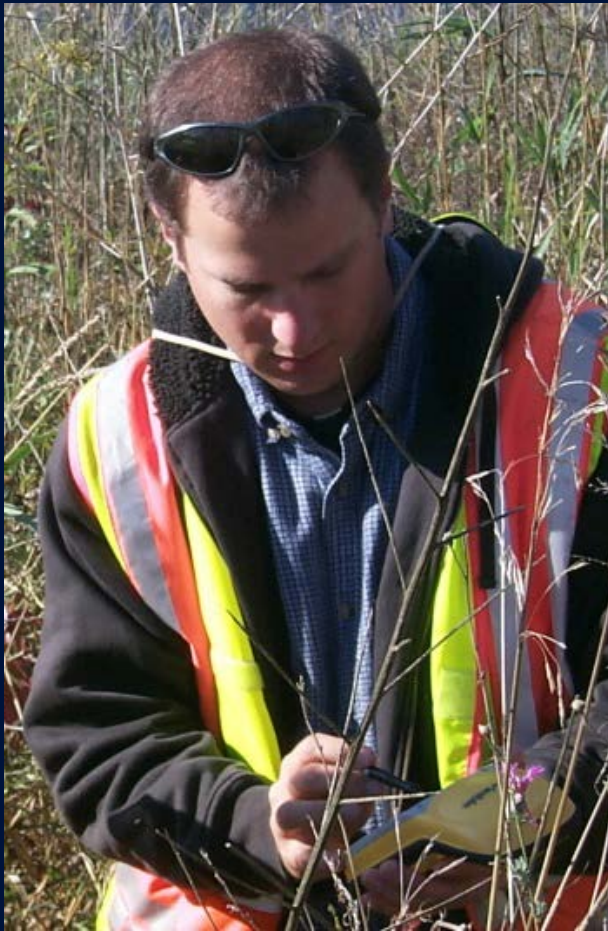
HydInfra Inspectors inspect drainage features with Trimble GPS devices

(Terrasync or ArcPad software)

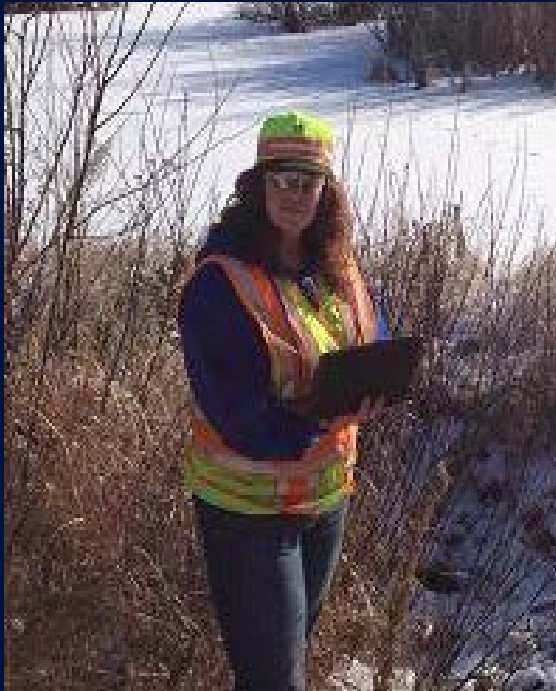
Maintenance records Culvert Repair Cost with ArcGIS Online Application for iPad or PC

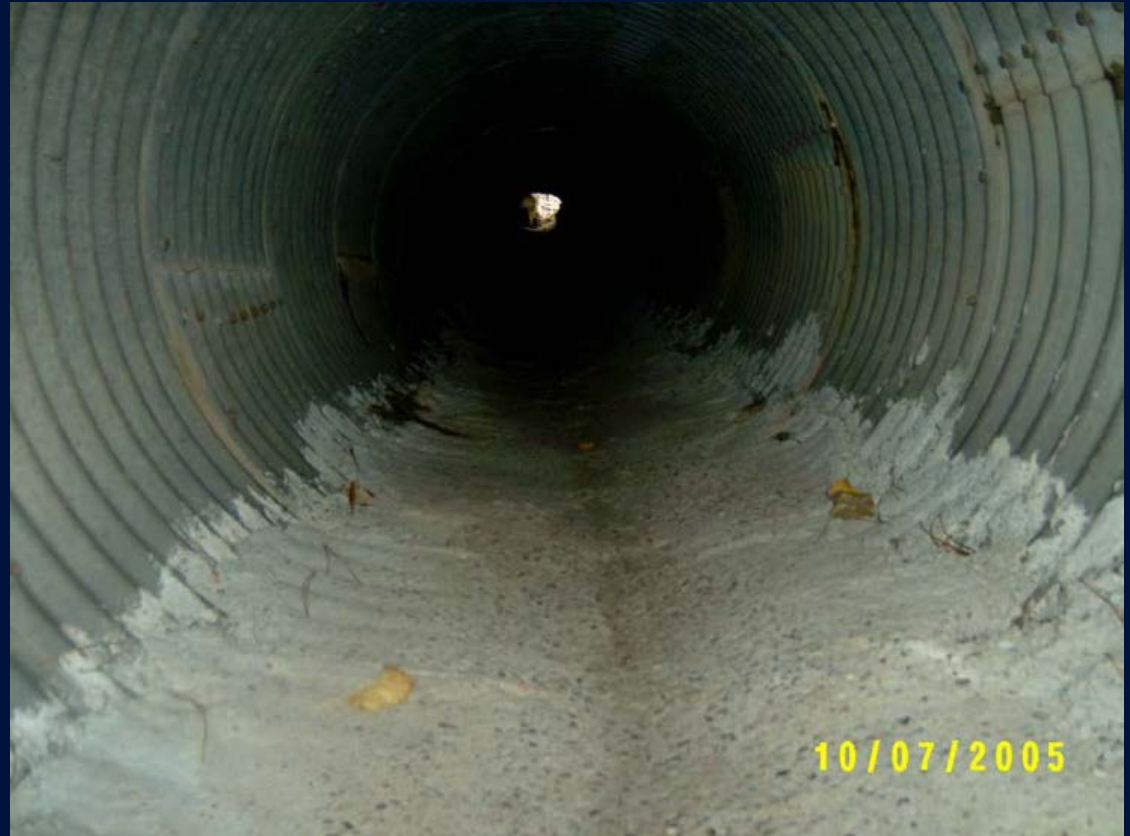
Fix the invert of the pipe by pouring, troweling or covering the invert with concrete or other material, usually in a larger metal pipe (accessible for interior repair). May also include filling voids in road bed. Repaired Length = length of paved invert.

Paved Invert repair, done in 1971, on steel plate culvert still looks good in 2015. Has a channel that keeps most flows away from galvanized steel sides. 2005 Photo from Bergstrand, D1

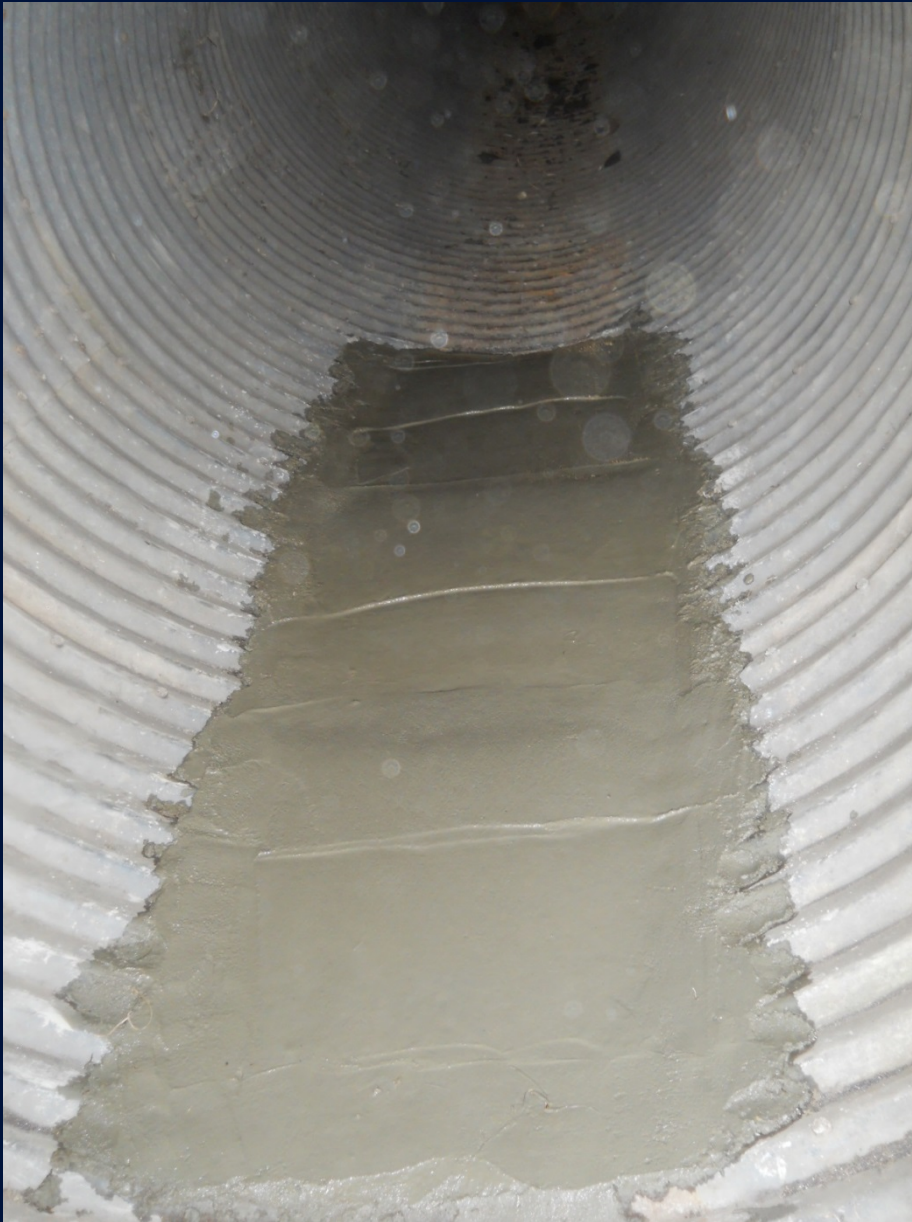
Fresh
Paved Invert

Pipe is
condition 2
if repair is
successful

D6 Rob Coughlin, 2013

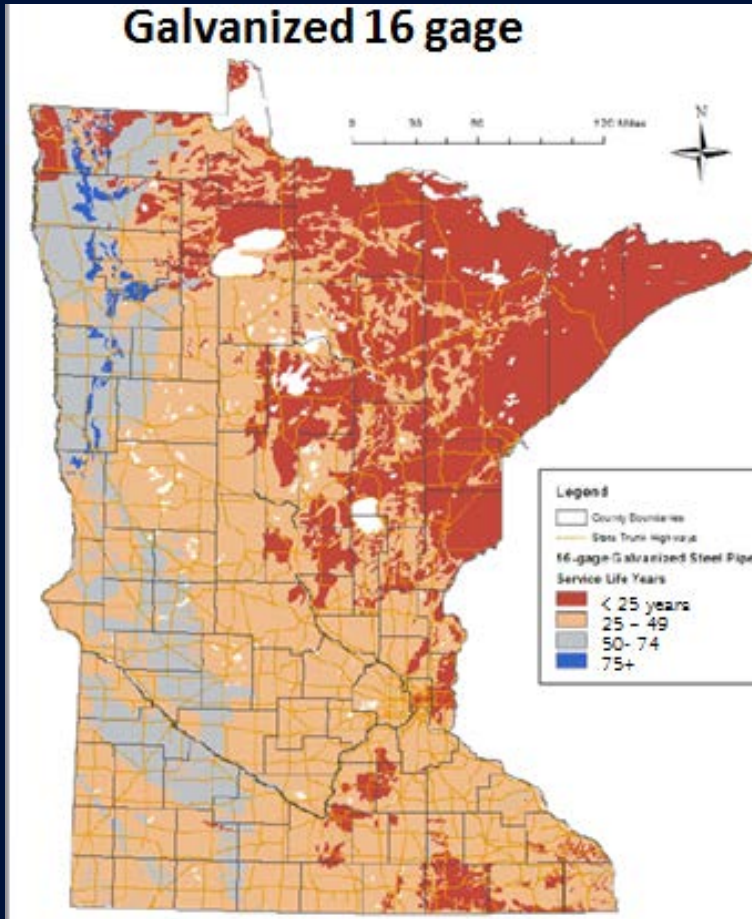
MnDOT Research shows projected lifespan for Galvanized Steel (red northeast MN is bad for galvanized)

Research focusing on the projected lifespan of steel pipe is underway. The map below shows roadside pH overlaid on NRCS pH data. Acidity, or low pH, is a factor in steel pipe deterioration rates. The research is being done by Barbara Burkholder Heitkamp, U of M.
