TAMS-HydInfra Training

Surveys' Condition Ratings for Pipes and Structures

HydInfra Inspection Manual

Culvert and Storm Drainage Systems

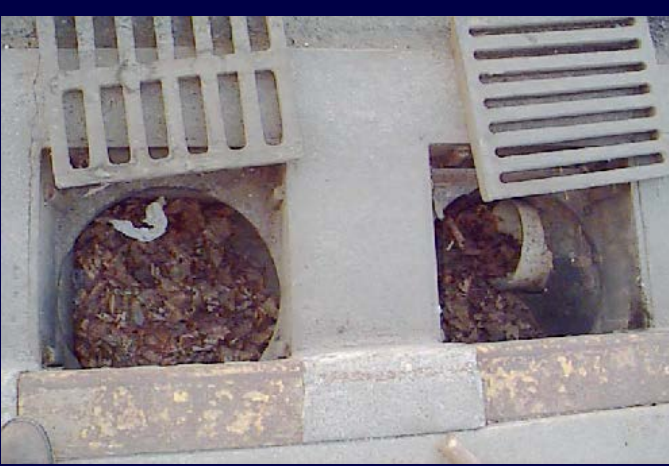
- Catchbasin - CB

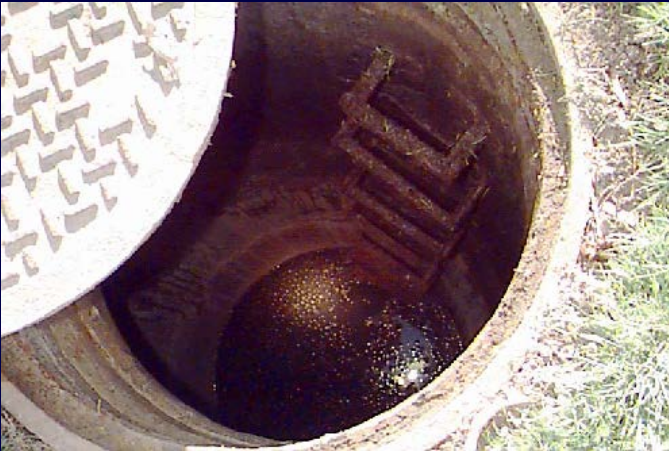
- Manhole - STMH

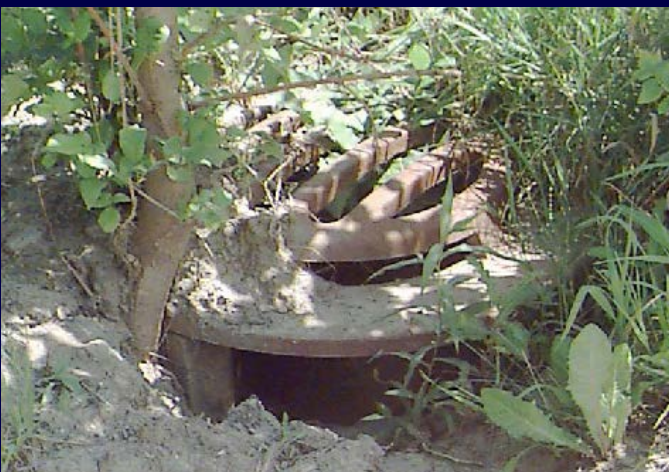
- Drop Inlet - DI

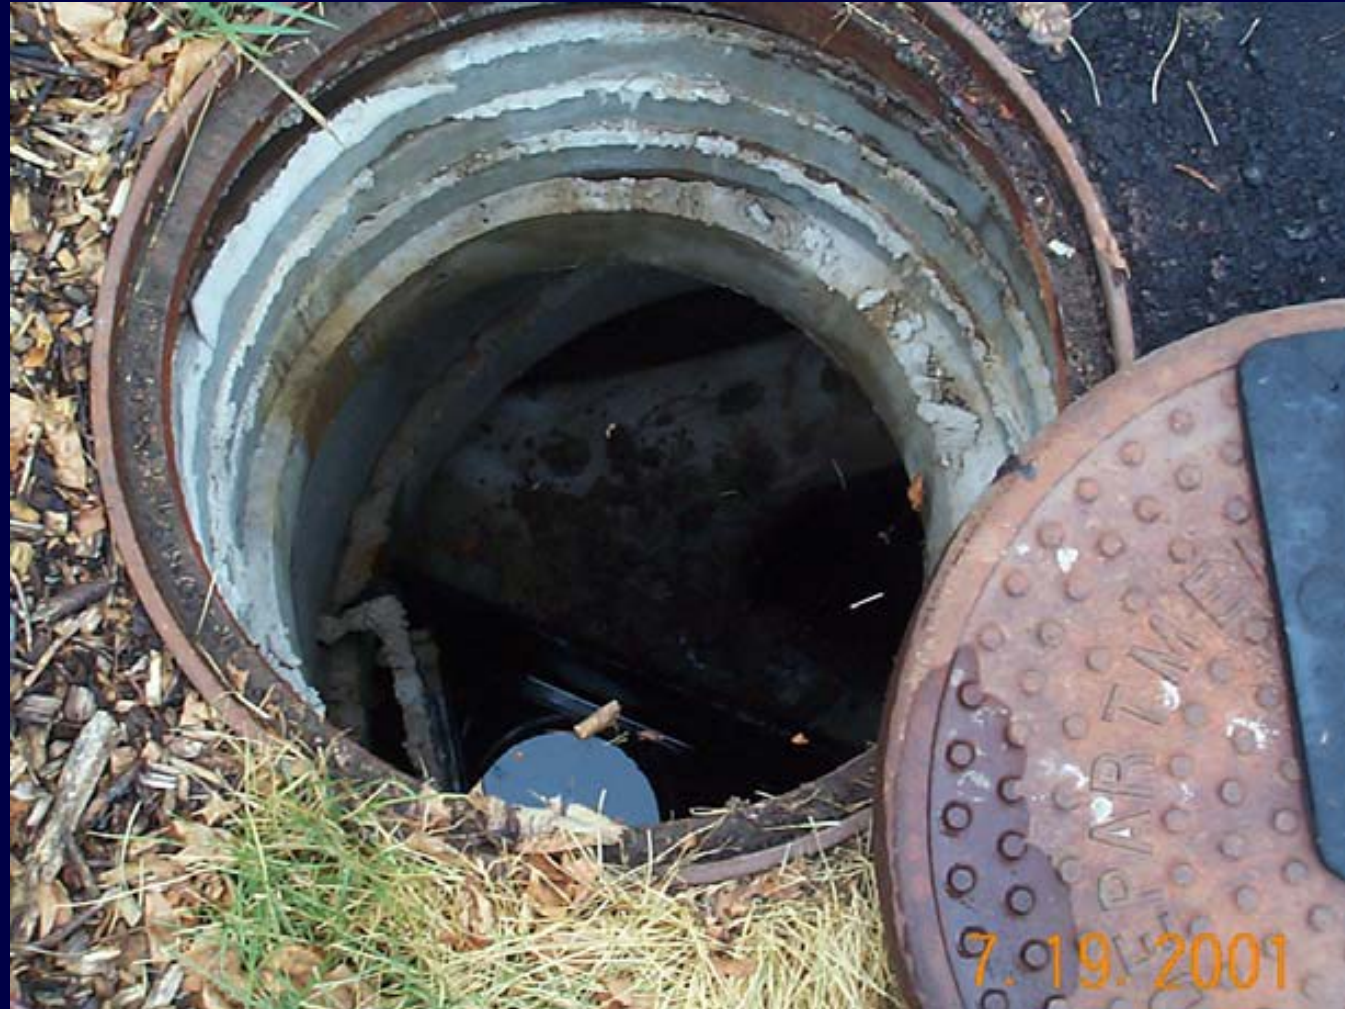
Manhole (solid cover) with too many rings

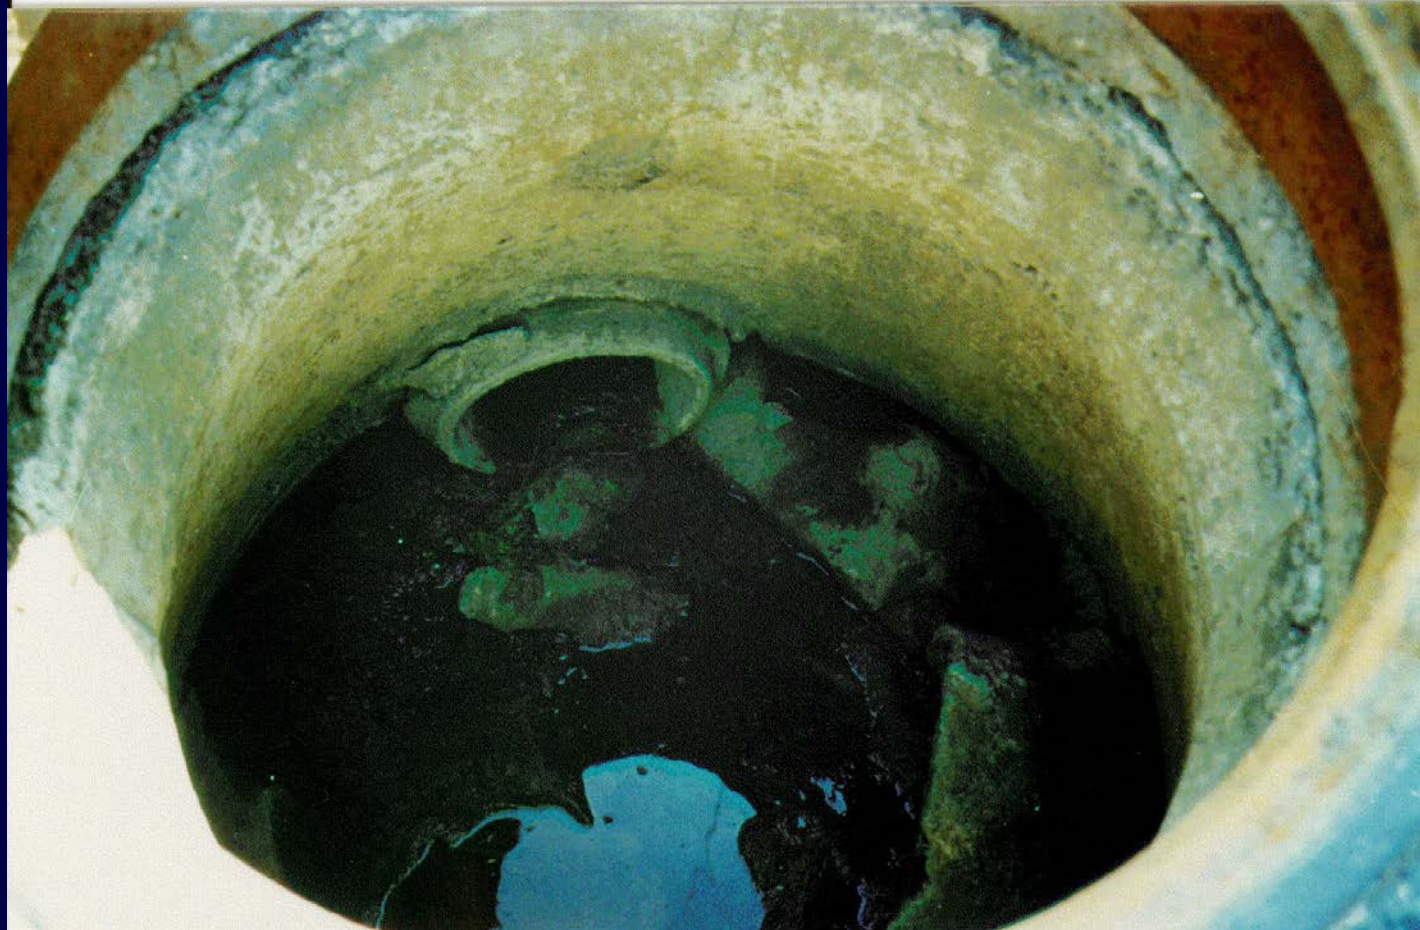
Look for gaps and cracks at rings, structure walls, connected pipes and invert.

Imagine water rising at the pipe inlet.

A **gap** between pipe and structure can cause piping and loss of road fill.

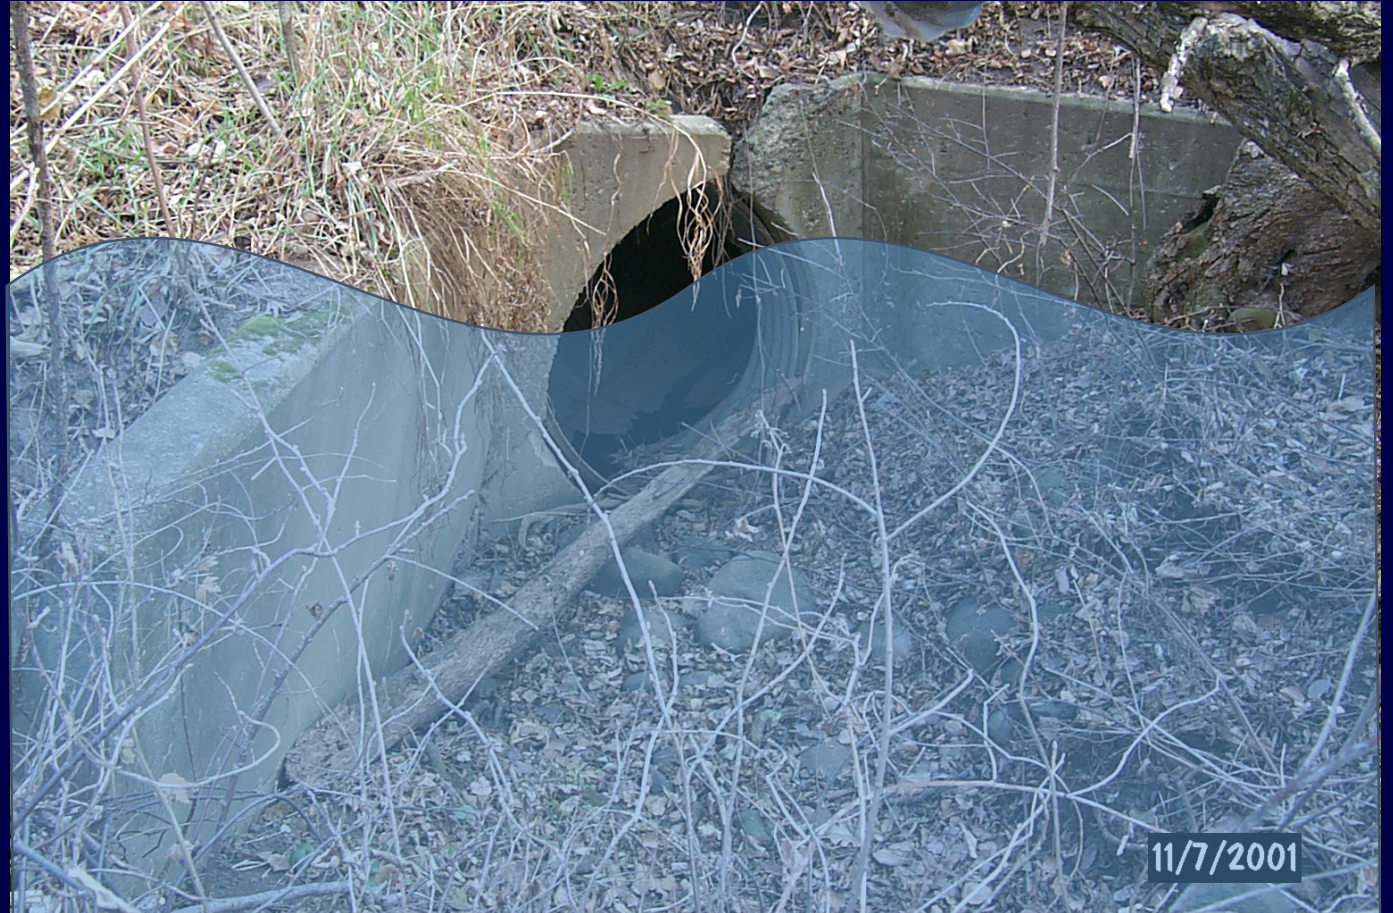
Is soil leaking through
structure walls?

Weakened?

Or worn but still okay?

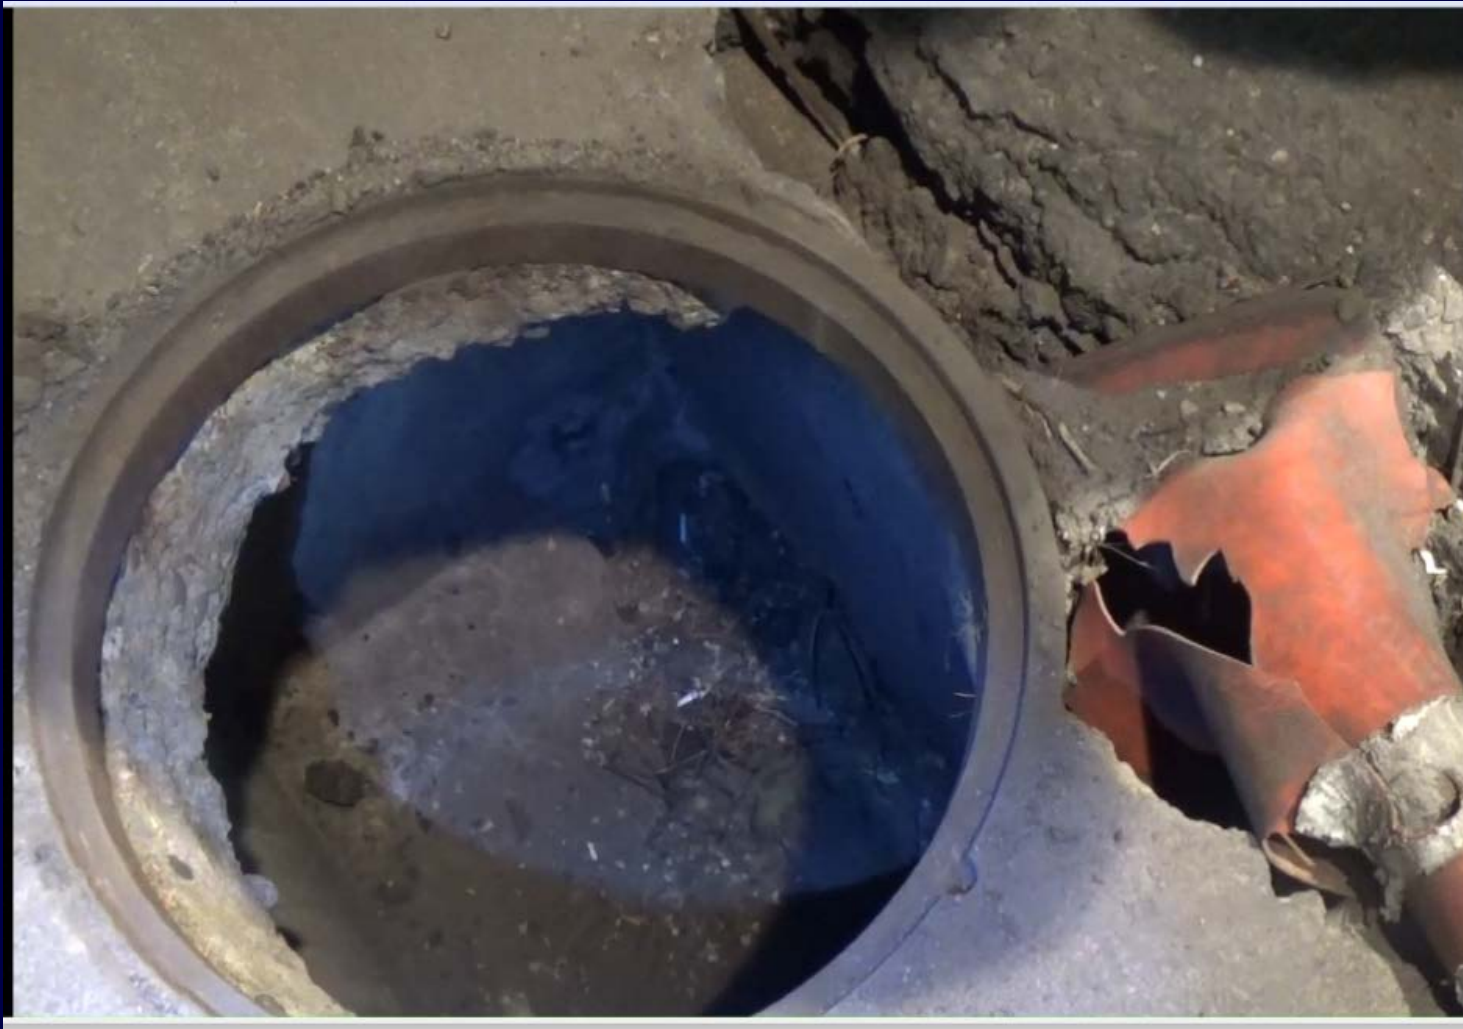
Loss of fill outside the structure points to a gap in the structure or rings.

Structures with gaps are Condition 4

- Holes
- Cracks with gaps
- Leaking fill
- Missing blocks

Replace structure or
rebuild to “**Repair Depth**”

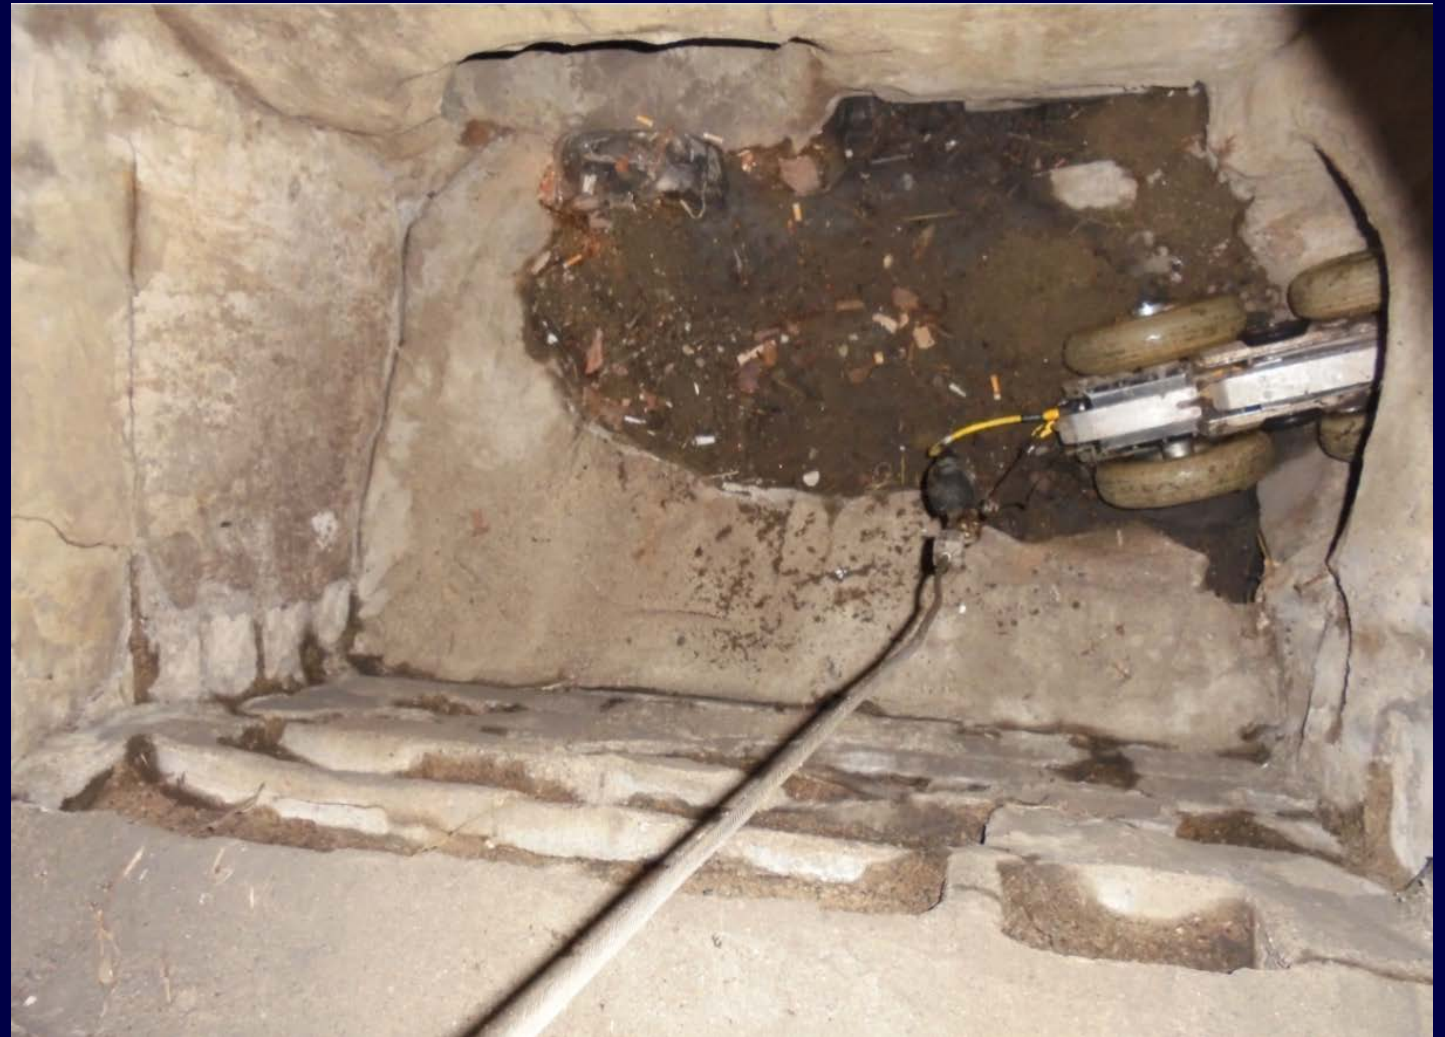
Settling in
pavement or curb
may indicate a
road void

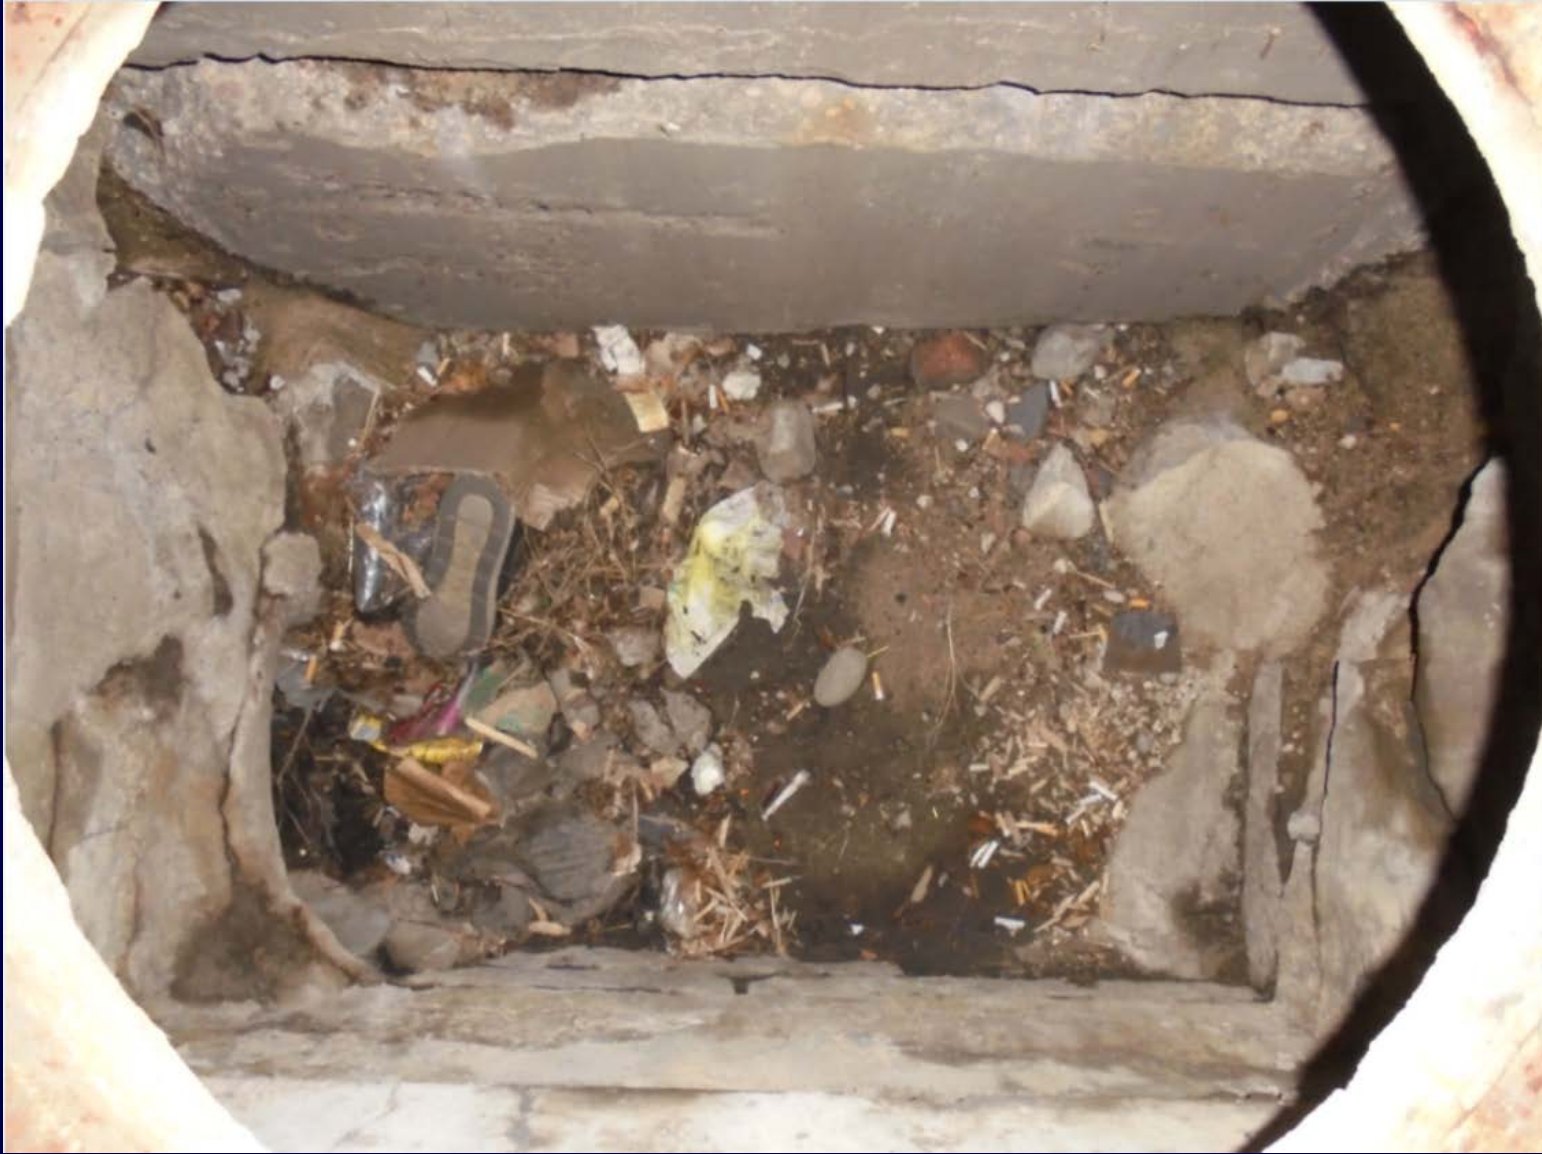
A pile of dirt
in the
structure
indicates a
road void

Concrete pipe fails most often when
Joint Separation and **Piping** causes **Road Void**

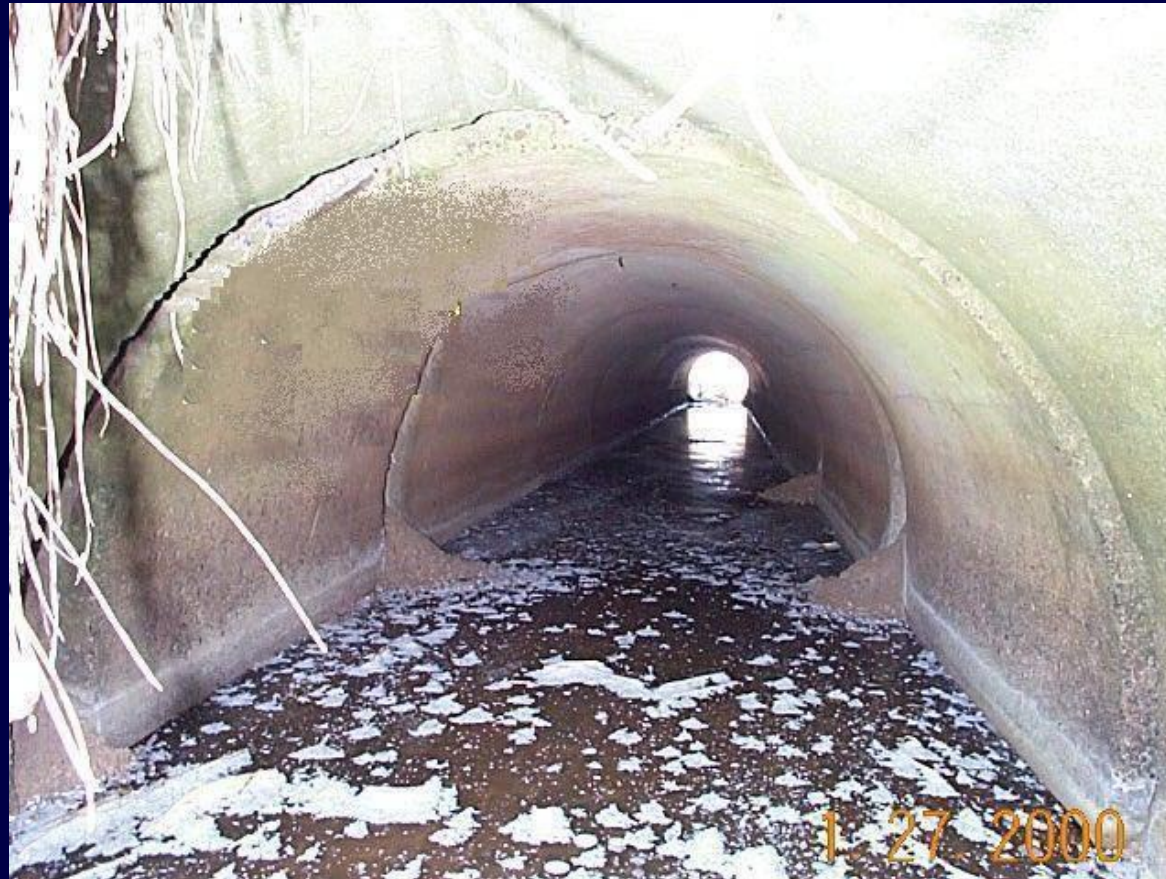
HydInfra data shows about 7% of MnDOT's
concrete pipes have separated joints

Piping looks like this –
water leaves the pipe at holes or joints and
flows along the outside

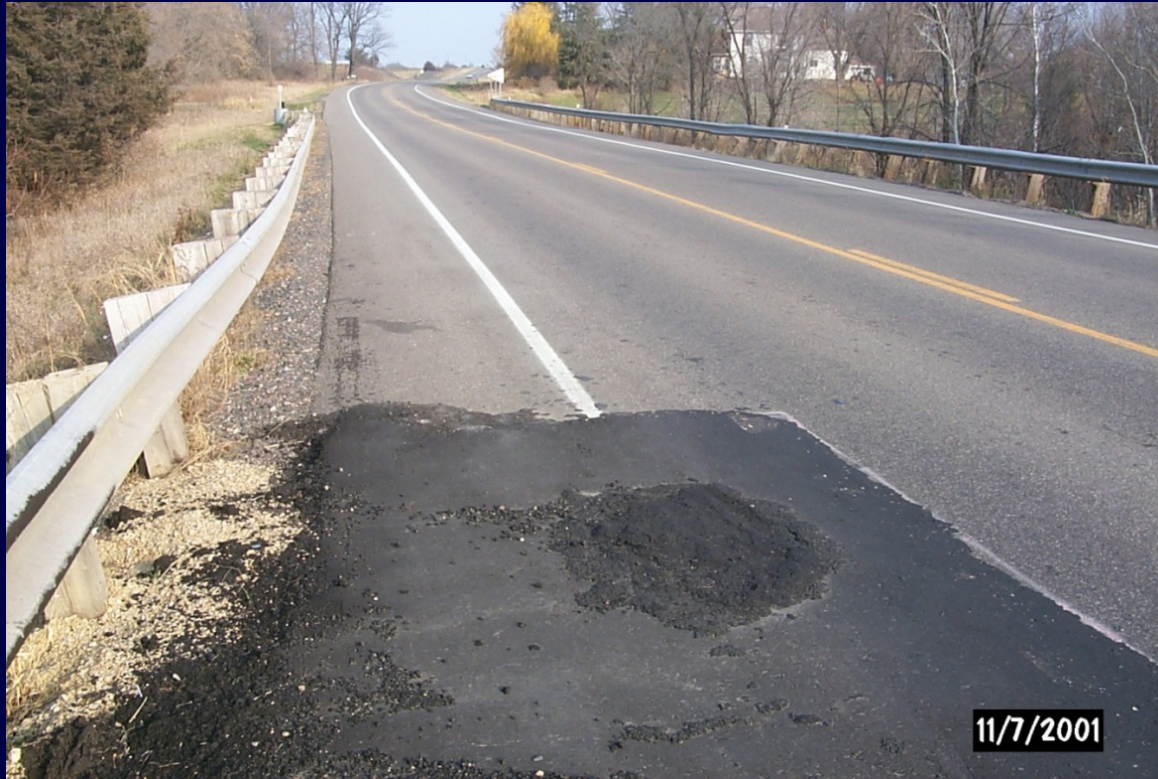
Condition 4 Culvert –
Gaps in culvert cause
piping and road void

Loss of road fill is Condition 4

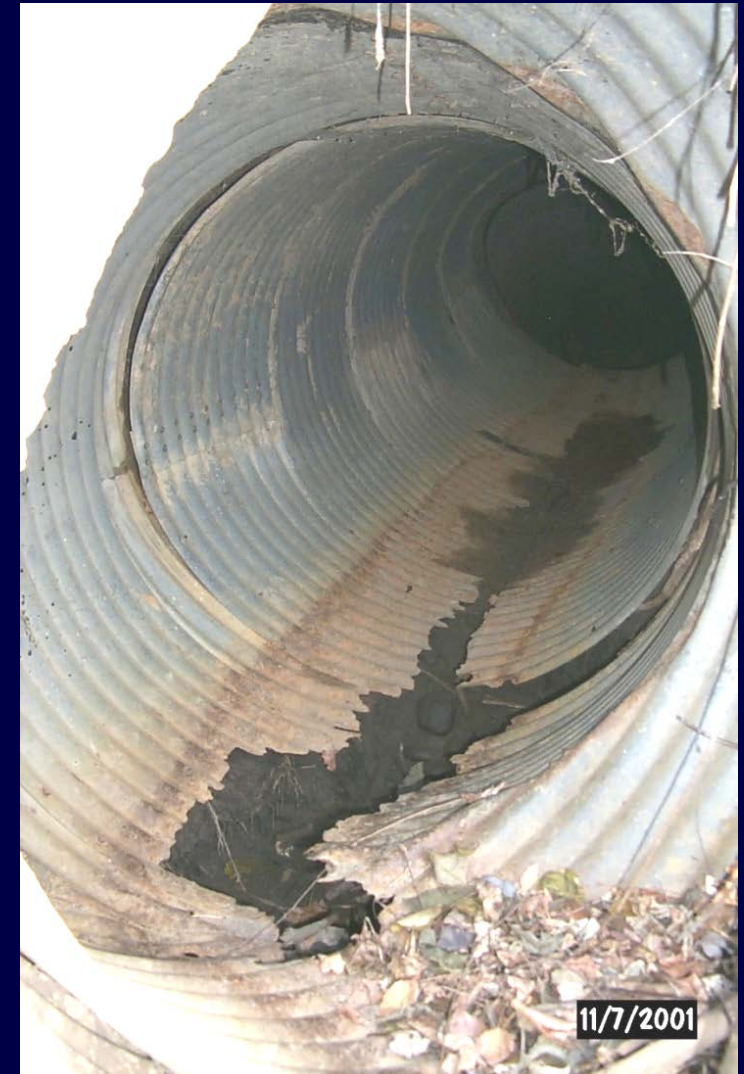
Does the structure have a restricted access because of an odd repair?

Needs a rebuild.

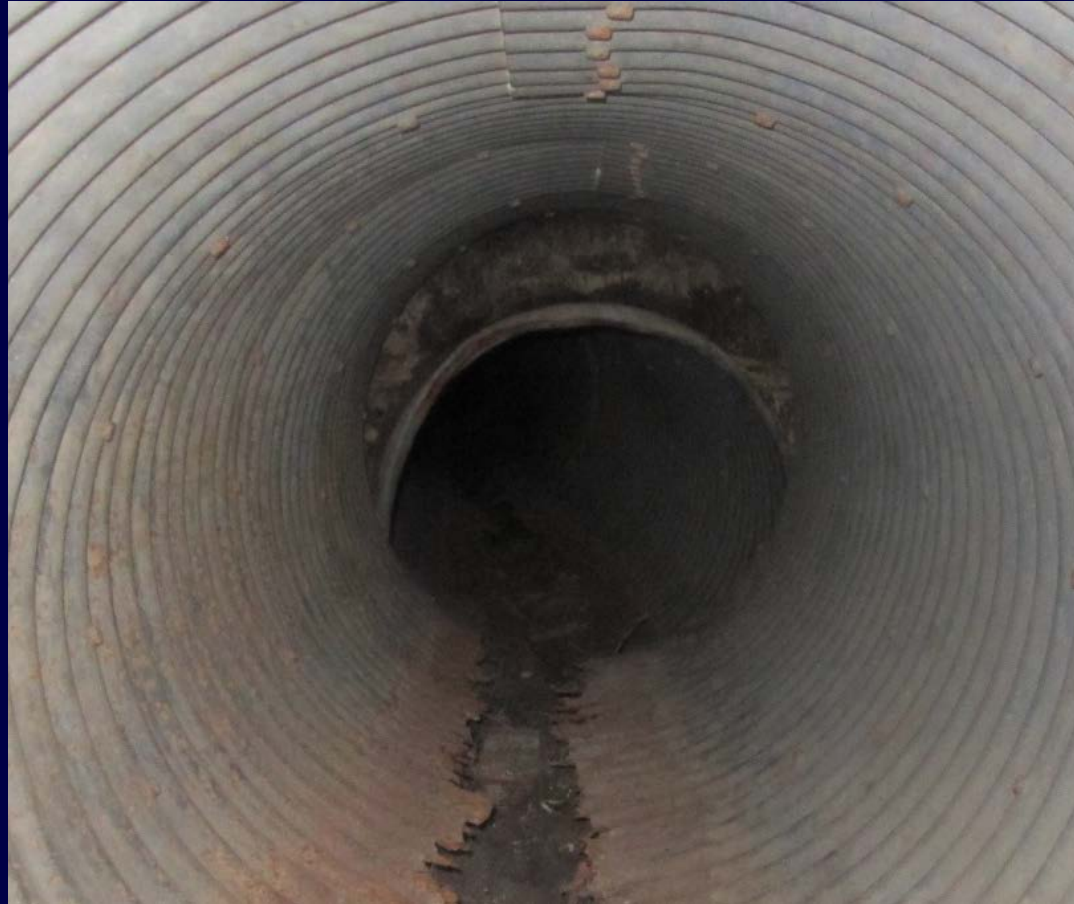
Slope failure
around a pipe or
structure is
Condition 4

Horseshoe-shaped slope failure

Chicken or Egg – did the leaking pipe
cause the slope failure or did slope
failure cause the leaking pipe?

Joint Separation and Misalignment
is rare in Steel pipe
and may indicate a slope failure

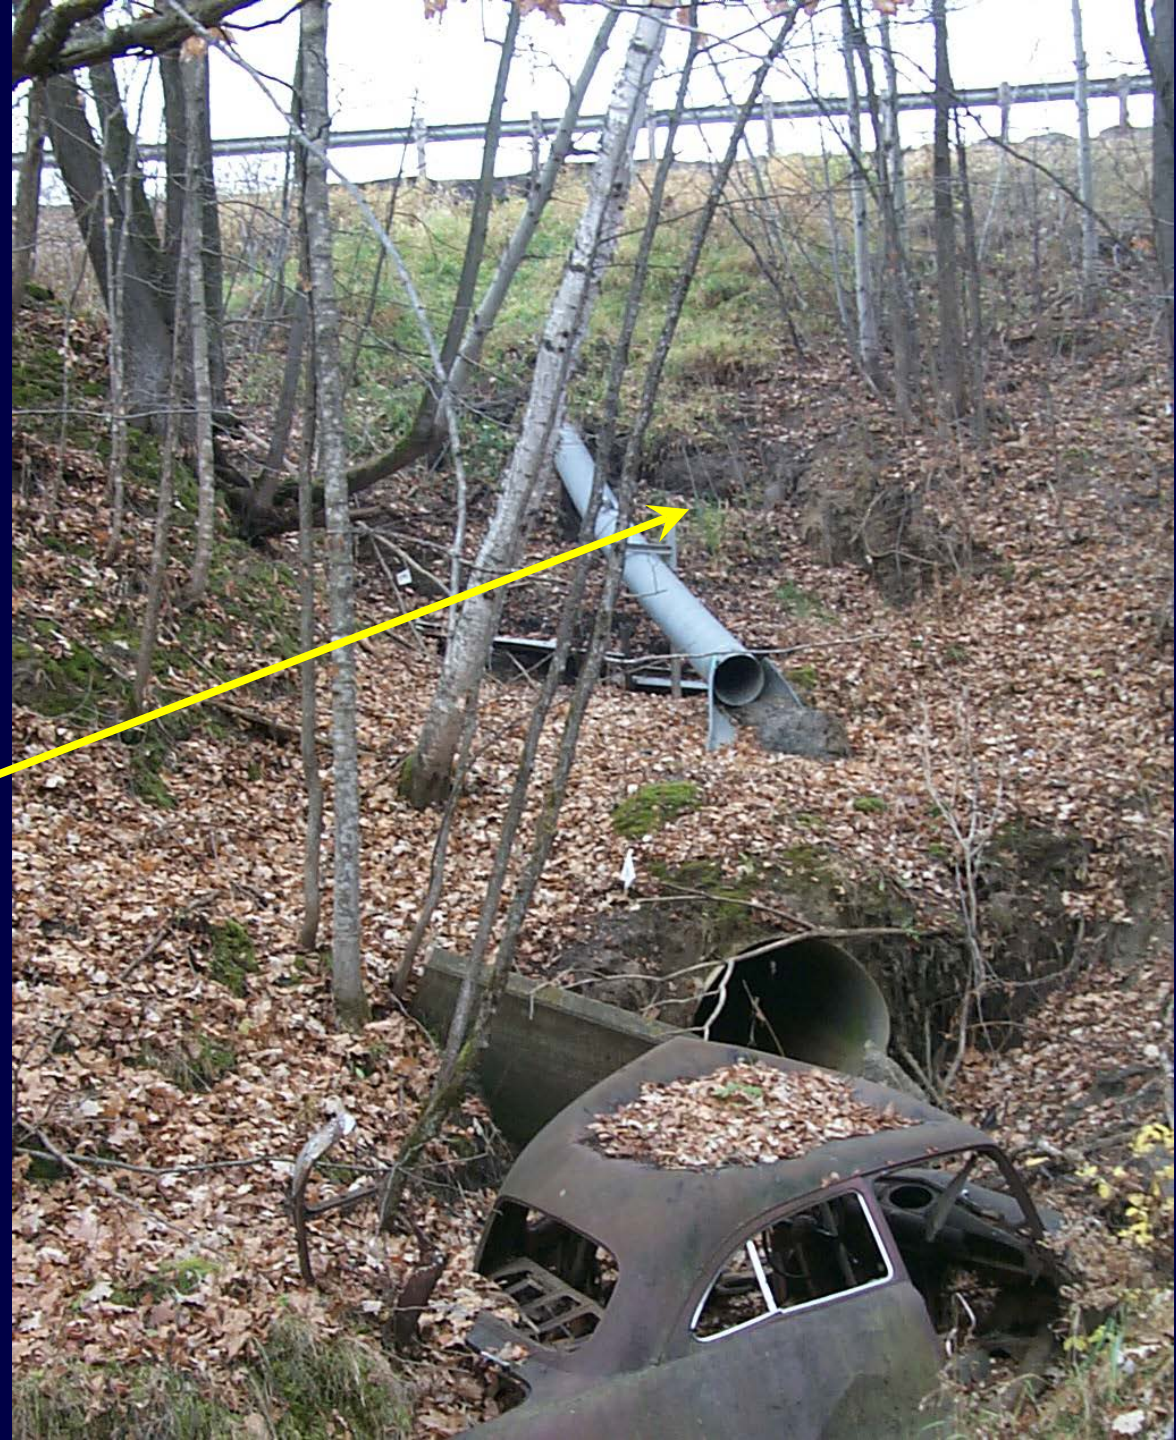
While some steep slopes are prone to failure **leaking pipes lubricate the slide**

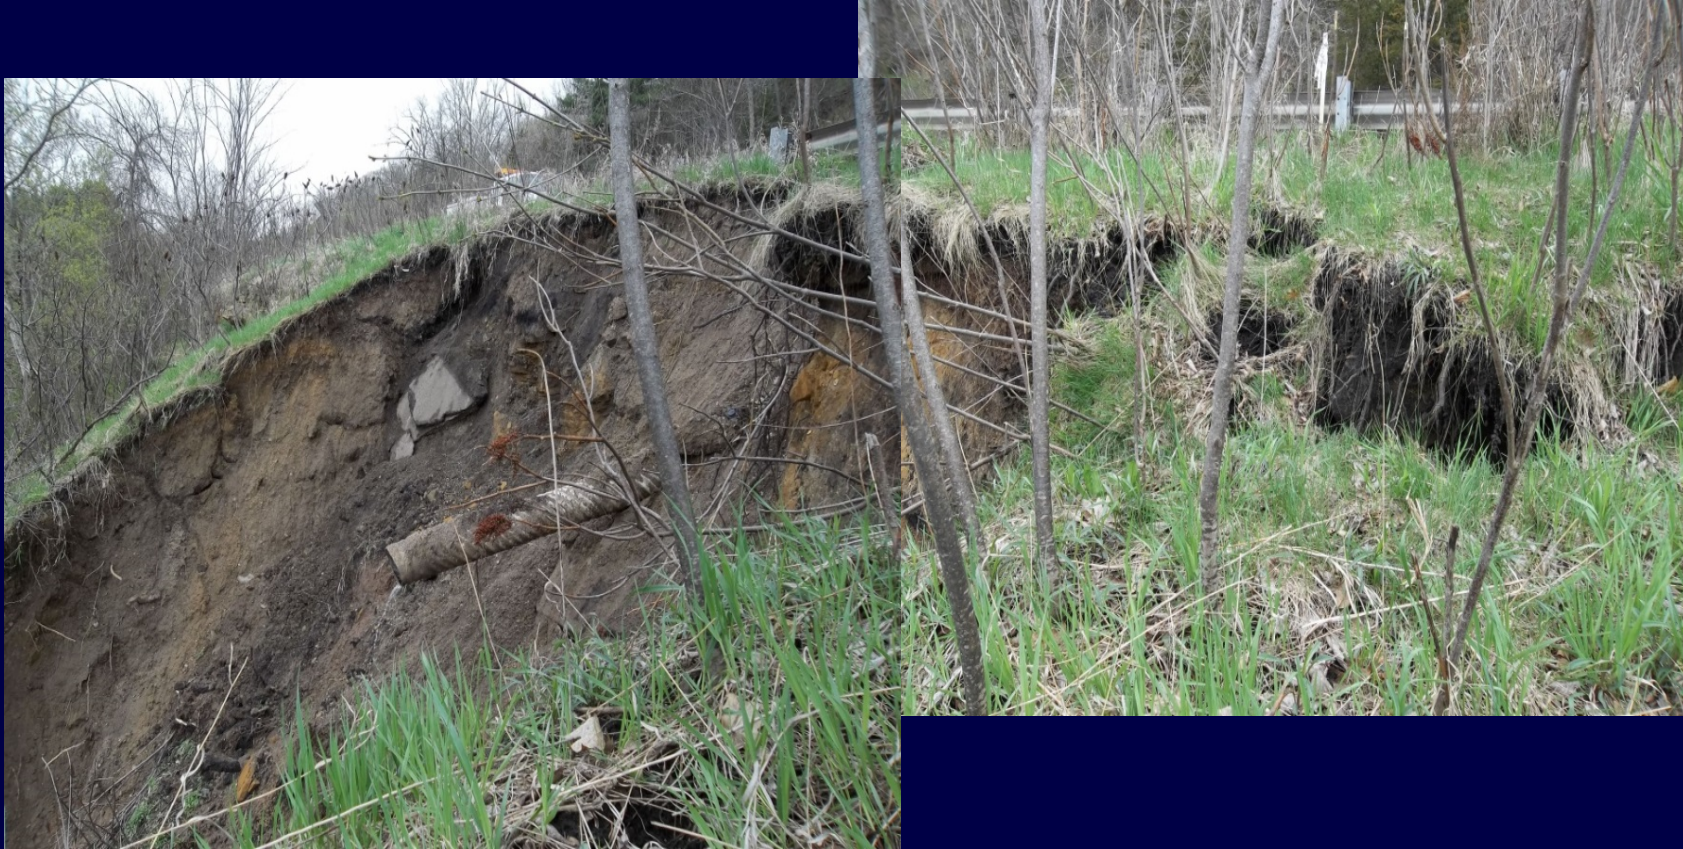
Or, the **downstream channel is lowering**, causing channel sides to fall in

In this case, a headcut in the downstream channel lead to culvert joint separation.

Another horseshoe slope failure downstream is a symptom of the lowering gully.

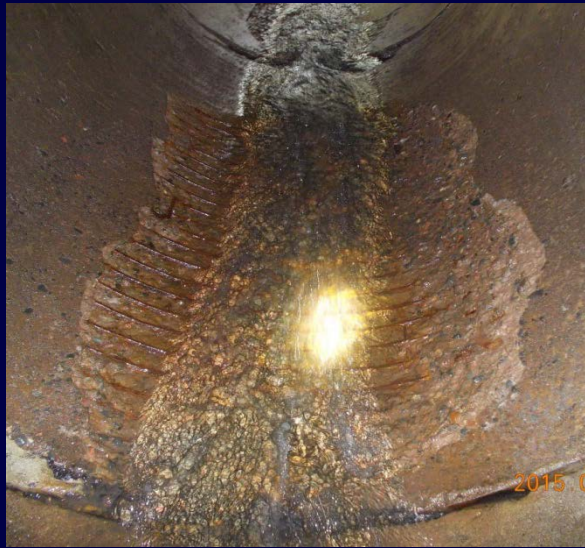
Abrasion from rocks
District 1 Duluth

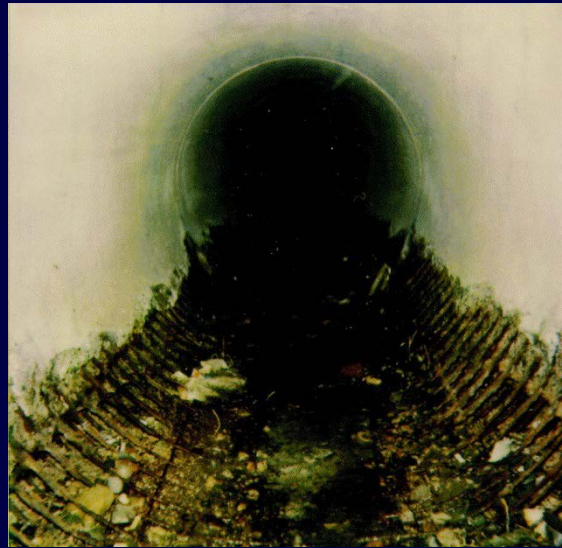
Acidic factory
discharge,
I-94 St. Paul
Metro District

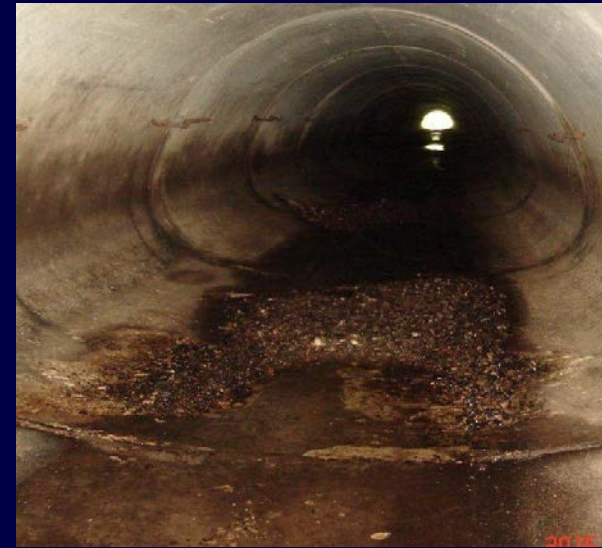
Bad concrete mix
in alternating pipe
sections, District 3
Baxter

Porous weeping patches
indicate bad concrete
material

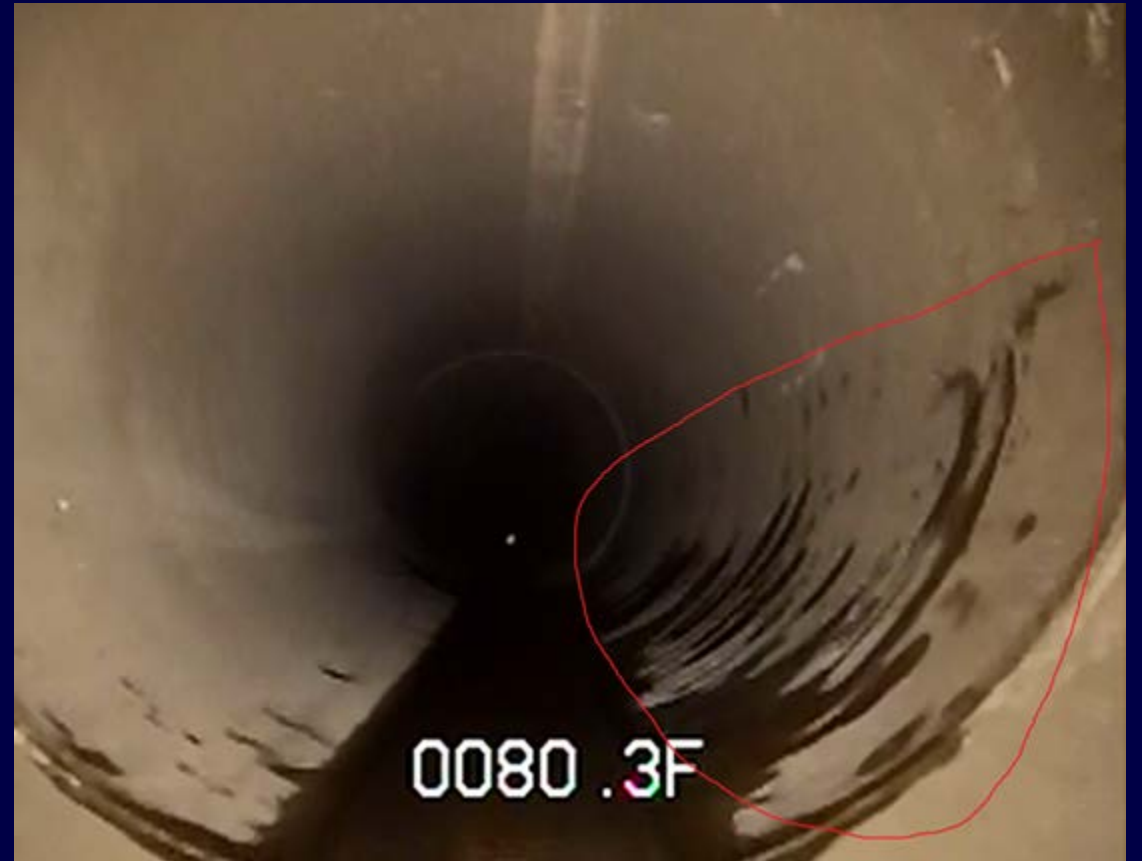
D7 MN Highway 22, 2014, Post-construction video

The pipe photo shows water trickling down the
inside wall through perforations or honeycombing.

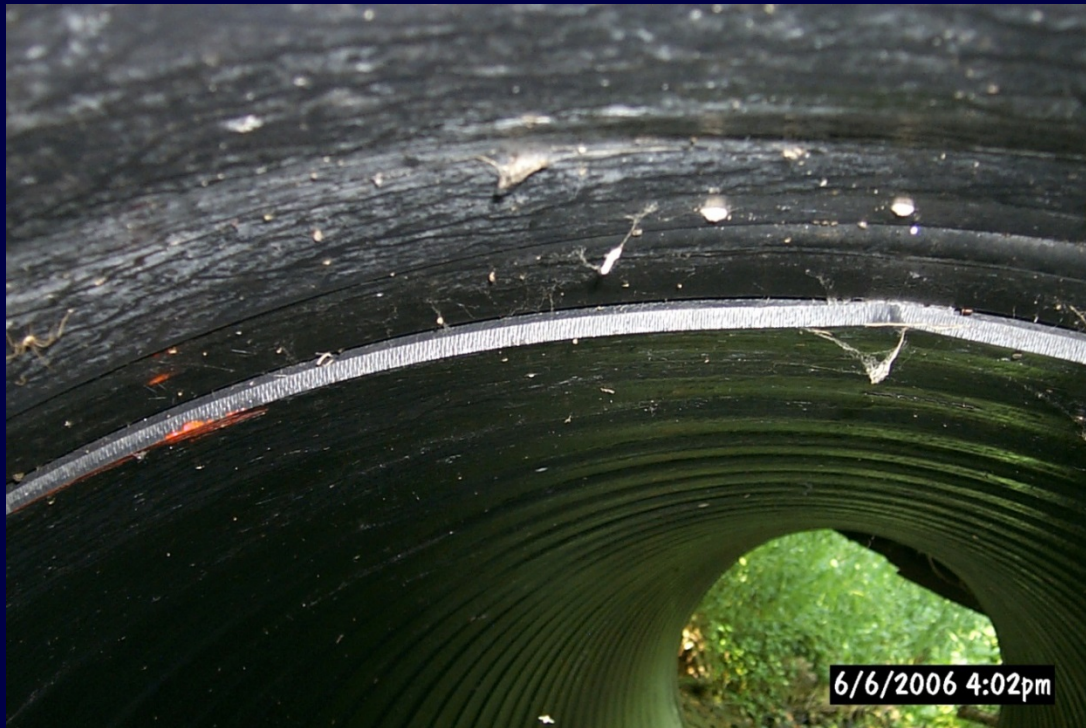
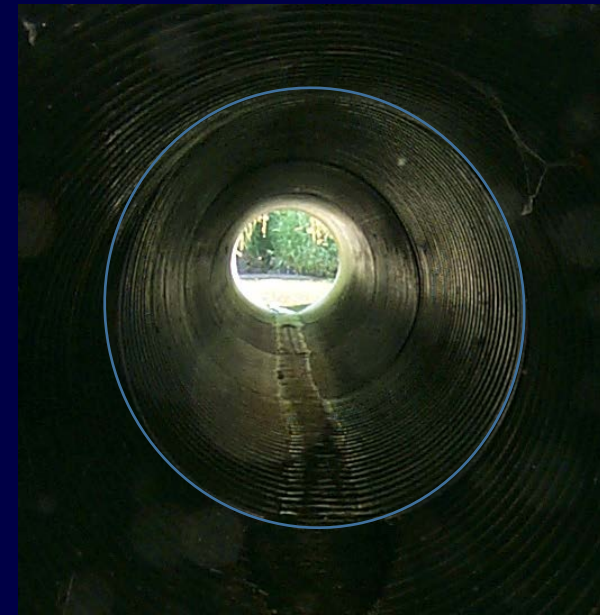
Bad Resin 1996 HDPE pipe shows Deformation, Misaligned and Separated Joints

Photo above shows 5% Deformation (rotated)

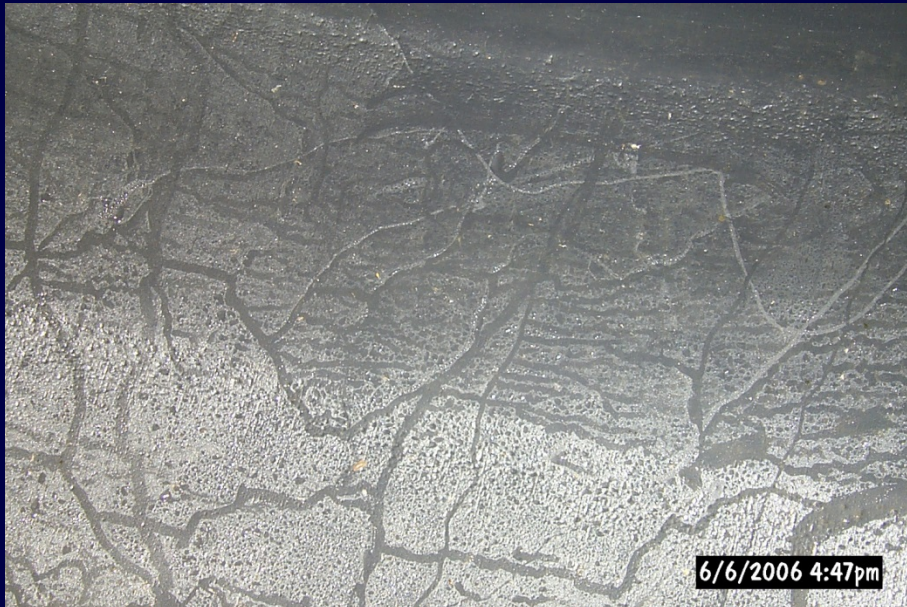
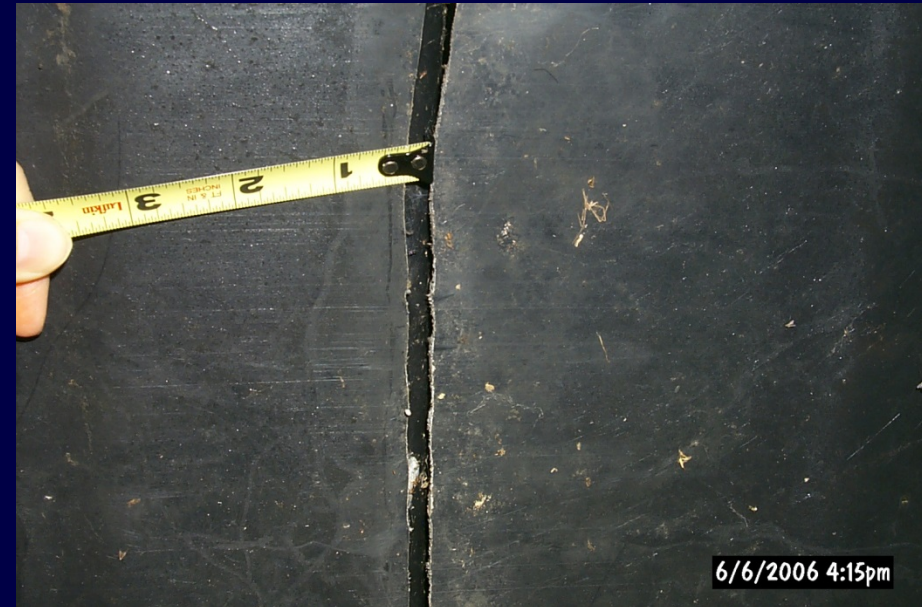
HydInfra ID 36918 has **manufacturing defect** in pipe material

1996 **bad resin** HDPE
has patterned surface and cracks in 2006

Resin Specs have been changed since this pipe was
manufactured

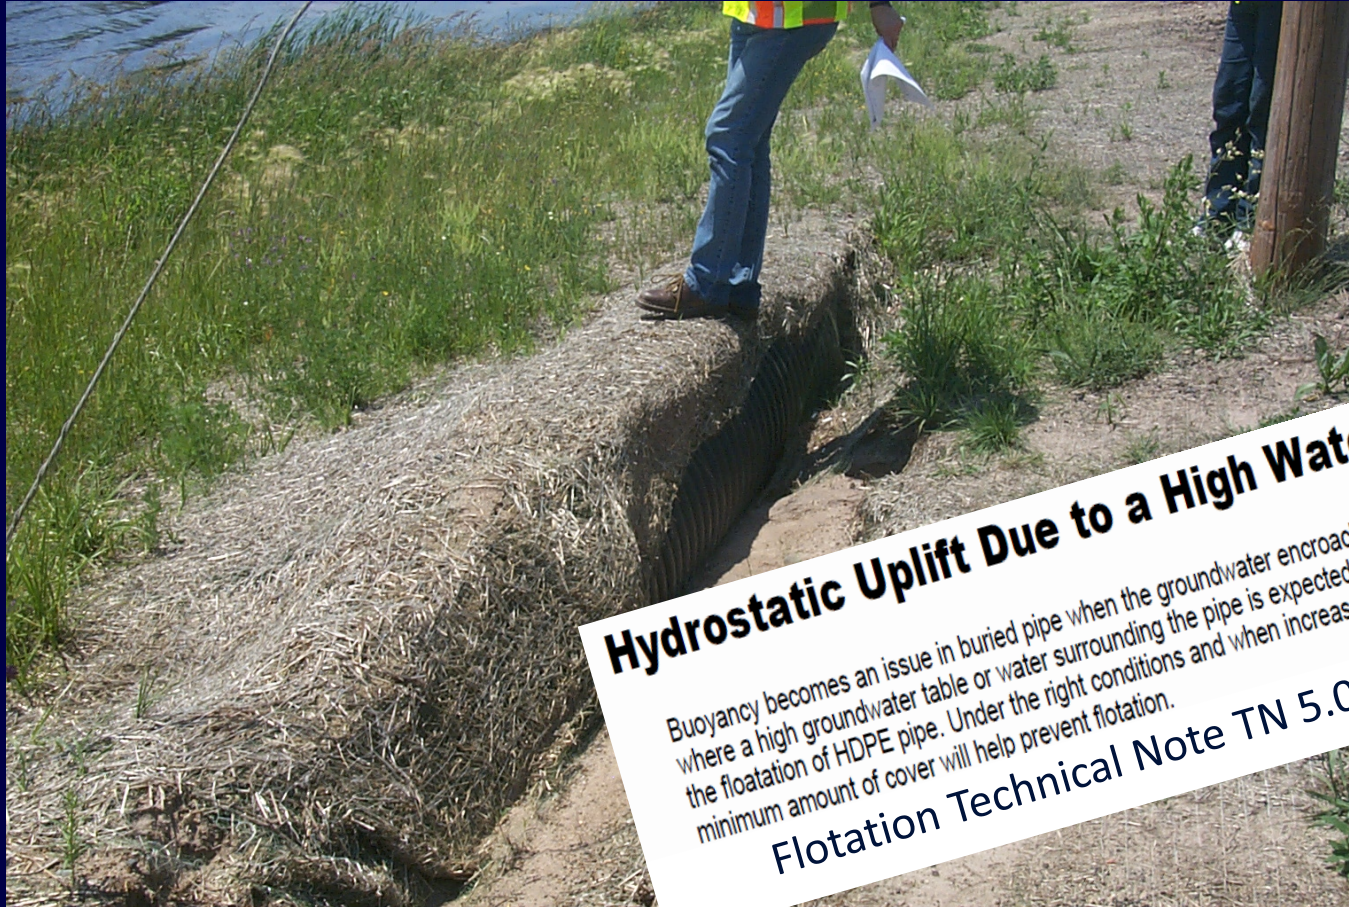
Construction change caused **Floated** HDPE

Pipe was re-routed across road inslope with too little cover (about 6 inches). High water or frost heave can cause the pipe to “float”.
