TAMS-HydInfra Training

Surveys' Condition Ratings for Pipes and Structures

HydInfra Inspection Manual

Culvert and Storm Drainage Systems

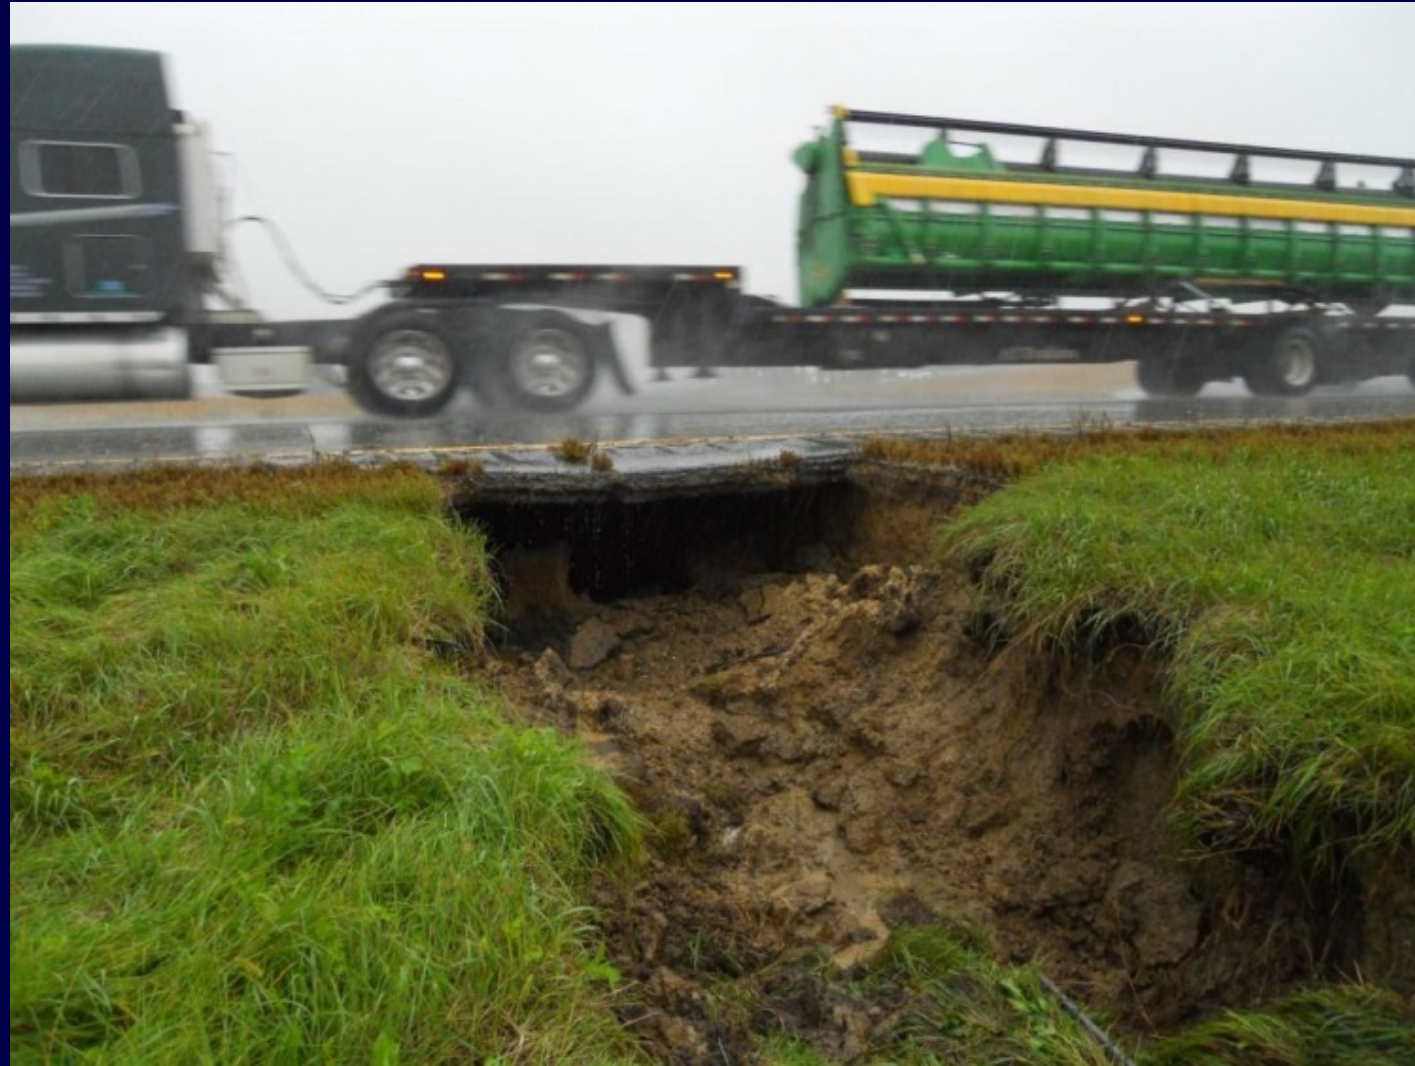
Big storm + bad pipe = wrecked road

We could have fixed it cheaper, sooner.
