# Put Your Drainage Asset Management System to Work

Adapted from Presentation at NHEC  
August 2014, Iowa City Iowa

Bonnie Peterson  
MnDOT Hydraulics

Culvert and Storm Drainage System  
Inventory and Inspection Program

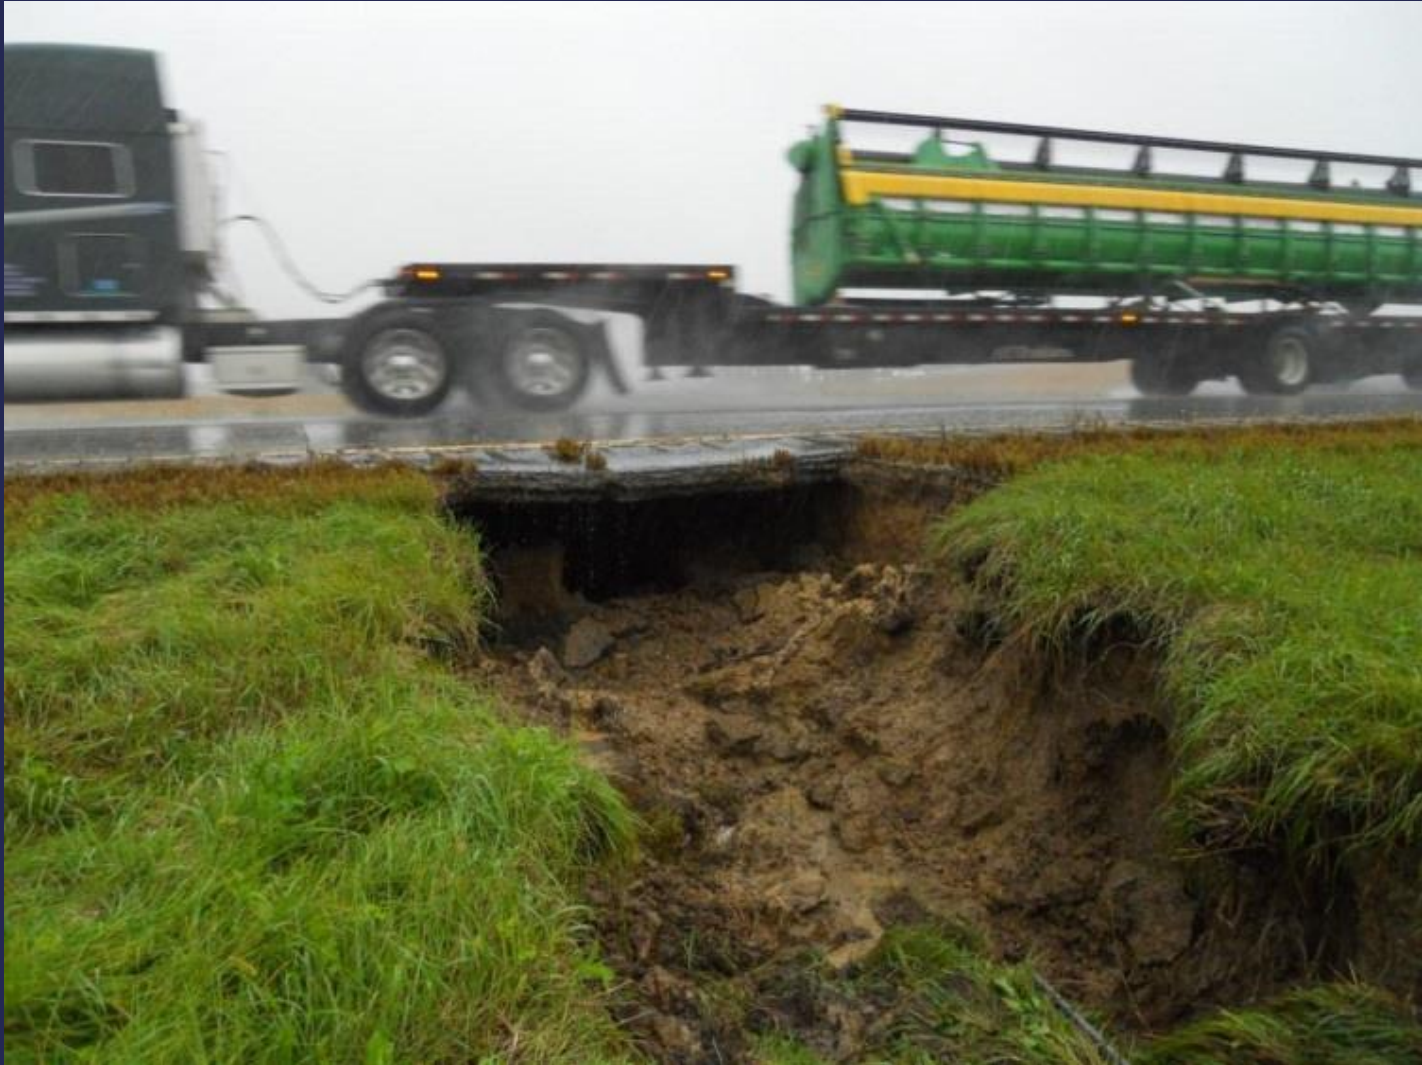
# Big storm + bad pipe = wrecked road

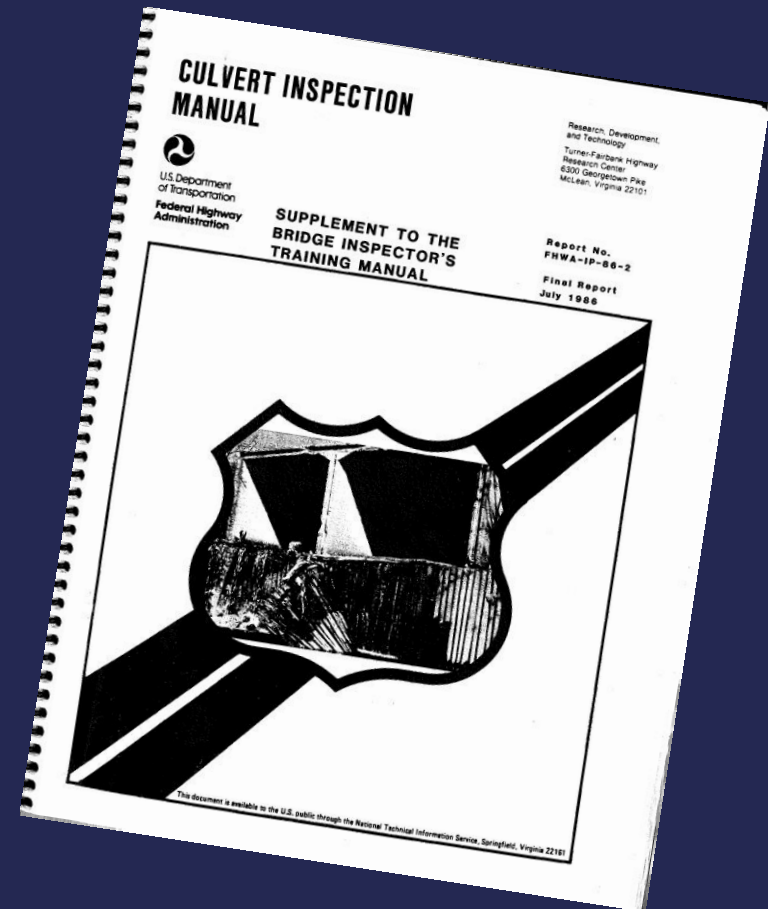
# HydInfra sprang from the 1986 Culvert Inspection Manual

with some  
important  
differences . . .

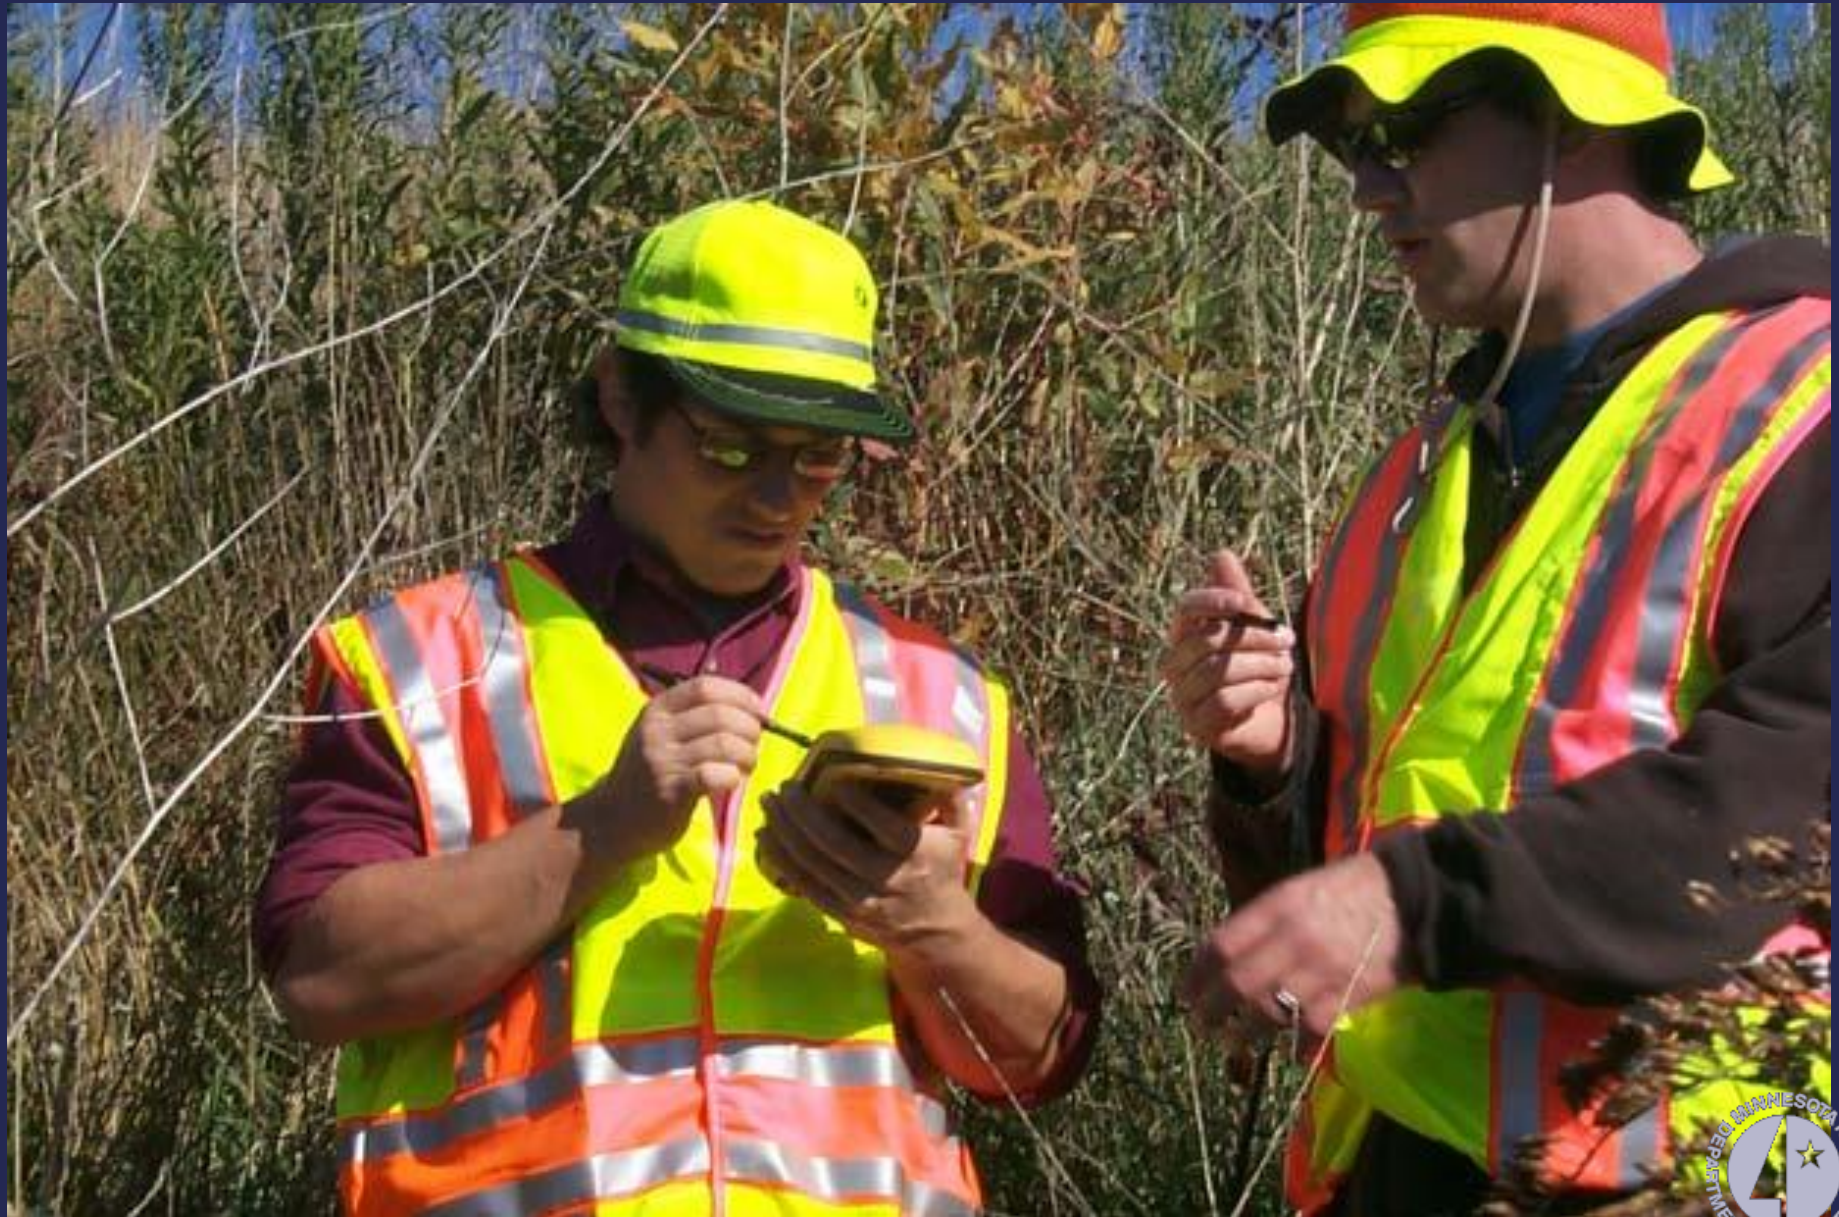
# GPS Inspections for mapping in GIS

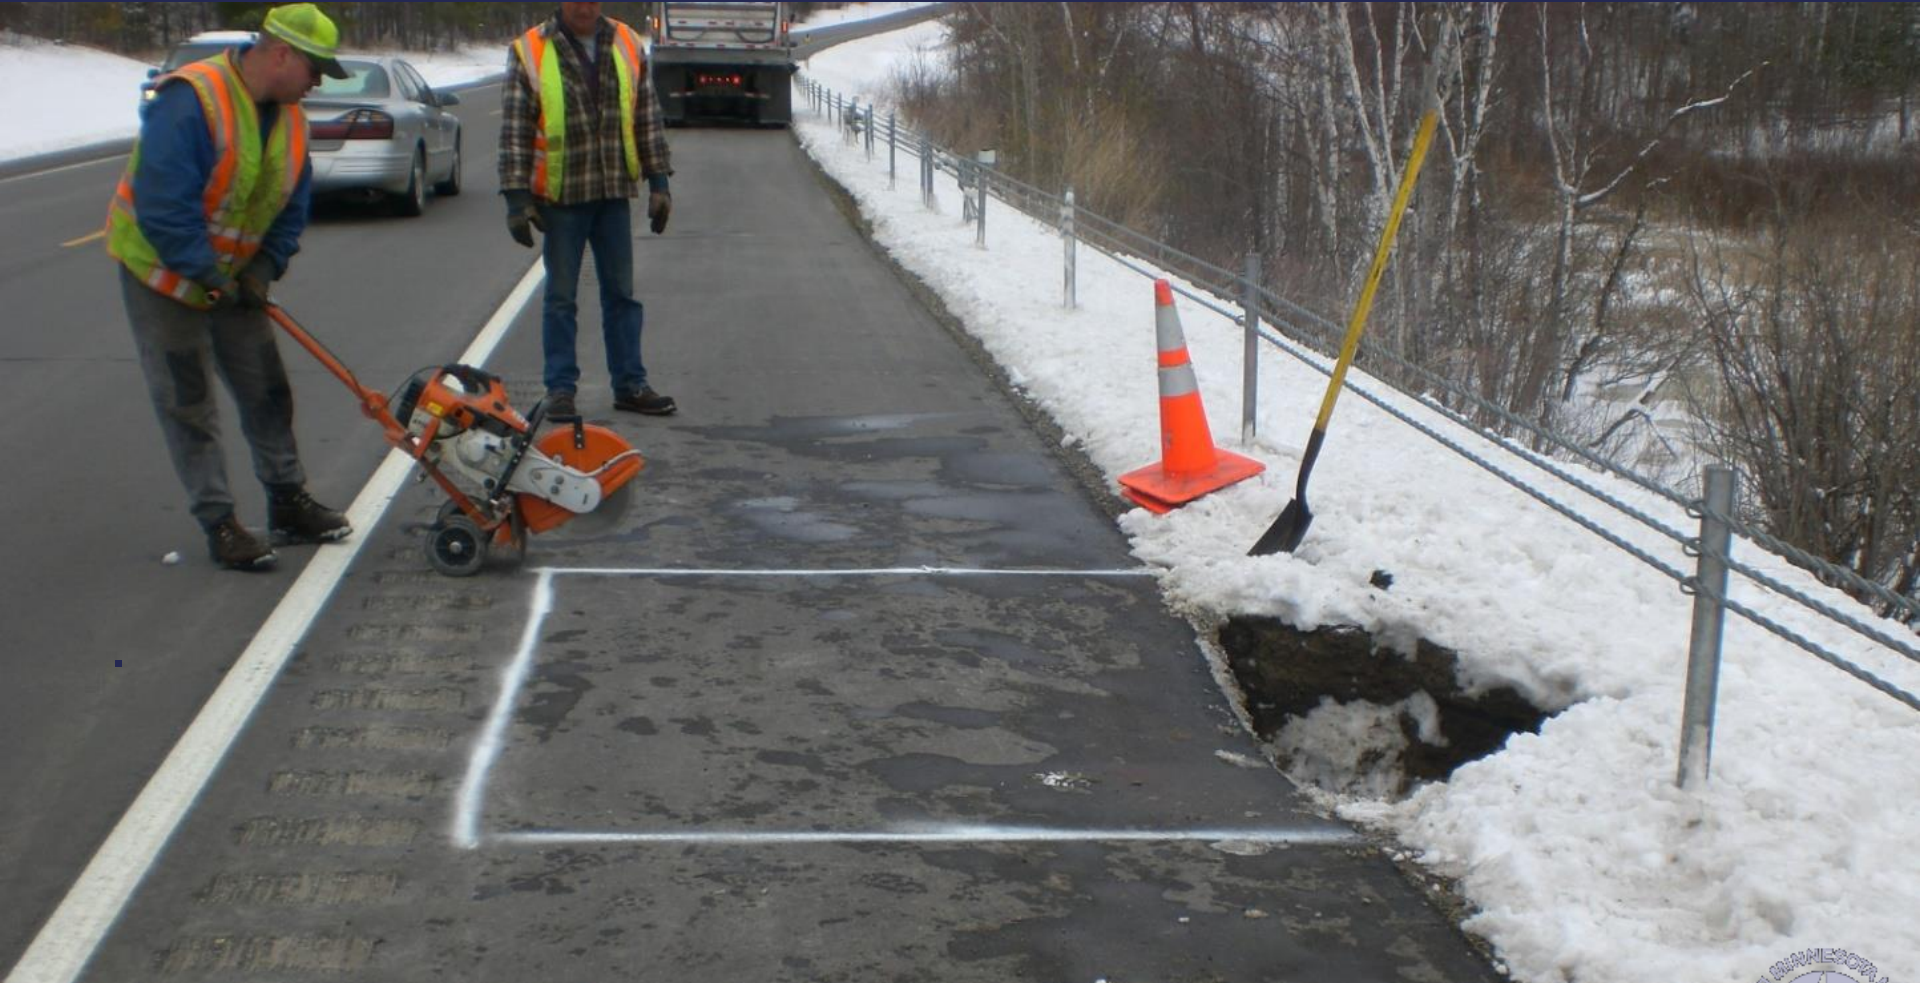
# Know which pipes to fix before the paving project (not after)

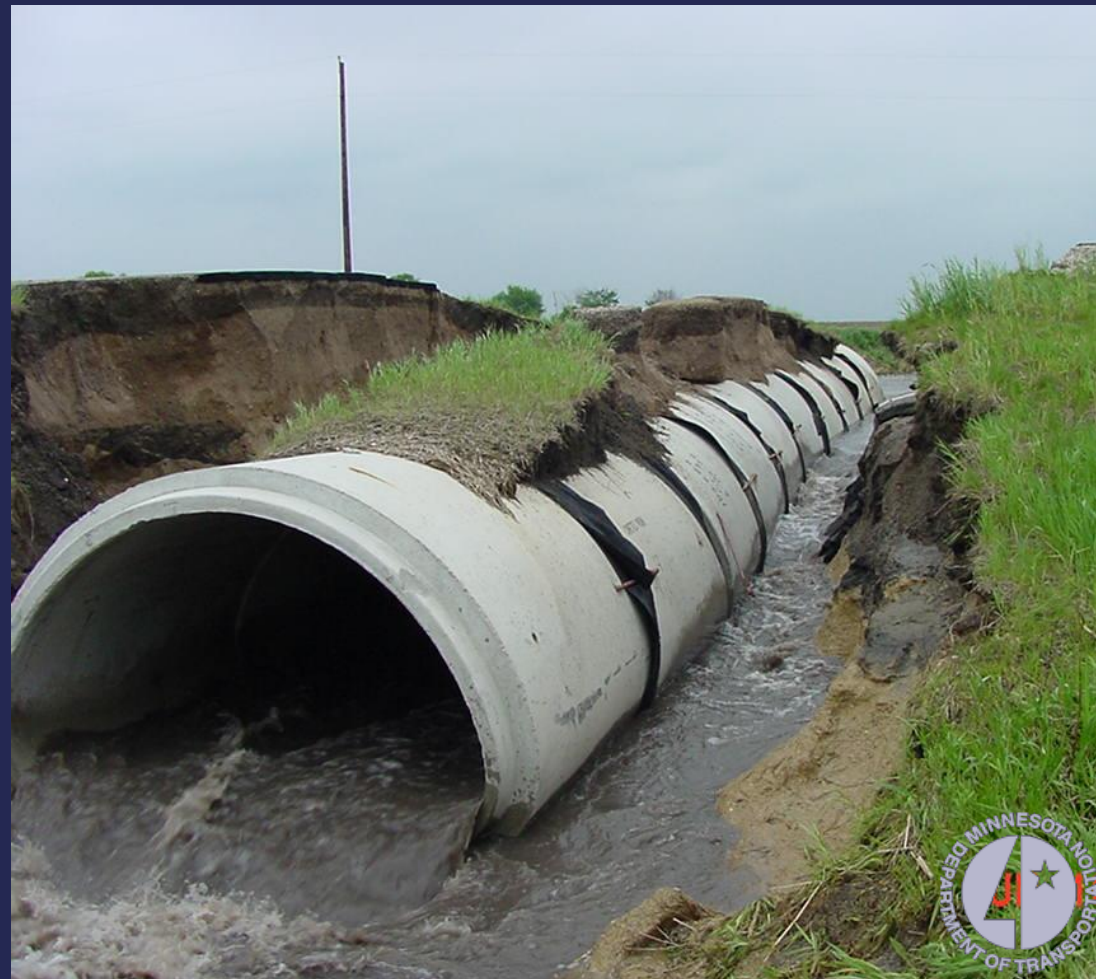
## 6. Respond to flood damage when heavy rains wash out culvert

- Roadway is out
- Culvert data is known
- FEMA disaster declared  
= special forms and records
- Asset Management to  
find spare parts

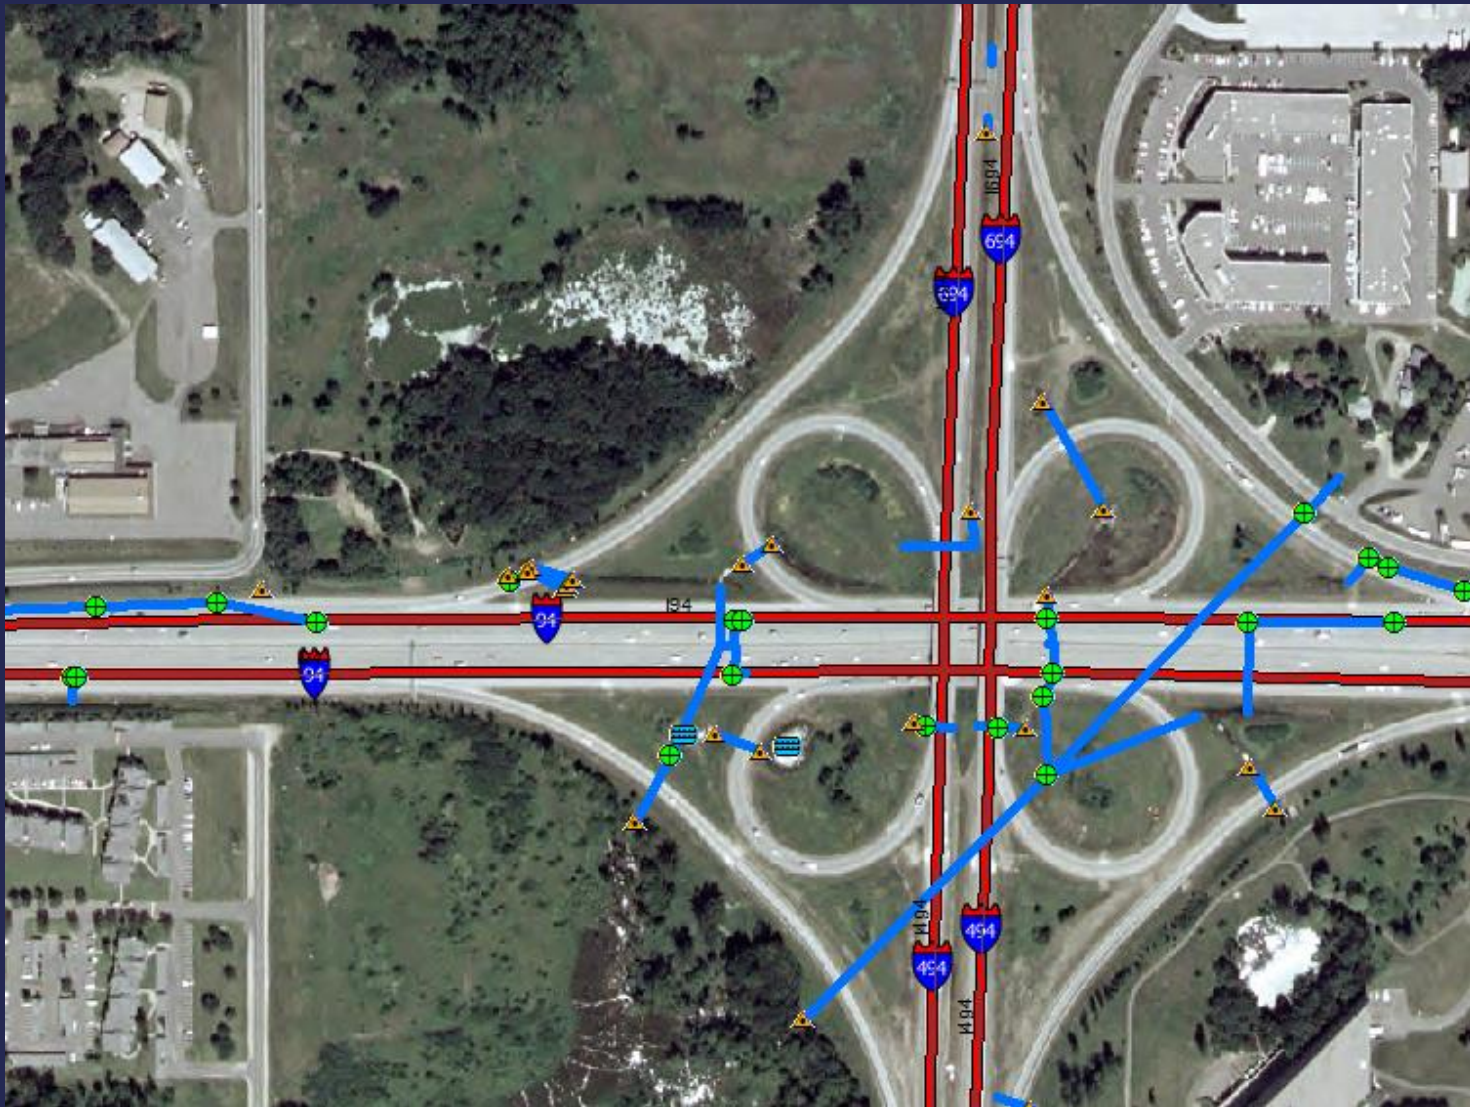
# 8. Storm utility locations for “Call before you dig”

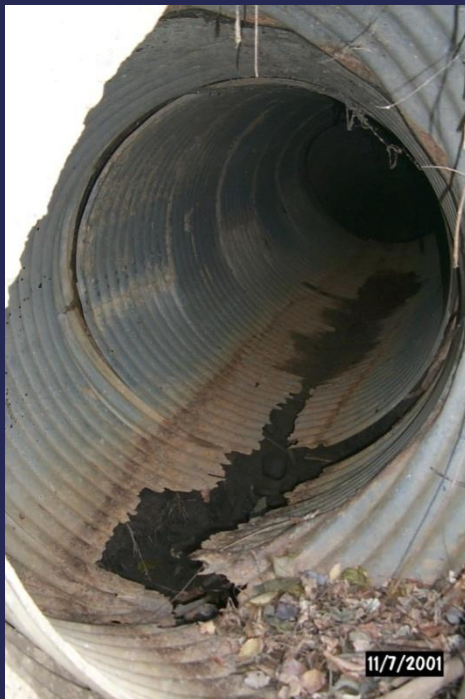
**Cause: Bad Pipe**

**Effect: Bad Road**

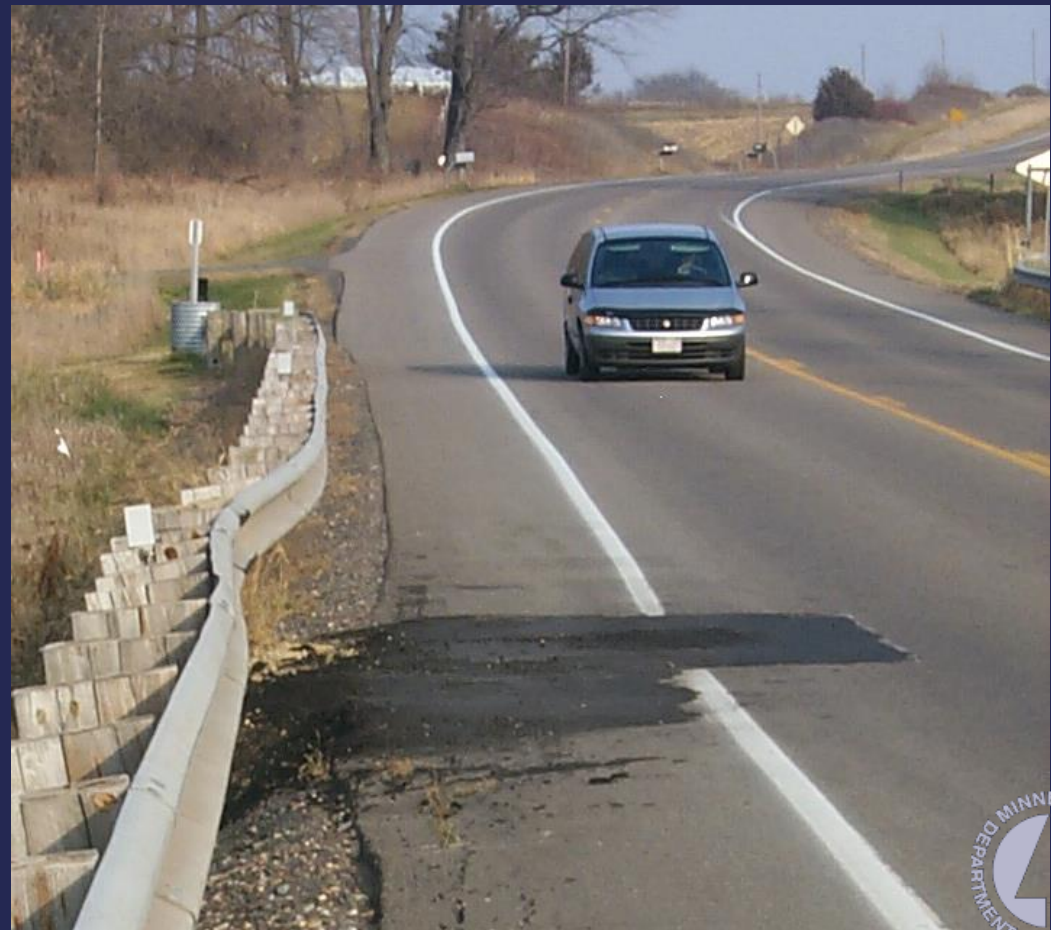
Piping: water runs outside the pipe causing void in road

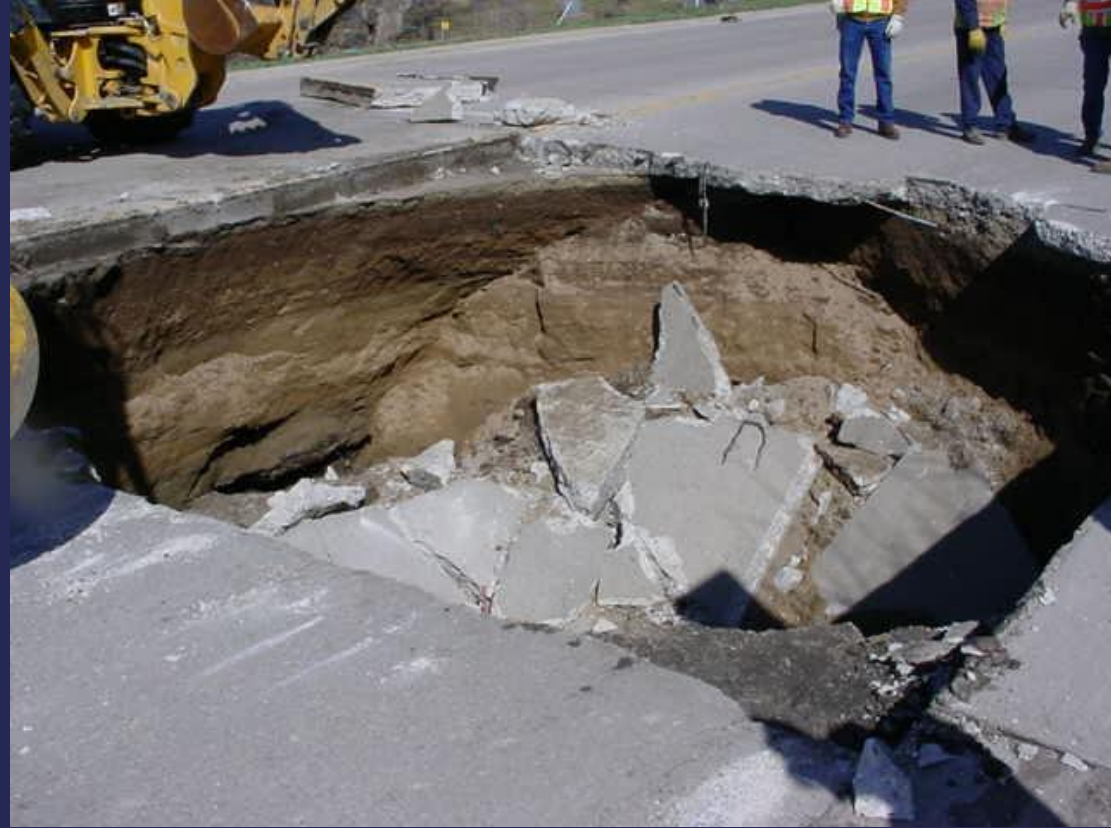
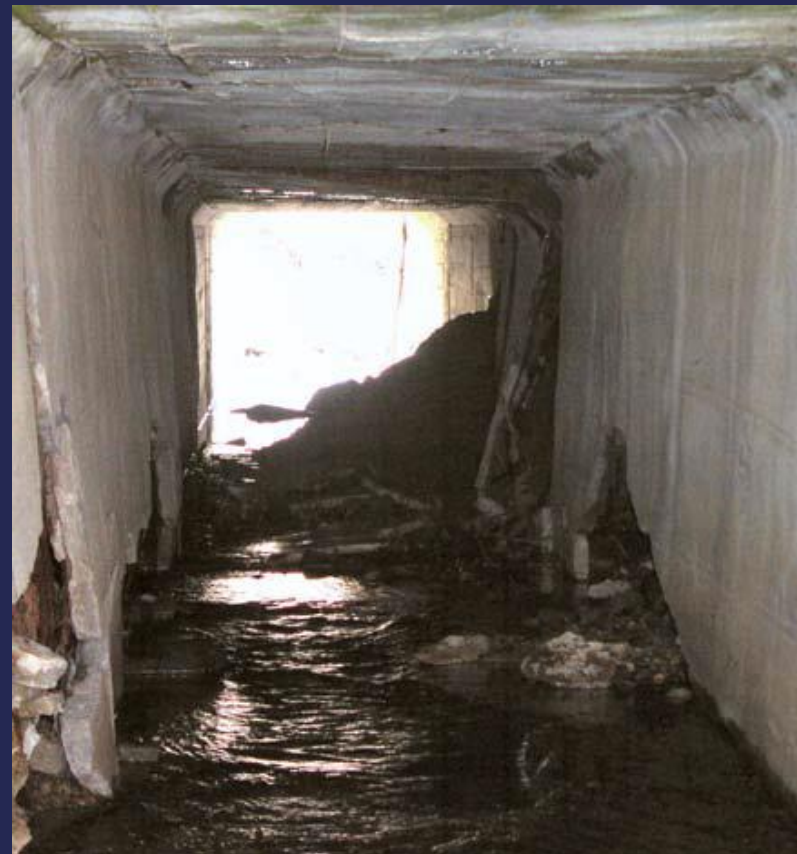
The road had collapsed.  
The culvert was still standing

Concrete pavement  
will span a road  
void for awhile,  
before it collapses.
