# HydInfra Terms, Flags and Measures

## Illustrated Guide to the HydInfra Manual

### HydInfra Inspection Manual

Culvert and Storm Drainage Systems

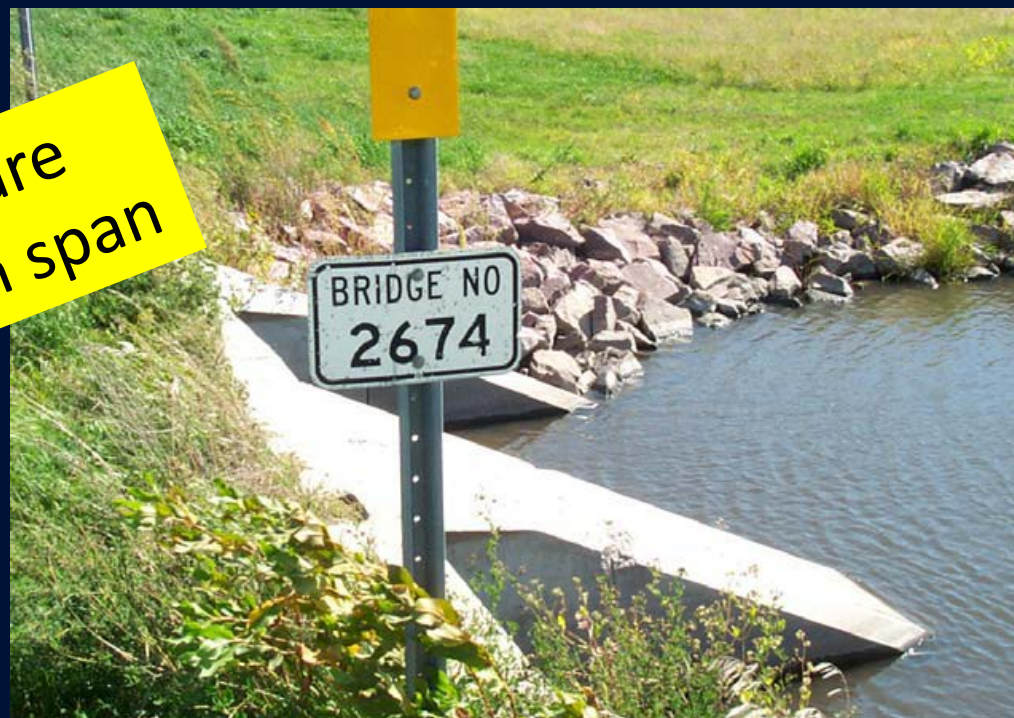
# HydInfra culverts are smaller than bridges (Not HydInfra if there's a Bridge No.)

HydInfra Culverts are less than 120 inch span

MN State Law defines Bridges as 10 foot span or greater. If it has no Bridge number, email [Lisa.Hartfiel@state.mn.us](mailto:Lisa.Hartfiel@state.mn.us)

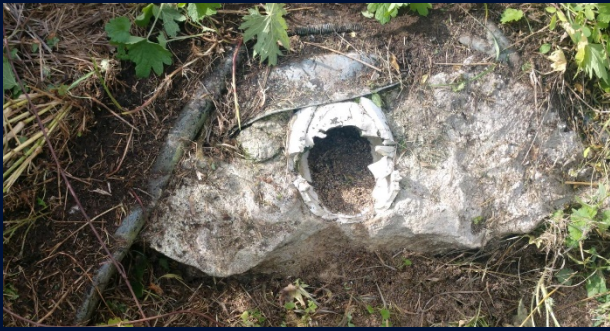
Status: **Abandoned**

is plugged and  
left in the ground

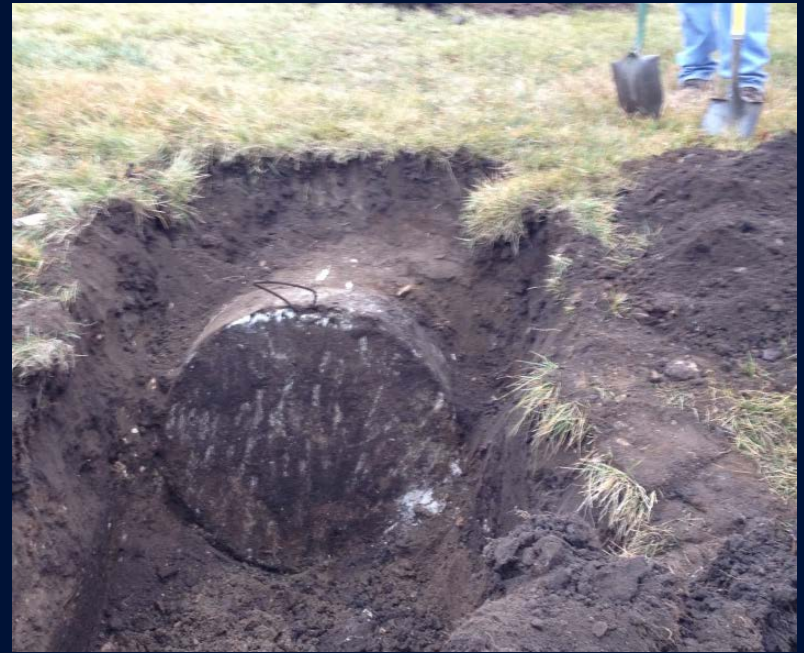
Status: **Removed**

is taken out of the ground

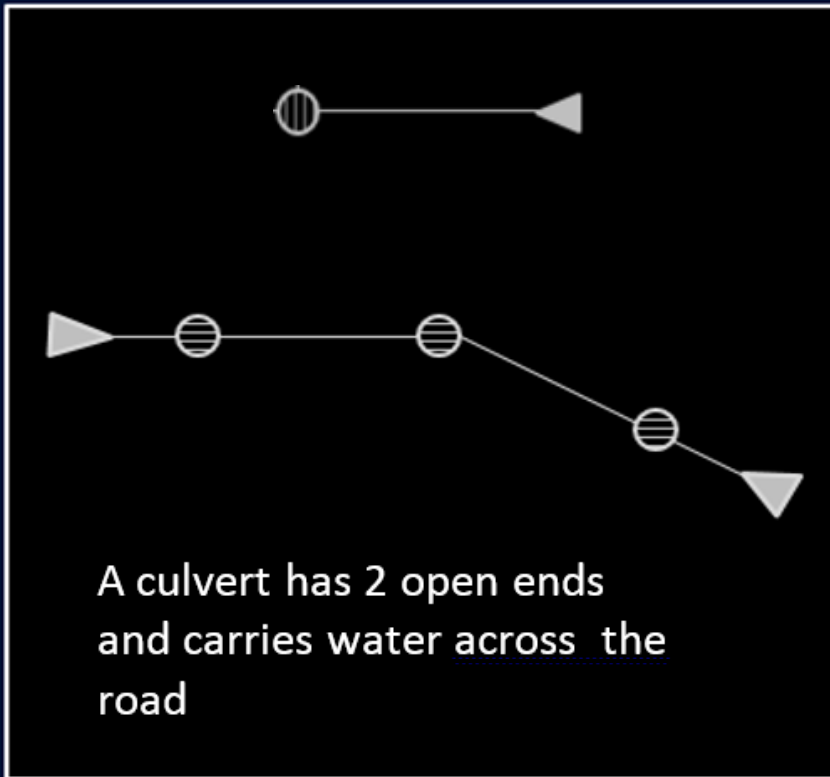
# Choose Pipe Class Code

Is it a **Culvert** or Storm Drain Pipe?

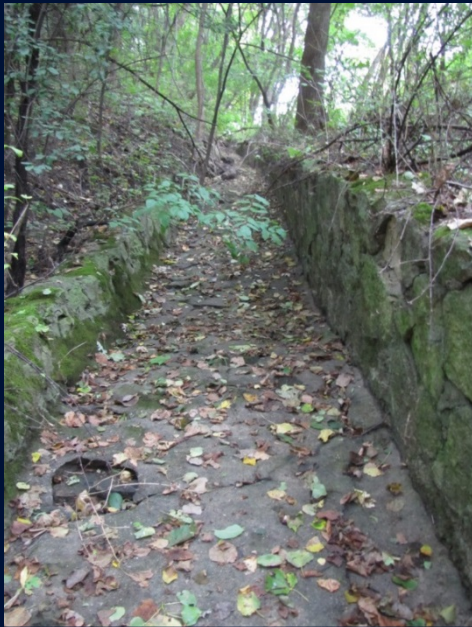
Class Code: Open Channel  
and Pipe Type: Open Flume

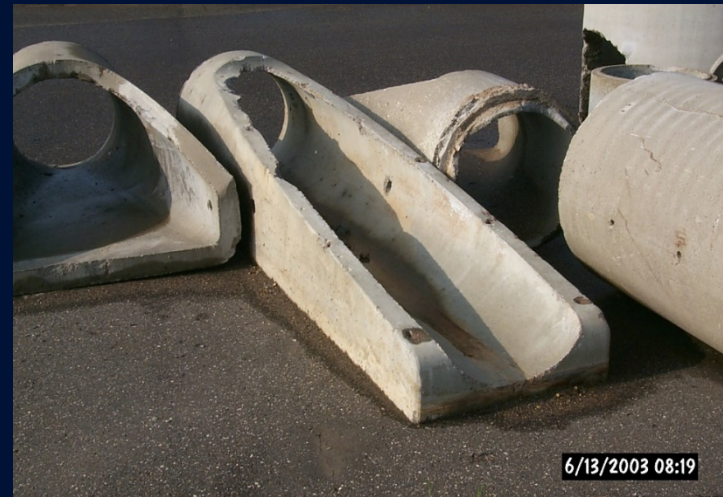
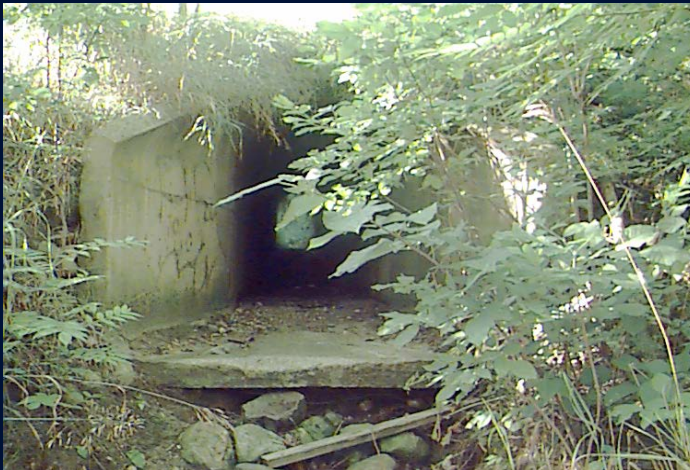
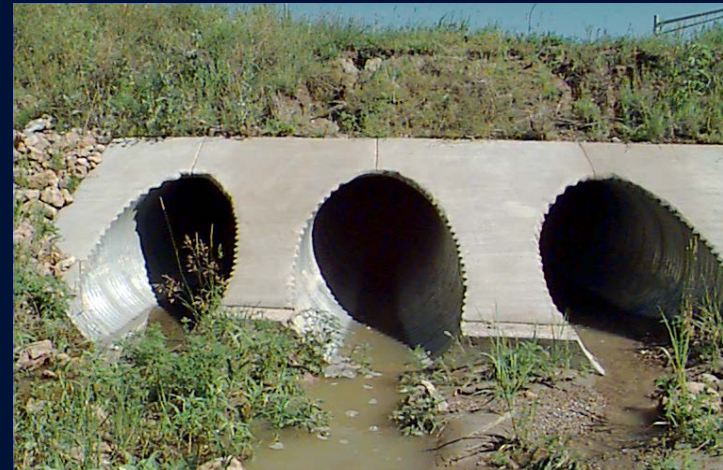
# Pipe End Sections

- Box End Section
- Flared Apron
- Safety Apron
- Flap Gate
- Headwall
- Headwall/Wingwall

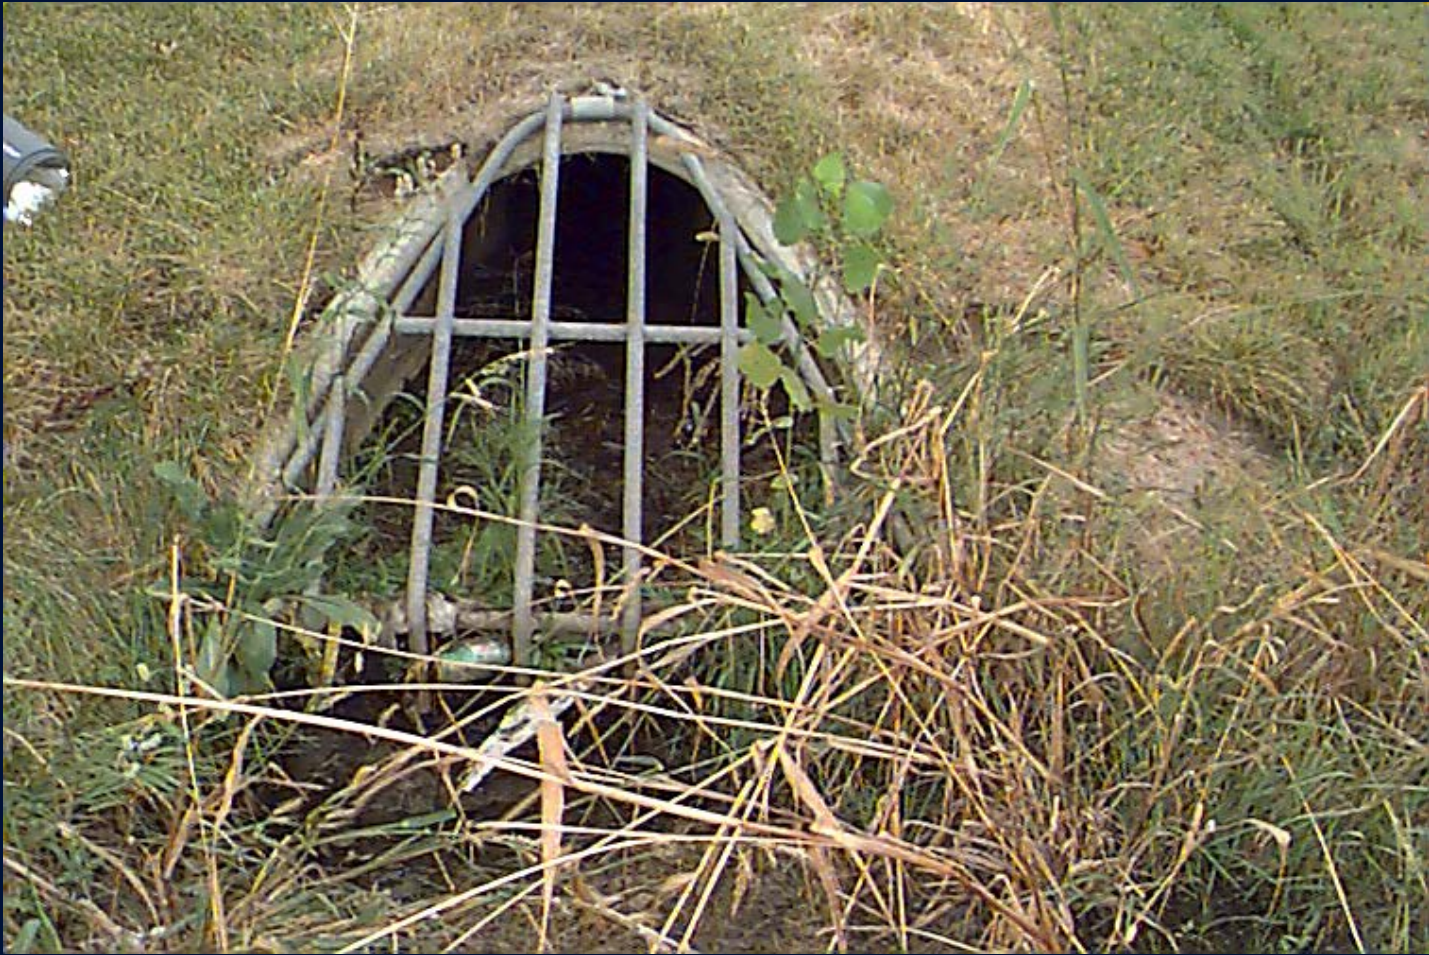
# Flared Apron with Trash Grate

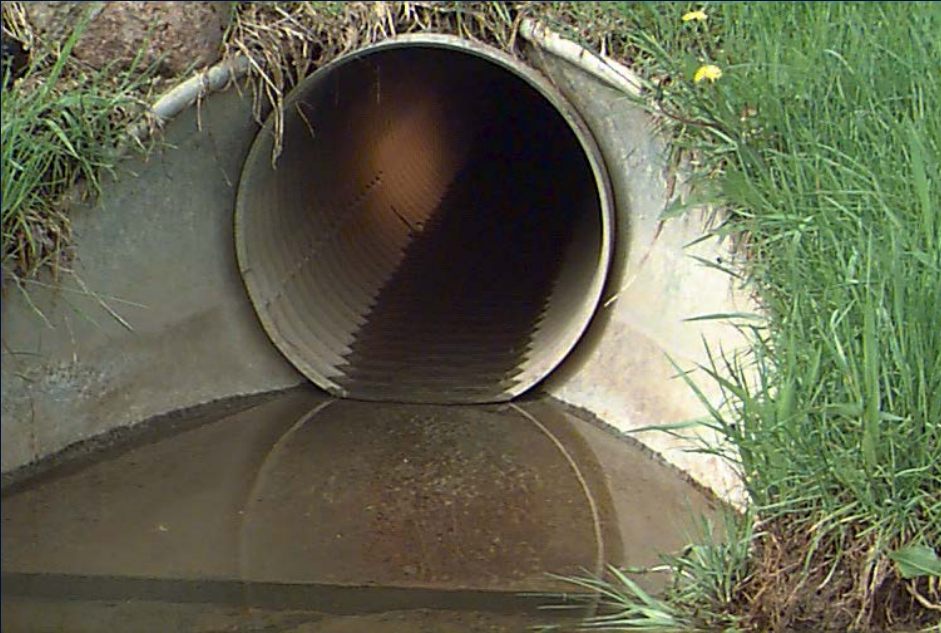
# Flared Apron

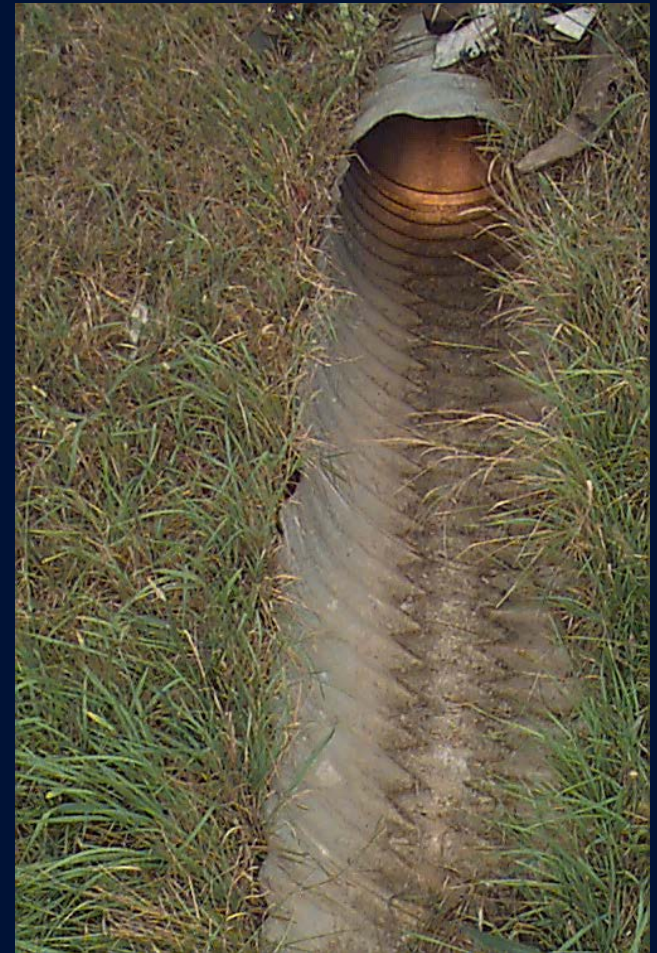
# Safety Apron 10:1

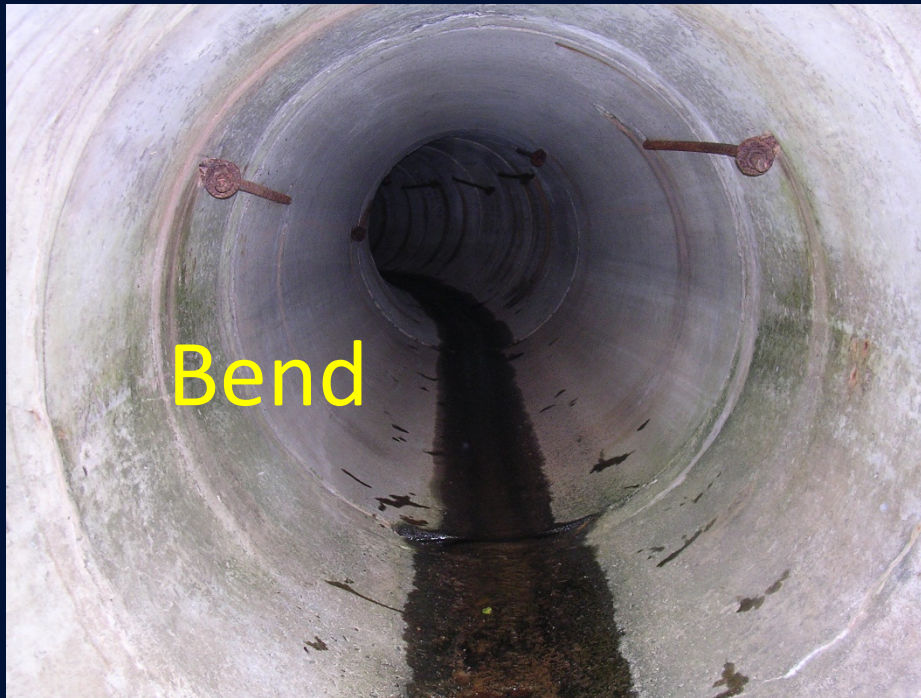
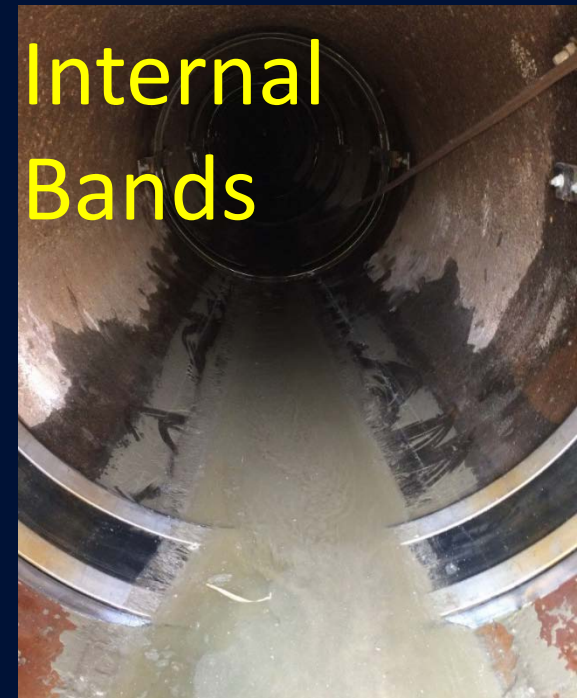
Pipe **Components** are captured in a submenu

Component describes other things inside the pipe including Increaser/Reducers, Energy Dissipater D-rings, Bend sections and Internal Band repairs.

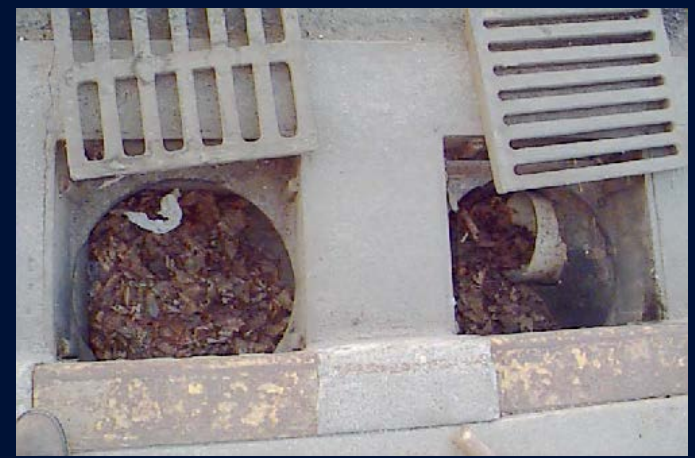
- Catchbasin - CB

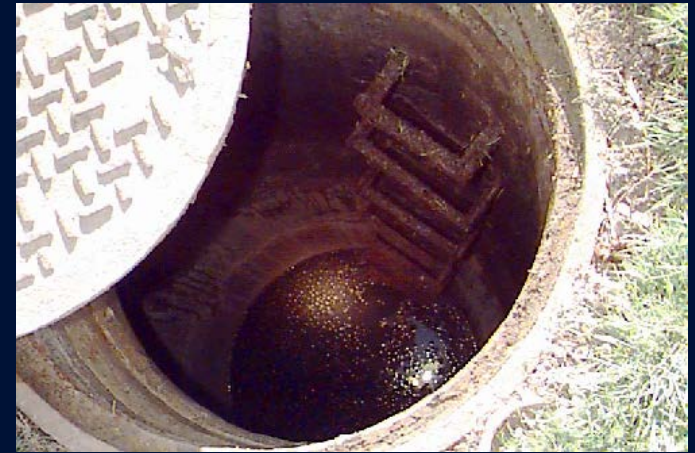
- Manhole - MH

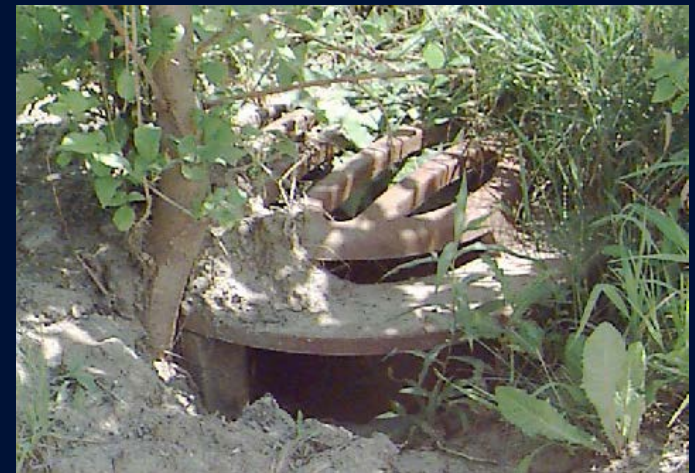
- Drop Inlet - DI

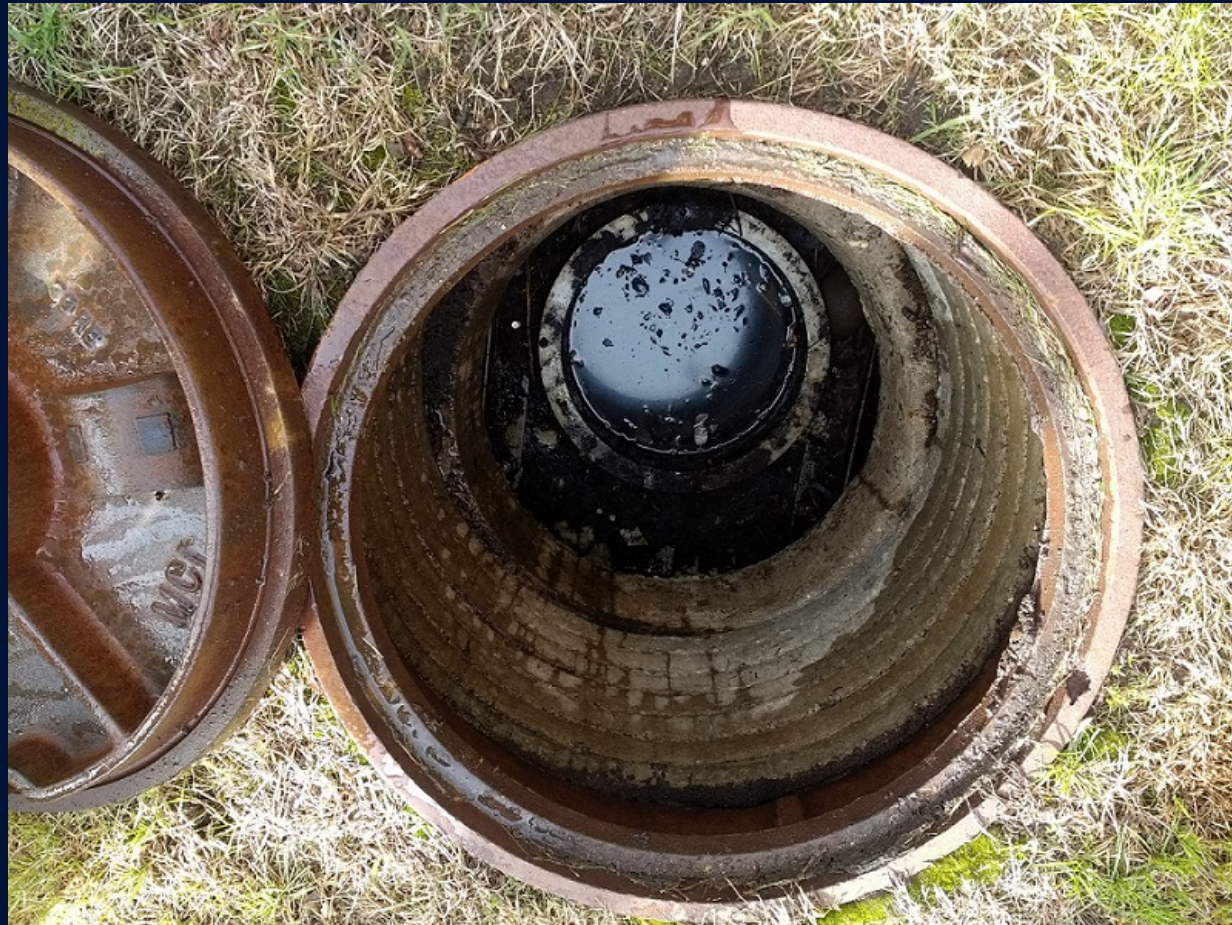
Class Code: Structure  
Structure Type: **SPCD**  
(a water quality device)

Structural Pollution Control Device, Separator on MN 23 D8

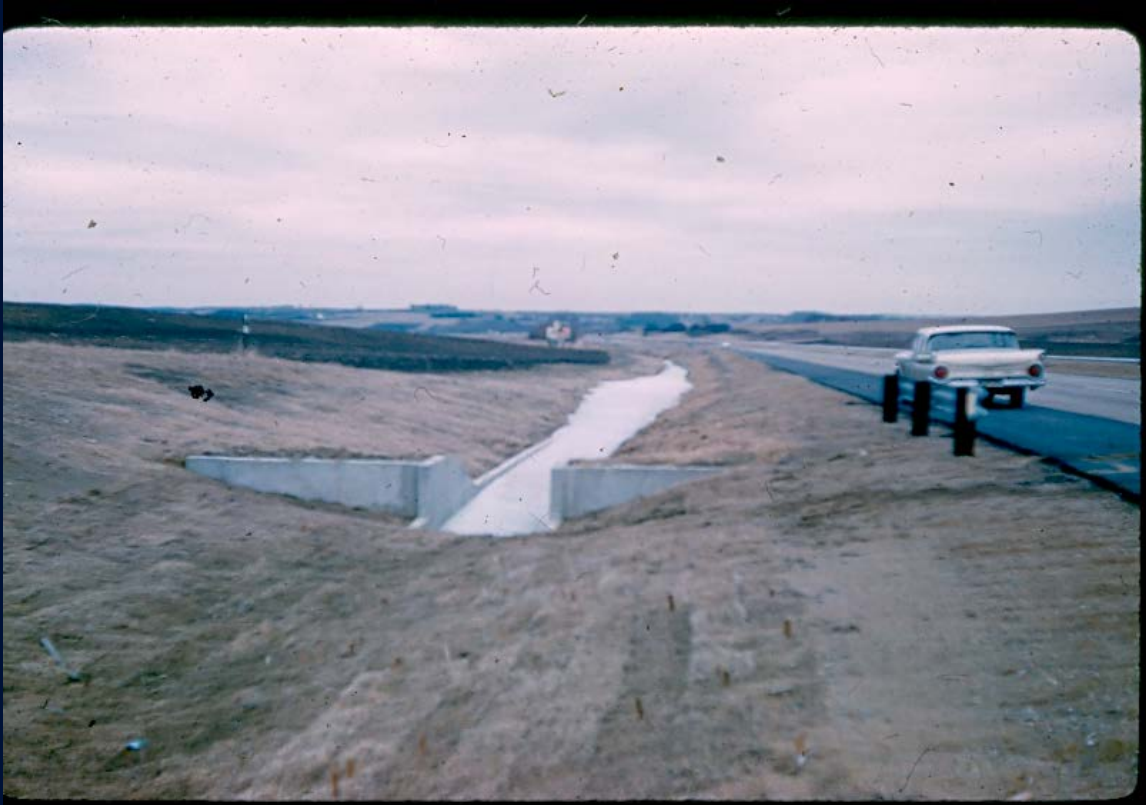
# Class Code: Structure

## Structure Type: **Special Feature**

### Structure Types for Special Feature:

- SpecFeat - Ditch Block
- SpecFeat - Energy Dissipater
- SpecFeat - Floodgate
- SpecFeat - Overflow
- SpecFeat - Riprap
- SpecFeat - Weir

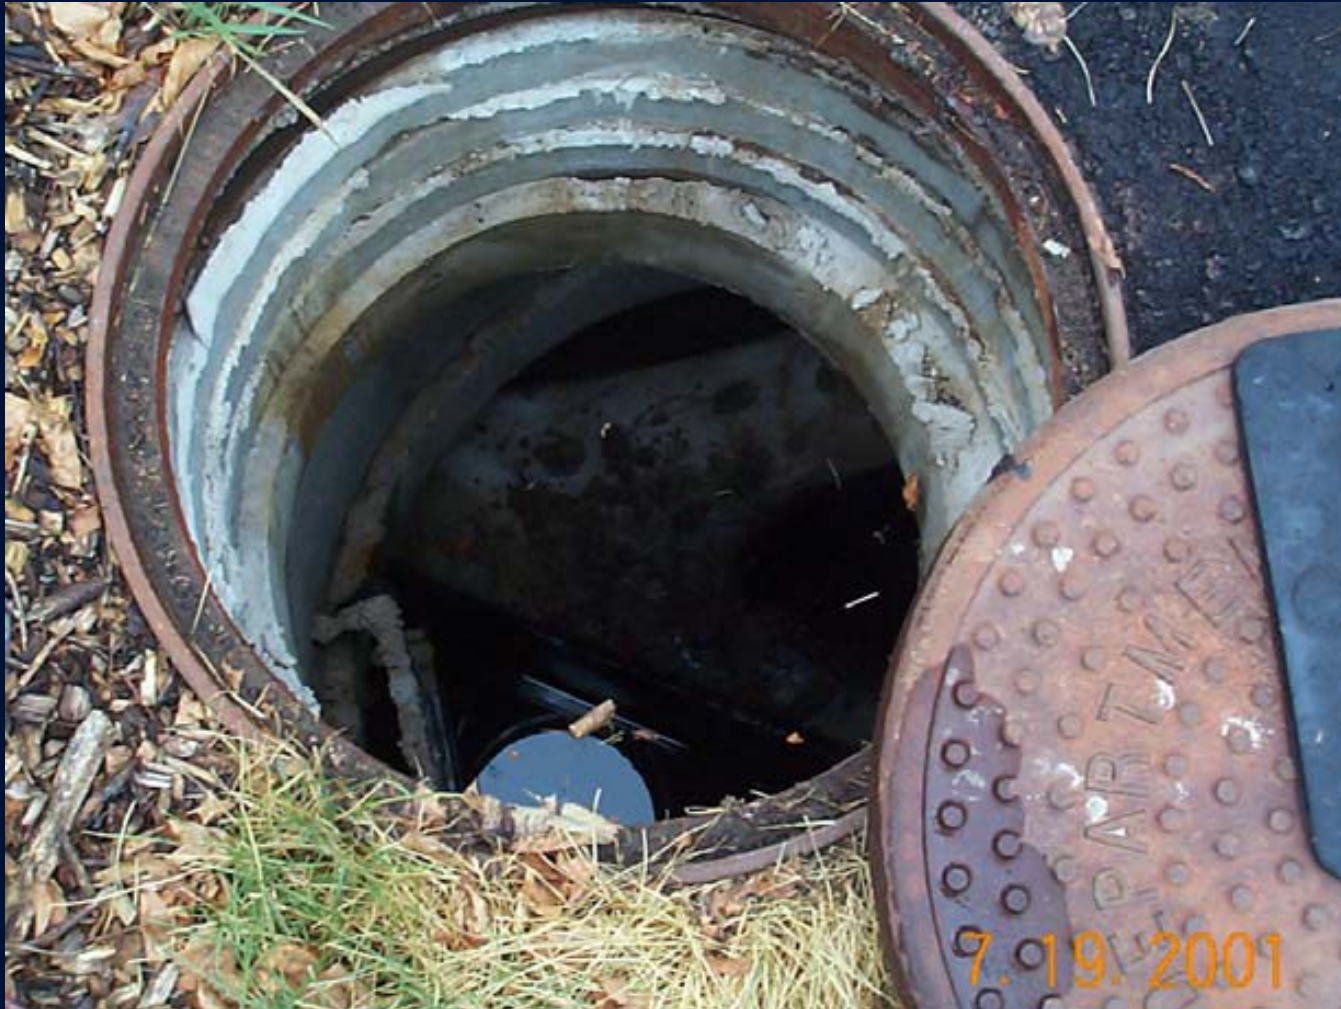
**Deteriorated Rings** – (an inspection flag) The adjusting rings (= layers below the iron casting assembly) are broken or cracked. Rings may also have missing mortar.

Inside the structure,  
**rings** are below steel casting

Manhole (solid cover) with 3 rings

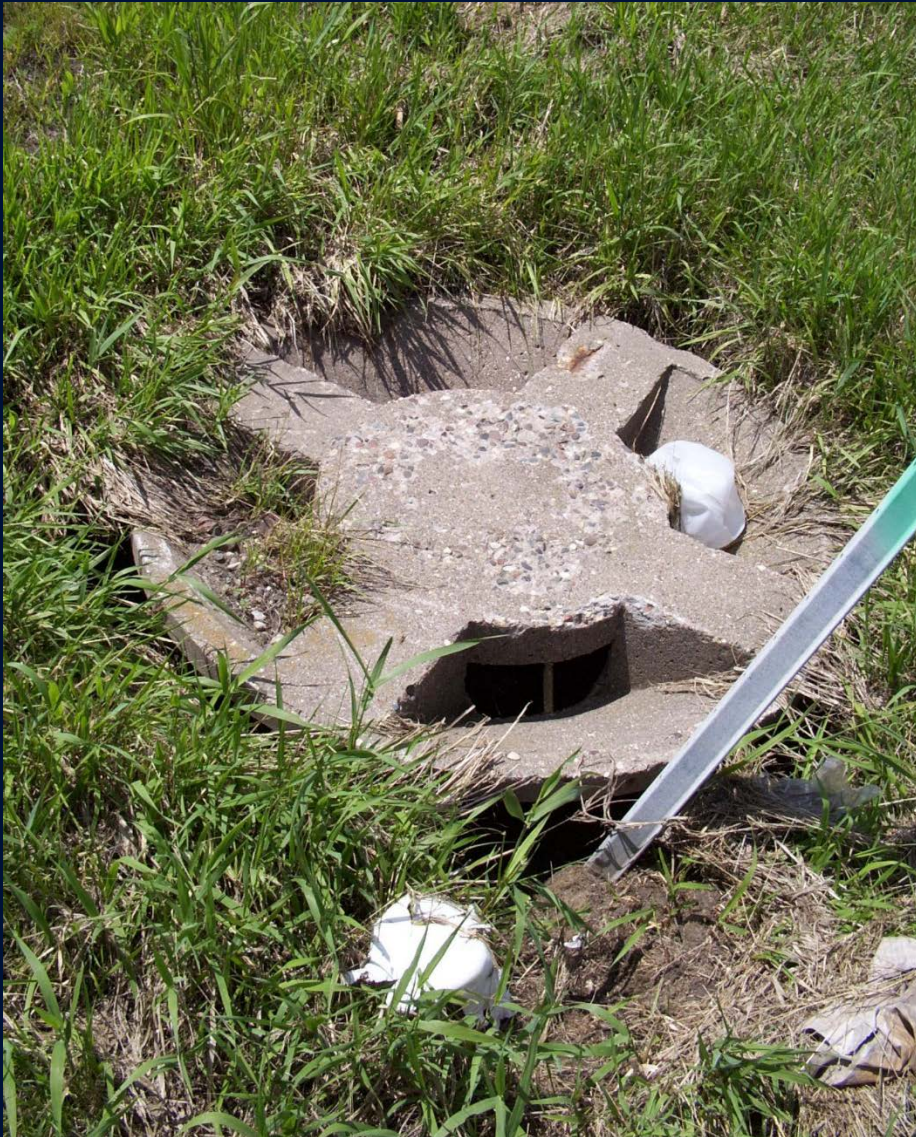
Drop Inlet  
“ankle buster”

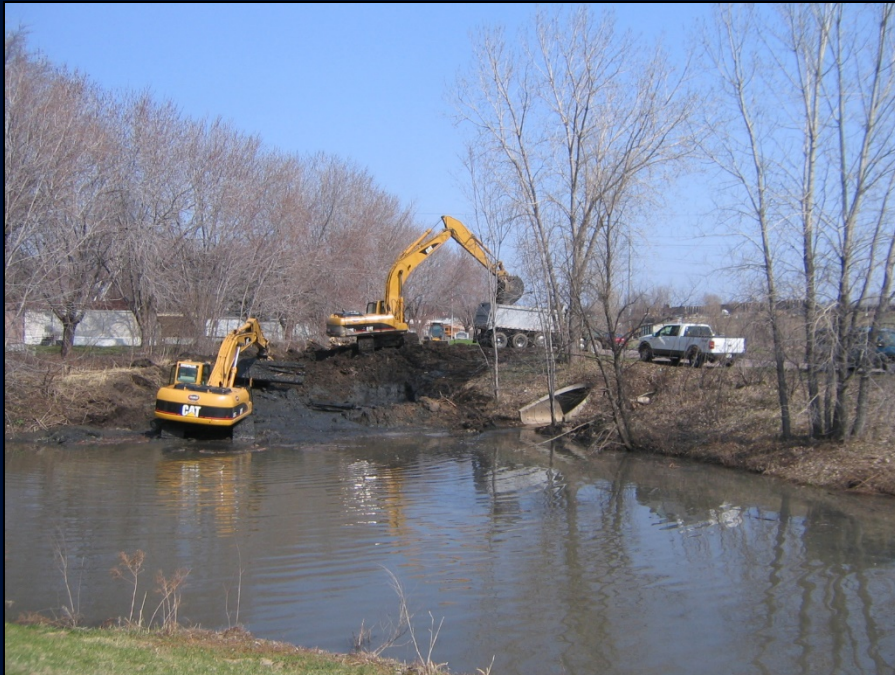
Ponds

are designed to detain or retain water and slow the outflow

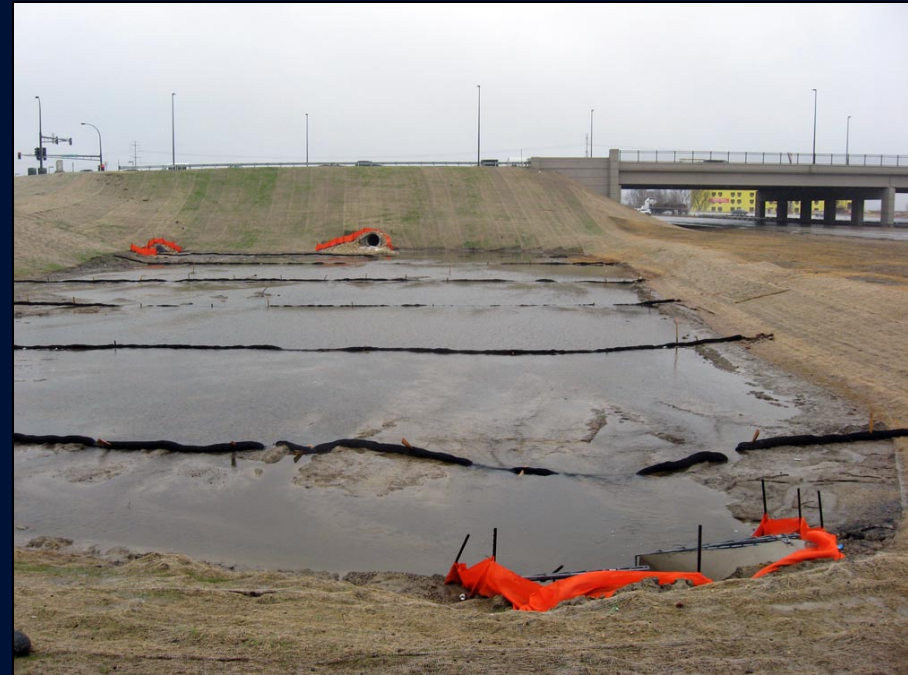
Basins

are designed to filter or infiltrate stormwater, and maintain vegetation

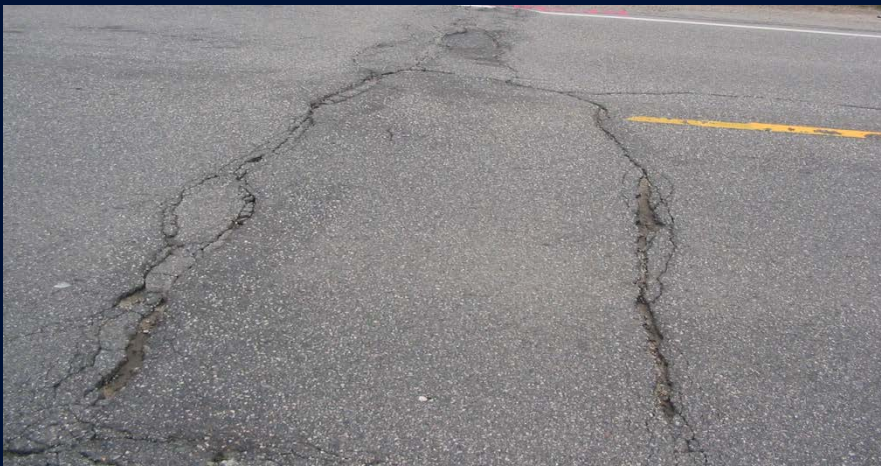
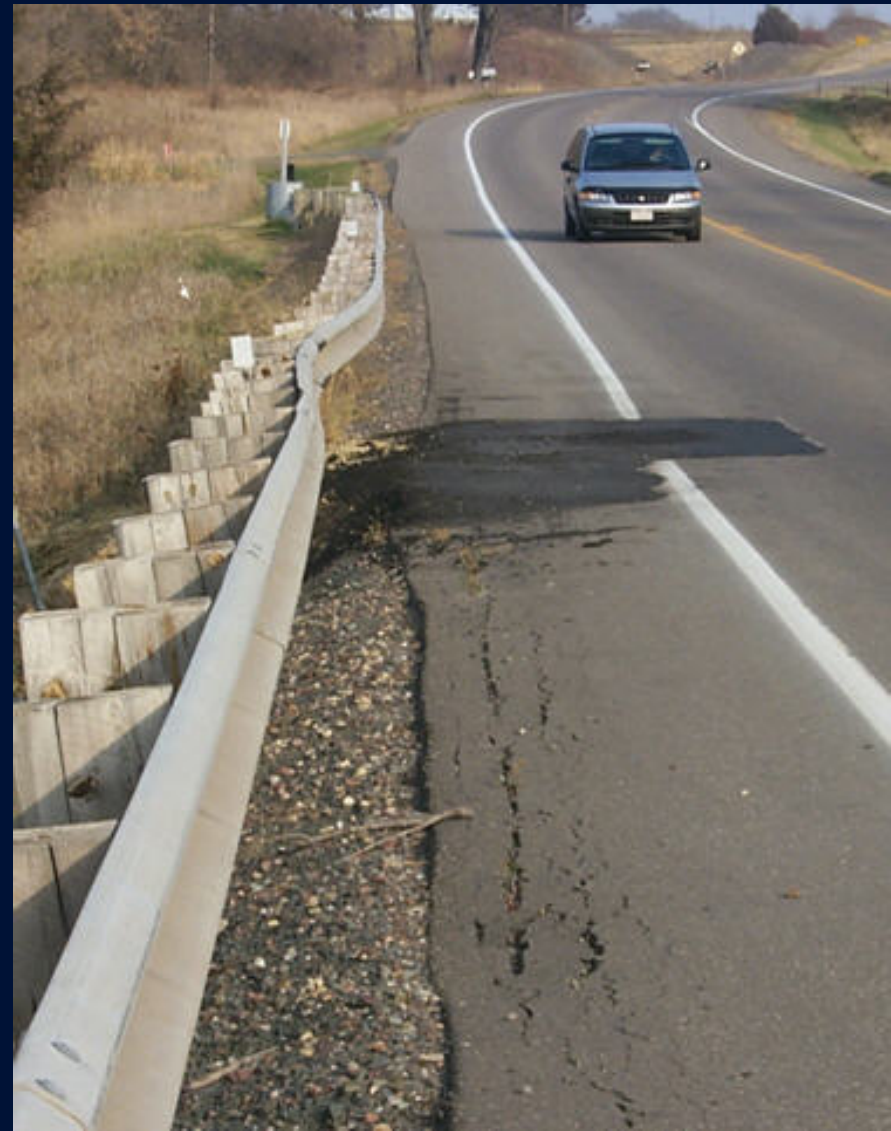
## Road Distress –

Pavement problem – Road Bump, Dip, Pavement Patch or Cracks (indicators of possible loss of roadbed through a poor condition pipe or structure).

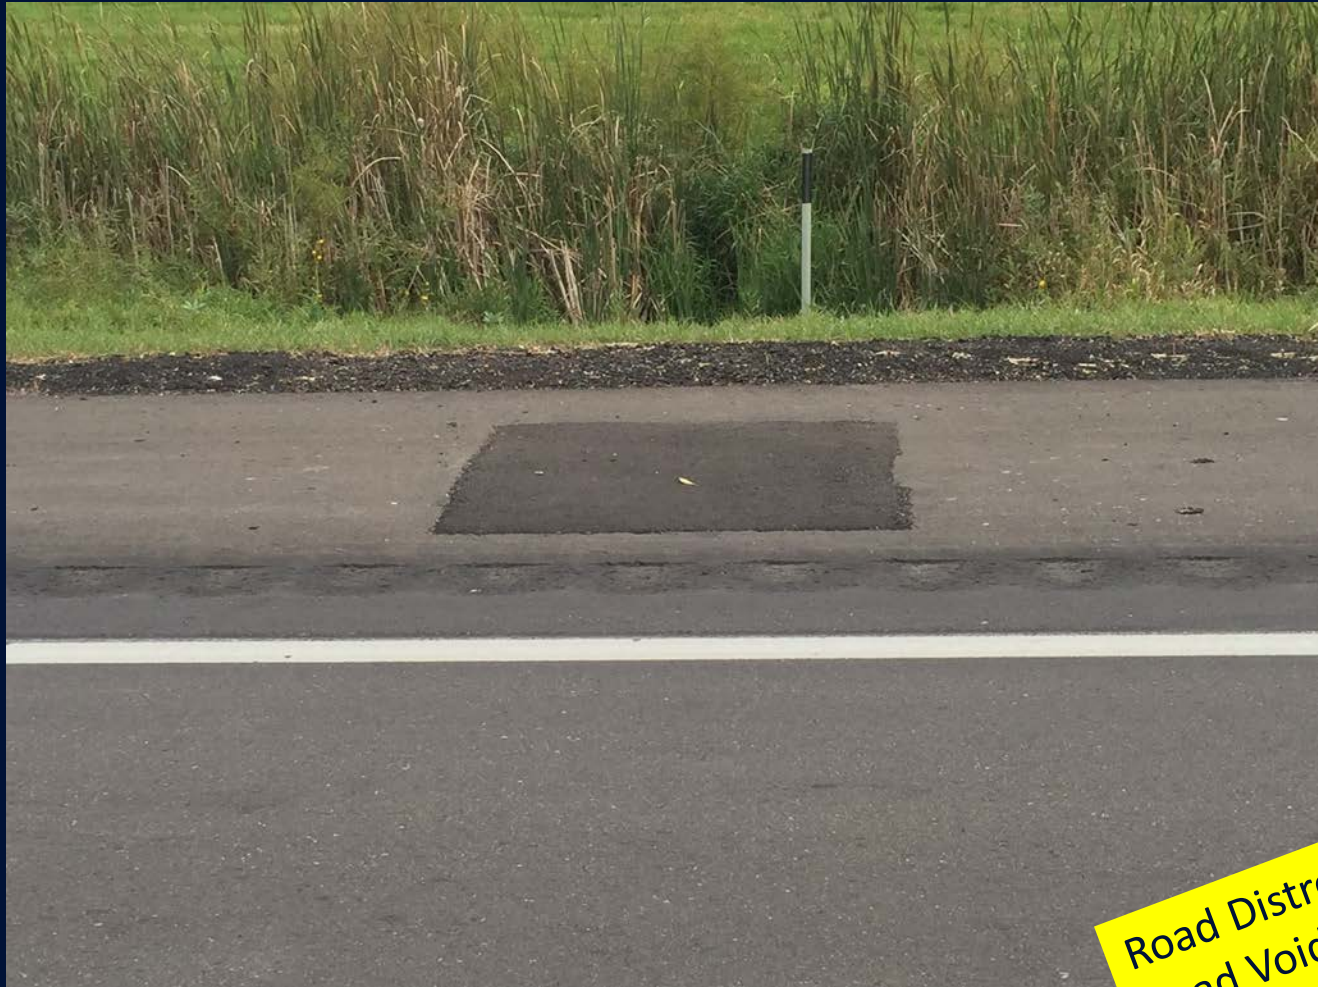
# Pavement problems can be visible when piping and road void are present.

Photo by HydInfra Inspector Brad Fredin  
October 2018, MN55 project

Road Distress,  
Road Void,  
Piping

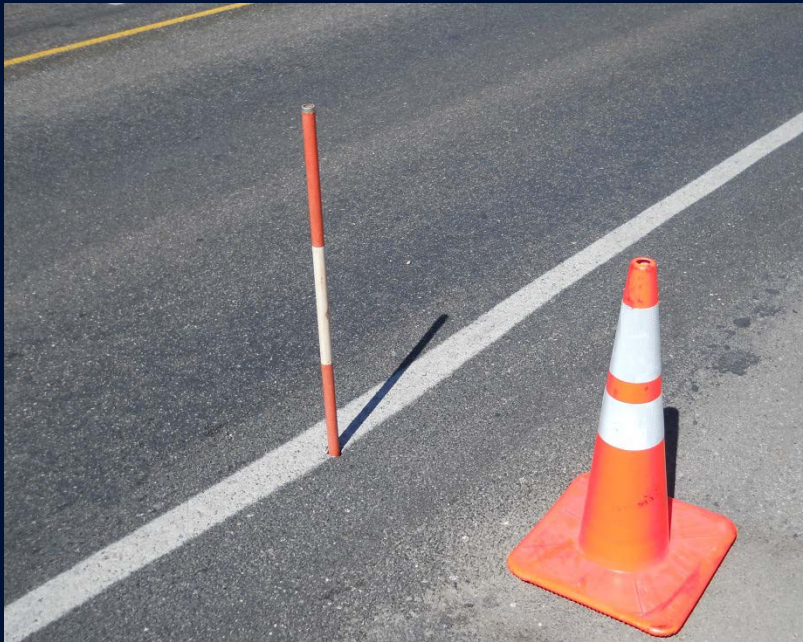
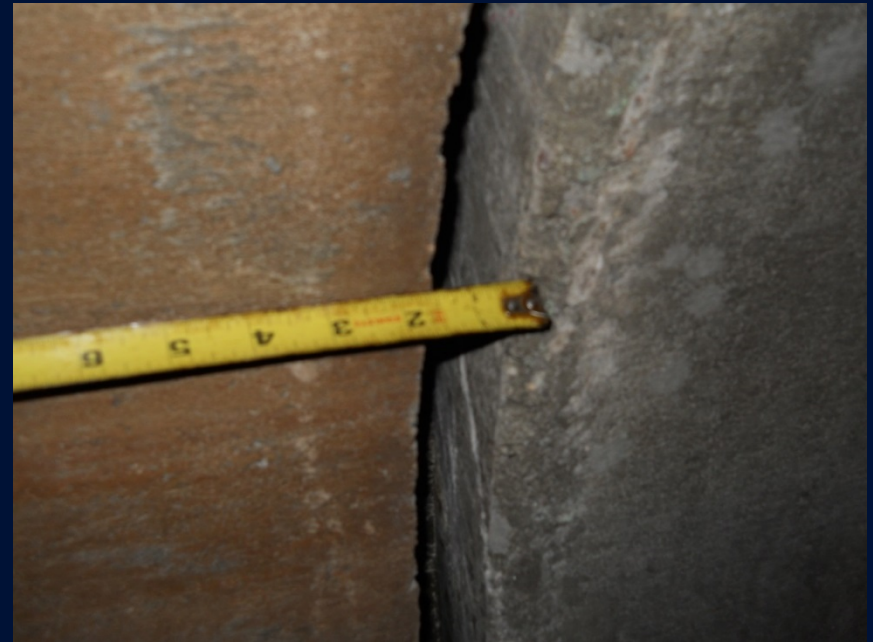
# Void in Road – Evidence of a loss of soil from the road around or near the pipe or other feature.

D6 Jacked Pipe creates road void 27SEP2011 – Rob Coughlin

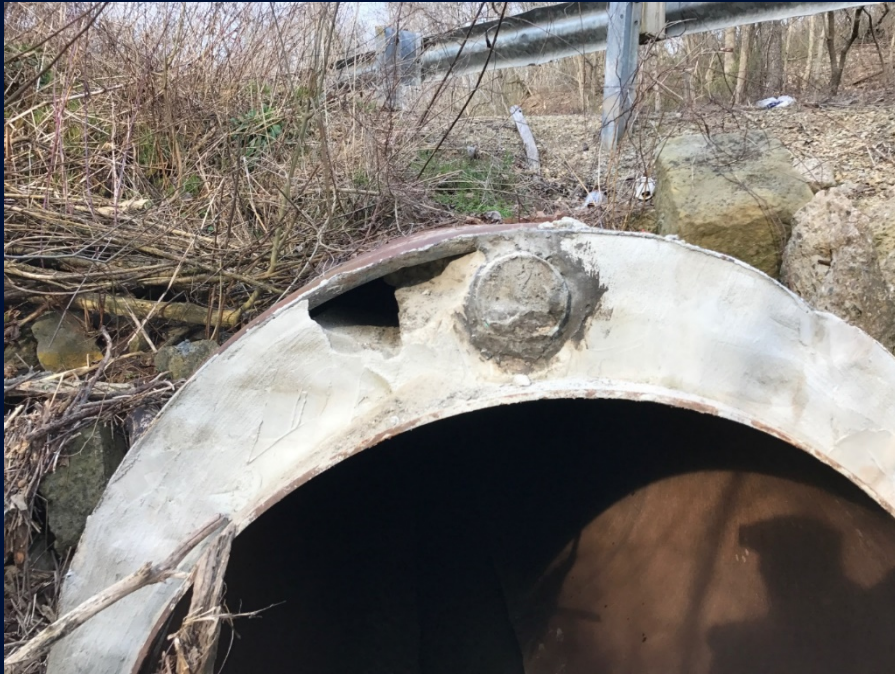
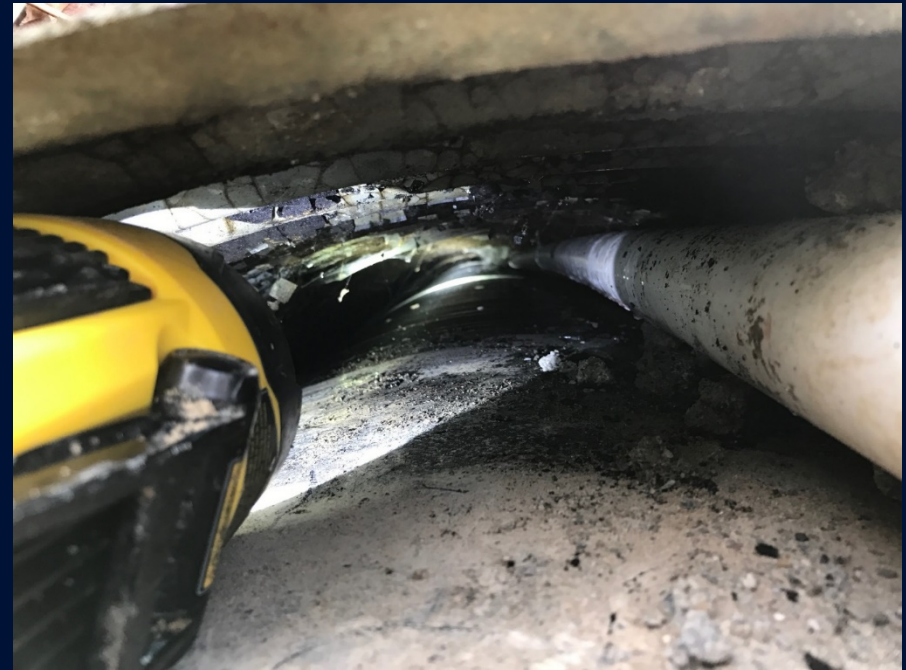
# Void in the grout between slipliner and host pipe allows continued Piping and Road Void

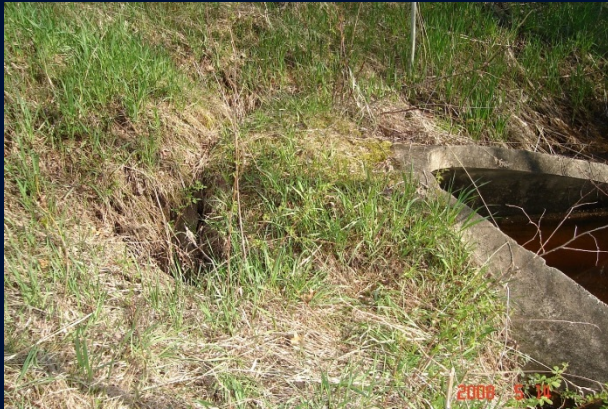
# Inslope Cavity –

A cavity or hole in the inslope of the roadway above an apron or pipe joint. Usually found in areas where joint separation has occurred.

Separated aprons affect the inslope, so are rated Condition 3. Condition 3 Highway Culverts only need inspections once every 4 years (that's not terribly often).

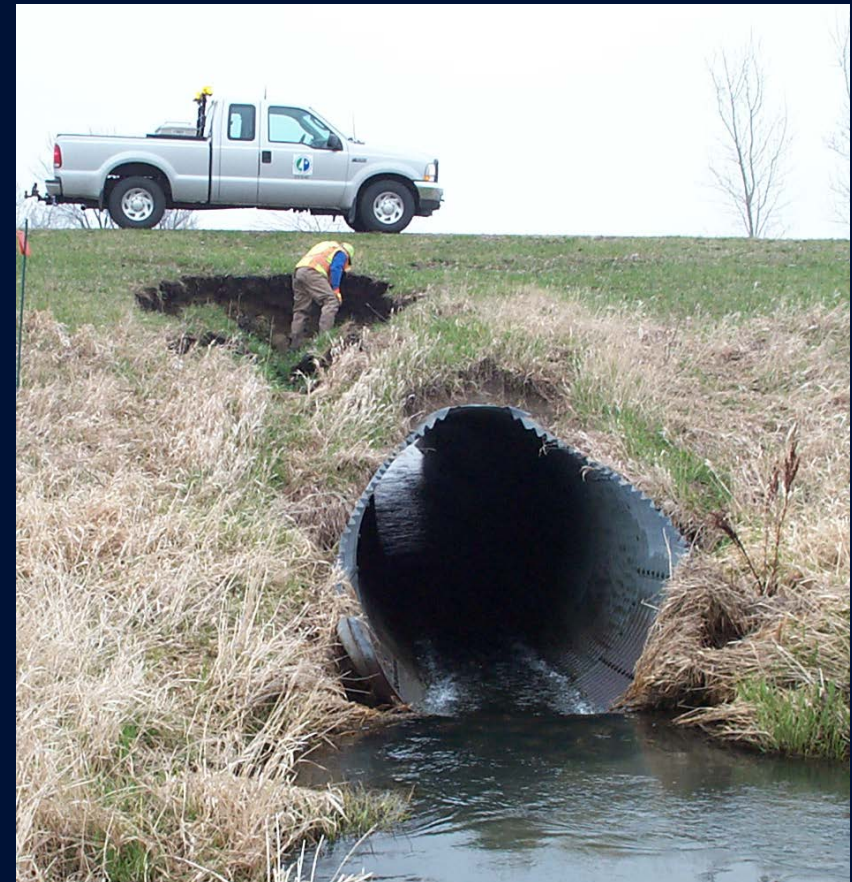
Separated aprons can be the first stage in major problems that can accelerate during a big rainstorm.

Inslope cavities caused by apron and joint separations are hazardous for mowers. Most are not obvious like this one is.

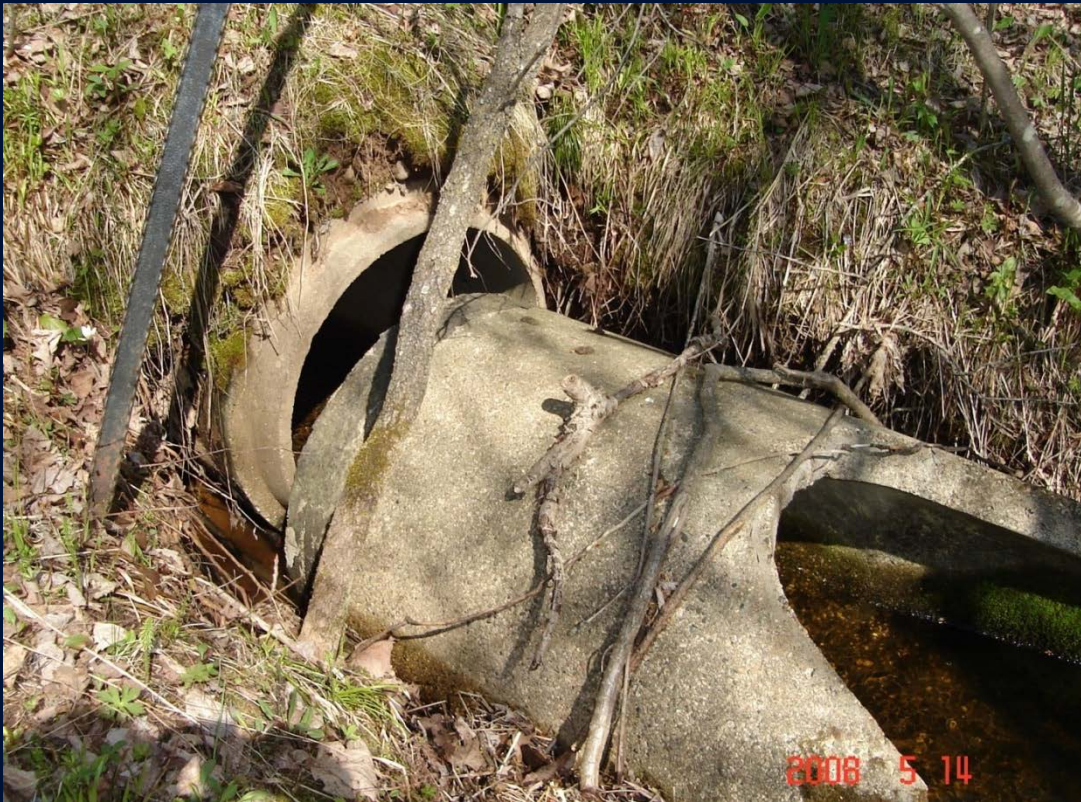
# Separated Apron –

Describe which end of pipe has a separated apron

- Inlet
- Outlet
- None
- Other
- Both
- No Aprons

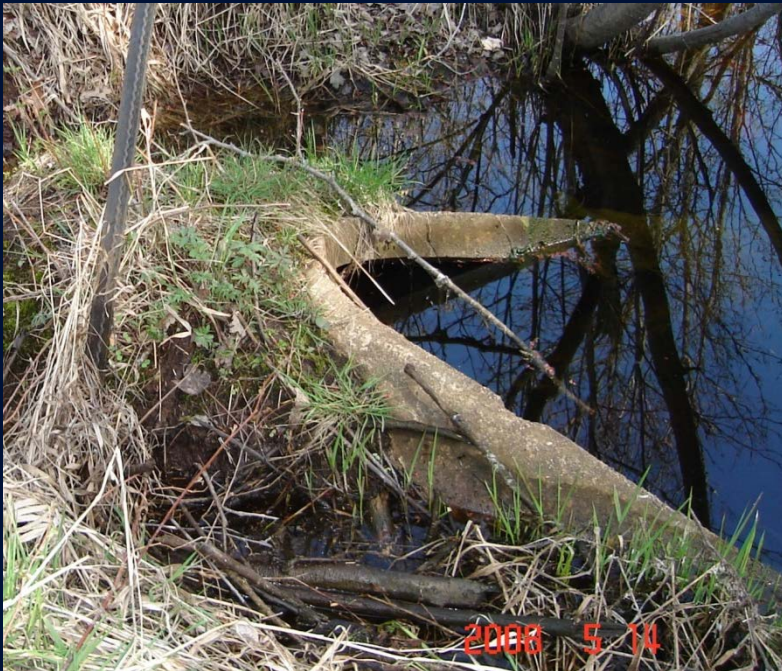
# Water Observed –

Describe the typical water situation in the pipe:

- Dry (usually has no water)
- Slow
- Fast
- Standing
- Full
- Saturated Soils

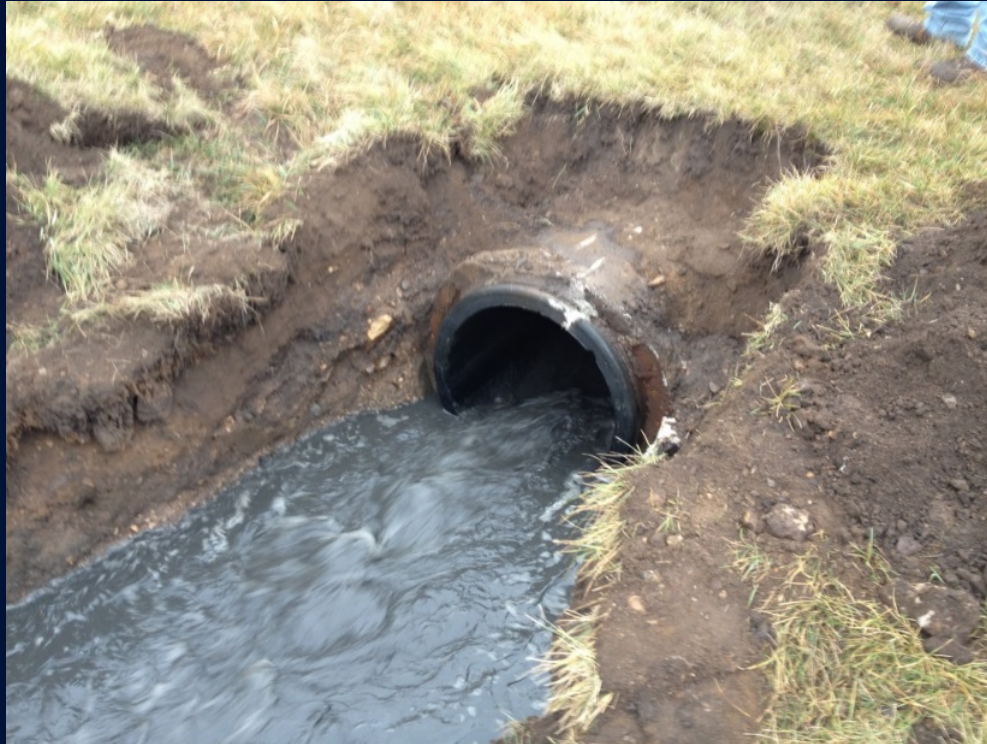
**Water % Full** – Today, how high is the water in the pipe, as a percentage of pipe height?
