# HydInfra Terms, Flags and Measures

## Illustrated Guide to the HydInfra Manual

### HydInfra Inspection Manual

Culvert and Storm Drainage Systems

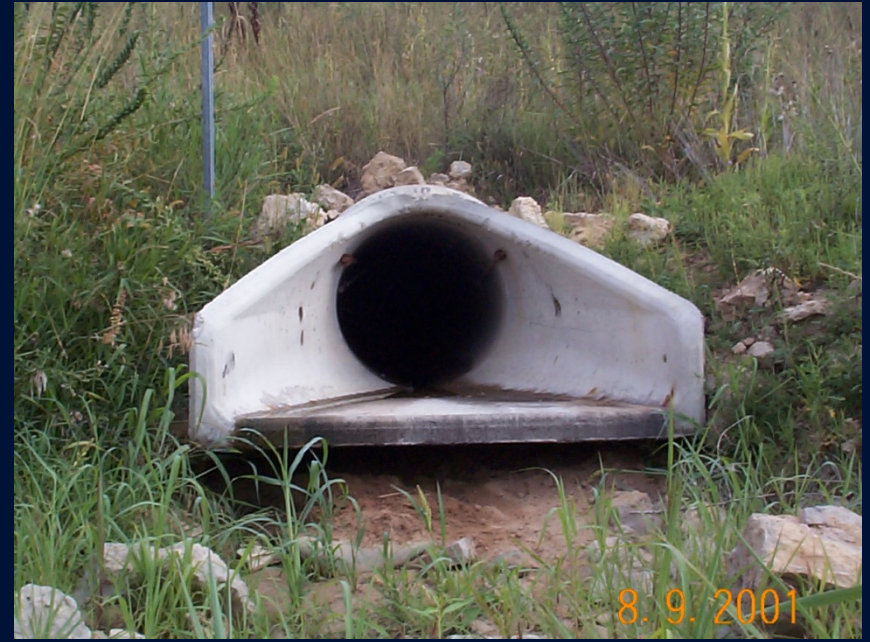
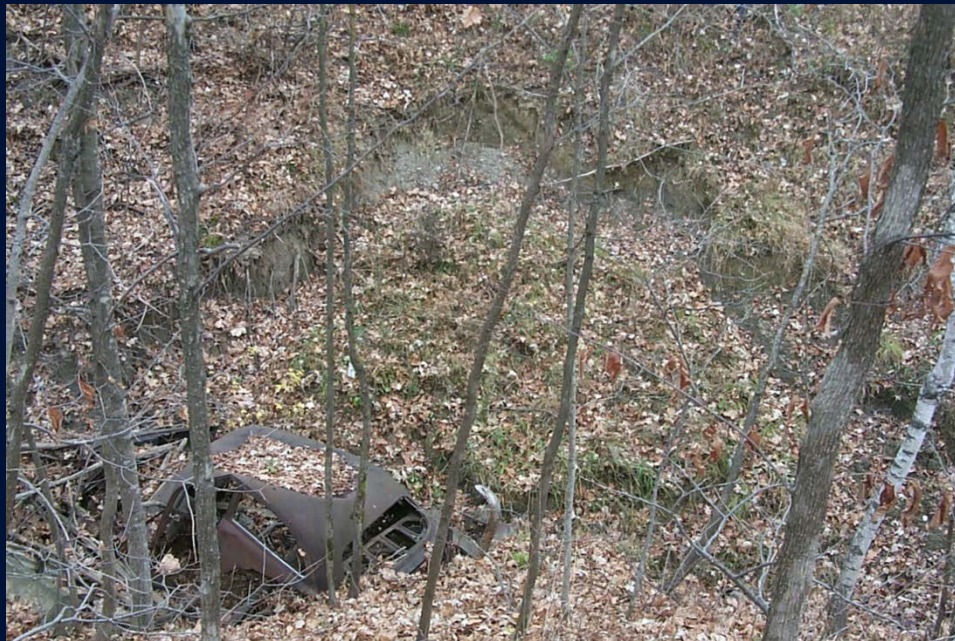
**Erosion** (or Scour) –  
Erosion or channel  
degradation has occurred  
as evidenced by a gully or  
loss of vegetation,  
caused by water flows.

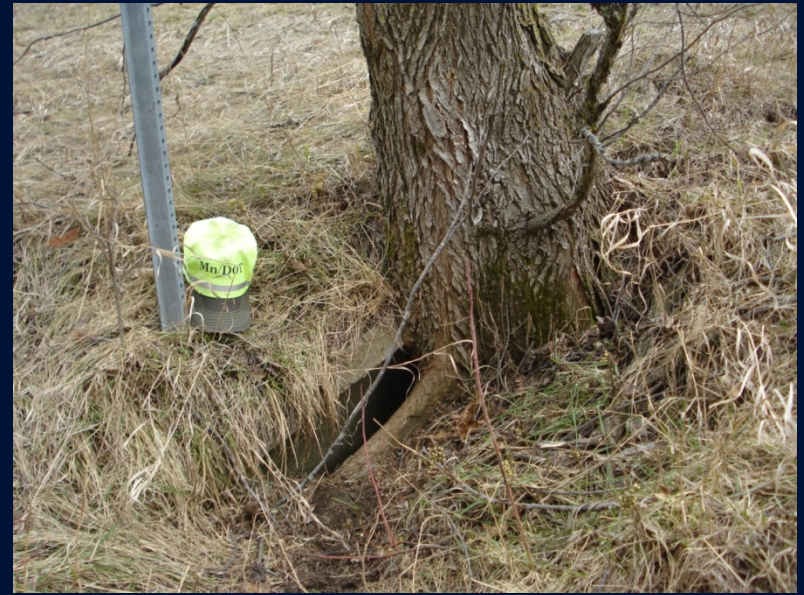
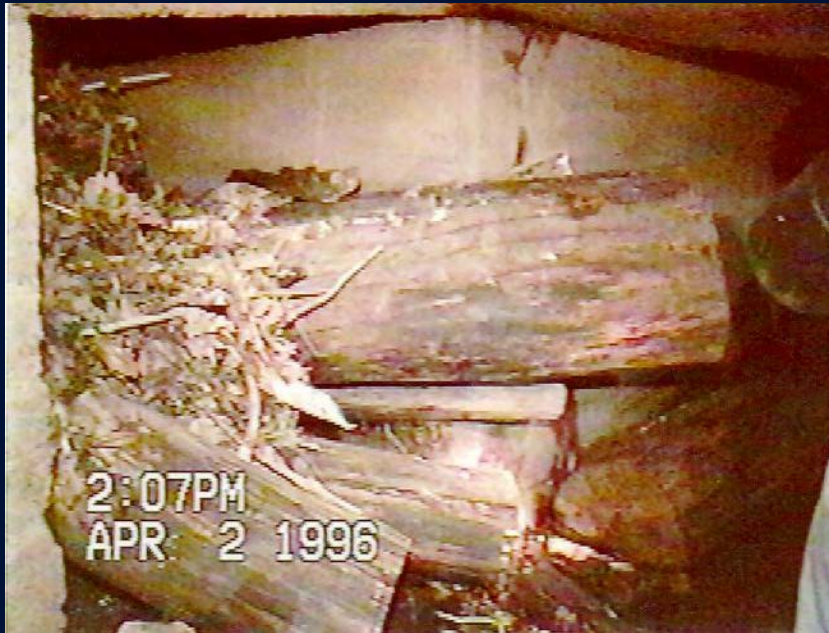
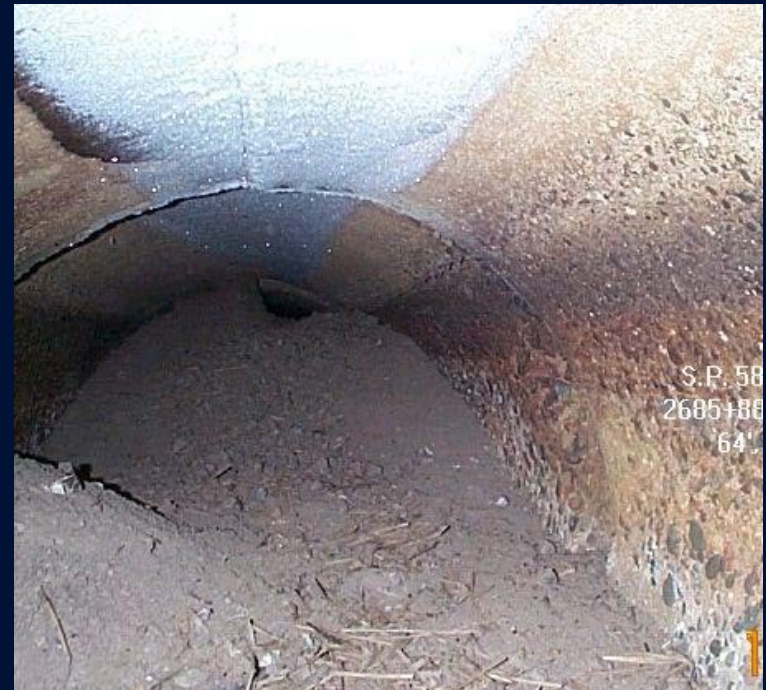
# Plugged –

Something is in pipe causing water to backup or restrict the water flow.

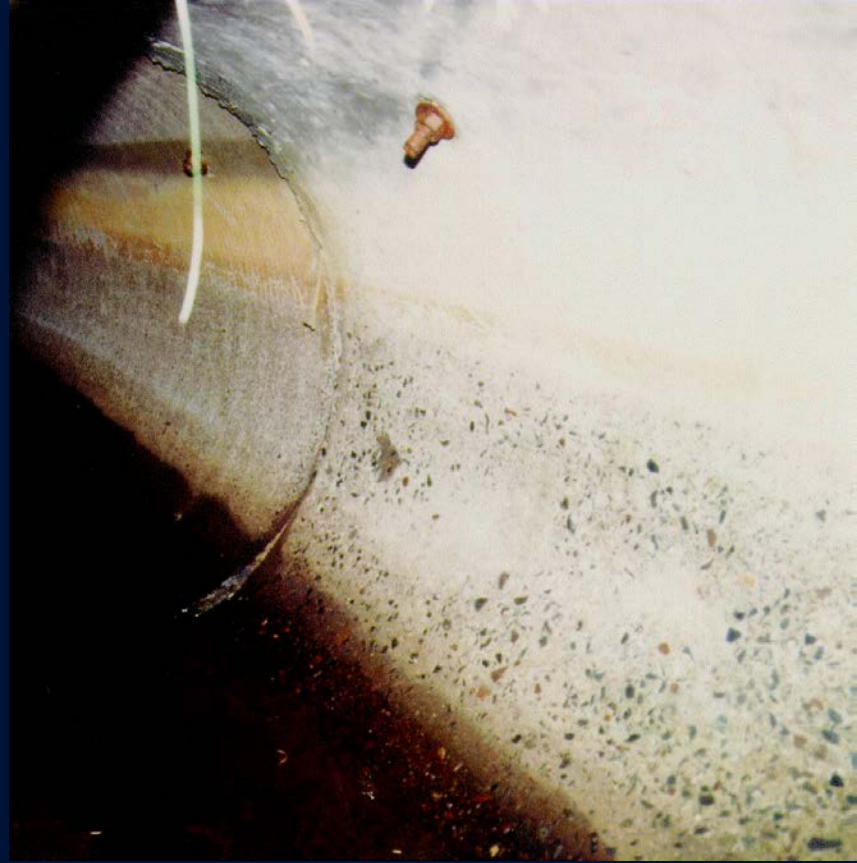
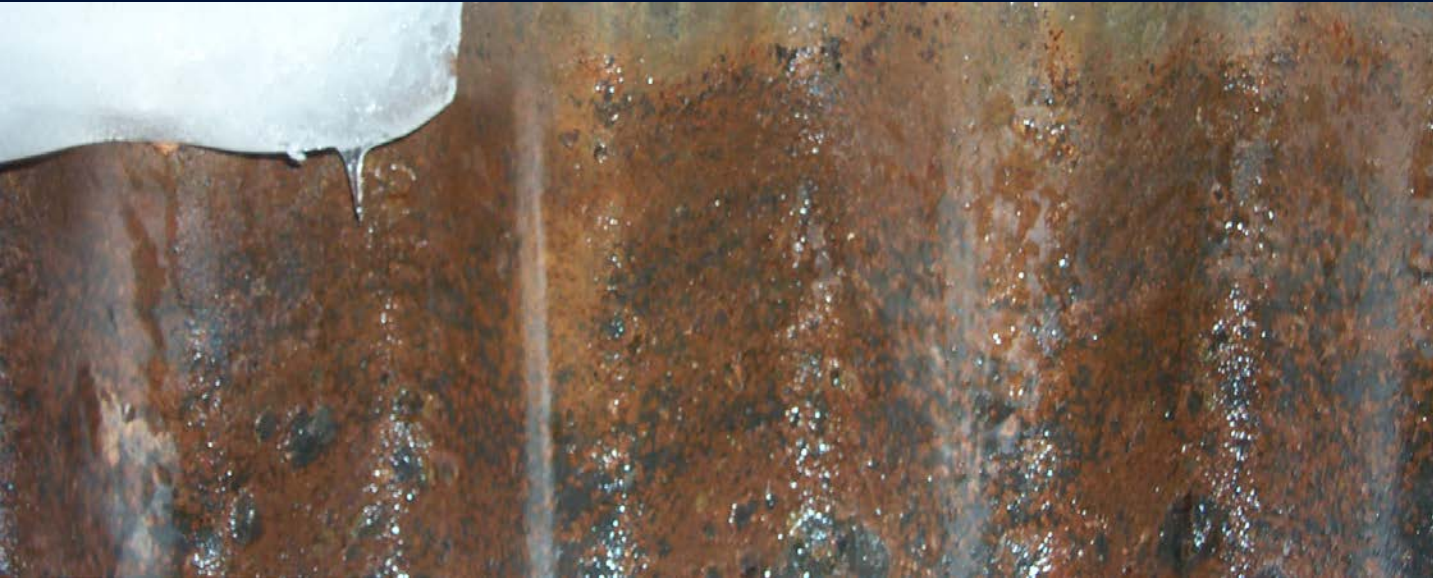
## Pitting/Rusting –

Small pits are visible in the surface of the pipe, or if metal, rusted but still solid.

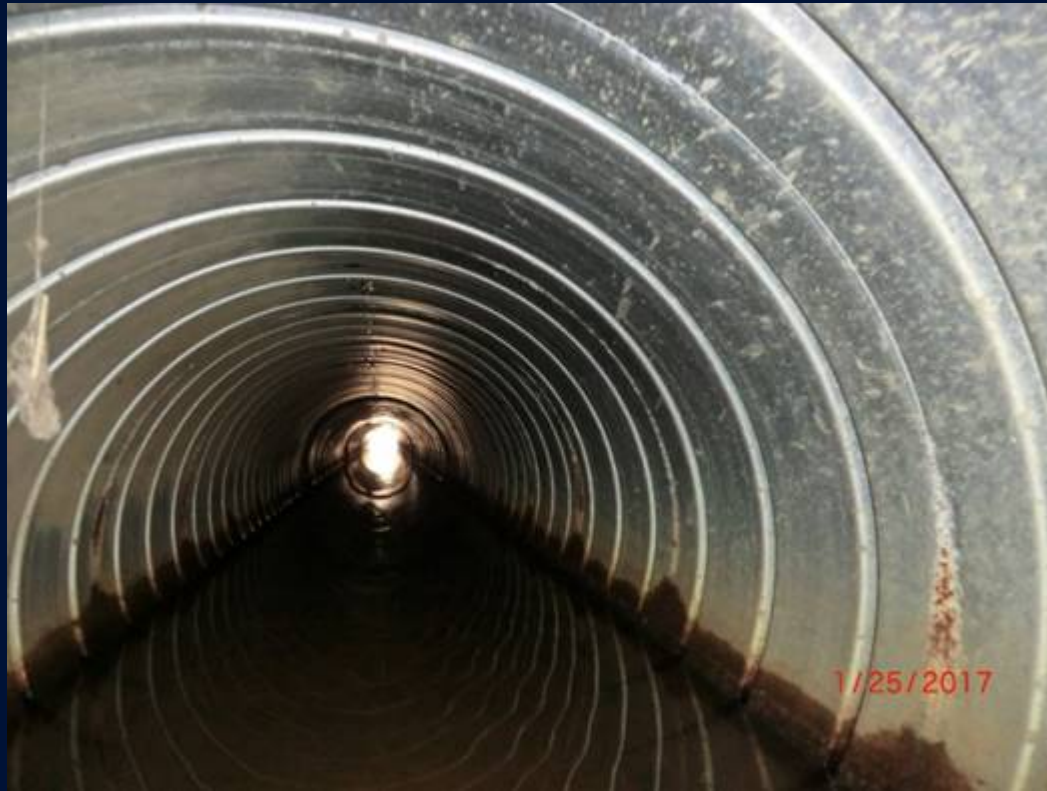
# Aluminized-steel pipe may have rust at seams or joints.

Why are some DOTs are seeing early corrosion in aluminized pipes? This aluminized pipe in Ohio is about 12 years old. The material is flat-seam spiral rib aluminized steel – the ribs are folded seams visible on the outside of the pipe.

Photo from Ohio DOT.

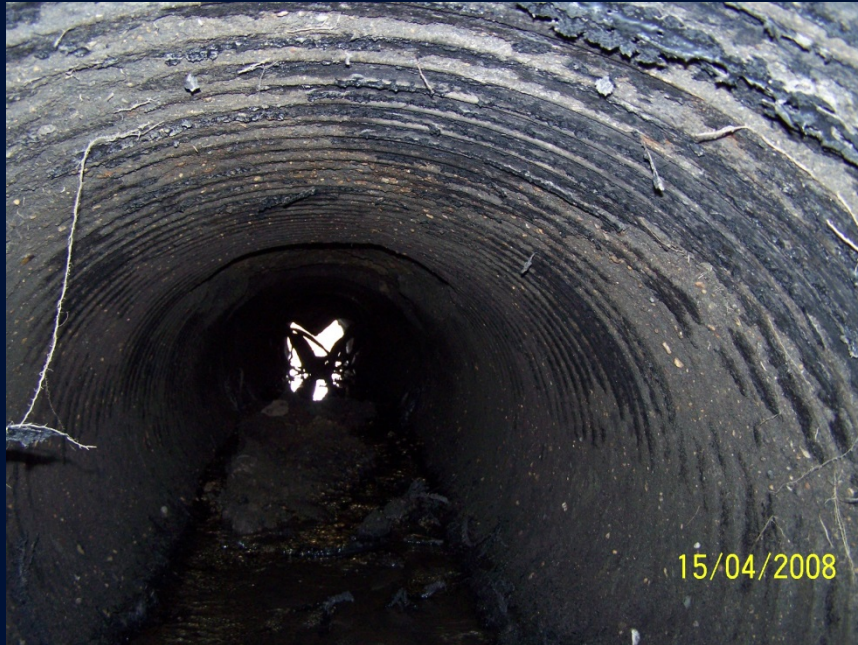
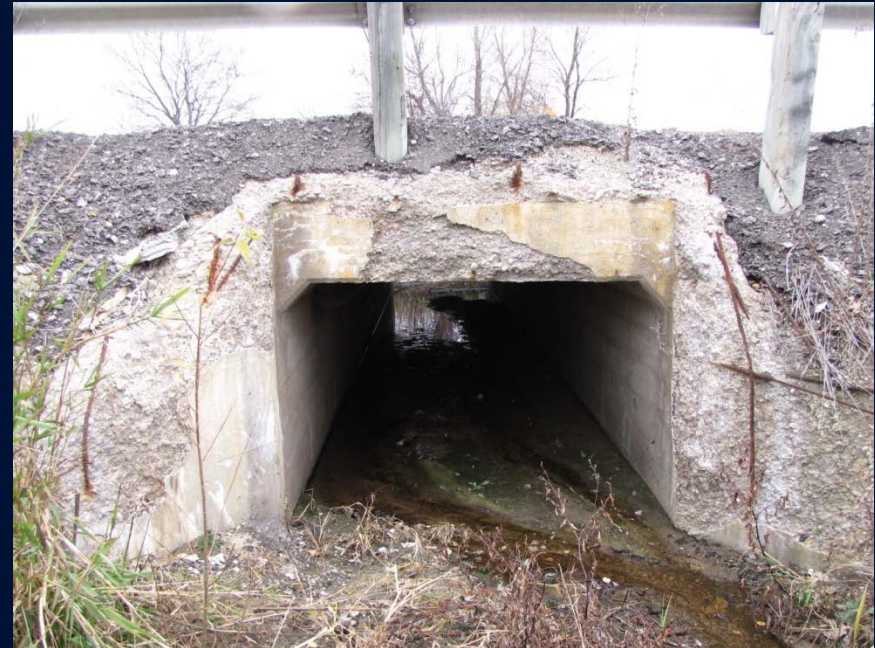
# Spalling/Flaking –

Flat chips of concrete are lost from feature's surface or if metal, flakes of rust are falling away.

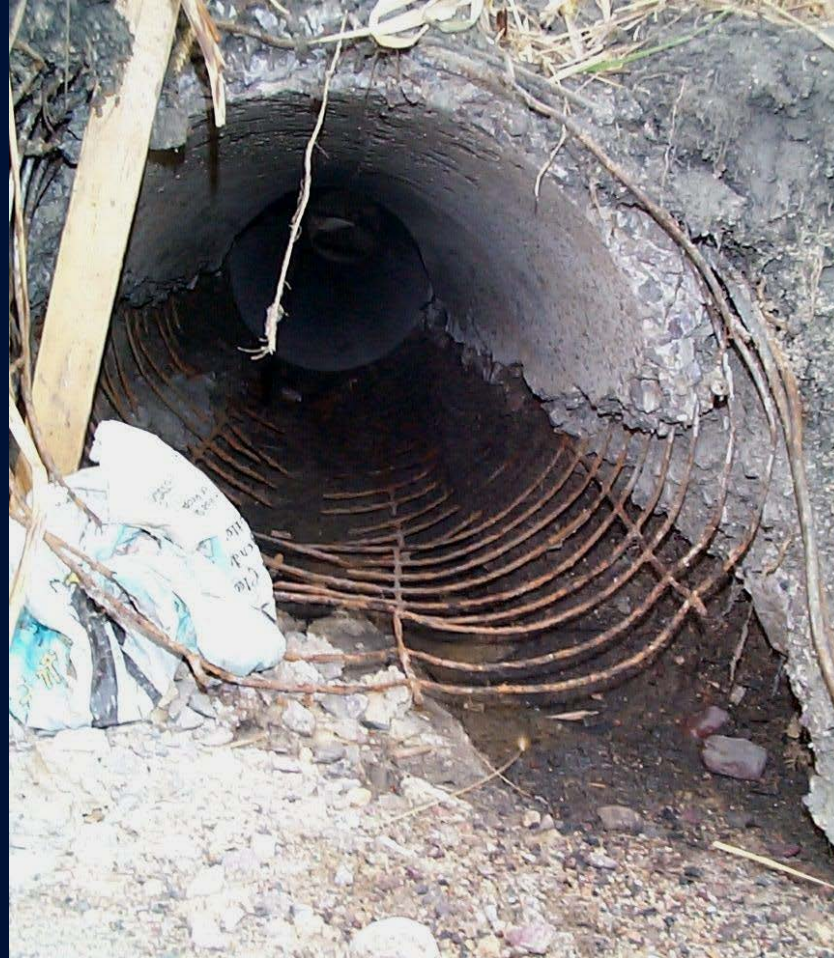
## Holes –

Hole goes completely through the asset's material.

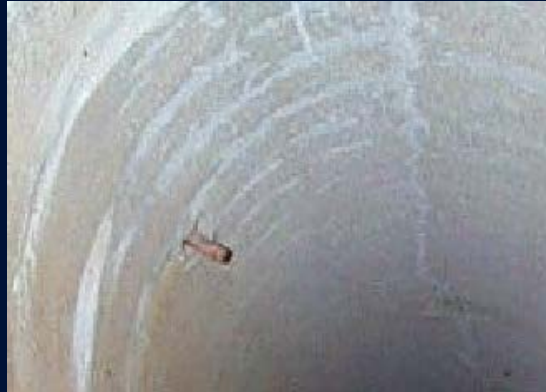
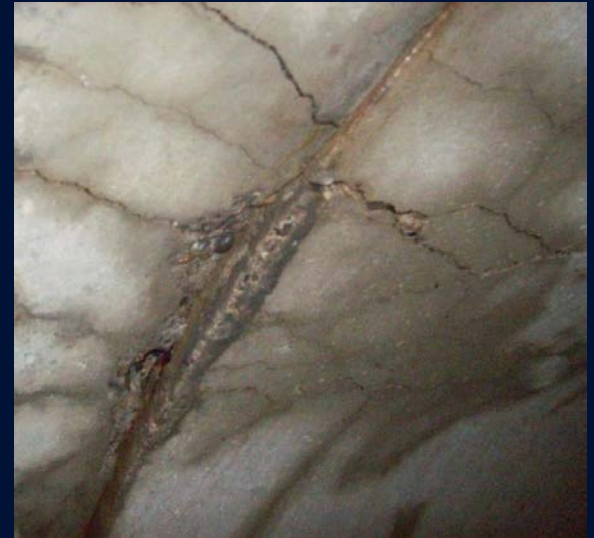
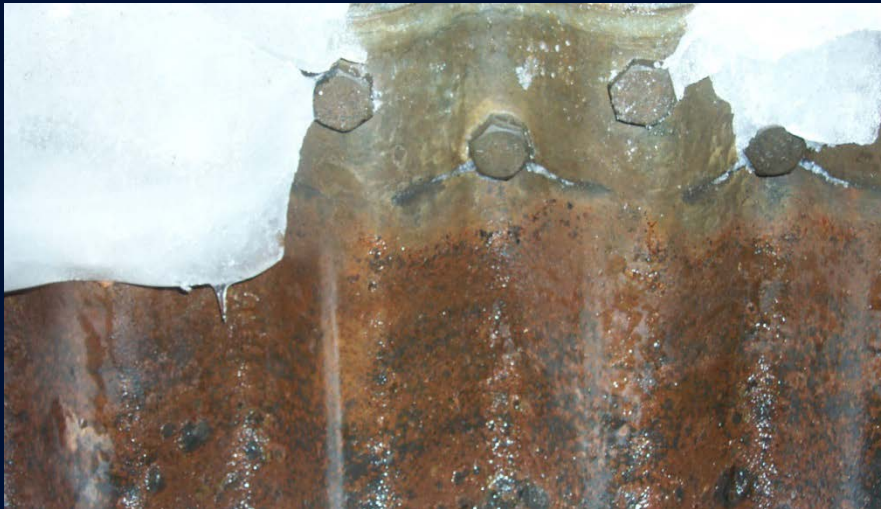
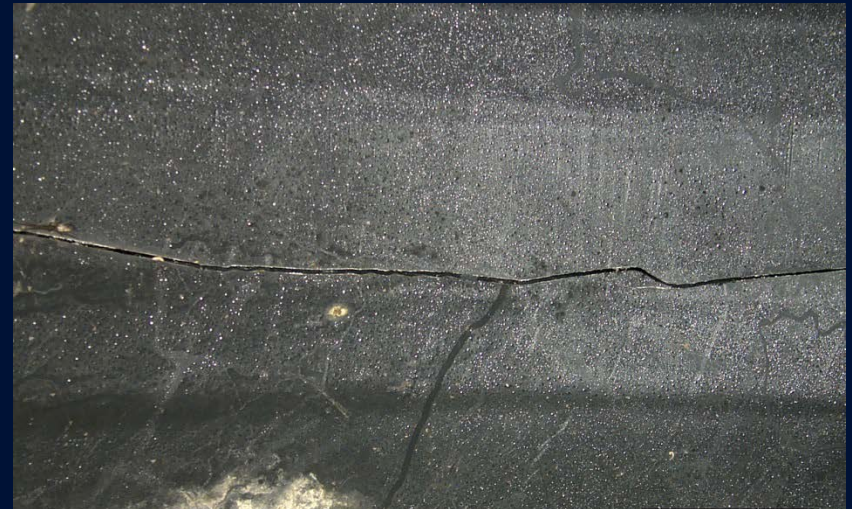
# Cracks –

- Not Visible
- Crack
- Fracture
- Displaced
- Unknown
- (don't use Yes)

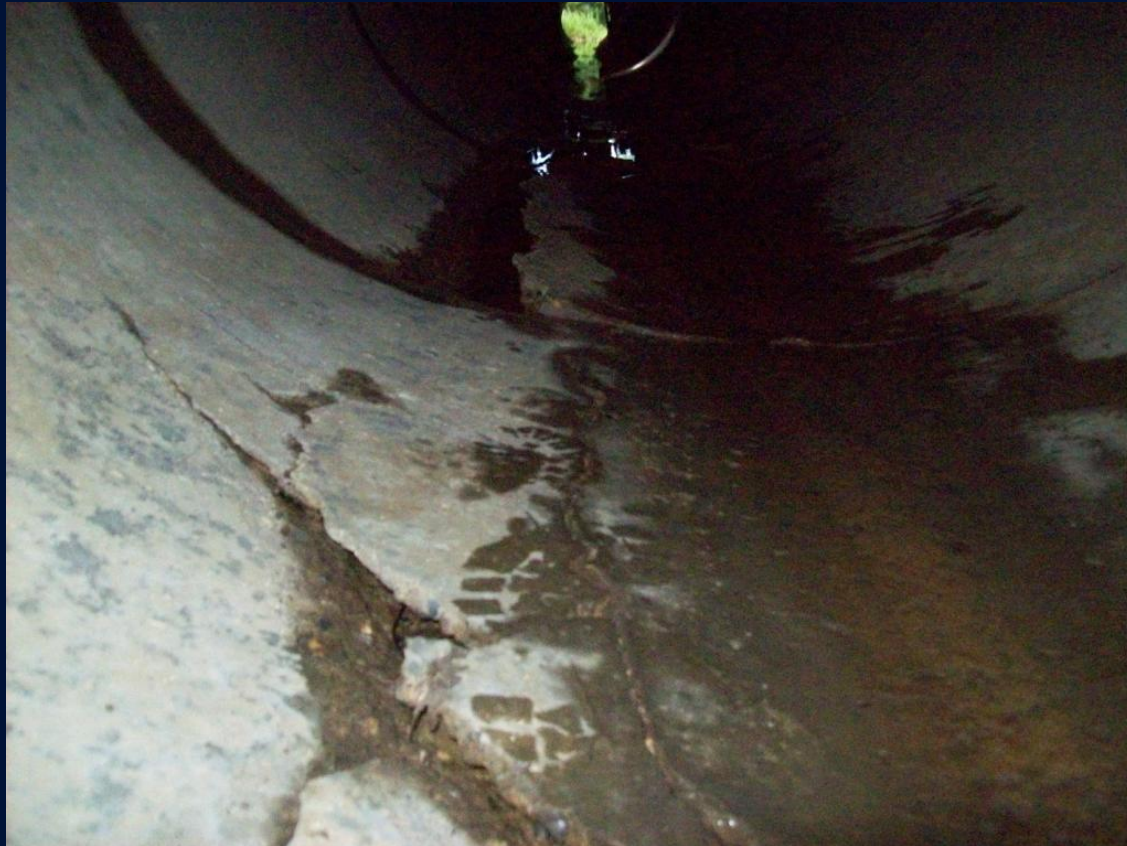
## Deformation –

Feature's shape is distorted, flattened or oval-ed.

Deformed Concrete pipe also has cracks, spalling, slabbing.

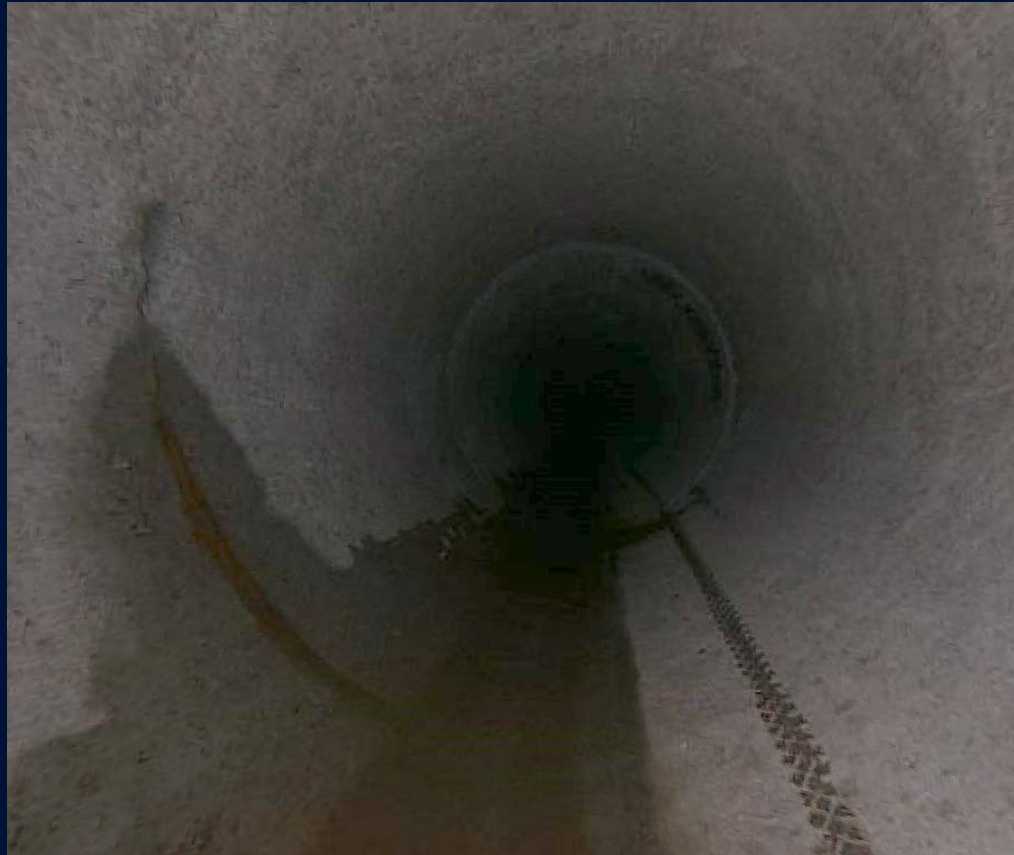
# Fracture shows rust from reinforcing steel

Concrete Fracture circumferential crack shown in video inspection.

Inspection criteria Condition 3:

\*Water infiltration through cracks or rust staining or efflorescence.

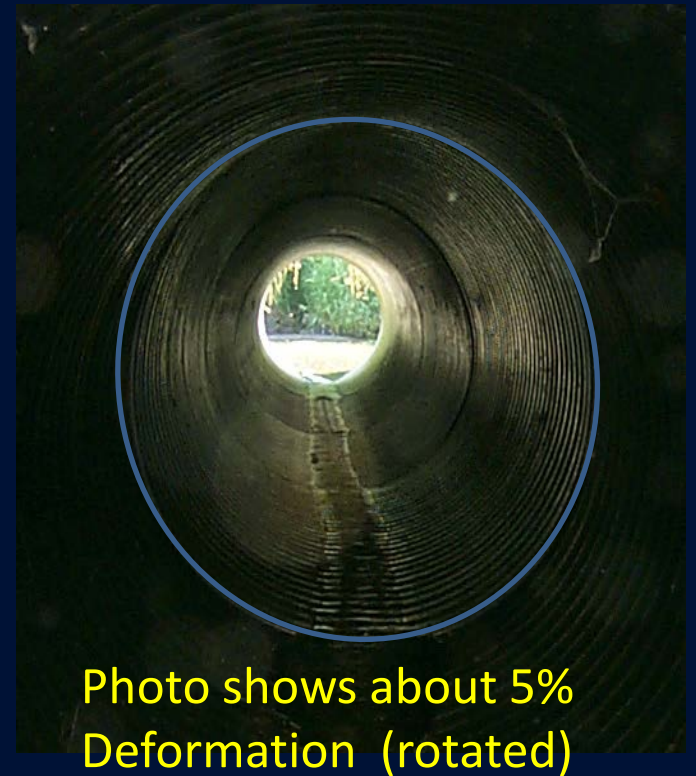
# Estimate **Deformation** in Pipe

Then apply Plastic rating criteria (pg. 30 and 31) for Condition Rating.

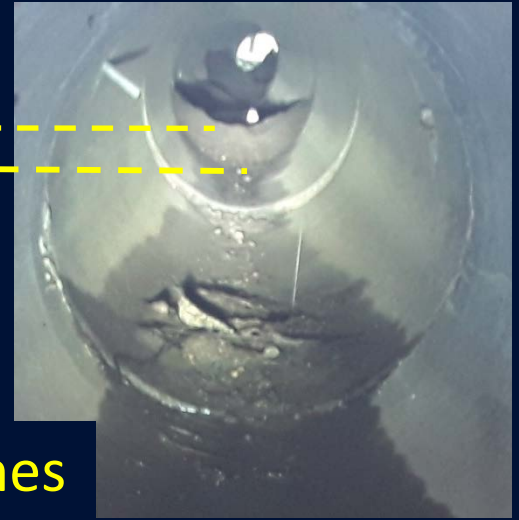
# Misalignment –

The pipe sections are offset and alignment is bad.

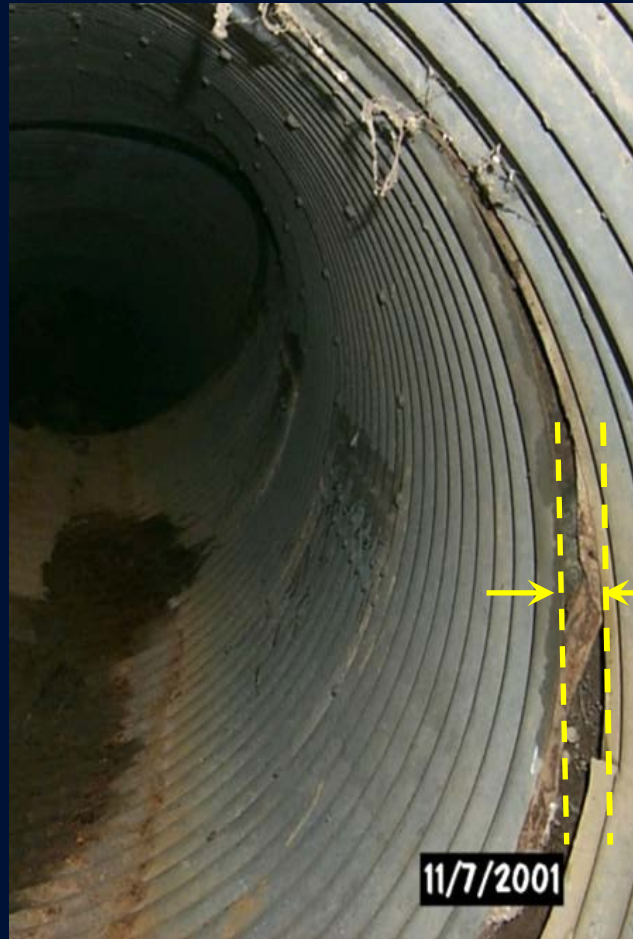
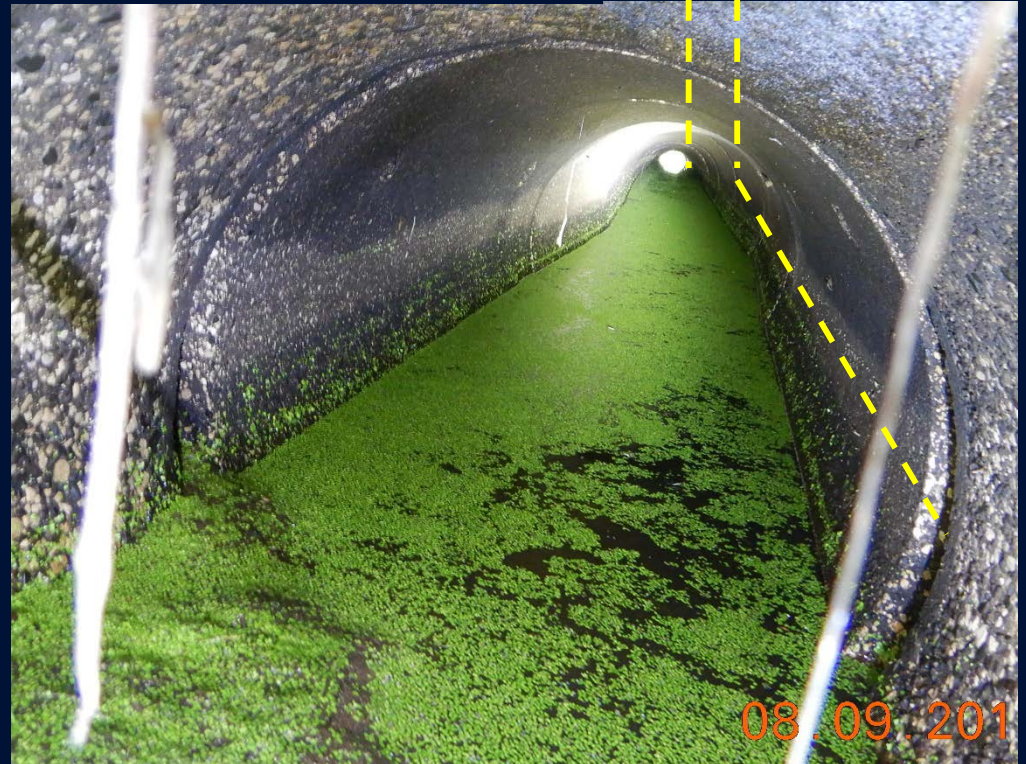
Estimate number of inches pipe is out of alignment

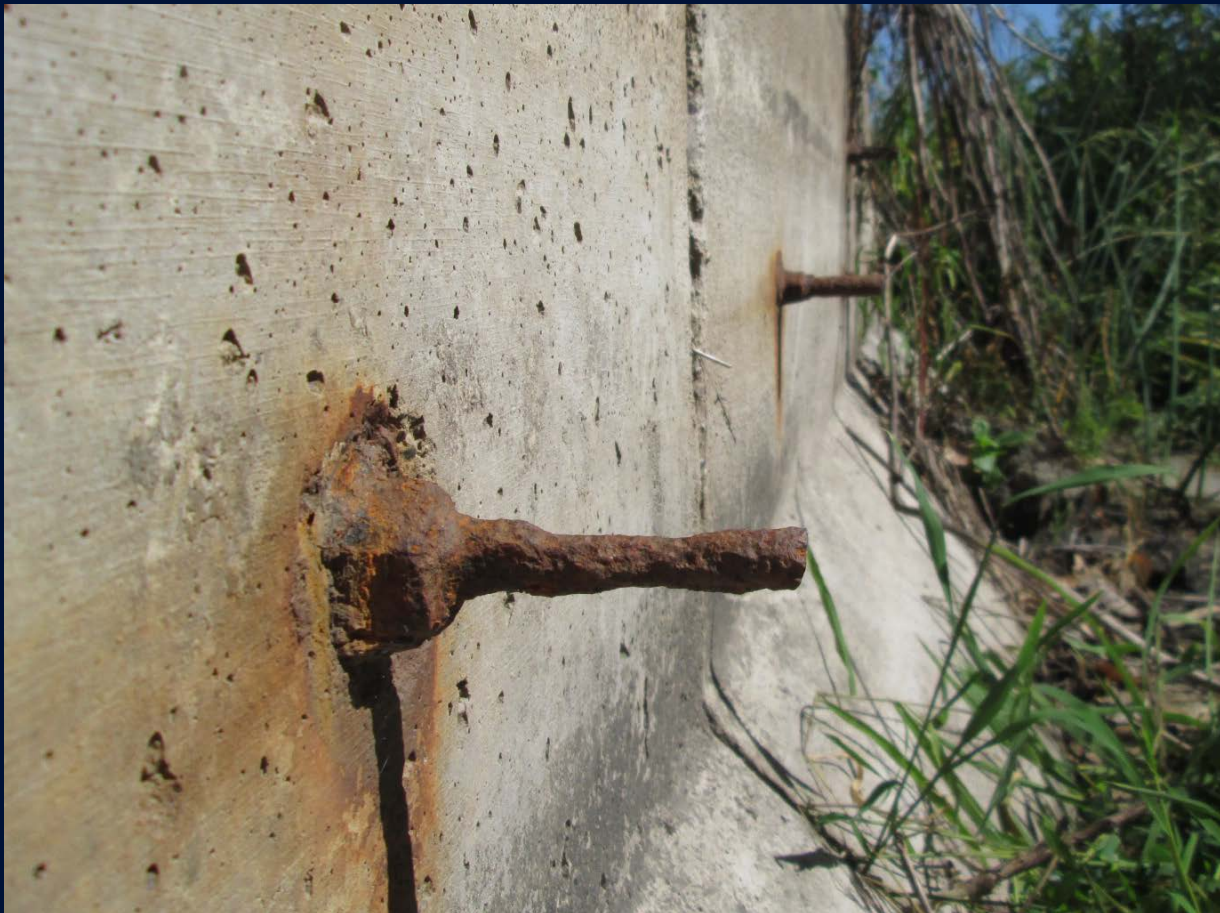
## Deteriorated Ties –

Pipe ties are rusted or broken, may not hold pipe joints together.

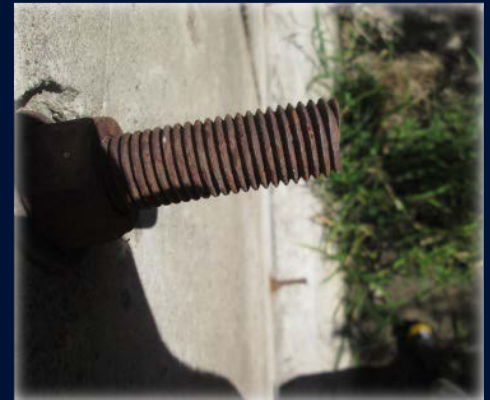
A good tie bolt looks like this:

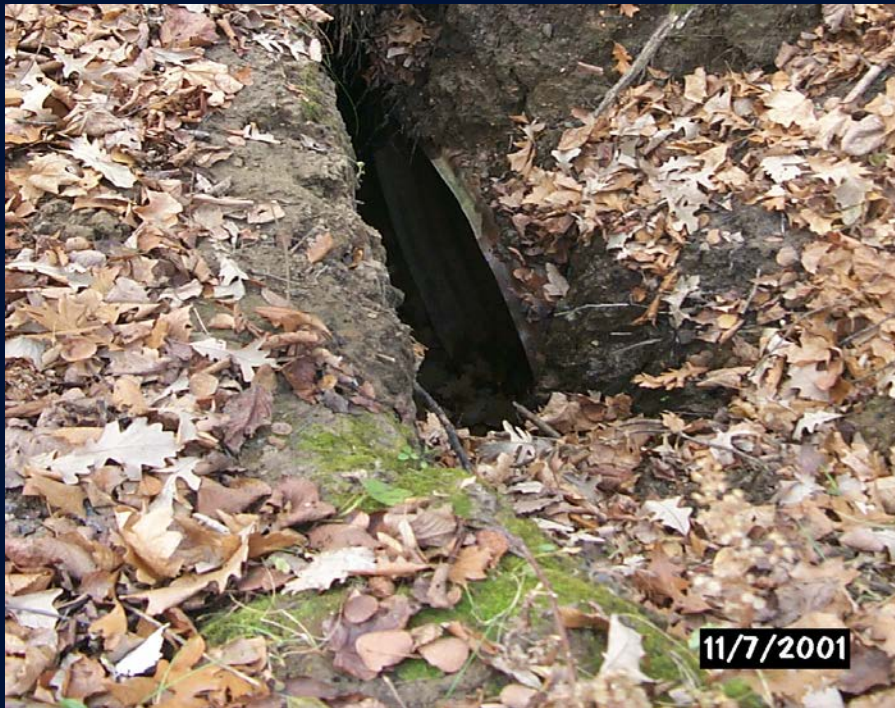
# Max Joint Separation –

Estimate or measure the largest separation between pipe sections

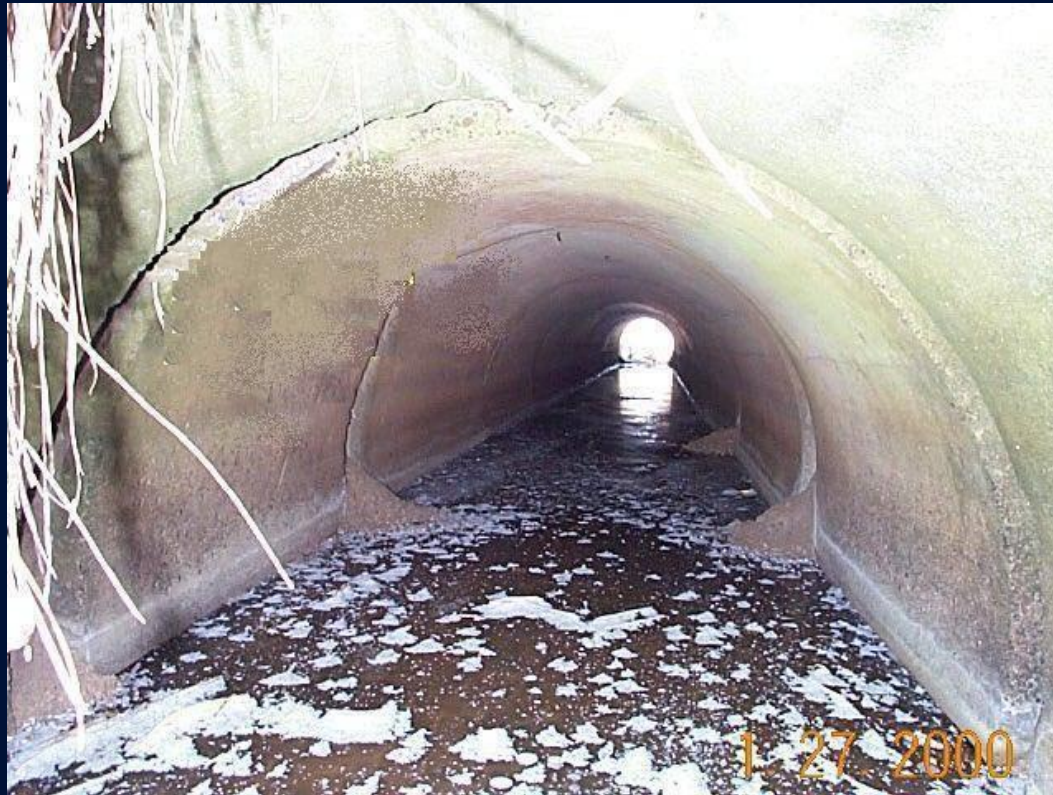
## # Joints to Fix –

Count the number of joints that are separated by 1 inch or more, or have evidence of soil infiltrating the joints.

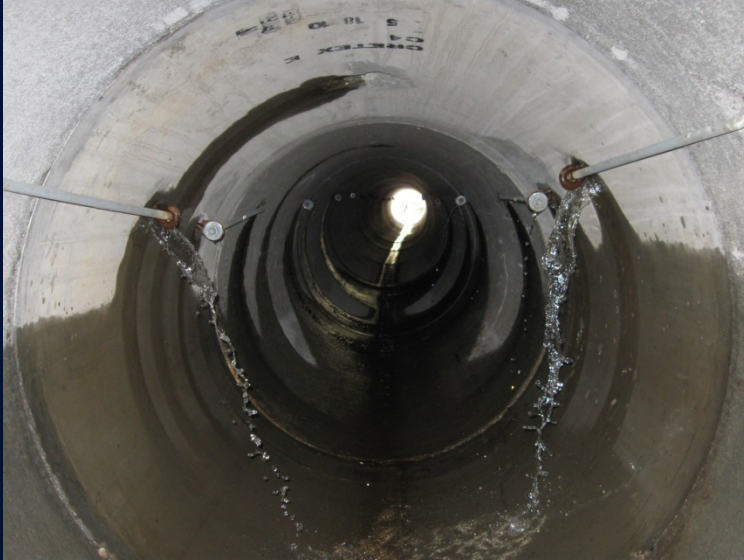
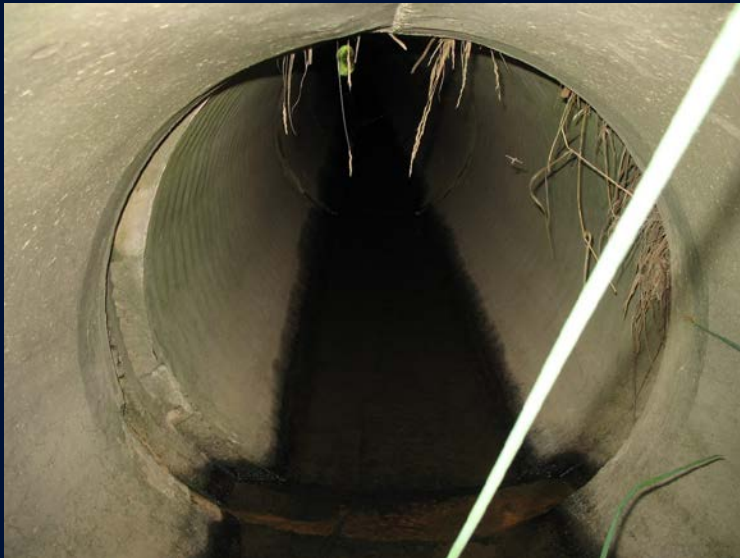
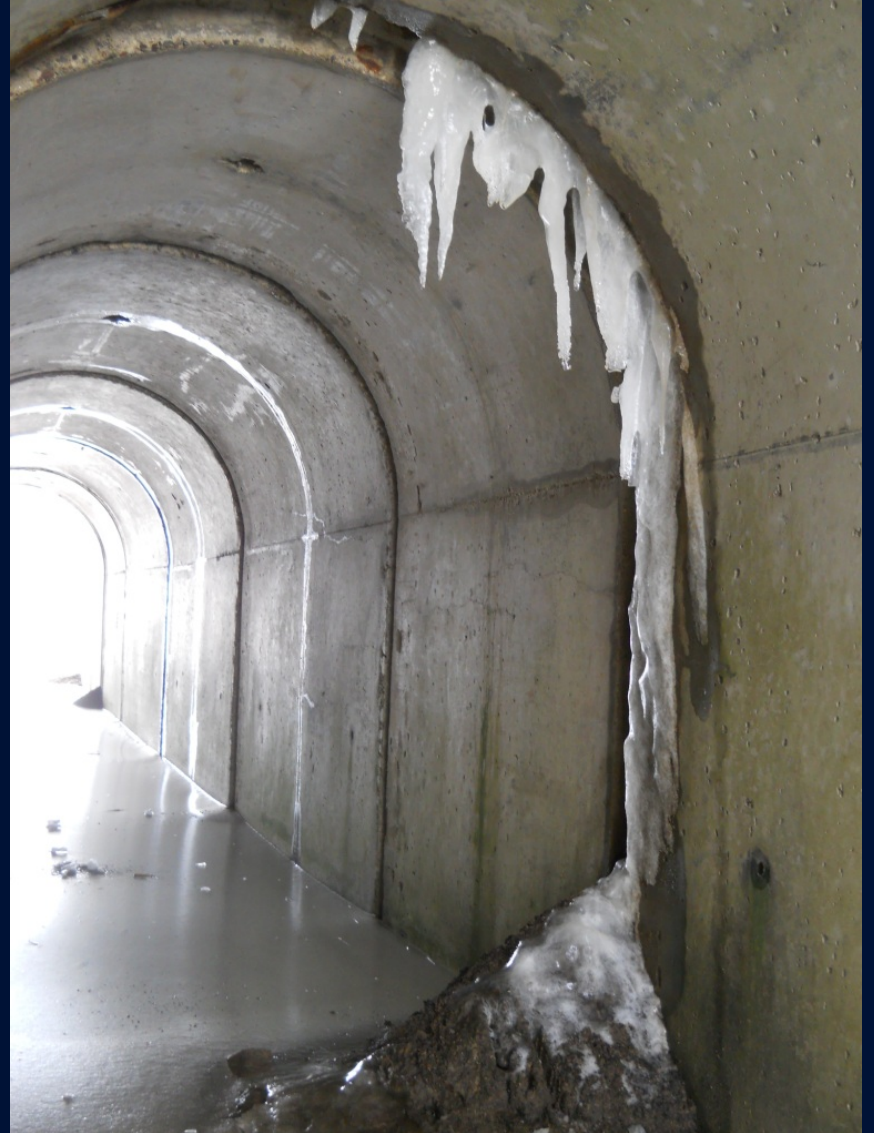
# Infiltration –

Evidence that soil or water is seeping into pipe.

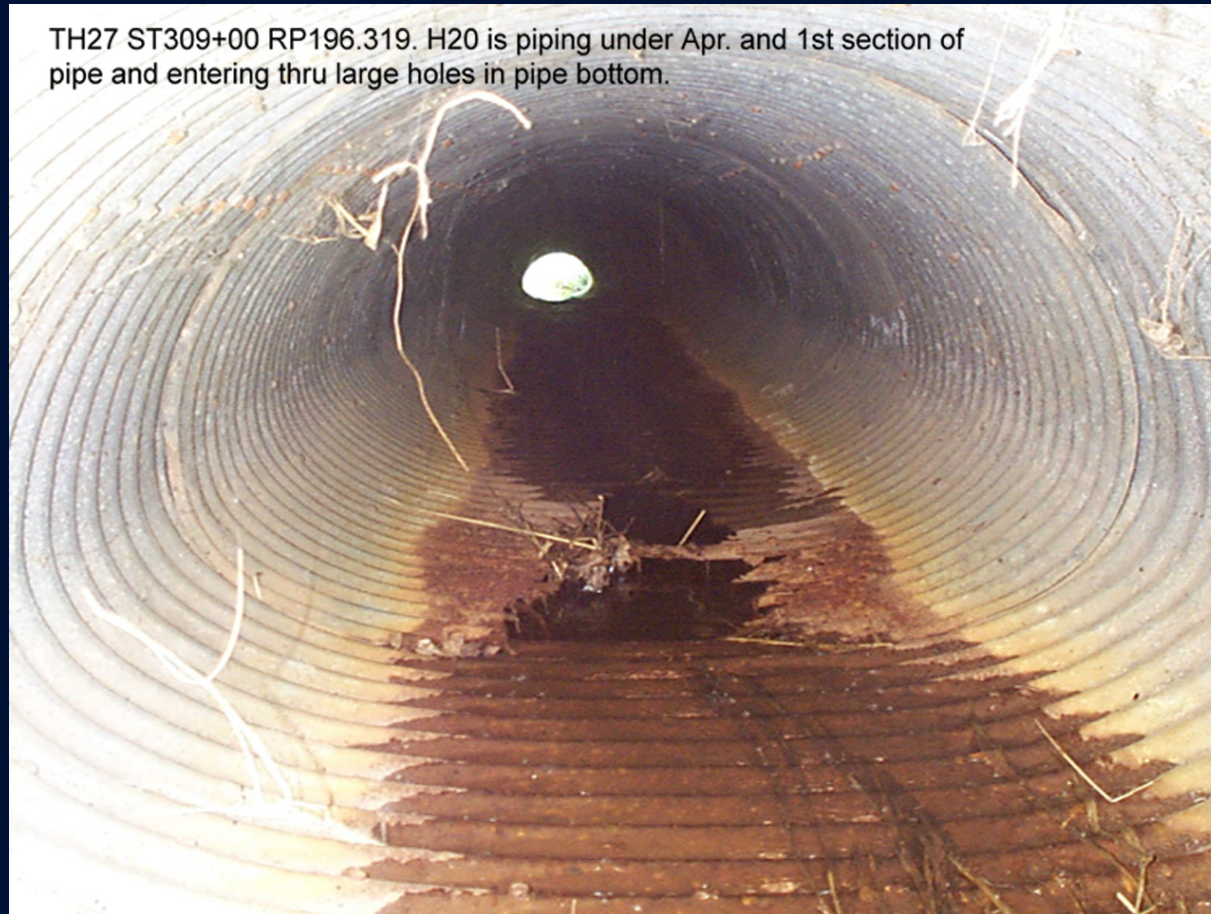
# Piping –

Water is flowing along the outside of pipe (causes loss of soil in roadbed).

Gap outside of pipe allows water to carry road fill away.

Imagine water rising at  
the pipe inlet.

A **gap** between pipe  
and structure can  
cause **pipng** and loss  
of road fill.

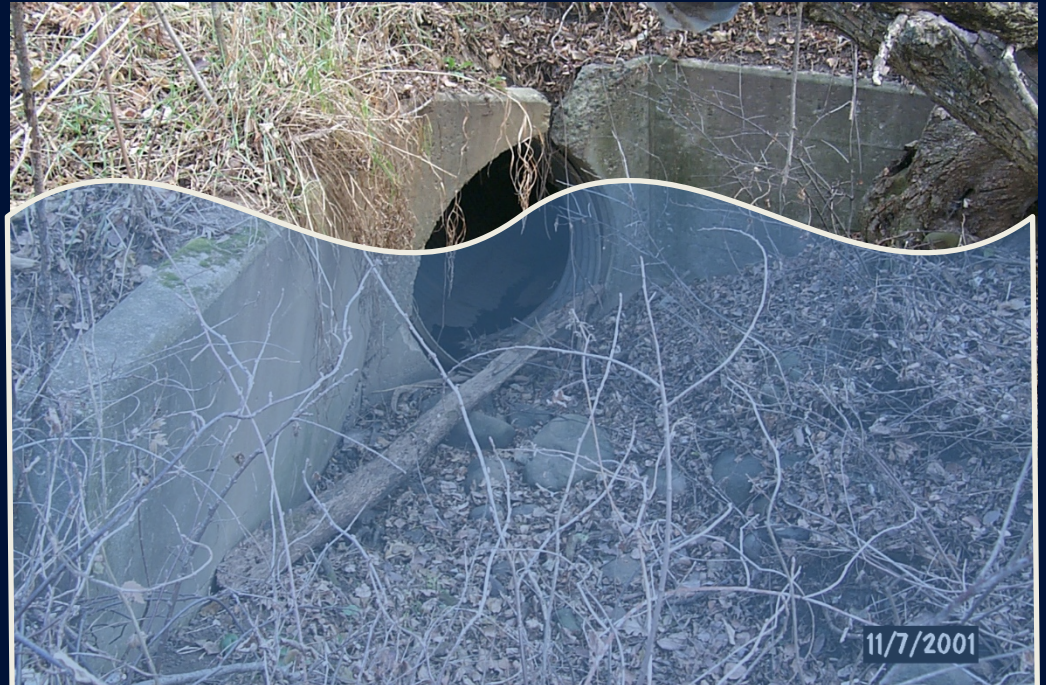
This is what **pipng** looks like –  
water leaves the pipe at holes or joint separations  
and **flows along the outside**

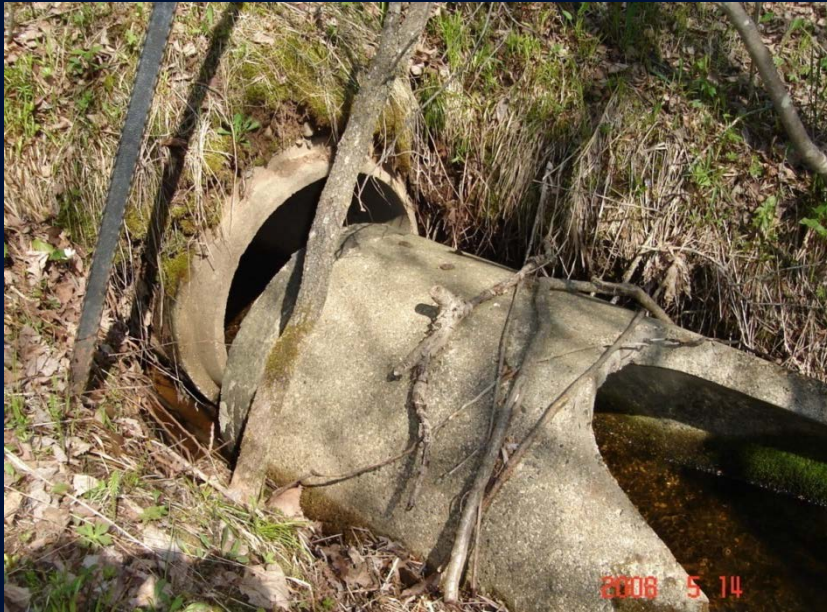
No

(not under road)

Shoulder P.I. is the dividing line.

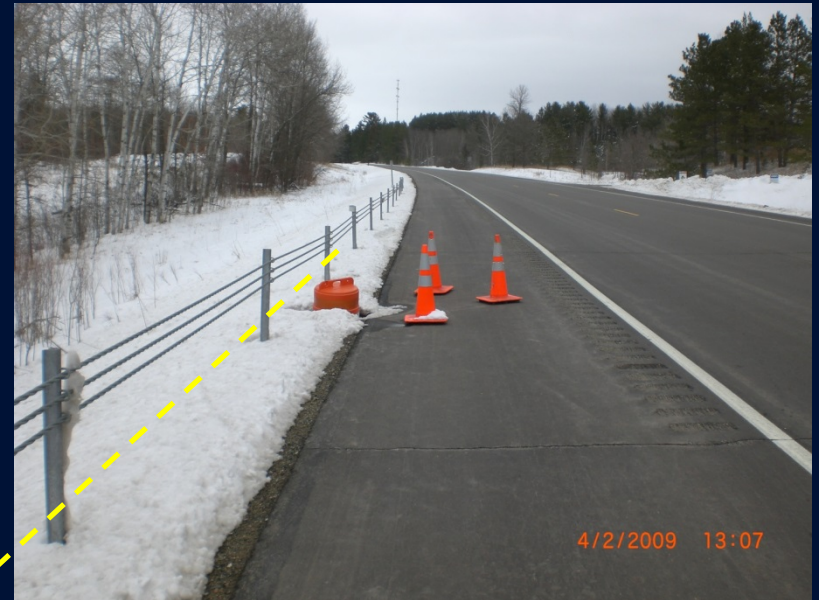
Yes

(is under road)

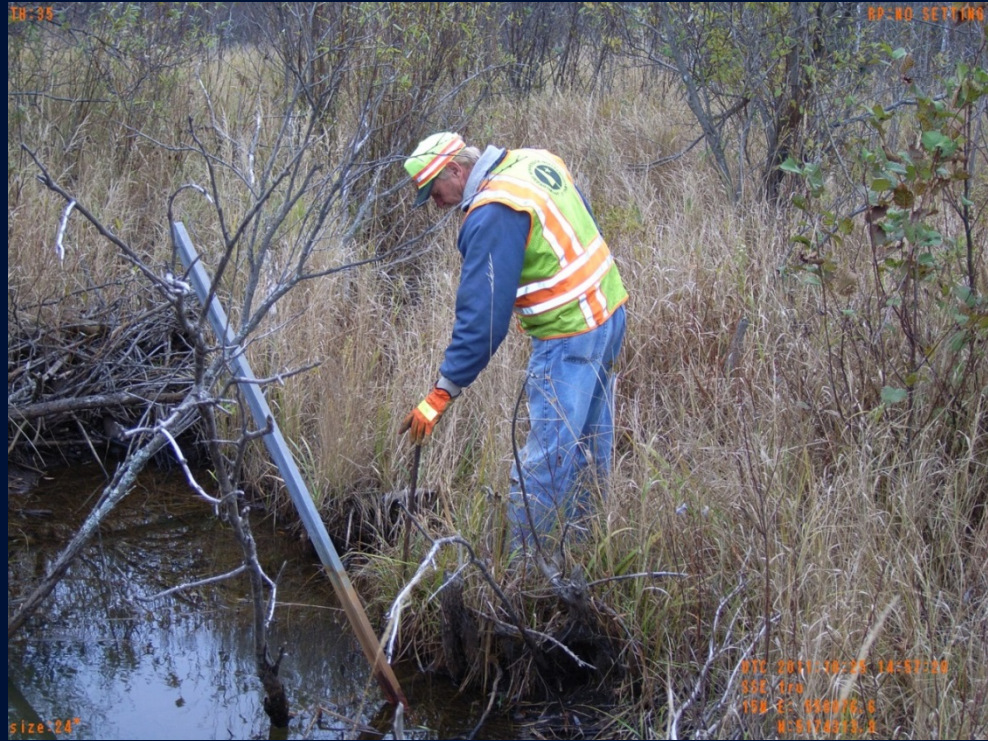
# Condition 0: Unknown

Not Accessible  
or  
Underwater  
or  
Under Dirt

- But, if you see serious defects from criteria, **rate it 3 or 4.**
- **Don't overwrite condition 3 or 4 rating** with a 0.
- Flags are mostly left blank, except Water, Sediment, etc.

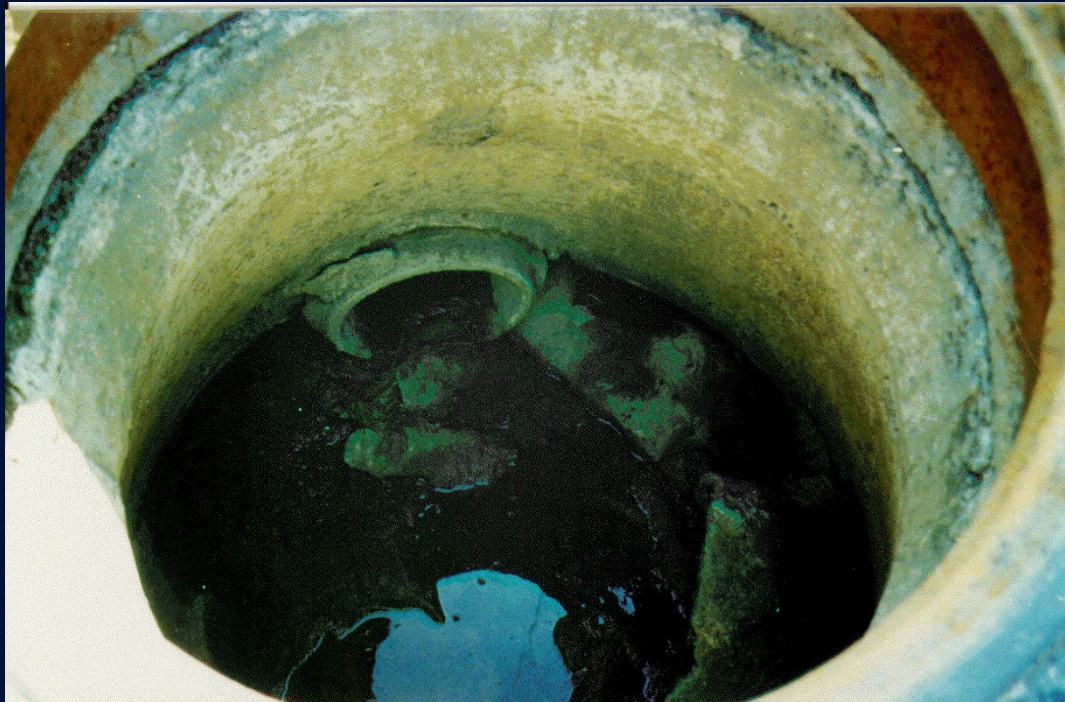
## Deteriorated Rings

# Structure Inspection:

Look for **gaps** and **cracks** or **weakening** at rings, structure walls, connected pipes and invert.
