# HydInfra Terms, Flags and Measures

## Illustrated Guide to the HydInfra Manual

### HydInfra Inspection Manual

Culvert and Storm Drainage Systems

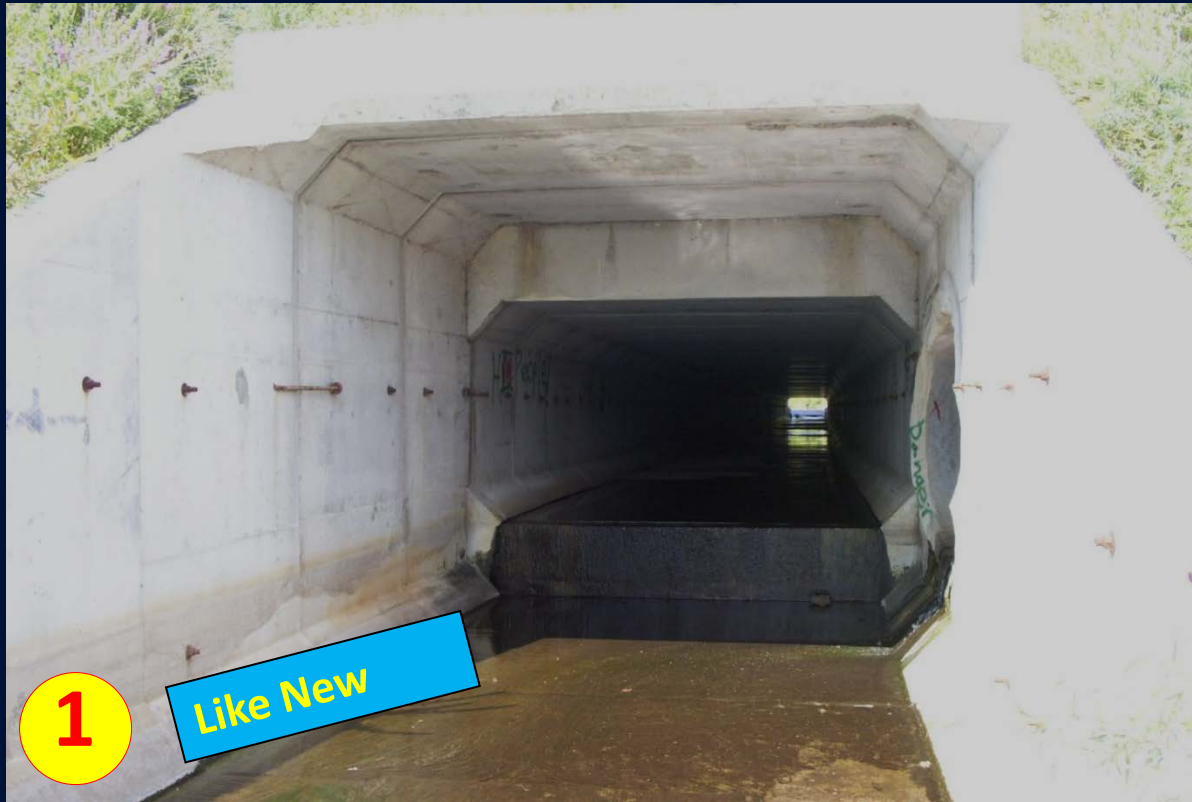
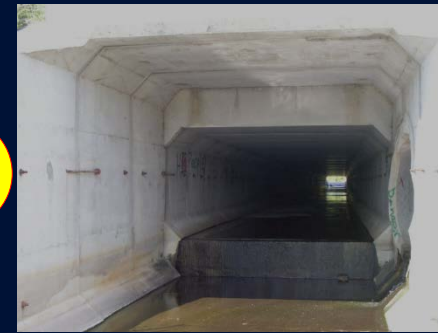
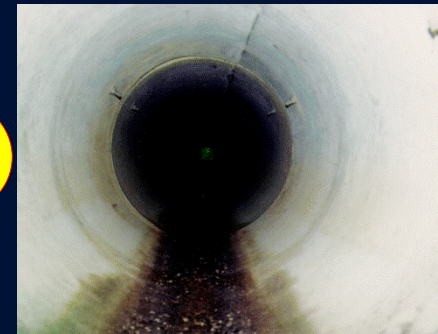
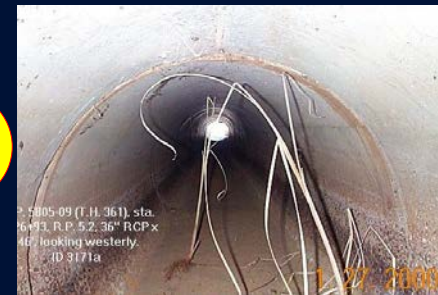
# Concrete Pipe **Joint Separation** 1

## Concrete Condition 1 Excellent

- Minor chipping at joints/openings
- **No Joint Separation**
- \*Crack - Not Visible or hairline crack less than 1/100 inch
- Insignificant spalling or scaling

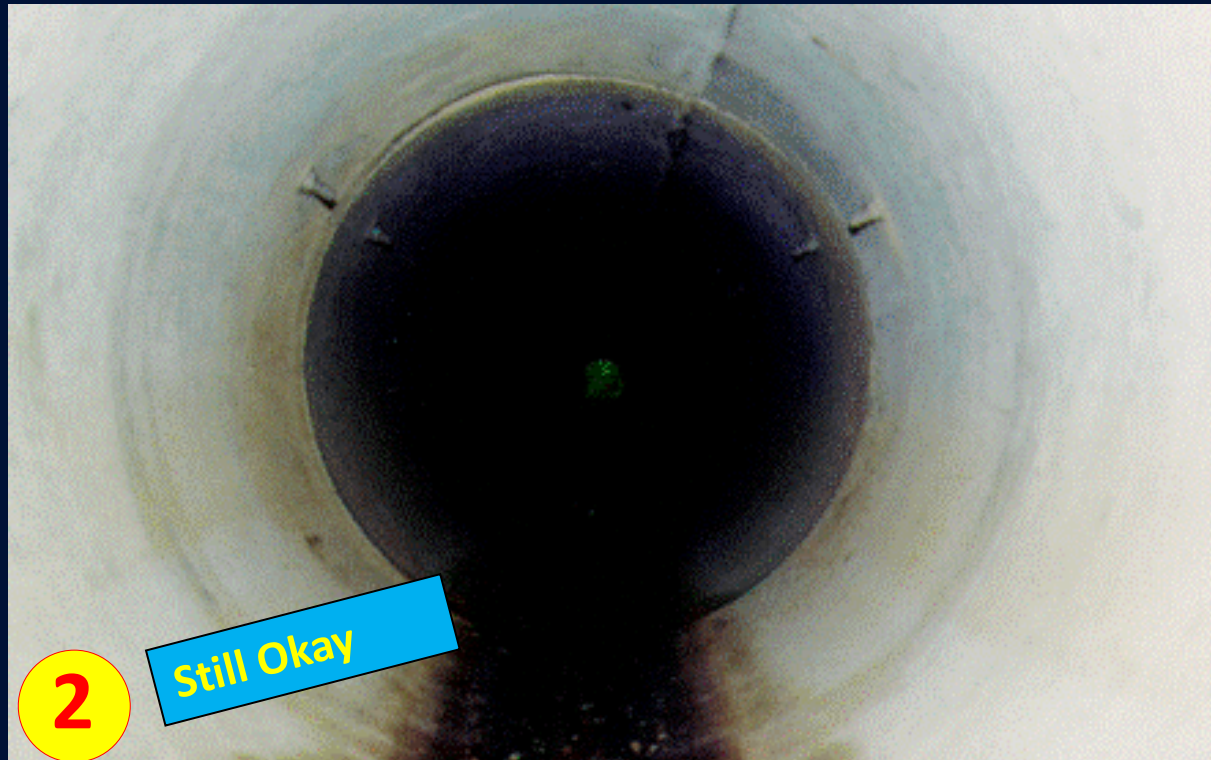
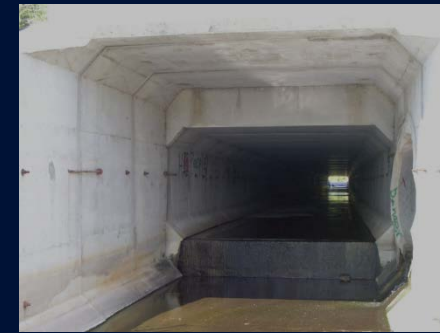
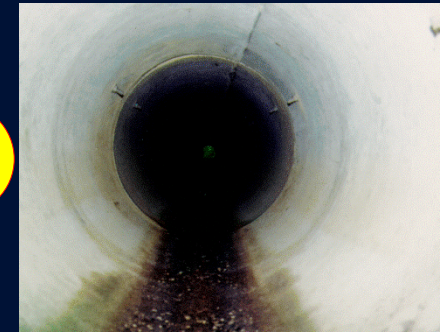
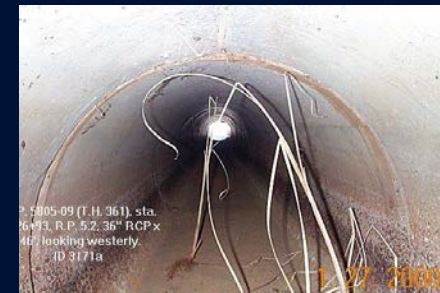
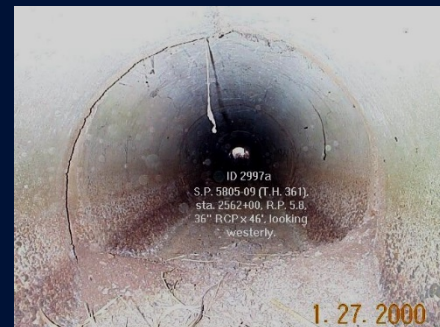
# Concrete Pipe Joint Separation 2

## Concrete Condition 2 Fair

- Joints broken or pulled apart up to 1"
- Exposed aggregate
- \*Spalling or scaling to ½ inch depth less than 6 inch diameter patch
- Lengthwise Crack less than 1/20 inch wide (thickness of one dime) or around the pipe with no infiltration (not wet, stained or deposit)

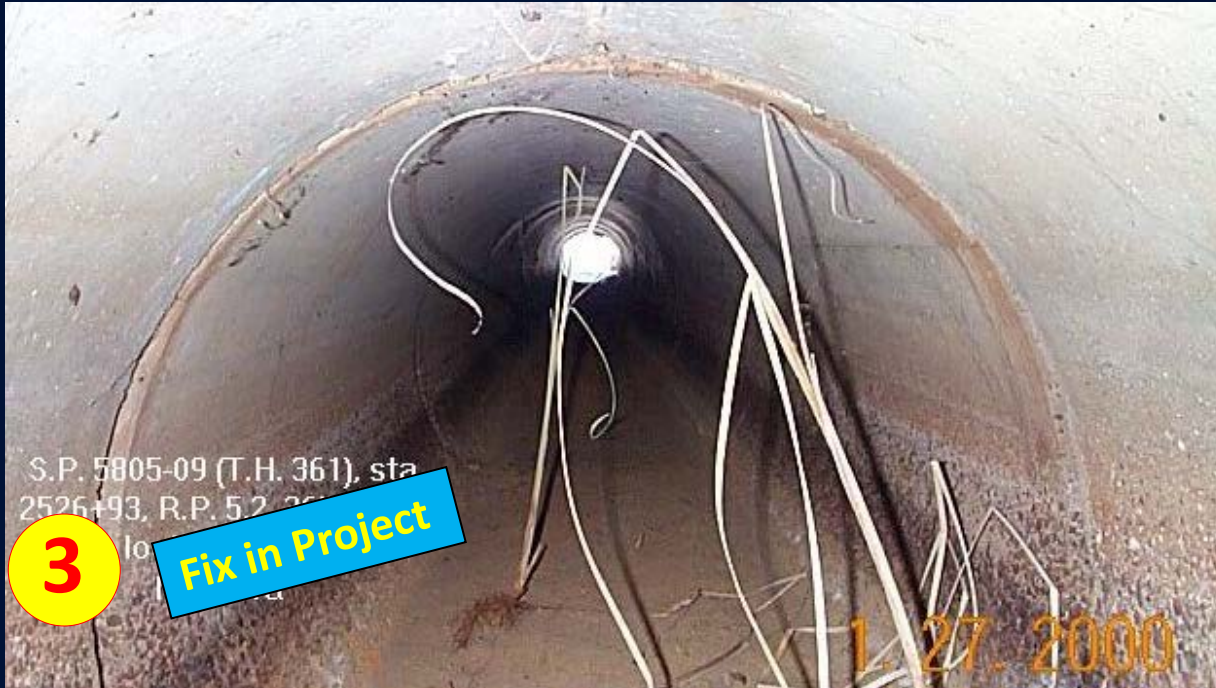
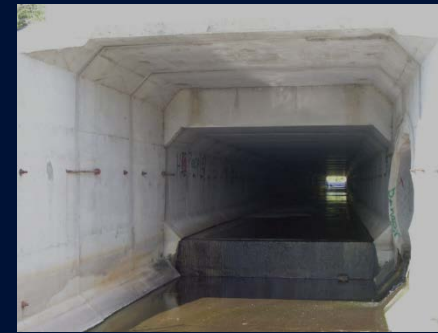
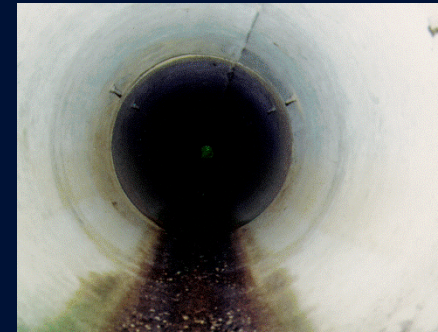
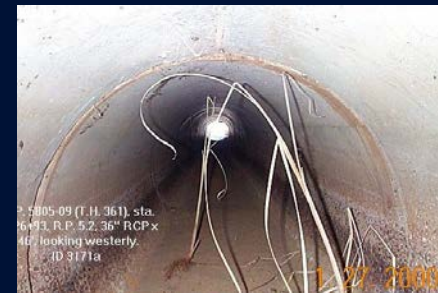
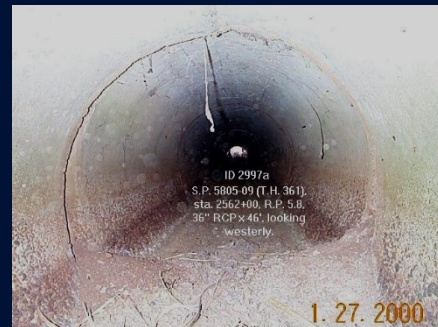
# Concrete Pipe Joint Separation 3

## Concrete Condition 3 Poor

- Joints broken or pulled apart 1"-3"
- Infiltration of water
- \*Lengthwise crack with width 1/20 to 1/10 inch (thickness of 1 to 2 dimes)
- \*Abrasion or Spalling ¼ to ½ inch with deeply exposed aggregate or reinforcement showing
- Apron is separated from pipe
- Pipe may be causing soil loss beneath road surface

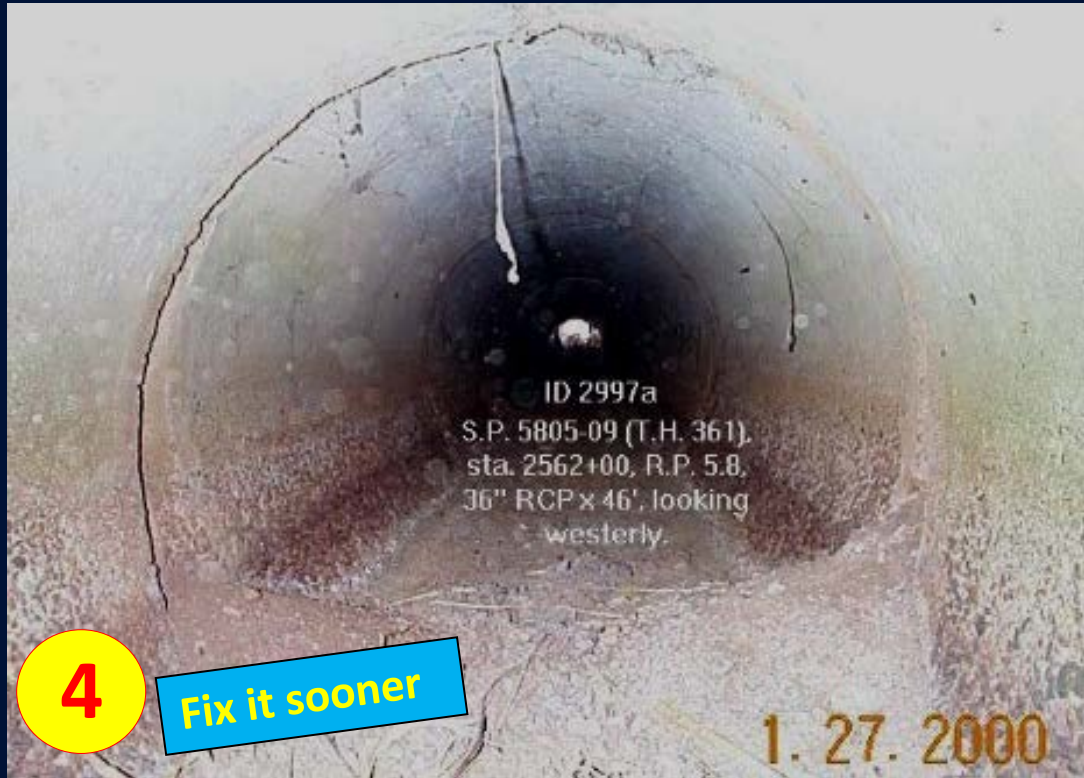
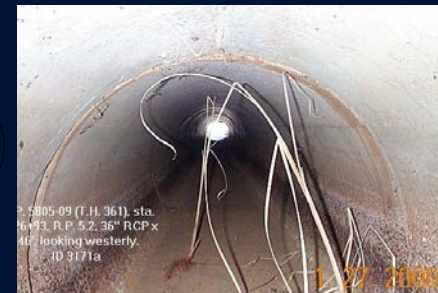
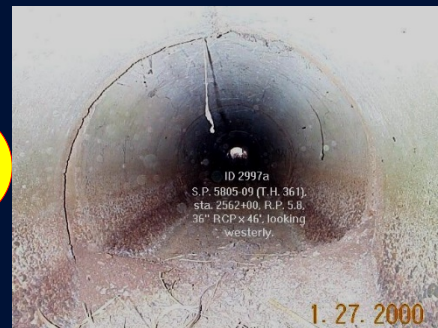
# Concrete Pipe Joint Separation 4

## Concrete Condition 4 Very Poor

- Joints pulled apart or broken more than 3" at any point along joint
- \*Lengthwise Fracture – crack greater than 1/10 inch wide (width of 2 dimes)
- \*Fractured crack with displaced pipe pieces
- \*Widespread spalling more than ¾ inch depth or invert deterioration
- Piles of soil at joints, or any indication that soil infiltrates into pipe under roadway

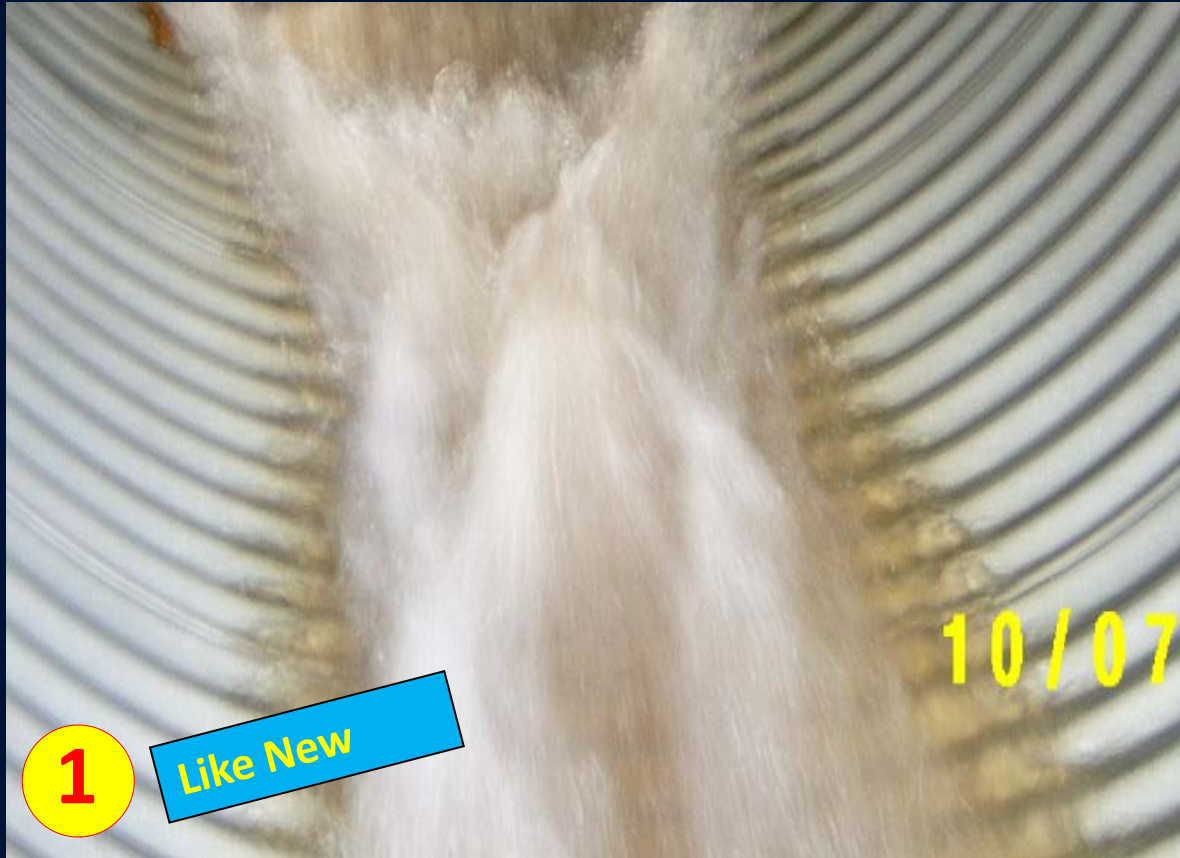
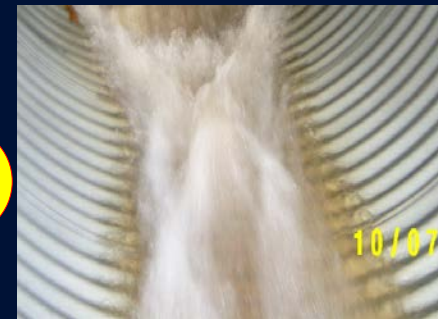
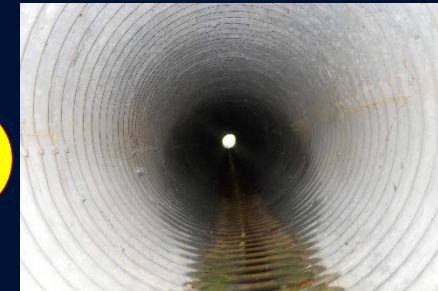
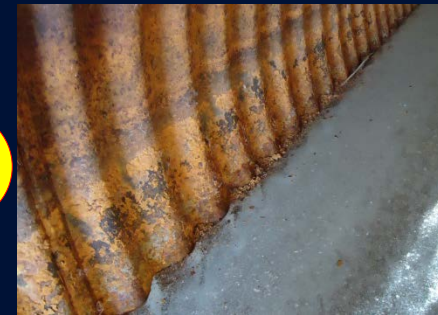
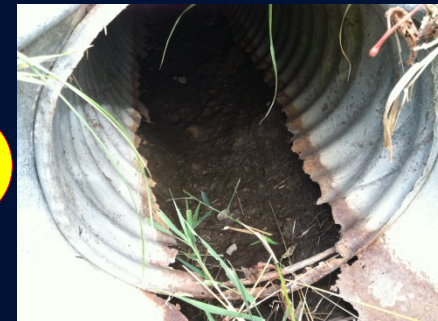
# Steel Pipe will rust, flake and get holes

## 1 Excellent Condition

- Discoloration of surface
- Galvanizing intact
- No rust or pitting

Rusting→Flaking→Holes→Infiltration→Piping→Road Void→Road Distress→Deformation

Common sequence for  
Condition Deterioration of  
Corrugated Metal Pipe

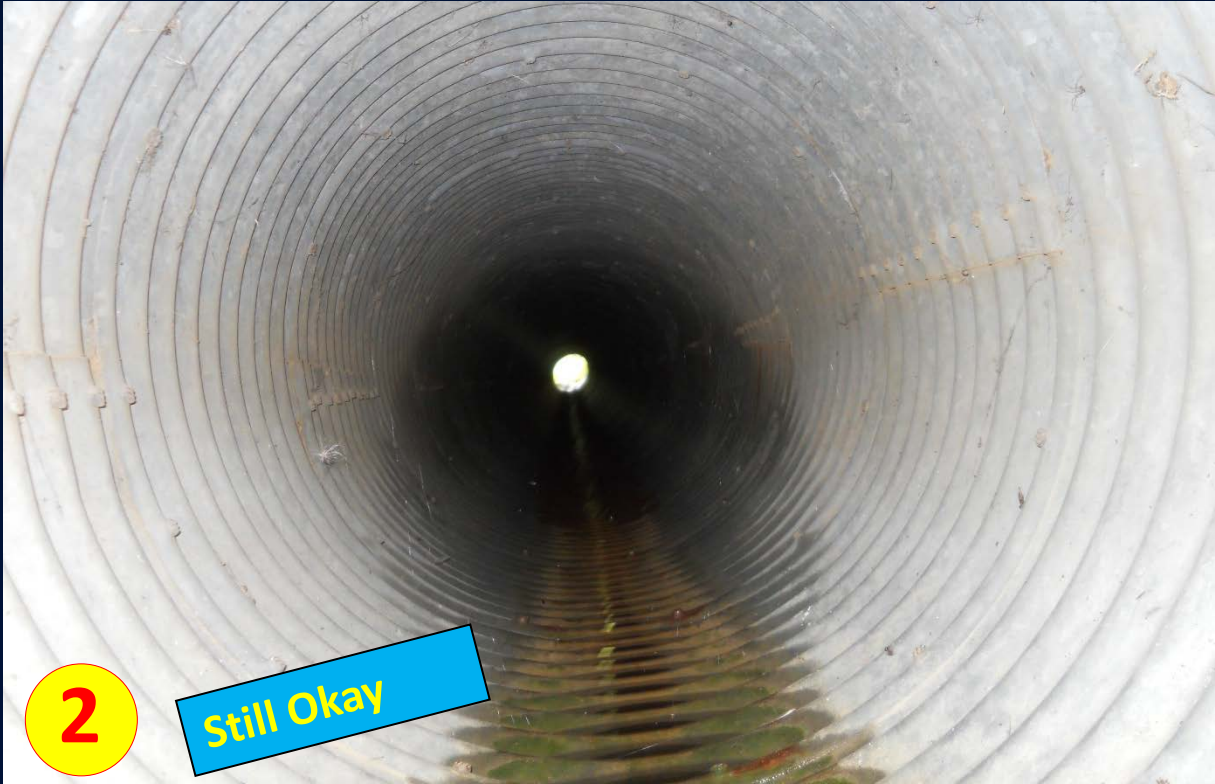
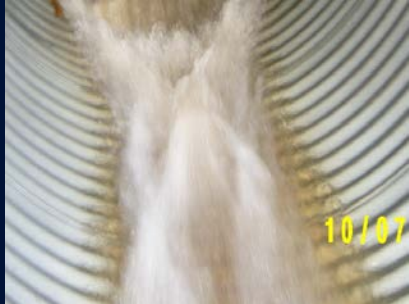
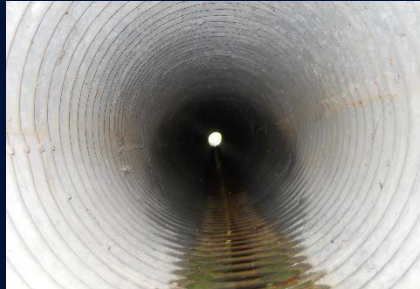
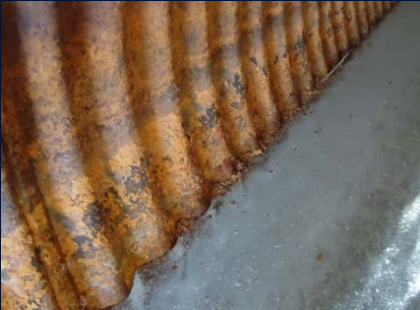
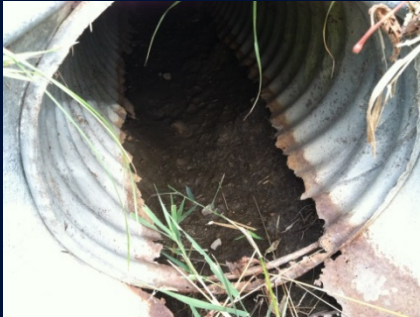
# Steel Pipe Rusts 2

**2 Fair Condition**

- Galvanizing gone
- Pitting, superficial rust or tight rust flakes

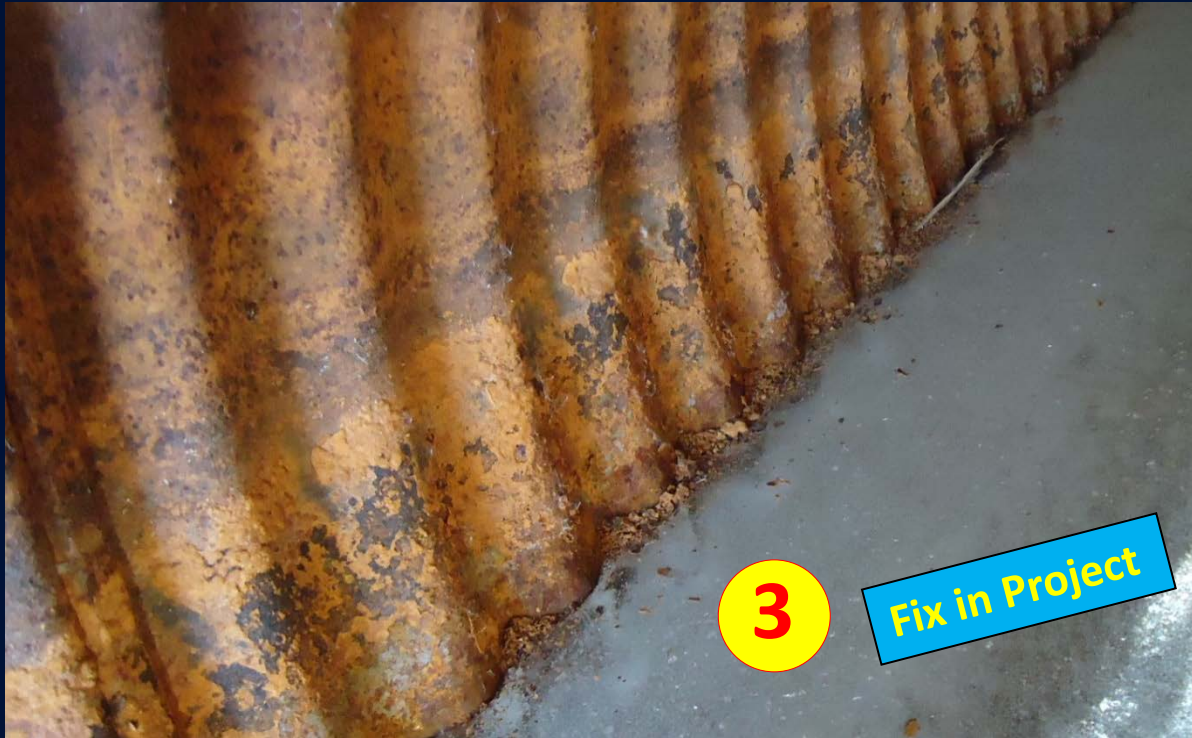
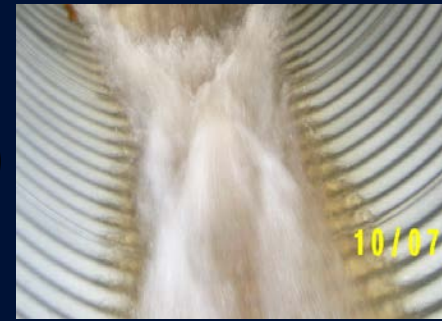
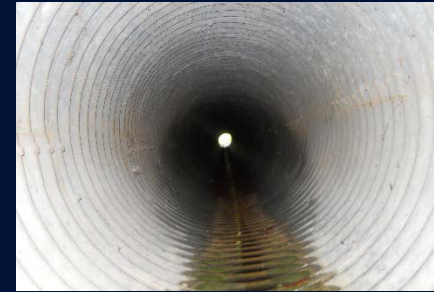
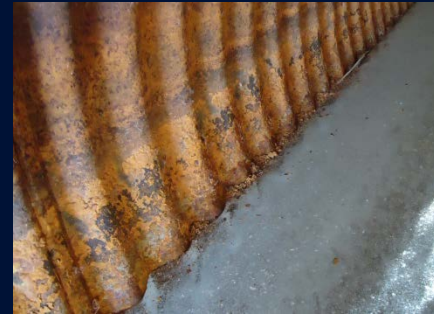
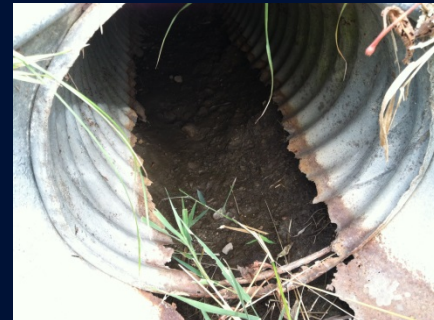
# Steel Pipe rust flakes off, loses strength 3

## 3 Poor Condition

- Flaking rust evident, with some loss of wall thickness
- A hole, less than 1 inch in size
- Can poke a hole in pipe with a sharp point

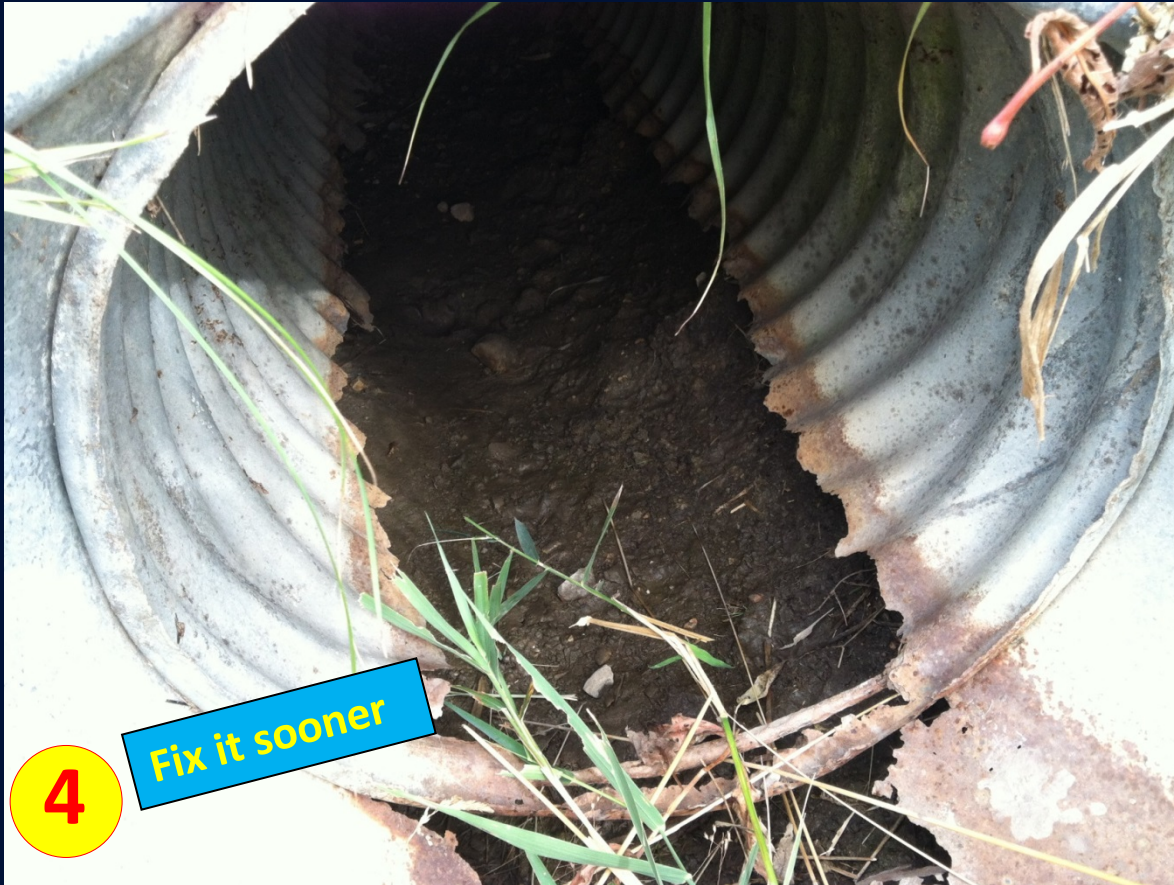
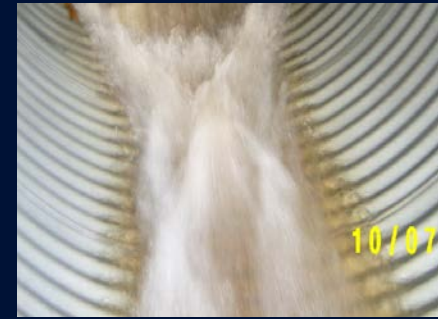
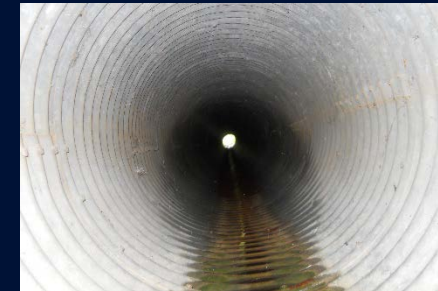
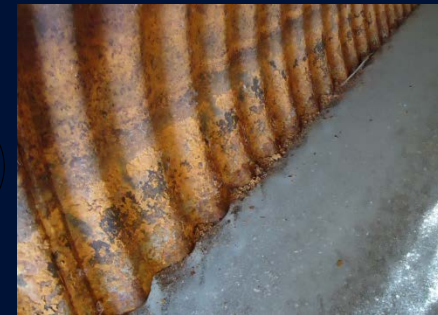
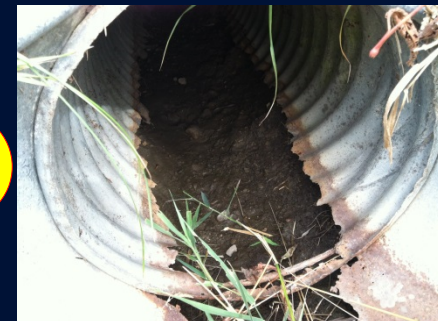
# Steel Pipe Rusts and gets Holes 4

## 4 Very Poor Condition

- Hole 1 inch or greater, or many small holes, or bottom gone
- Can poke a hole in pipe with a blunt rod
- Piping or Road Void -- Pipe condition is causing soil loss beneath road surface

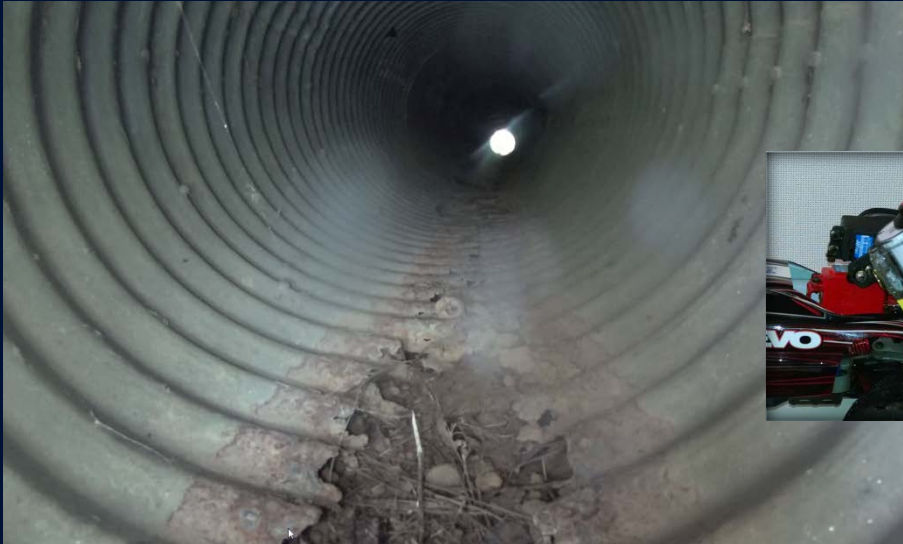
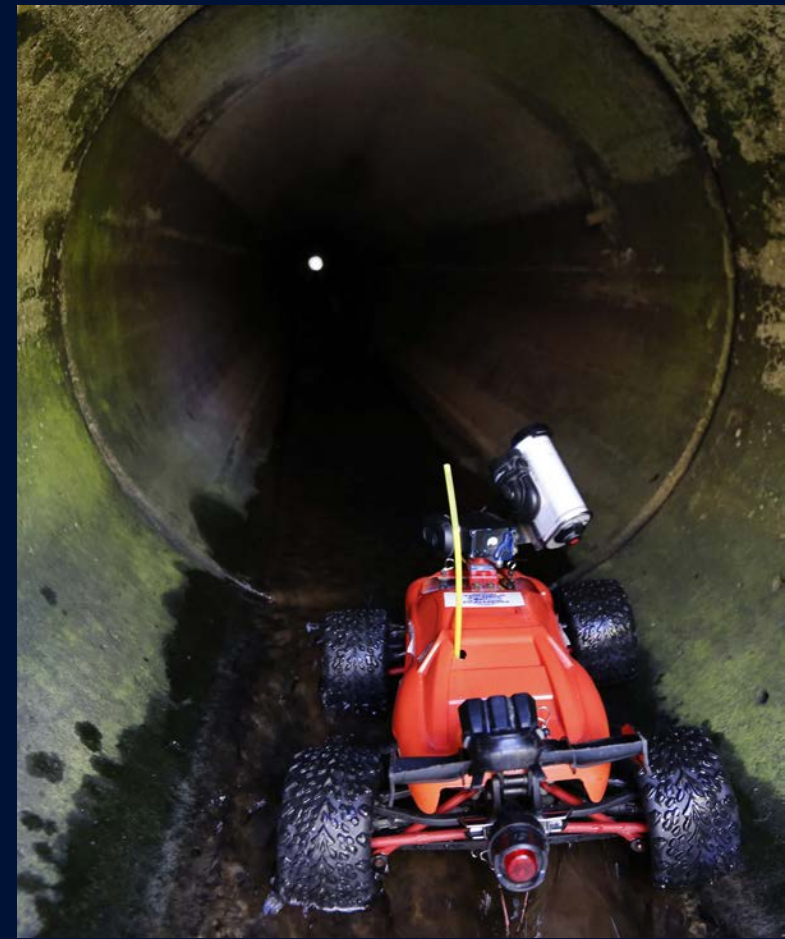
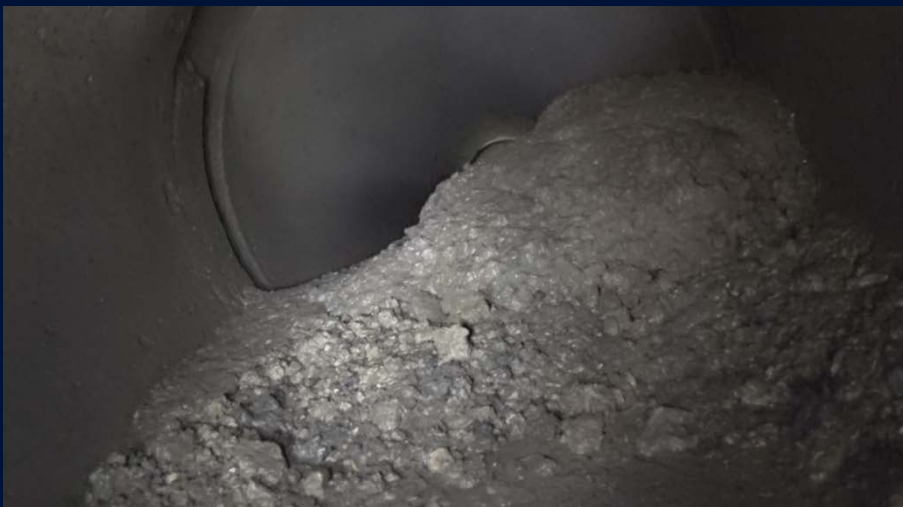
# D6 HIVE unit with Pan and Tilt video

HIVE inspects inside pipes  
more than 55 feet long and  
climbs over obstacles.

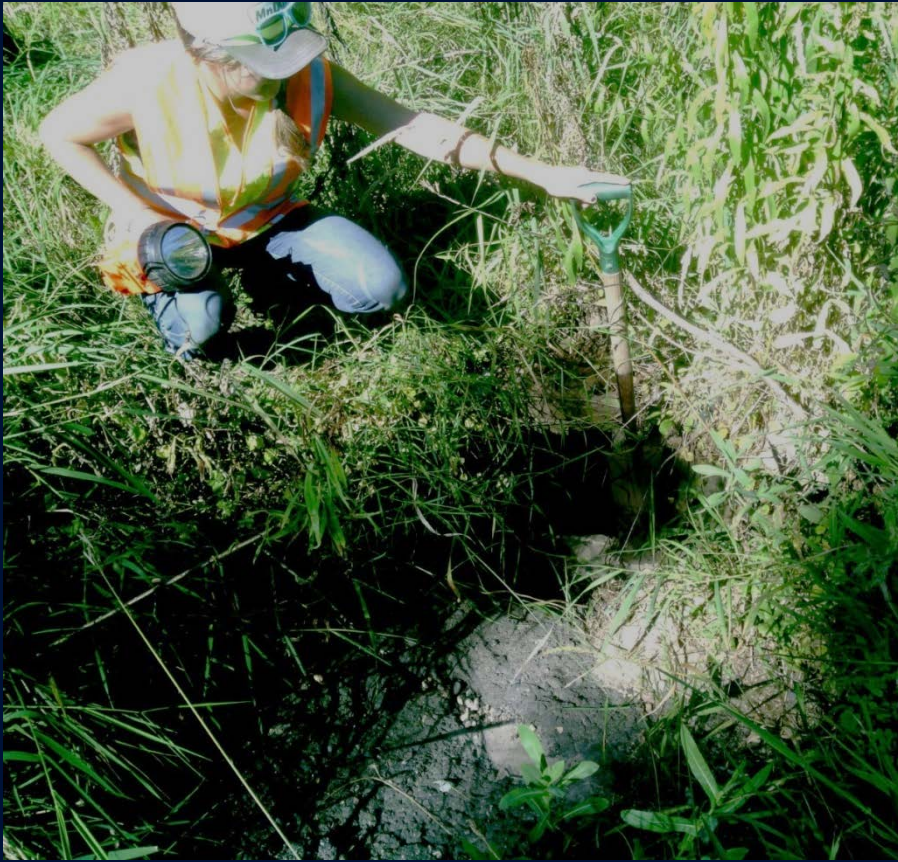
# Essential Inspection Tools

## Useful tools to bring for inspections

- Tablet with cellular data internet
- R1 GPS
- DMI
- Optional - Paper HydInfra reports for staying organized/taking notes
- Whiteboard/marker (label photos)
- Ruler/other measuring tools
- PPE – floatation vest
- Flashlight
- Bug Spray
- Hip boots/waders
- HIVE vehicle for smaller pipes
  - Spool/Cable
  - Tablet
  - Camera
  - Spare Batteries
  - Portable chargers if available and make sure all batteries are charged

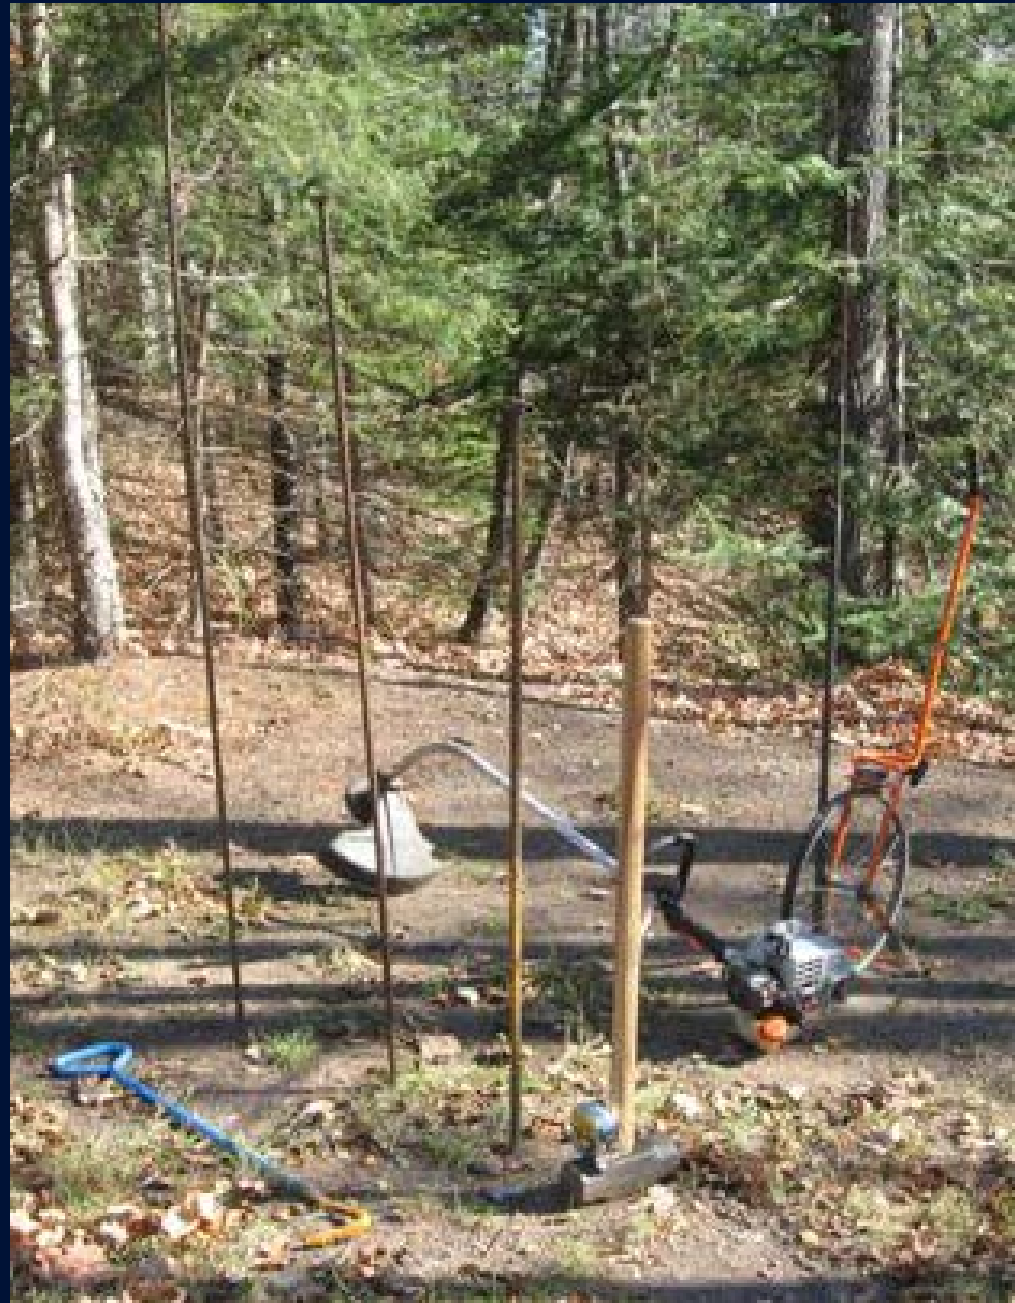
# LaMourea's Inspection Tools

- HydInfra Inspection Manual
- Mega Flashlight
- Shovel
- Measuring tape
- MH cover lifter
- Measuring wheel
- Rods to probe in sludge
- Sledge hammer??
- Weed Wacker
- Special tubular telescoping measuring tool that extends inside the pipe

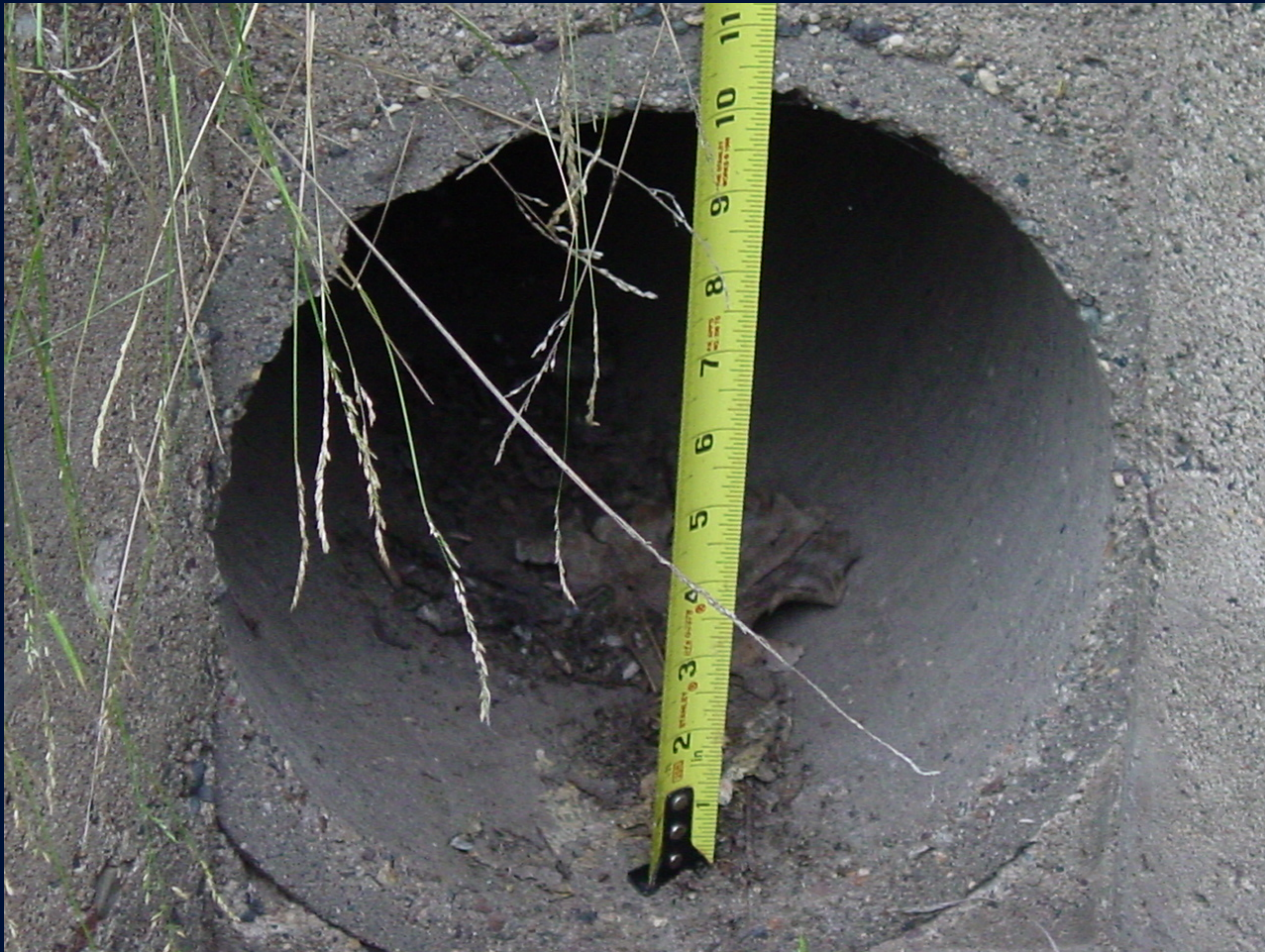
# Measure it.

Pipes sometimes are ordered for future Construction projects based on HydInfra dimensions
