HydInfra Inspection Manual

Culvert and Storm Drainage Systems

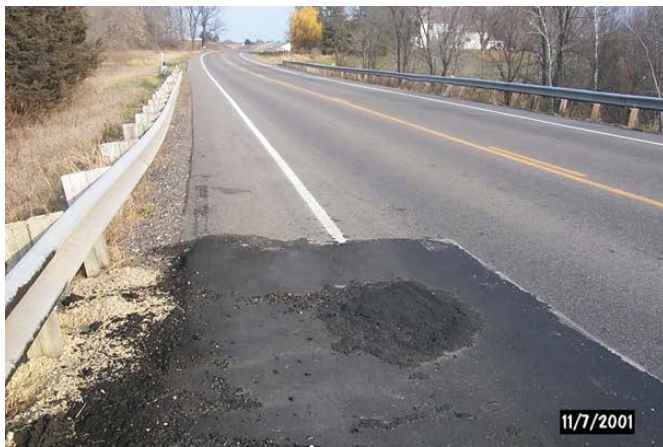
Road surface may indicate condition of pipe

MN 95 near MP 89, near Marine on the St. Croix

The general conditions of the roadway and adjacent area are used as clues to help determine the condition rating for each hydraulic feature that is inspected. These general conditions may be indicators of concealed structural problems.

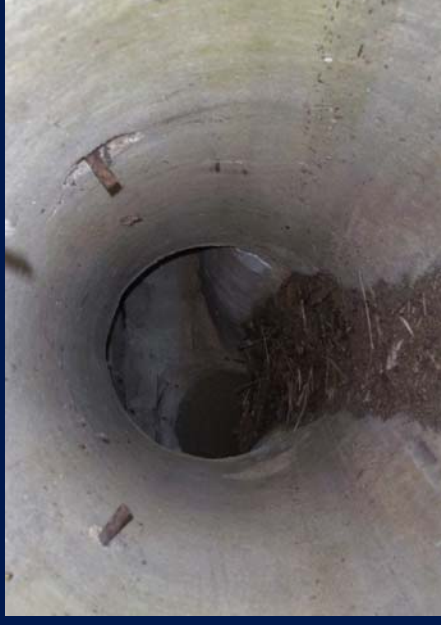
Concrete Pipe

Material Type: Concrete

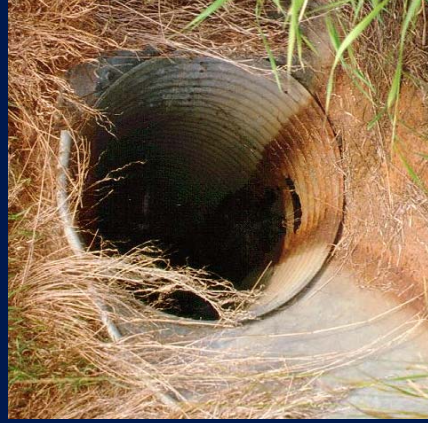
Corg. Steel (CSP)

(galvanized steel pipe)

Material Type: Steel

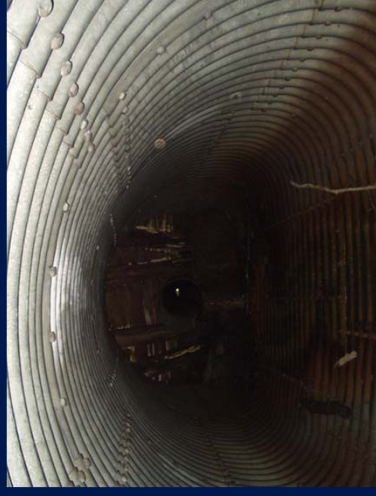
Structural Plate

Material Type: Steel

US 61 Silver Bay, r.p. 53,26

Galvanized steel plates are bolted together, was used in larger diameter culverts

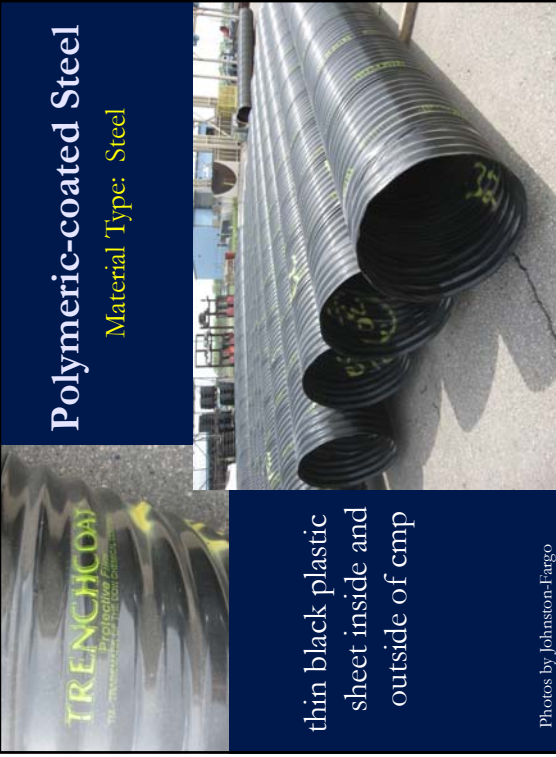
Polymeric-coated Steel
Material Type: Steel

thin black plastic sheet inside and outside of cmp

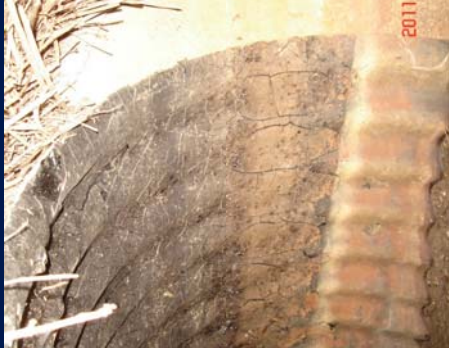
Bituminous-Coated Steel
Material Type: Steel

Looks like tar on cmp

May contain asbestos

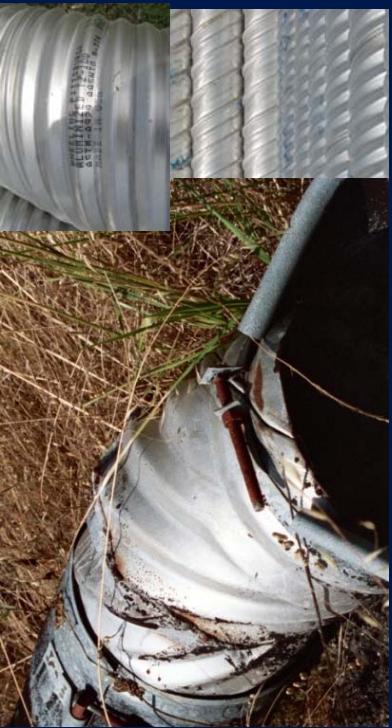
Aluminized Steel
Material Type: Steel

Magnetic and has a sheen like the inside of a pop can but edges may be rusty

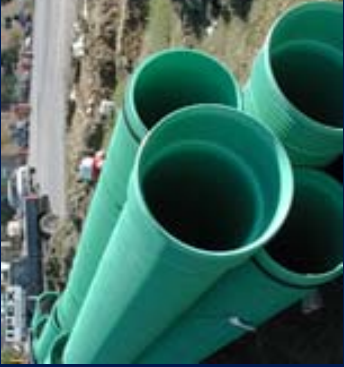
PVC Material Type: Plastic

Photo PVC pipe from <http://www.pvcinc.com/>

White or green, more brittle than HDPE, especially in cold

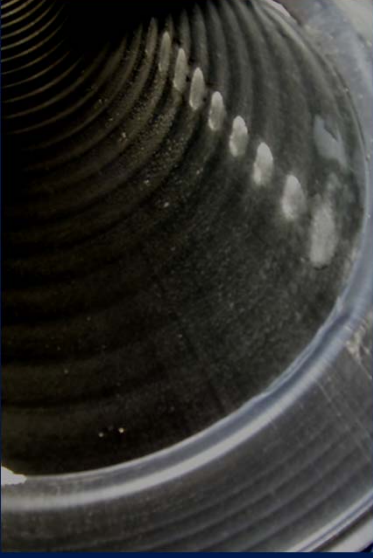
Corg. Plastic (HDPE) Material Type: Plastic

HDPE = High Density Polyethylene has smooth inside and corrugated outside. HDPE is always black

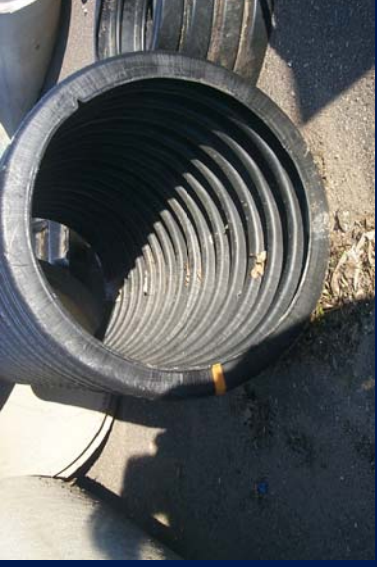
Corg. Plastic (HDPE) Material Type: Plastic

Add a comment because single wall corrugated HDPE should not be used as highway culverts or storm drain.

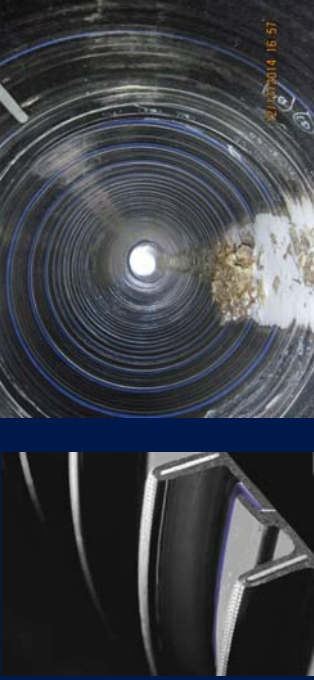
SRPE - Steel-Reinforced PolyEthylene
Material Type: Plastic

Blue line shows it's SRPE
Exterior flanges are steel, coated with HDPE

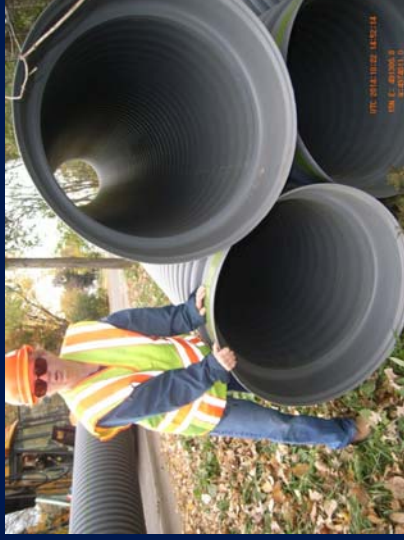
Material Type: Plastic

PP = Polypropylene Pipe is grey and stiffer than HDPE

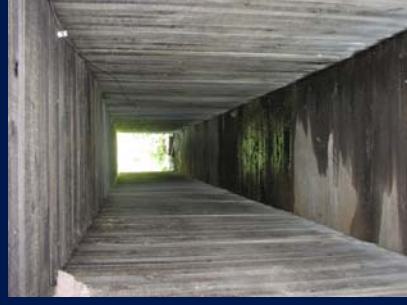
Wooden cattle pass
in D6 on MN 60
r.p. 185.91

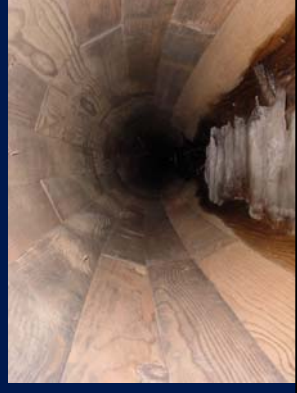
Timber

Material Type: Other
also used in wet box culverts

Wooden Pipe on Grand Ave,
MN 23 in Duluth

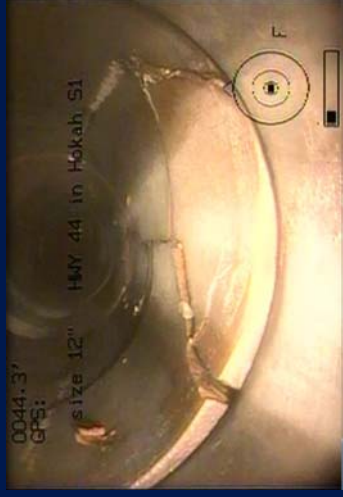
Vitrified Clay (VCP)

Material Type: Other

Red fired clay tile exists in some old small town storm drains and old farm drain tile.

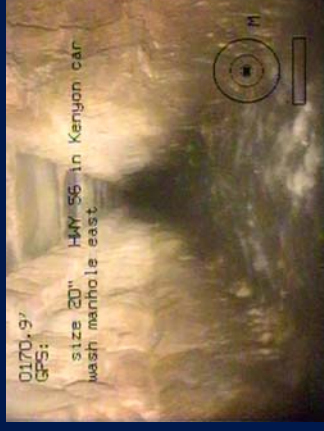
Material Type: Other

Excavated 20 inch box "pipe" carved from limestone provides outlet for old VCP storm drain -- D6 Hwy 56 Kenyon

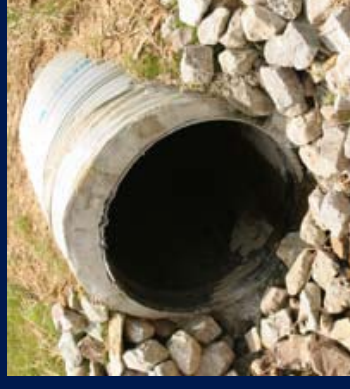
Liner HDPE

Material Type: Liner

Like Snap-Lite or butt-fused HDPE liner has grout between original pipe and liner.

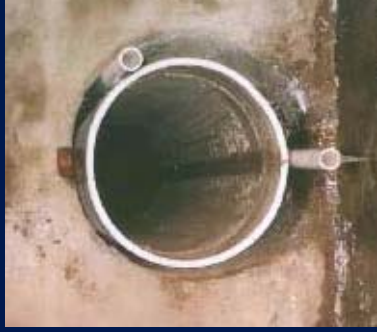
Liner PVC **Material Type: Liner**

Photo of PVC liner from Caltrans <http://www.dot.ca.gov/hq/oppd/dib/dib83.pdf>

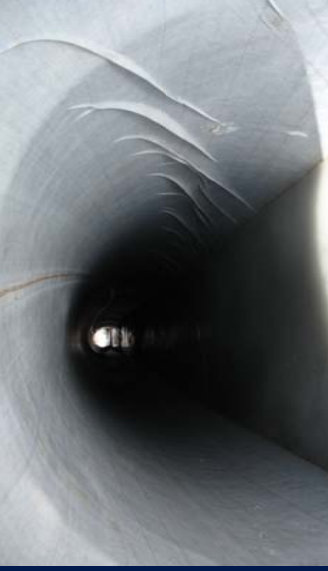
Liner Cured in Place **Material Type: Liner**

CIPP Liner is resin-filled fabric, inflated and cured with hot water or steam or UV light till it's rigid

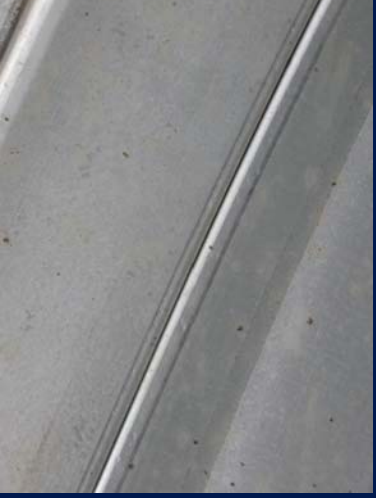
Liner Metal **Material Type: Liner**

Steel flat-seamed pipe is sometimes used as liner
