# HydInfra Condition Ratings and Inspection Terms

# HydInfra

# HydInfra Ratings Guide

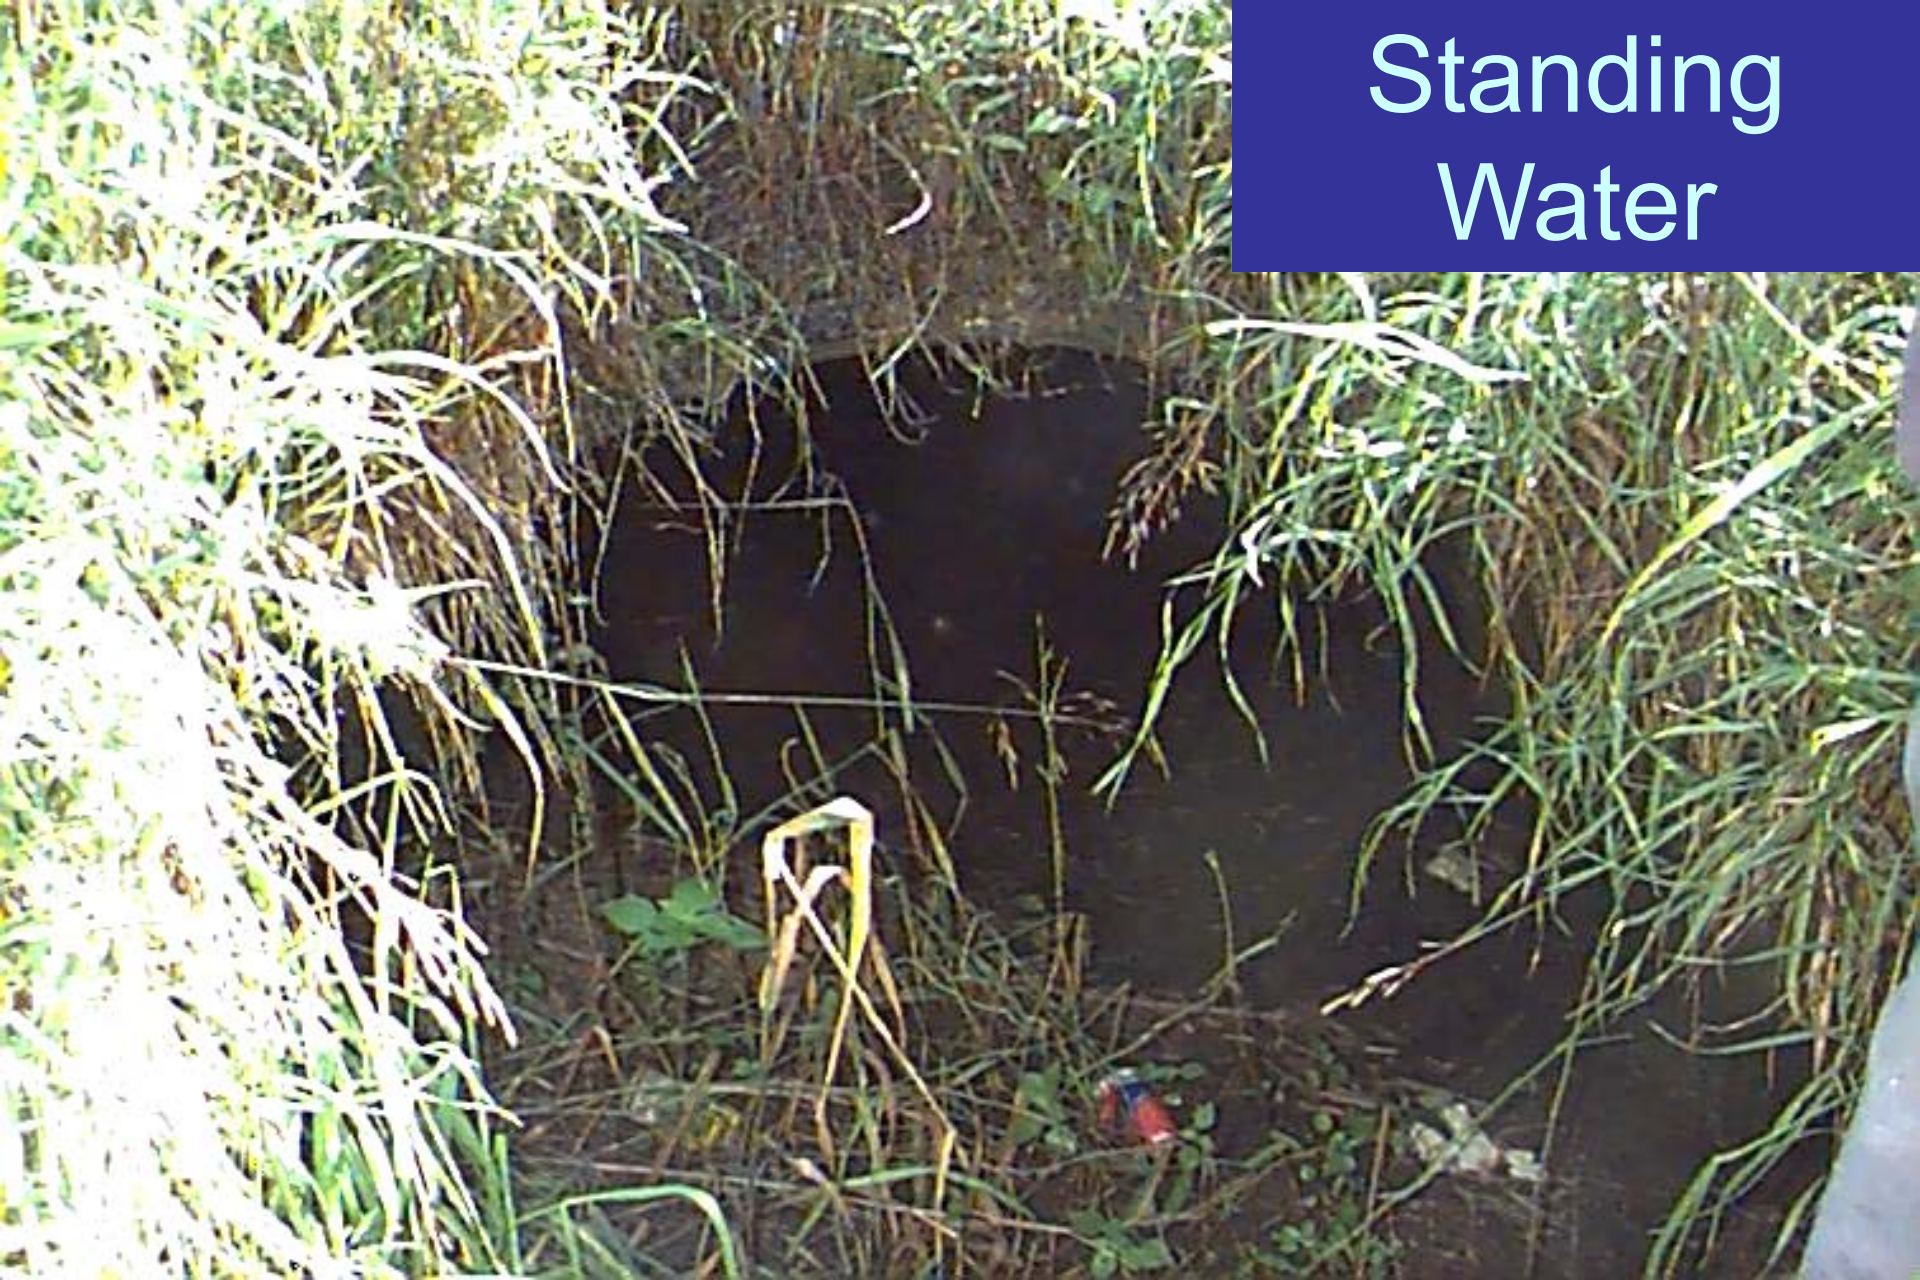
# Standing Water

Standing water or running water in the feature

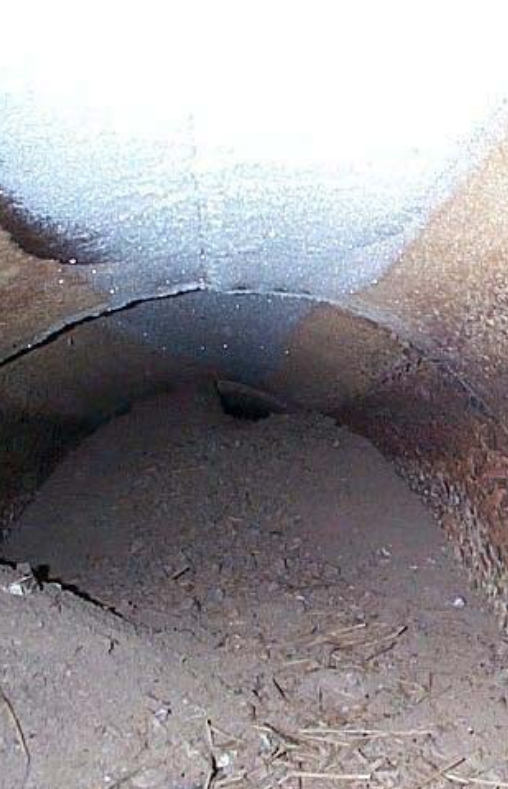
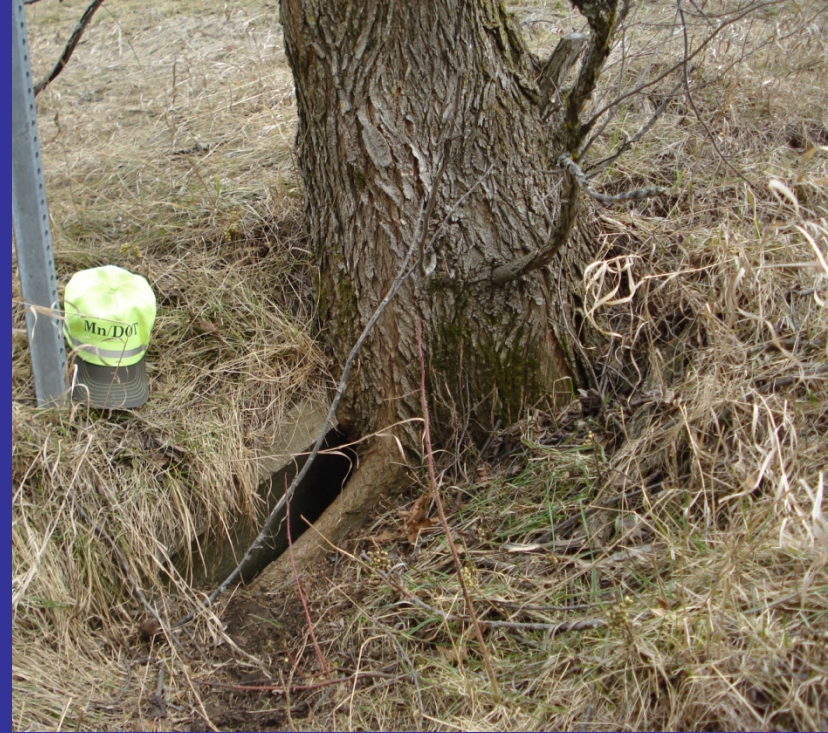
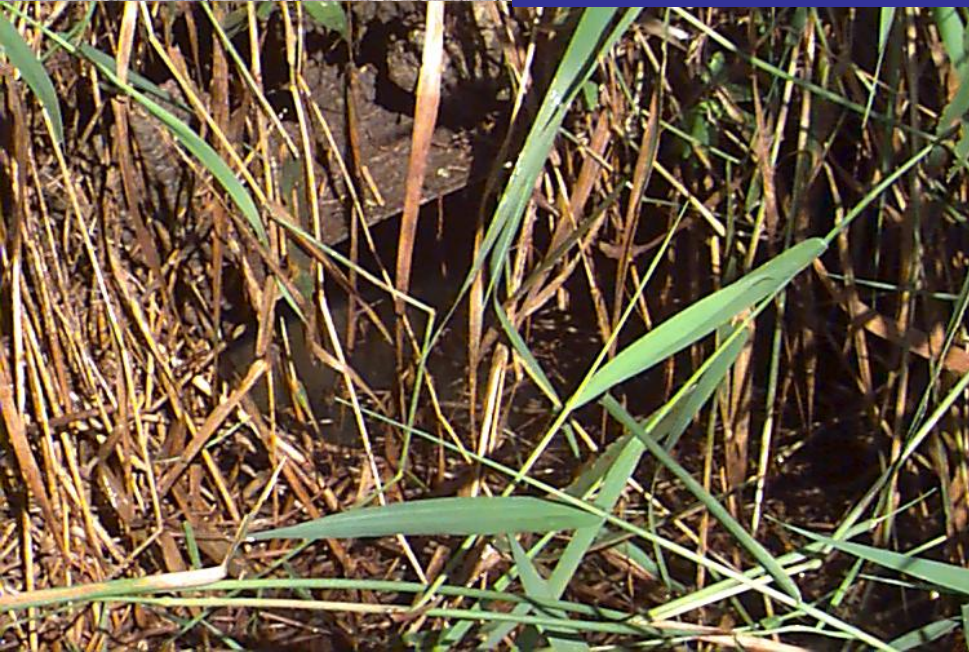
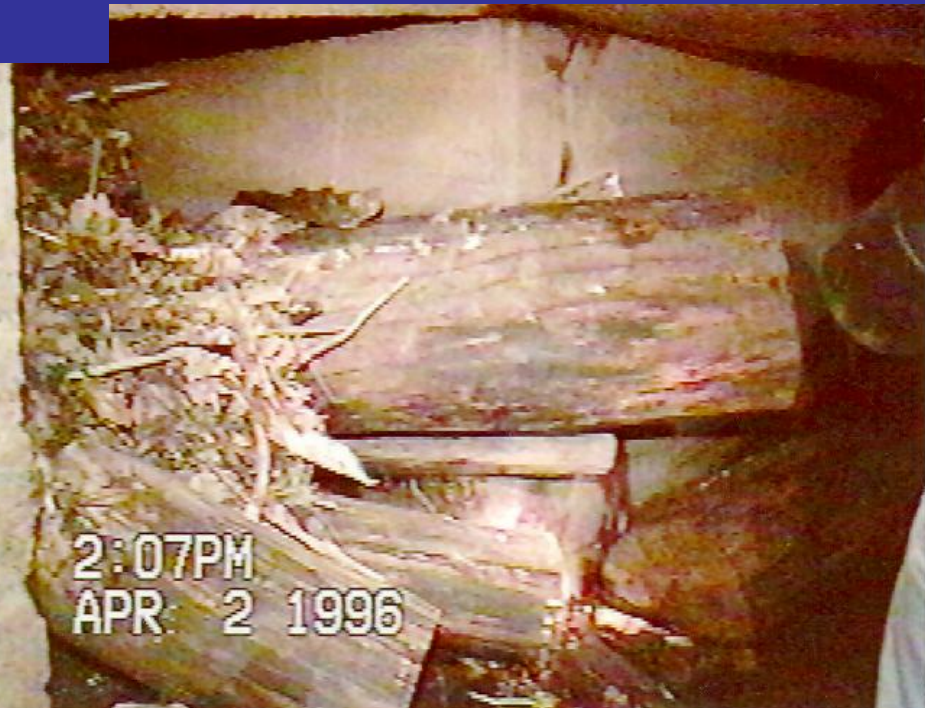
# Plugged

- Something is in pipe that substantially reduces or prevents water flow

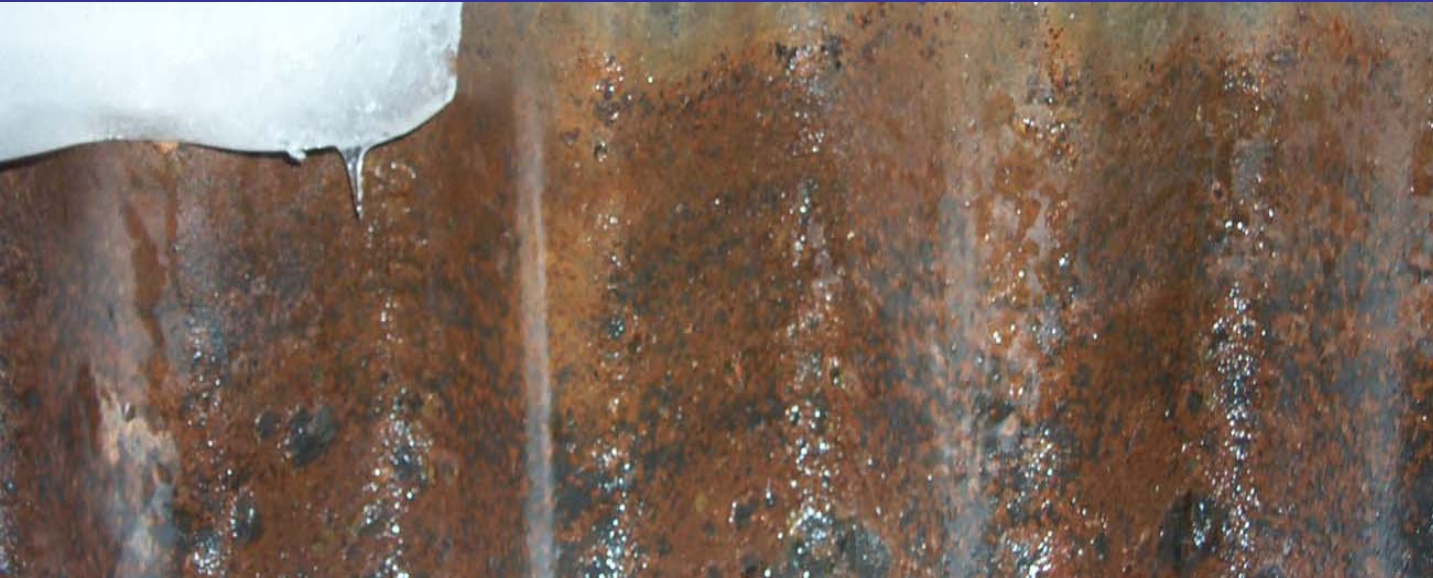
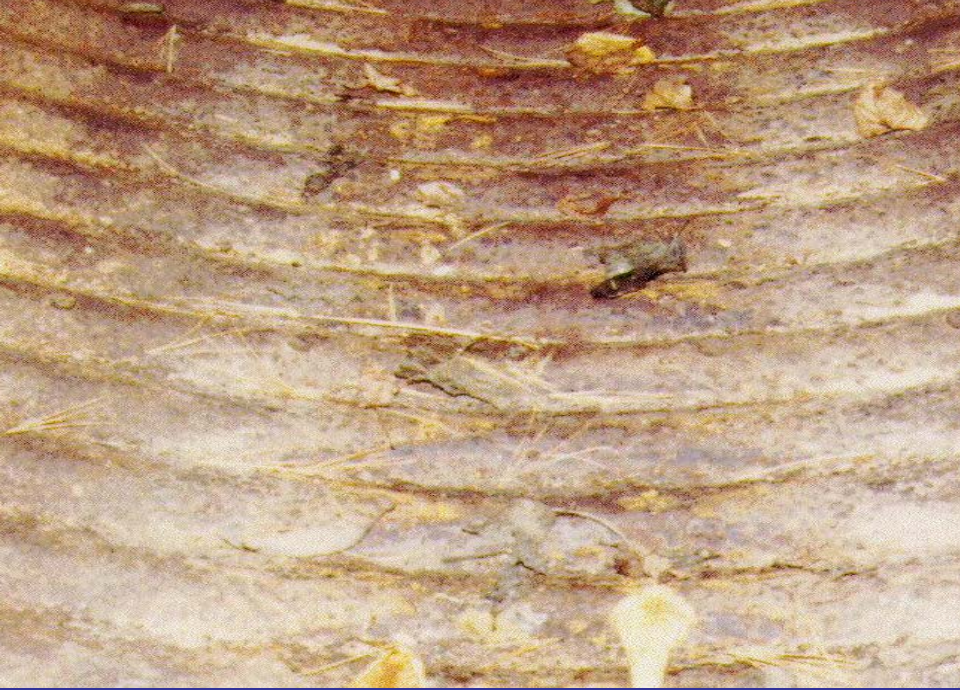
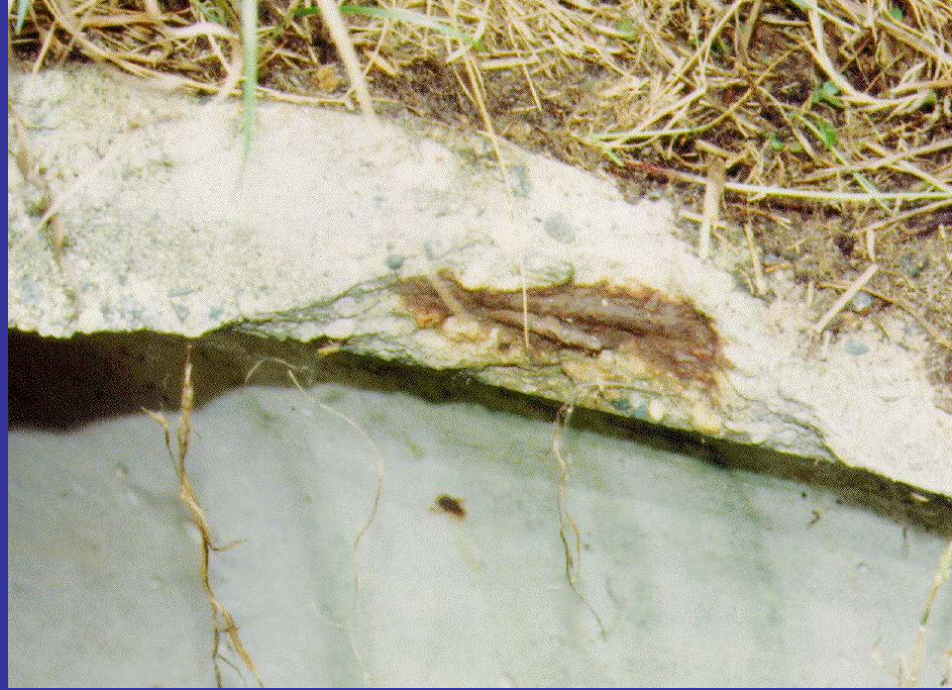
# Pitting/Rusting

- Superficial decay of surface material
  - Pitted if concrete
  - Rusty if steel
- Material is still solid

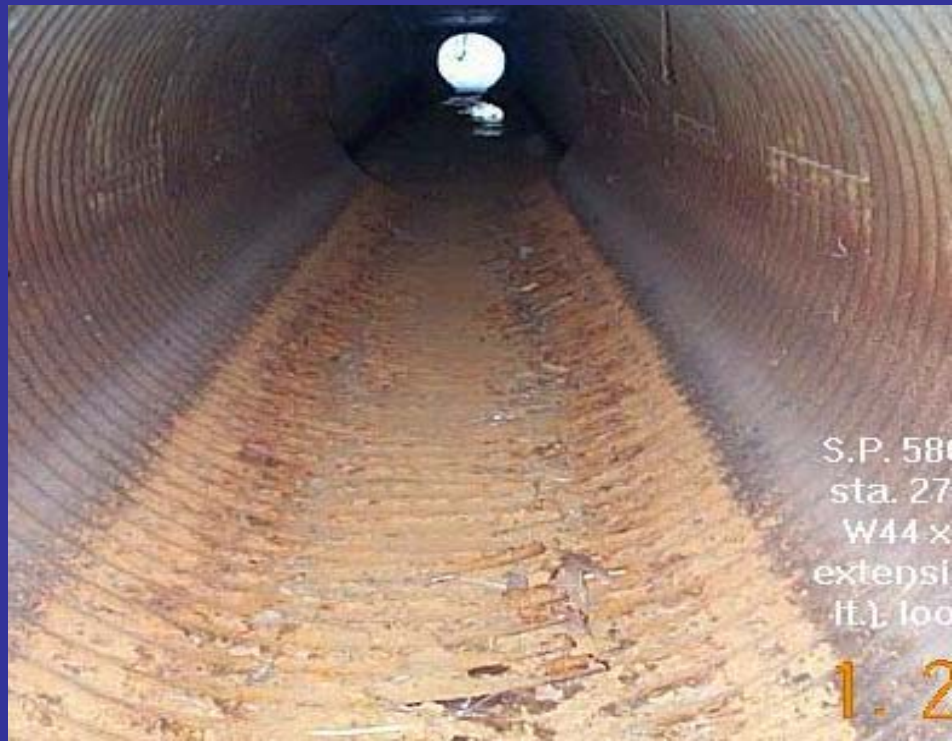
# Spalling/Flaking

- Material has been lost
  - spalled chips of concrete
  - flakes of rust
- Material may have lost strength

S.P. 5805-09 (T.H. 361), sta.  
2685+88.5, R.P. 8:0, 24" ROP x  
64", looking easterly  
JD 31145

More like  
Spalling  
than  
Pitting

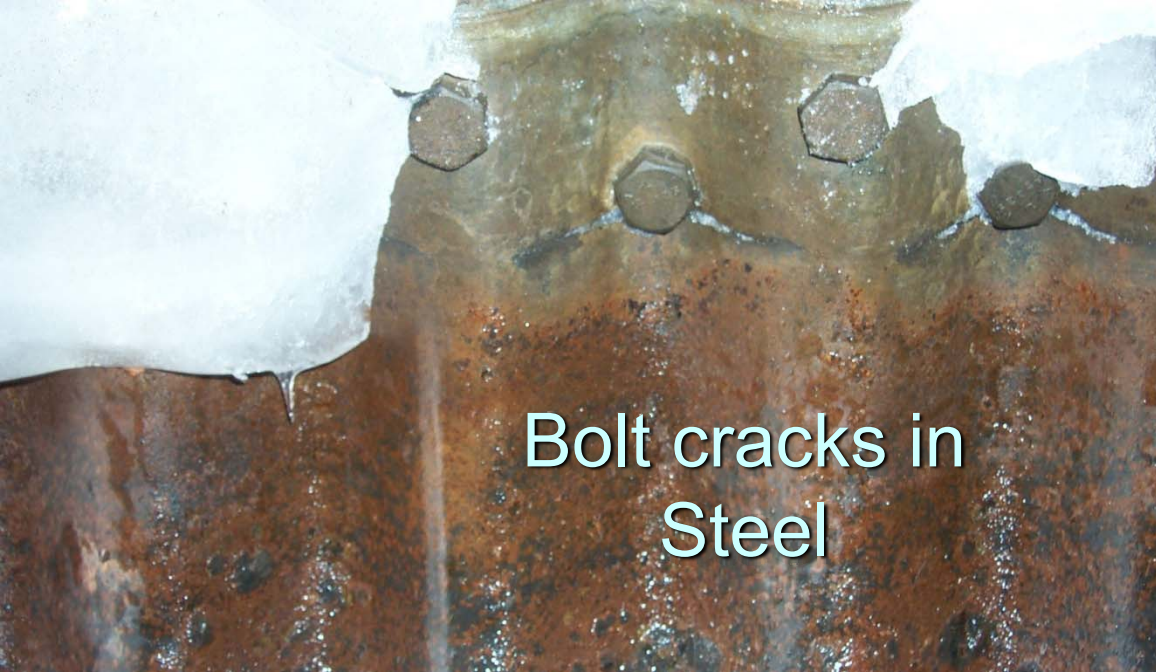
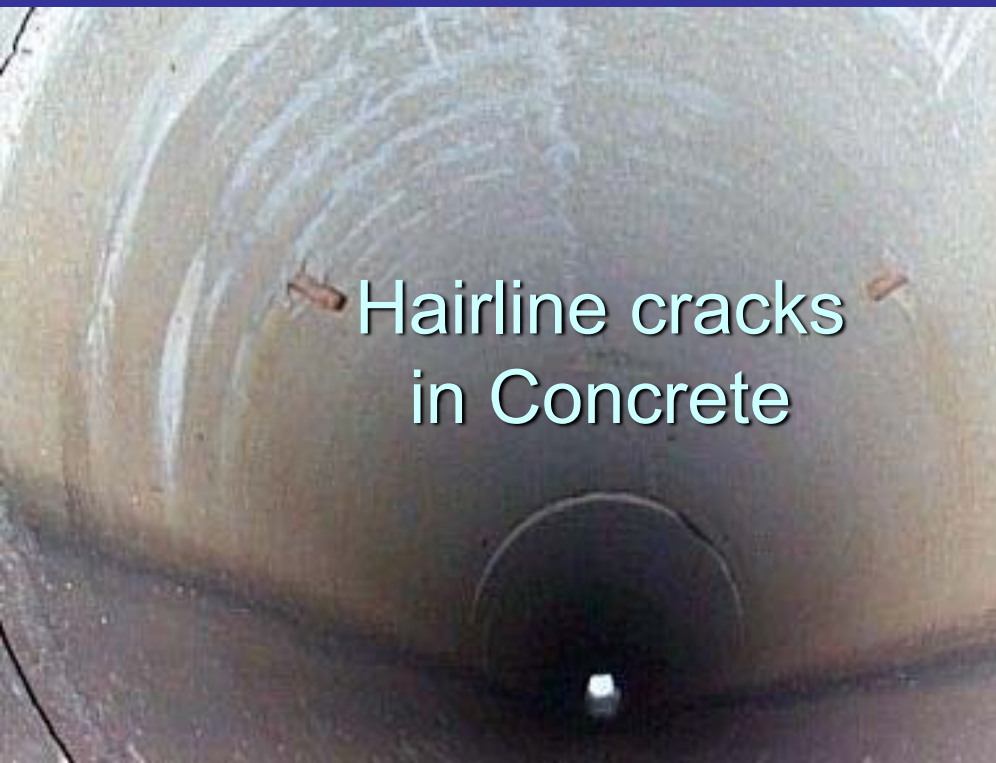
# Cracks

- A visible crack

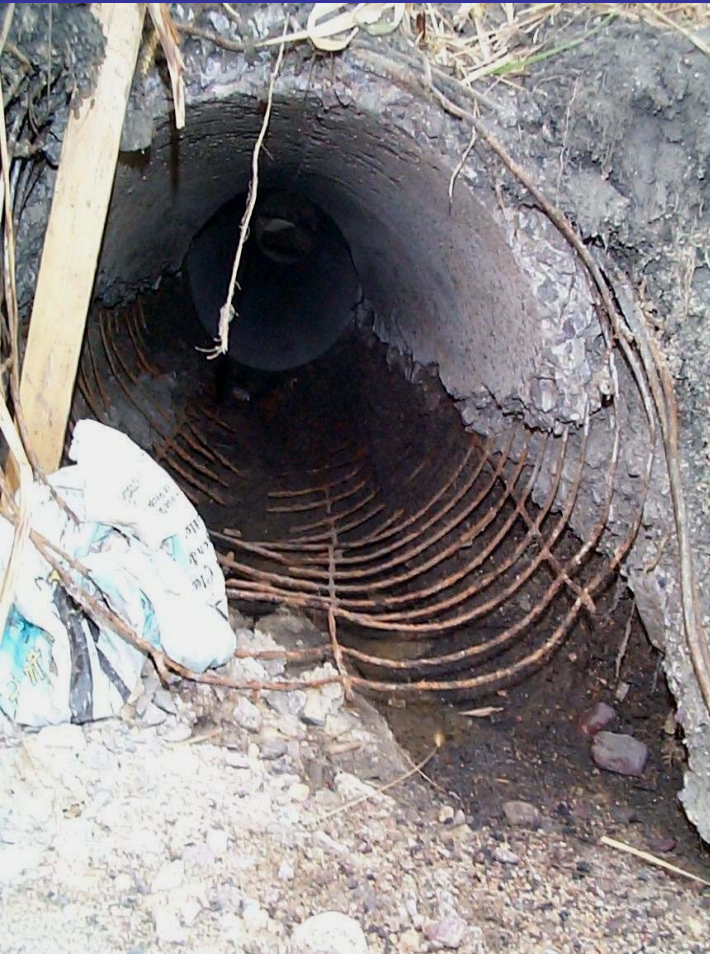
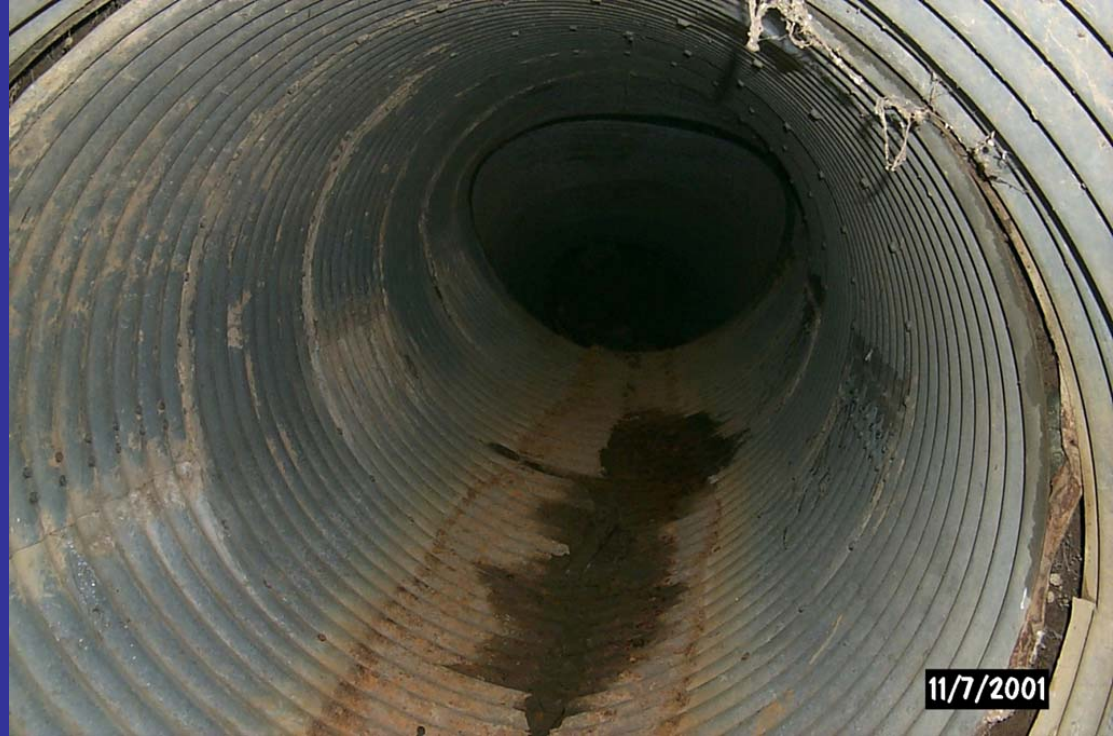
# Holes

- Hole goes completely through a features material

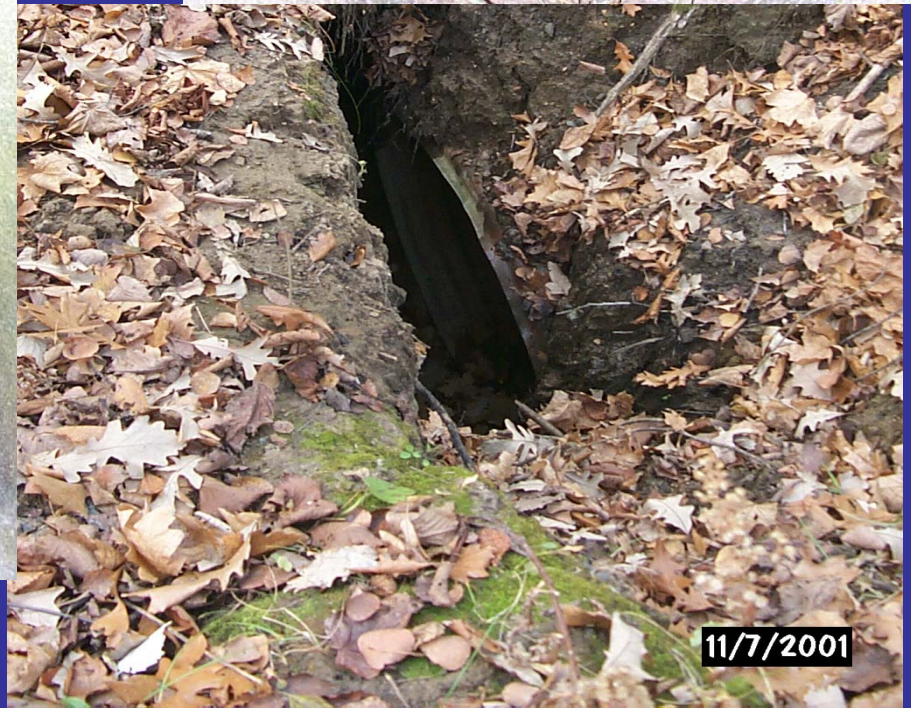
# Joints Separated

- The joints between two pipe sections are separated (lengthwise) and may allow soil to filter through

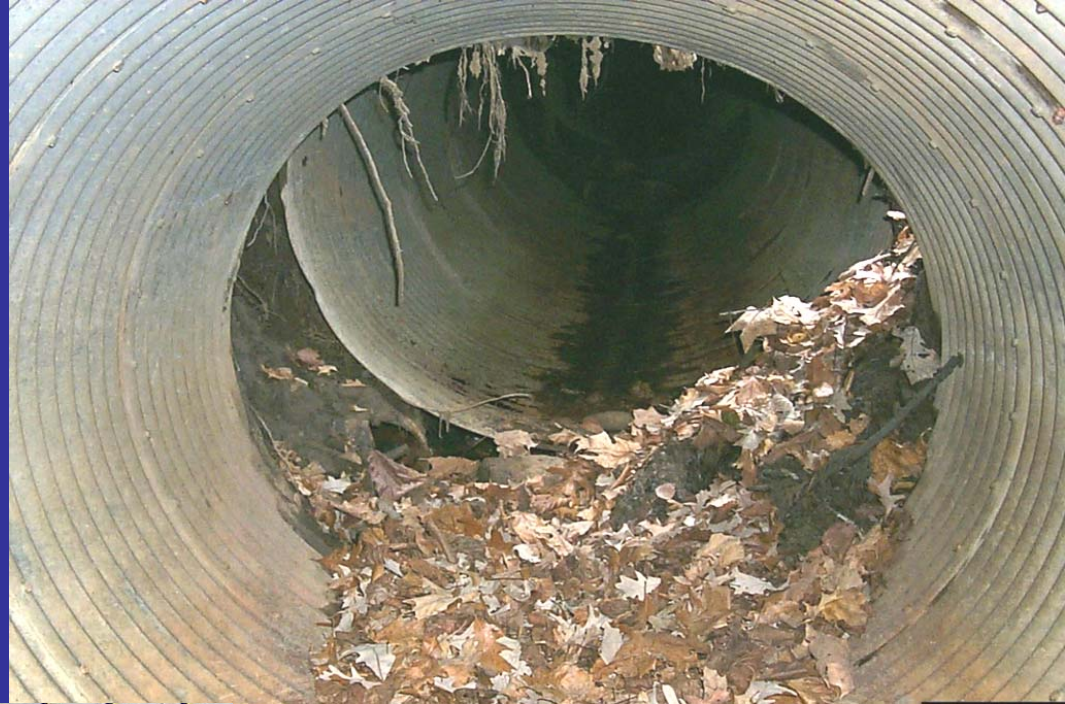
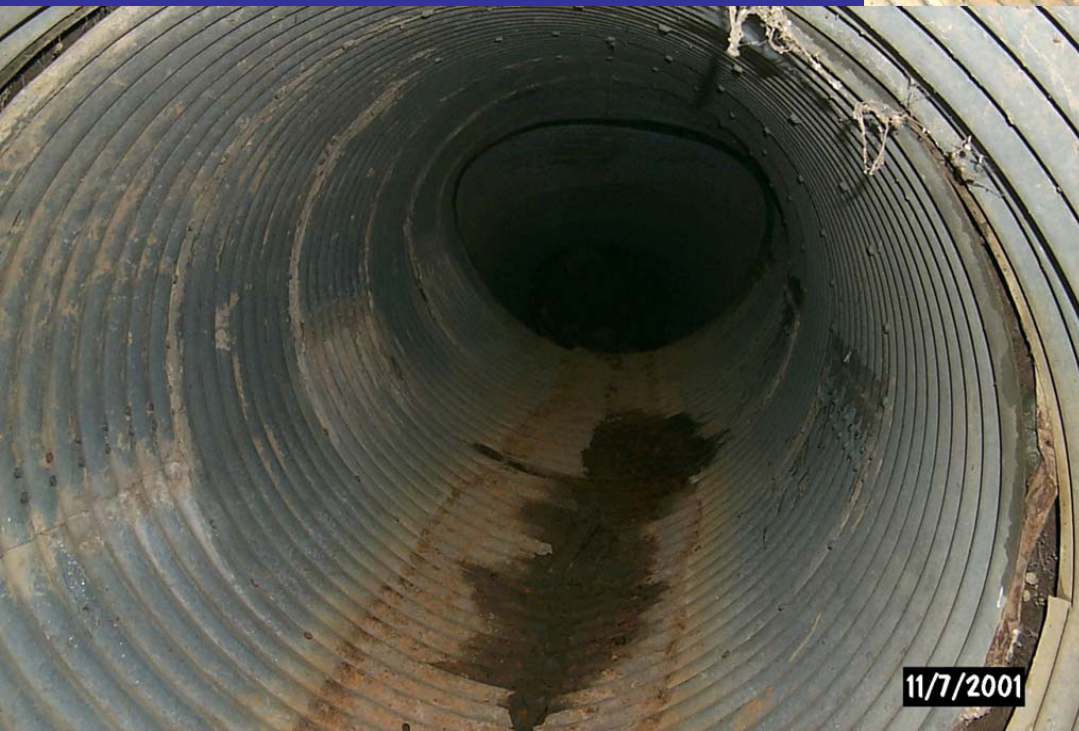
# Misalignment in Steel

- Pipe sections are offset, causing a non-linear or zigzag appearance

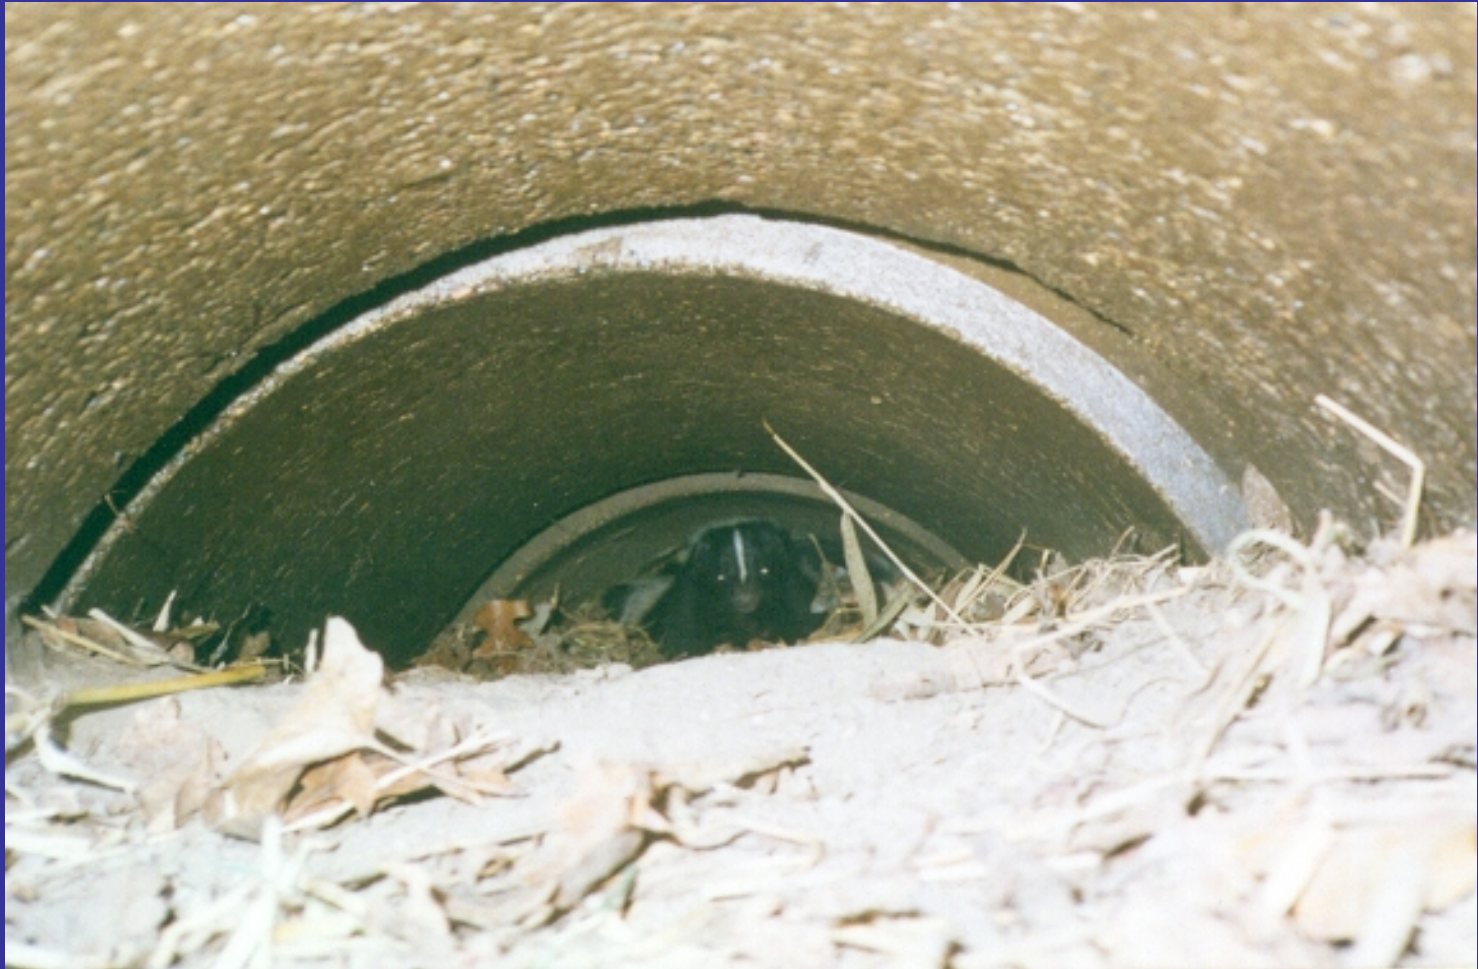
# Misalignment in Concrete Pipe

- Pipe sections are offset, causing a non-linear or zigzag appearance

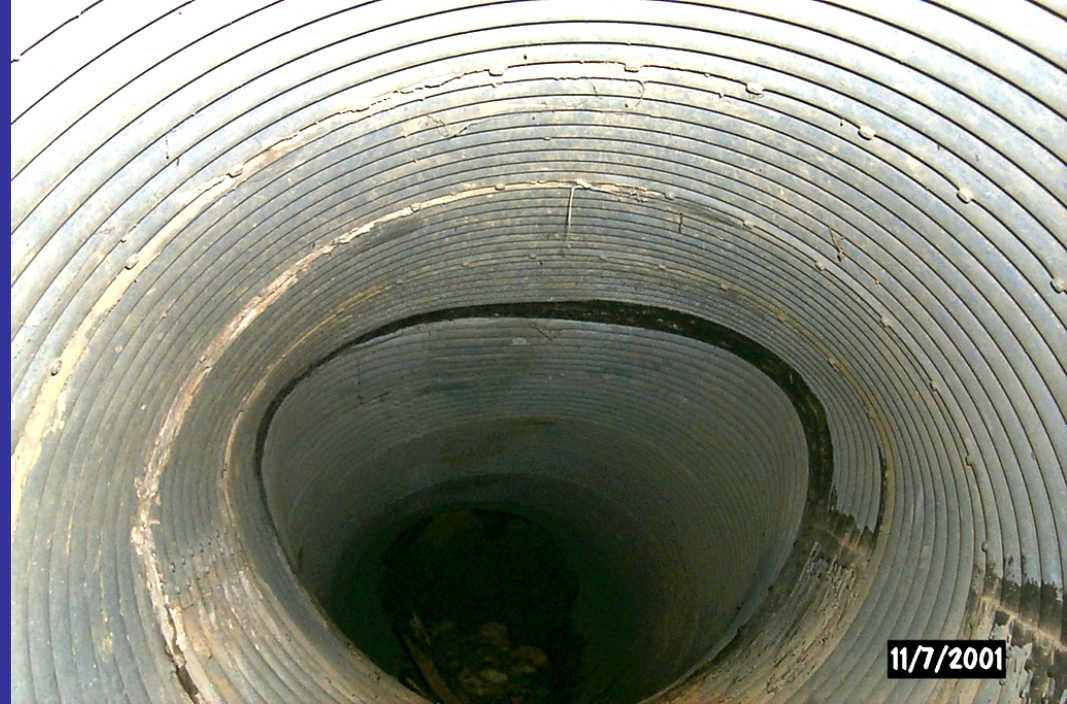
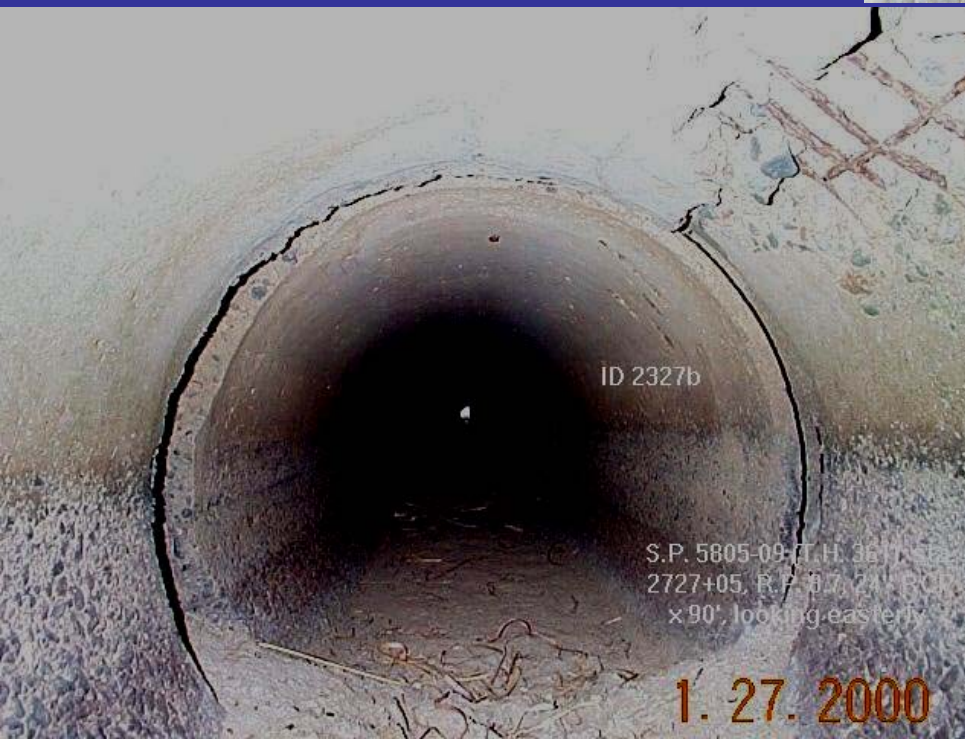
# Deformation

- Feature's shape is distorted, flattened or squashed

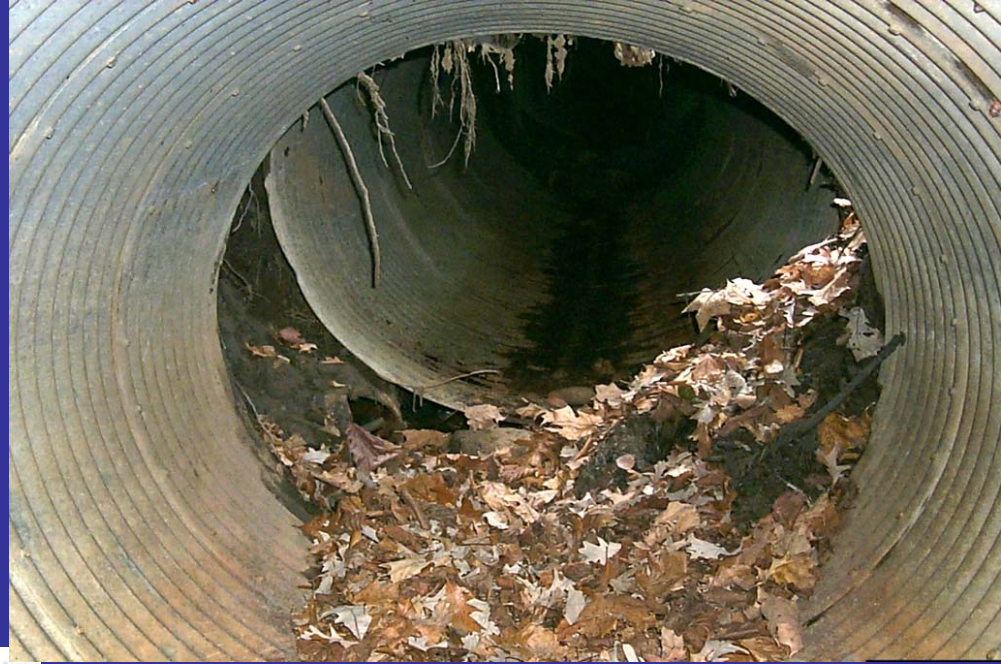
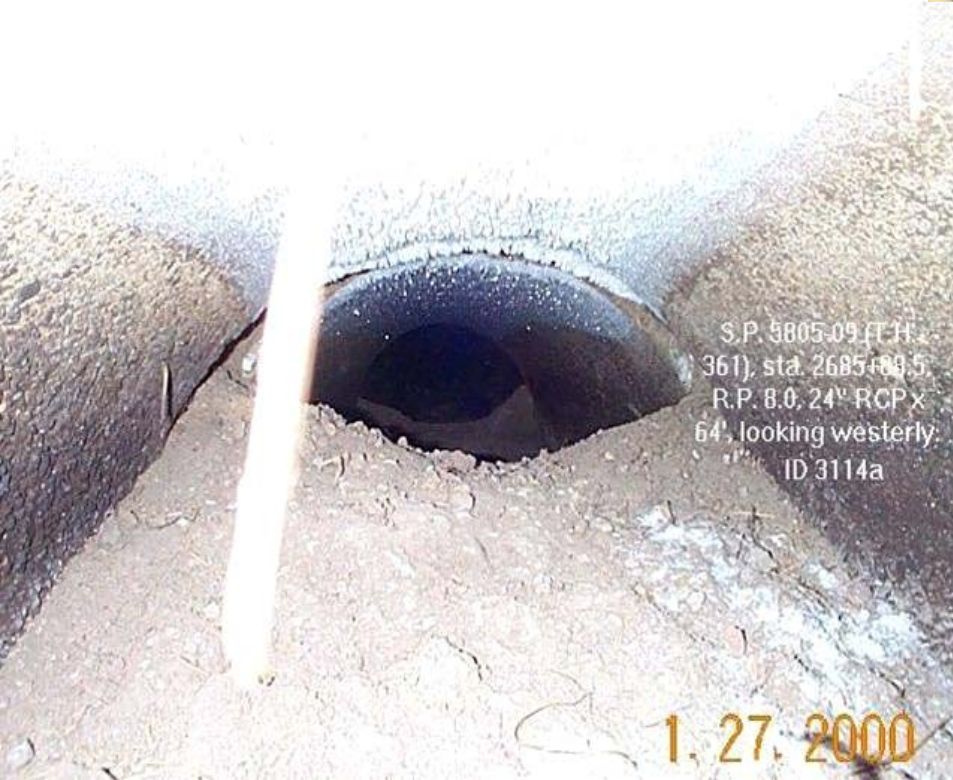
# Infiltration

- Evidence of soil or water seeping into pipe

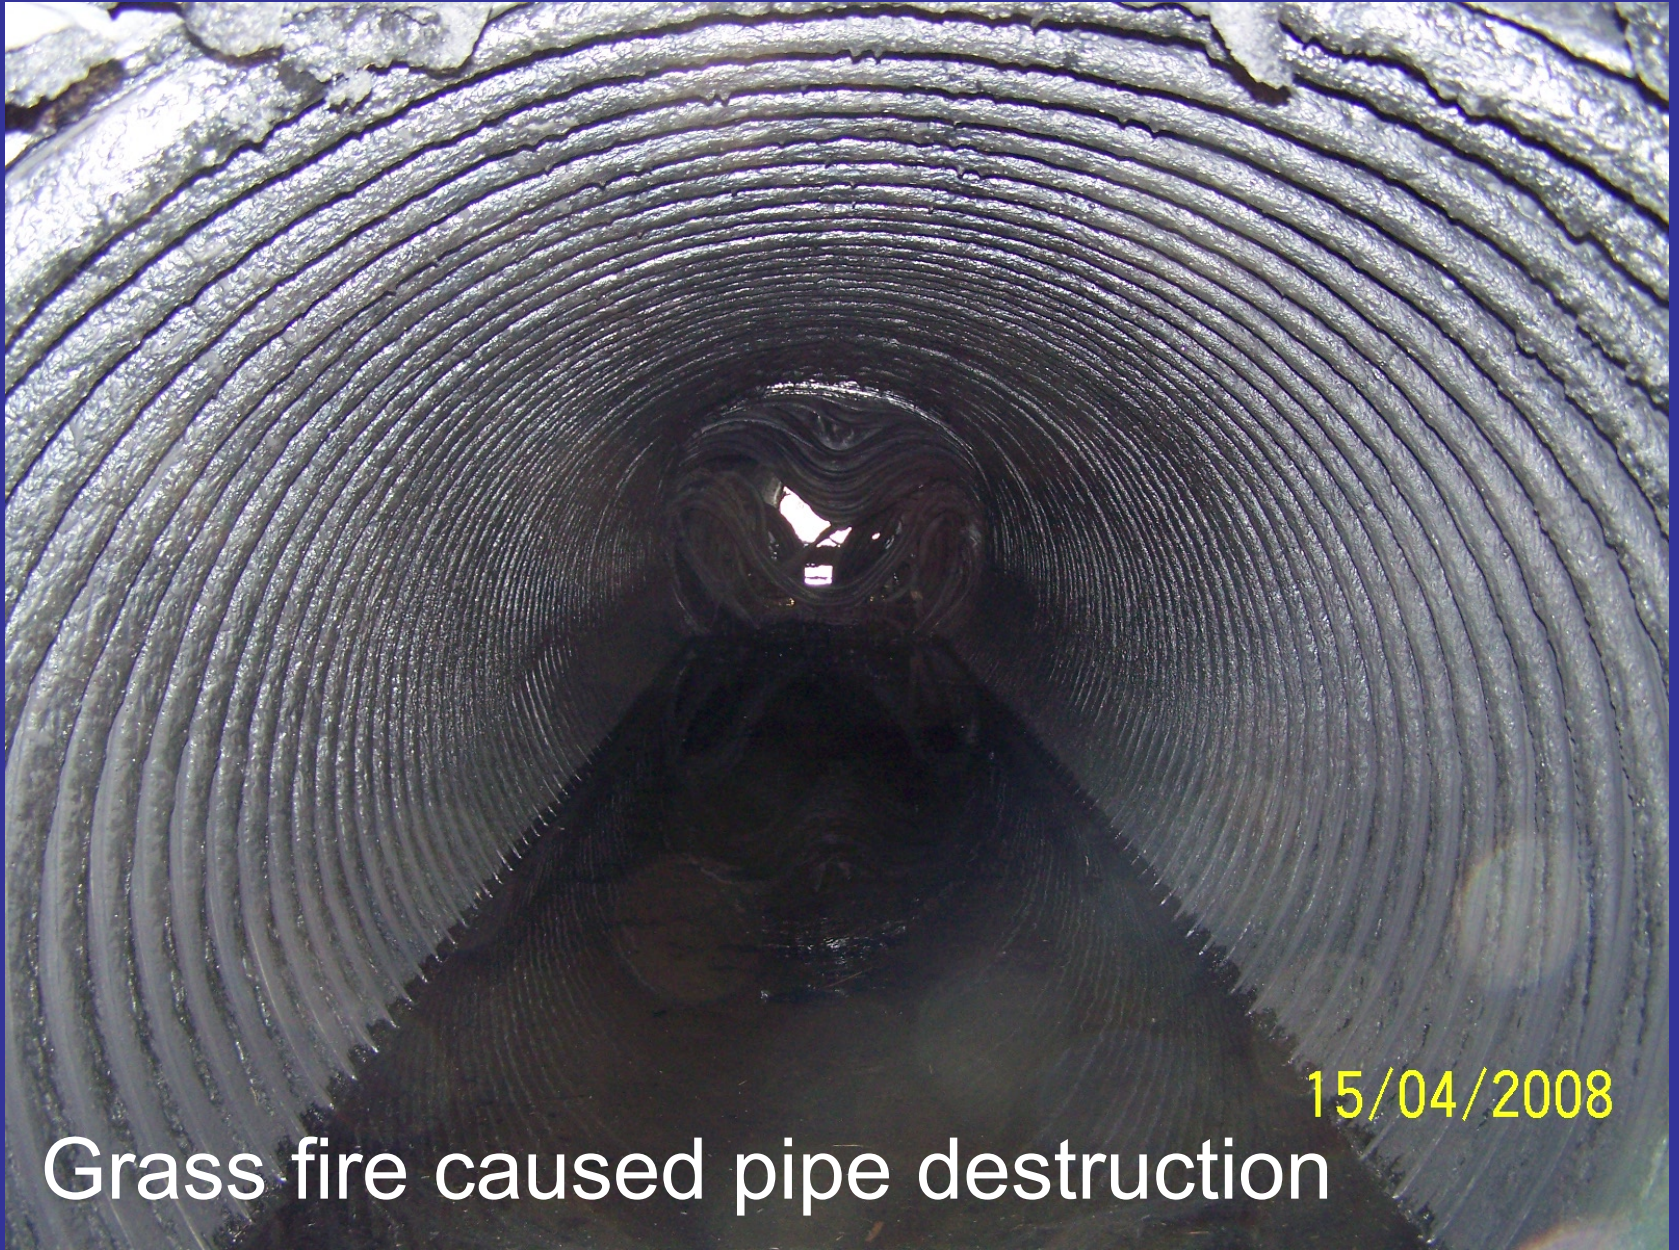
# Burnt Plastic (HDPE) PIPE

Grass fire caused pipe destruction

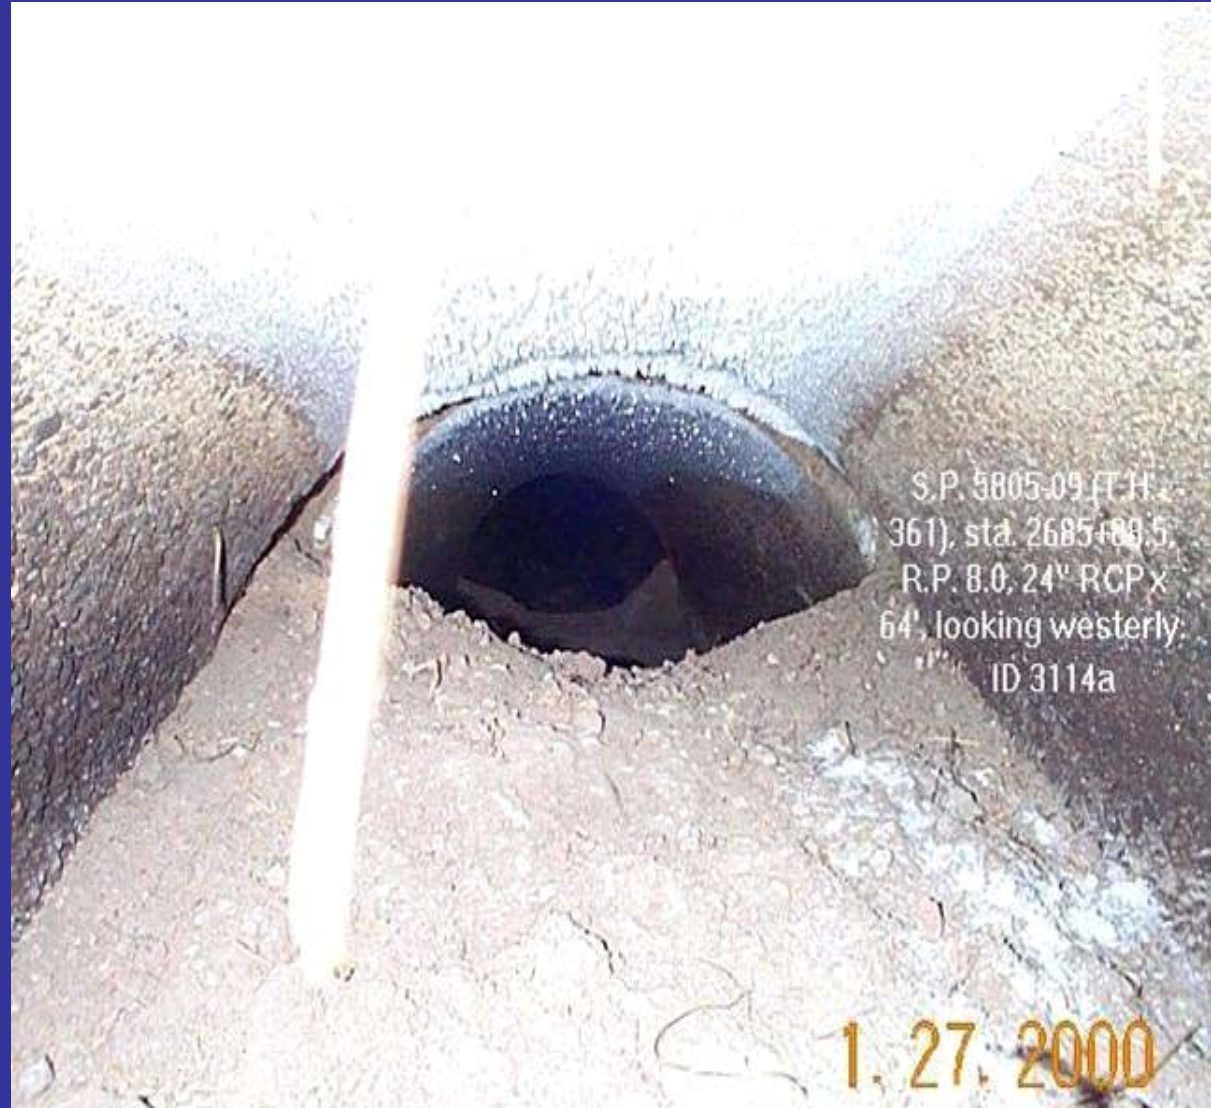
- Estimate depth of sediment compared to height of apron or pipe

60%?

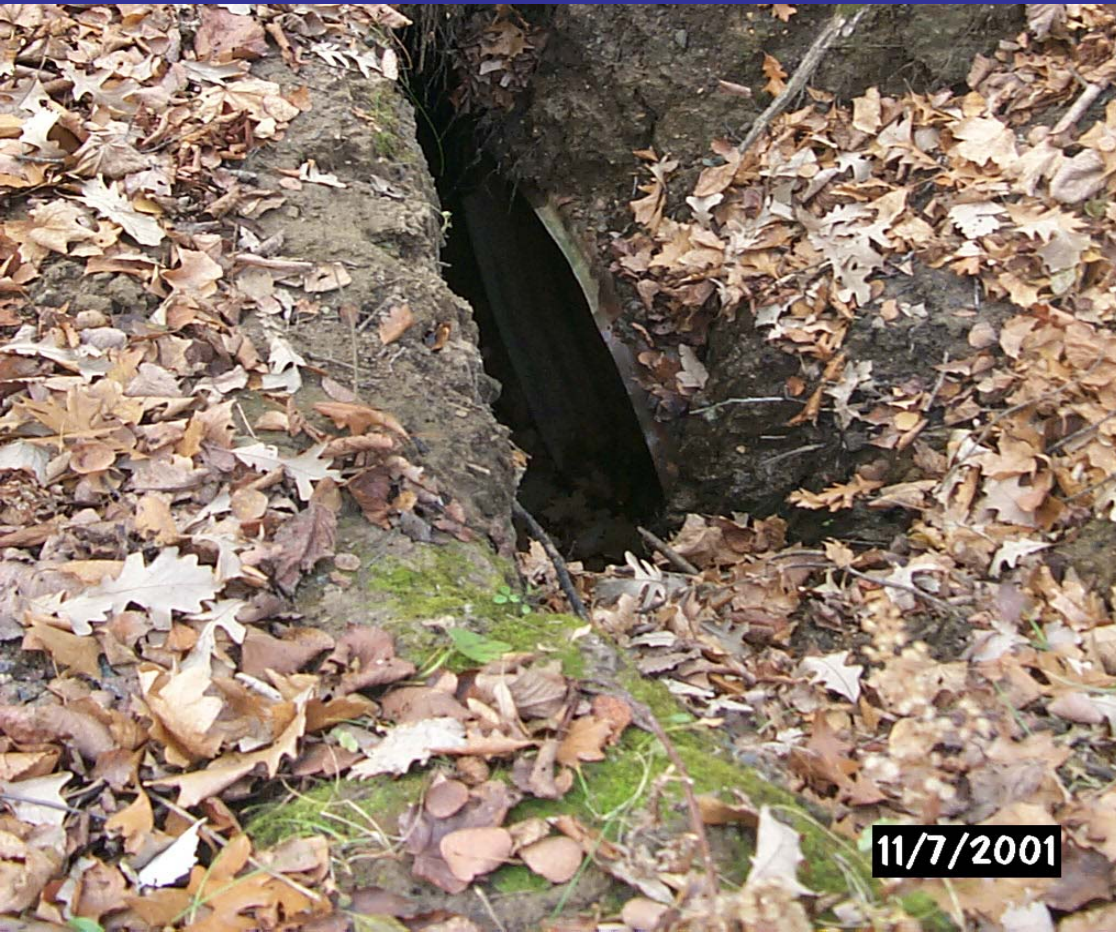
# Inslope Cavitation

- A cavity or hole in the inslope of the roadway above a pipe or apron. Usually found where a joint separation has occurred
