# HydInfra Condition Ratings and Inspection Terms

# HydInfra

# HydInfra Ratings Guide

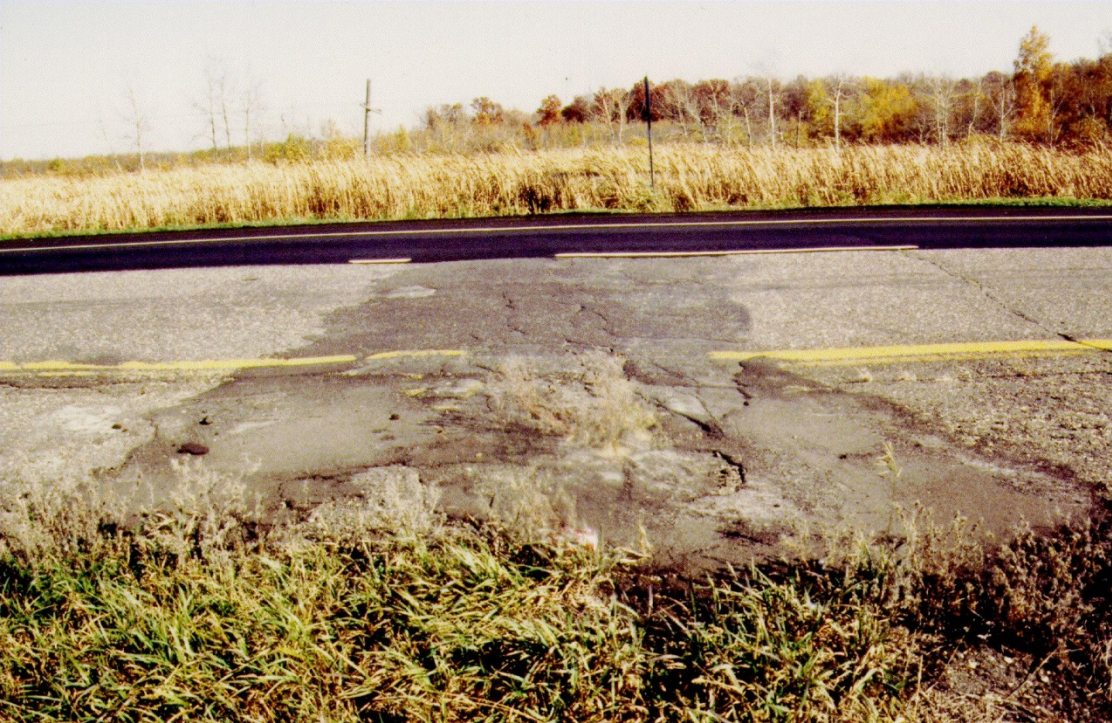
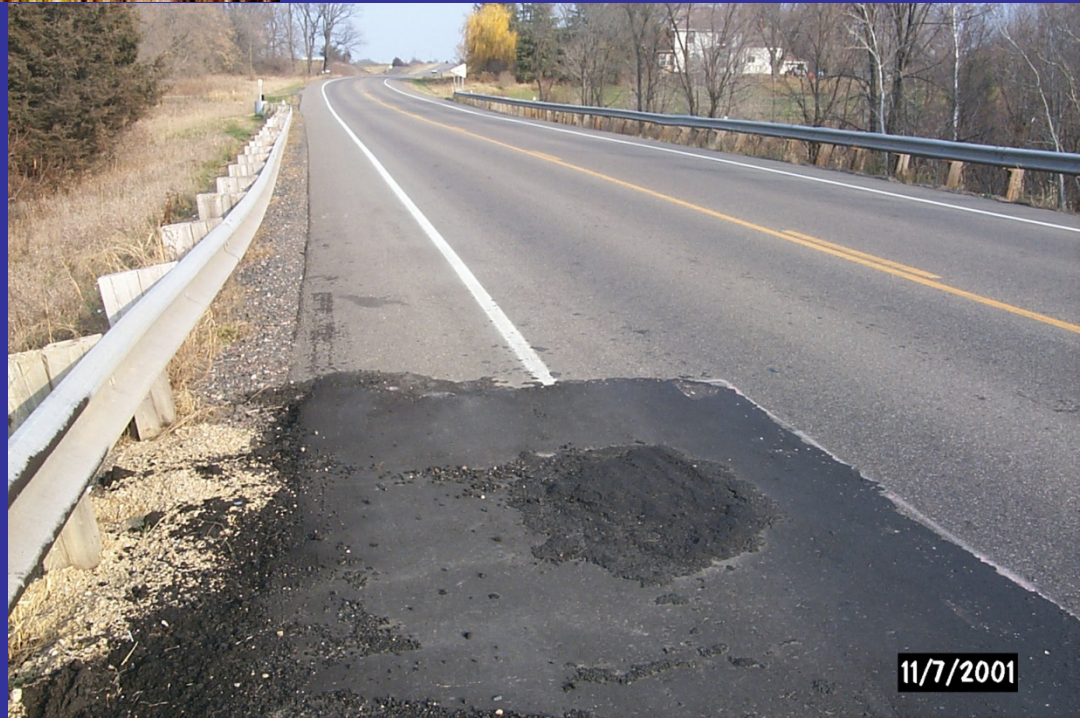
# Road Distress

- Road bump, dip, pavement patch or cracks.

Indicates possible loss of roadbed material through poor condition pipe or structure

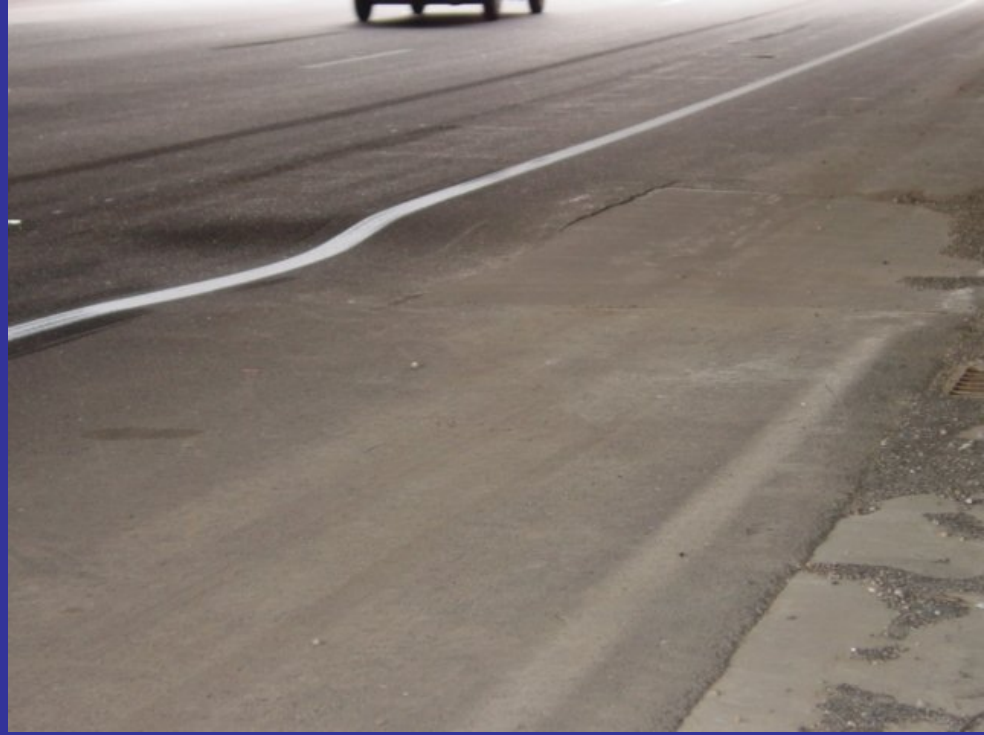
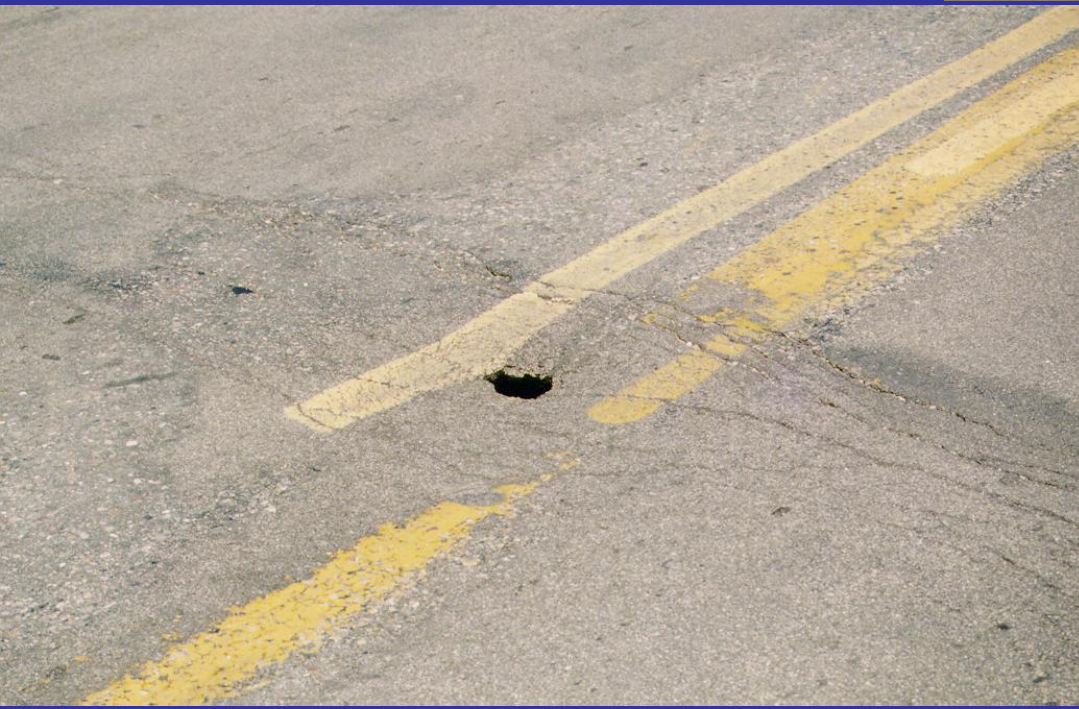
# Road Void

- Evidence of a loss of soil from the road above or near the pipe or structure
- Rate the pipe Condition 4

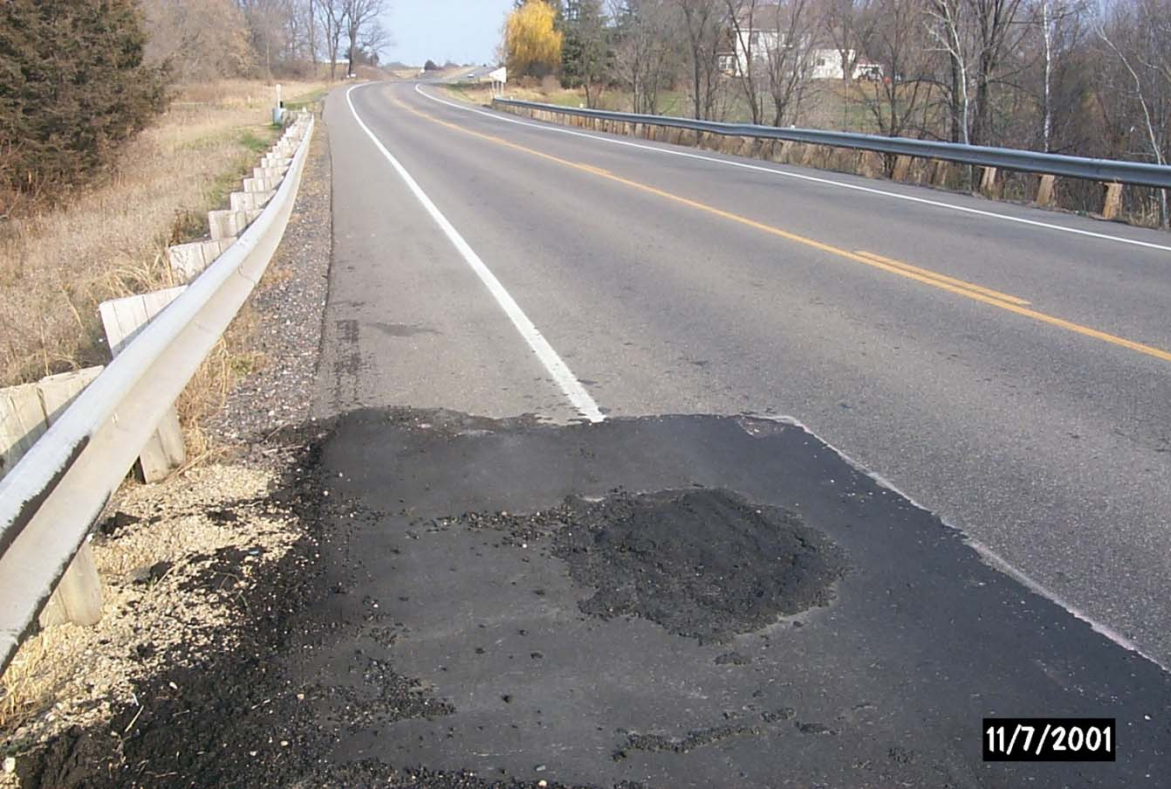
Road surface  
may indicate  
condition of pipe

MN 95 near MP 89, near Marine on the St. Croix

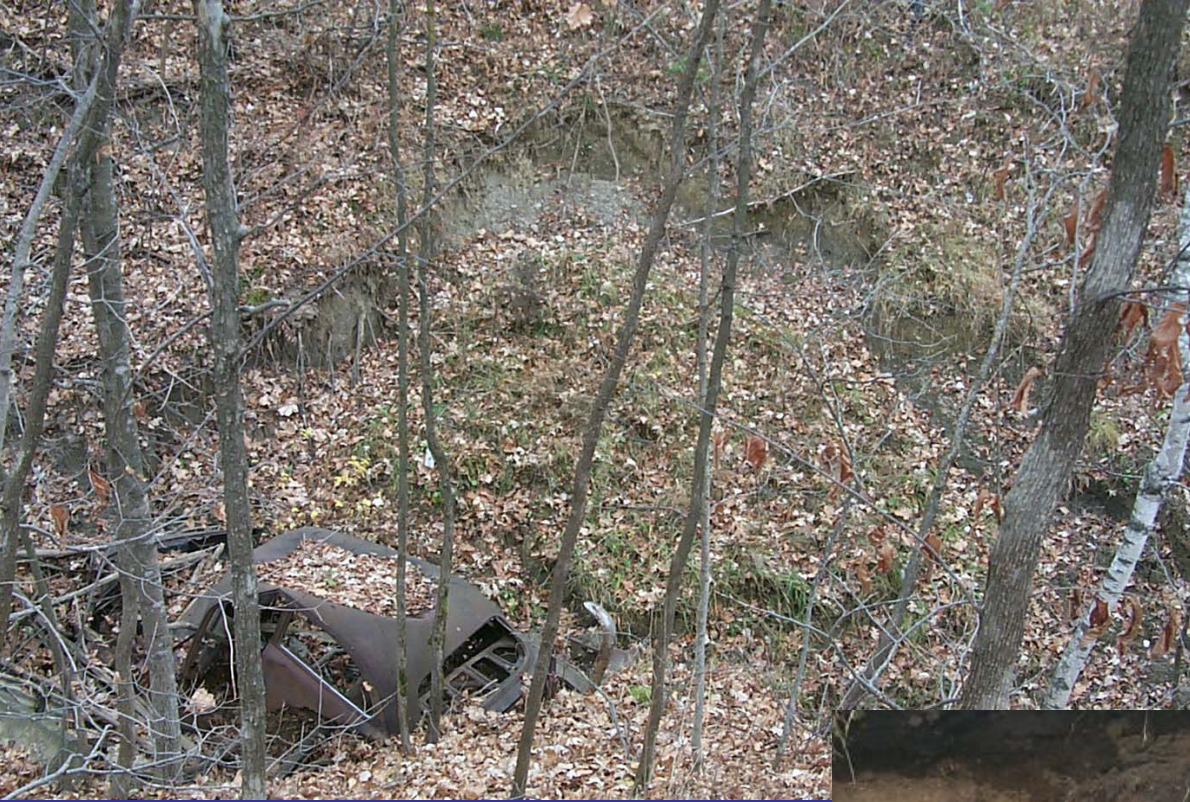
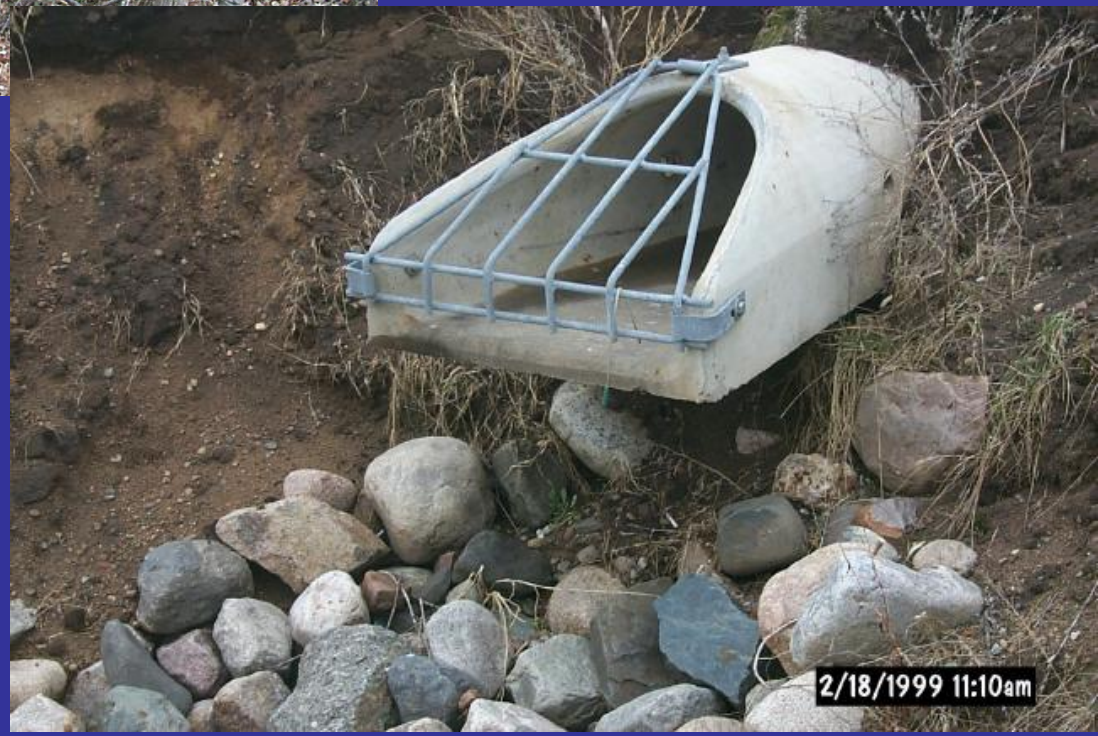
# Erosion

- Also known as scour or channel degradation, is evidenced by a gully, loss of vegetation or slumping of side slopes.

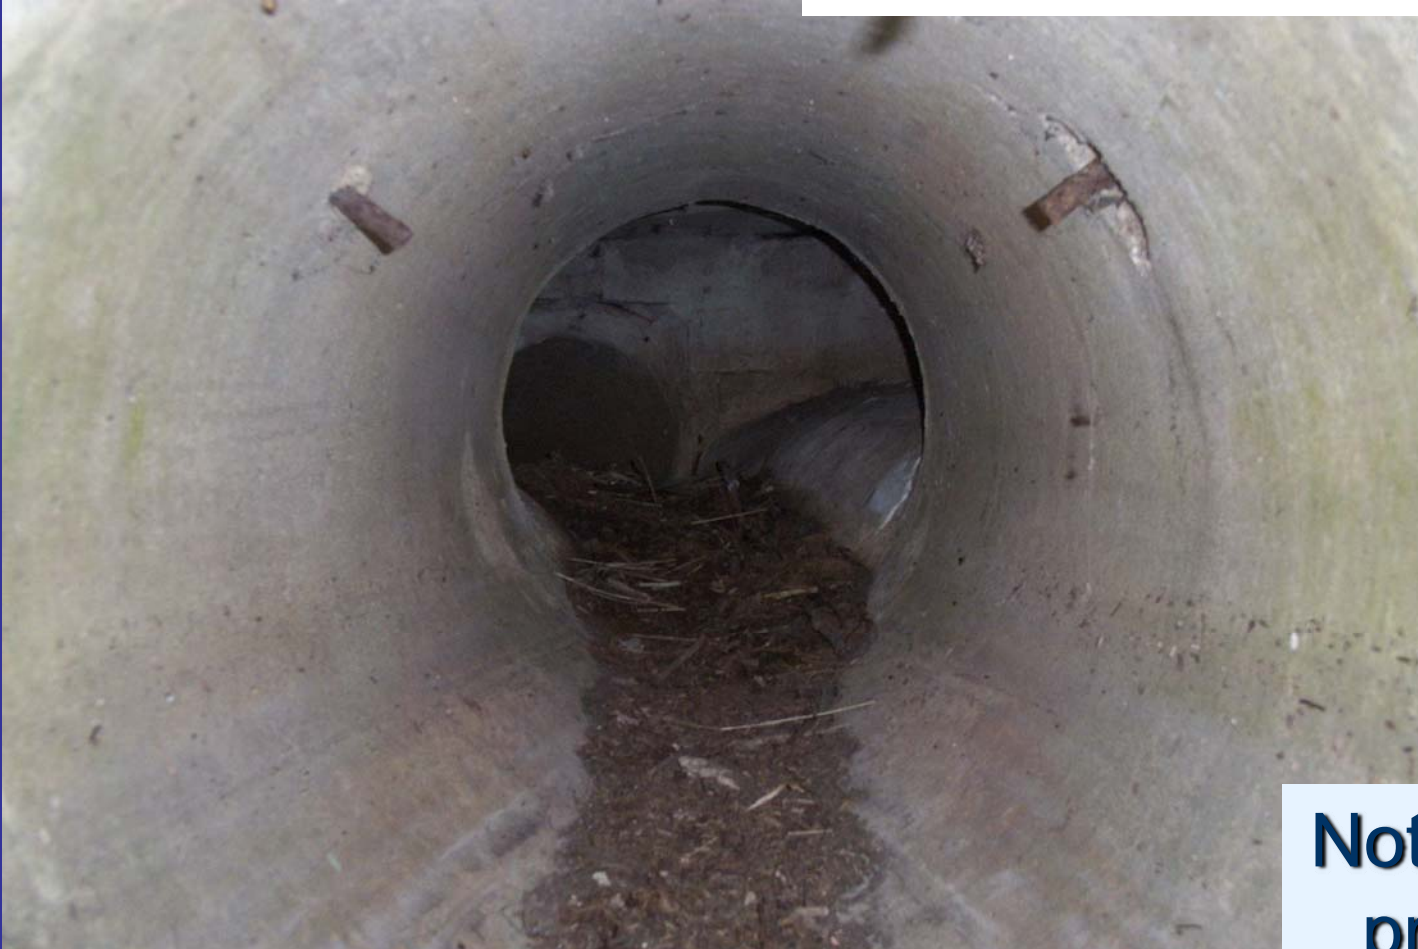
# Condition 1

- ☐ ☐ Minor chipping at joints/openings
- ☐ ☐ Hairline cracks
- ☐ ☐ Insignificant spalling or scaling

**Note also the  
protruding  
pipe ties**

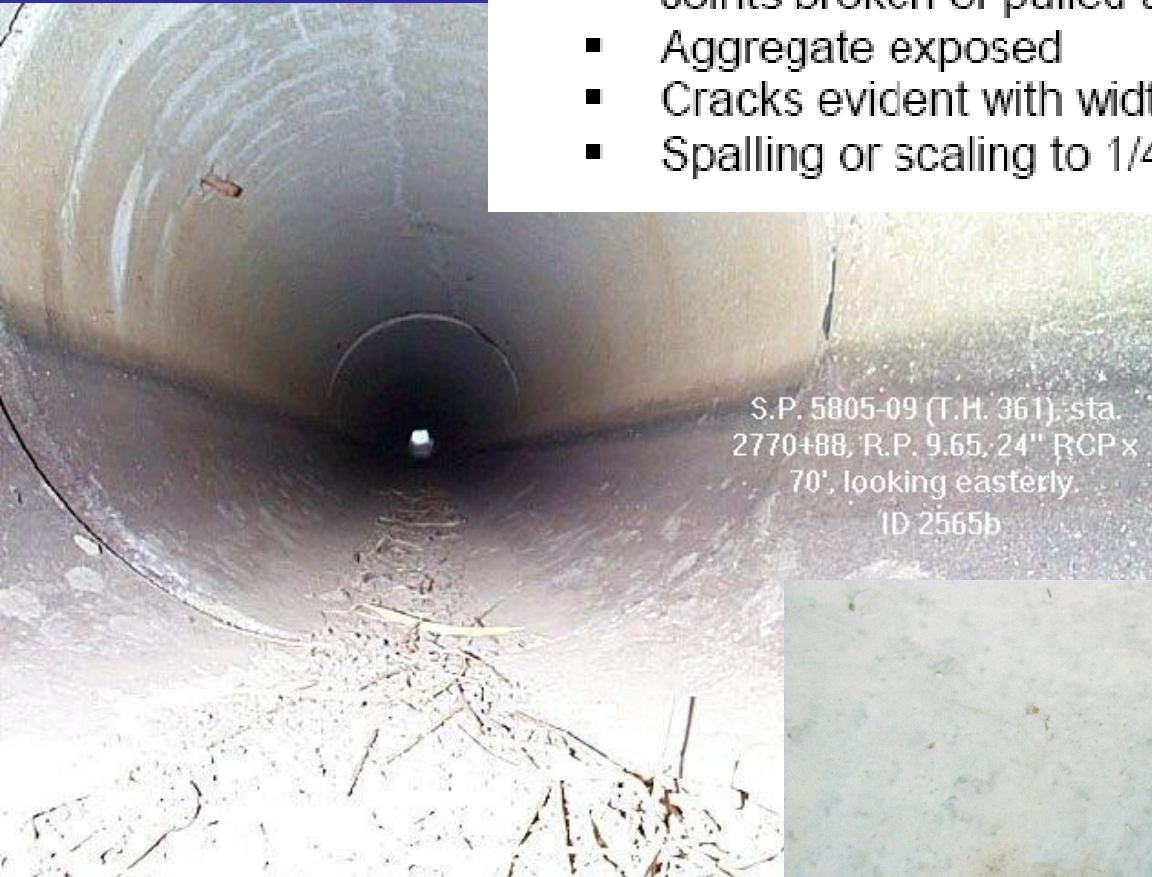
- Joints broken or pulled apart up to 1" (anywhere along joint)
- Aggregate exposed
- Cracks evident with widths up to 1/8 inch
- Spalling or scaling to 1/4 inch depth

S.P. 5805-09 (T.H. 361), sta.  
2770+88, R.P. 9.65, 24" RCP x  
70', looking easterly  
ID 2565b

Condition 2:  
No repair is  
required.

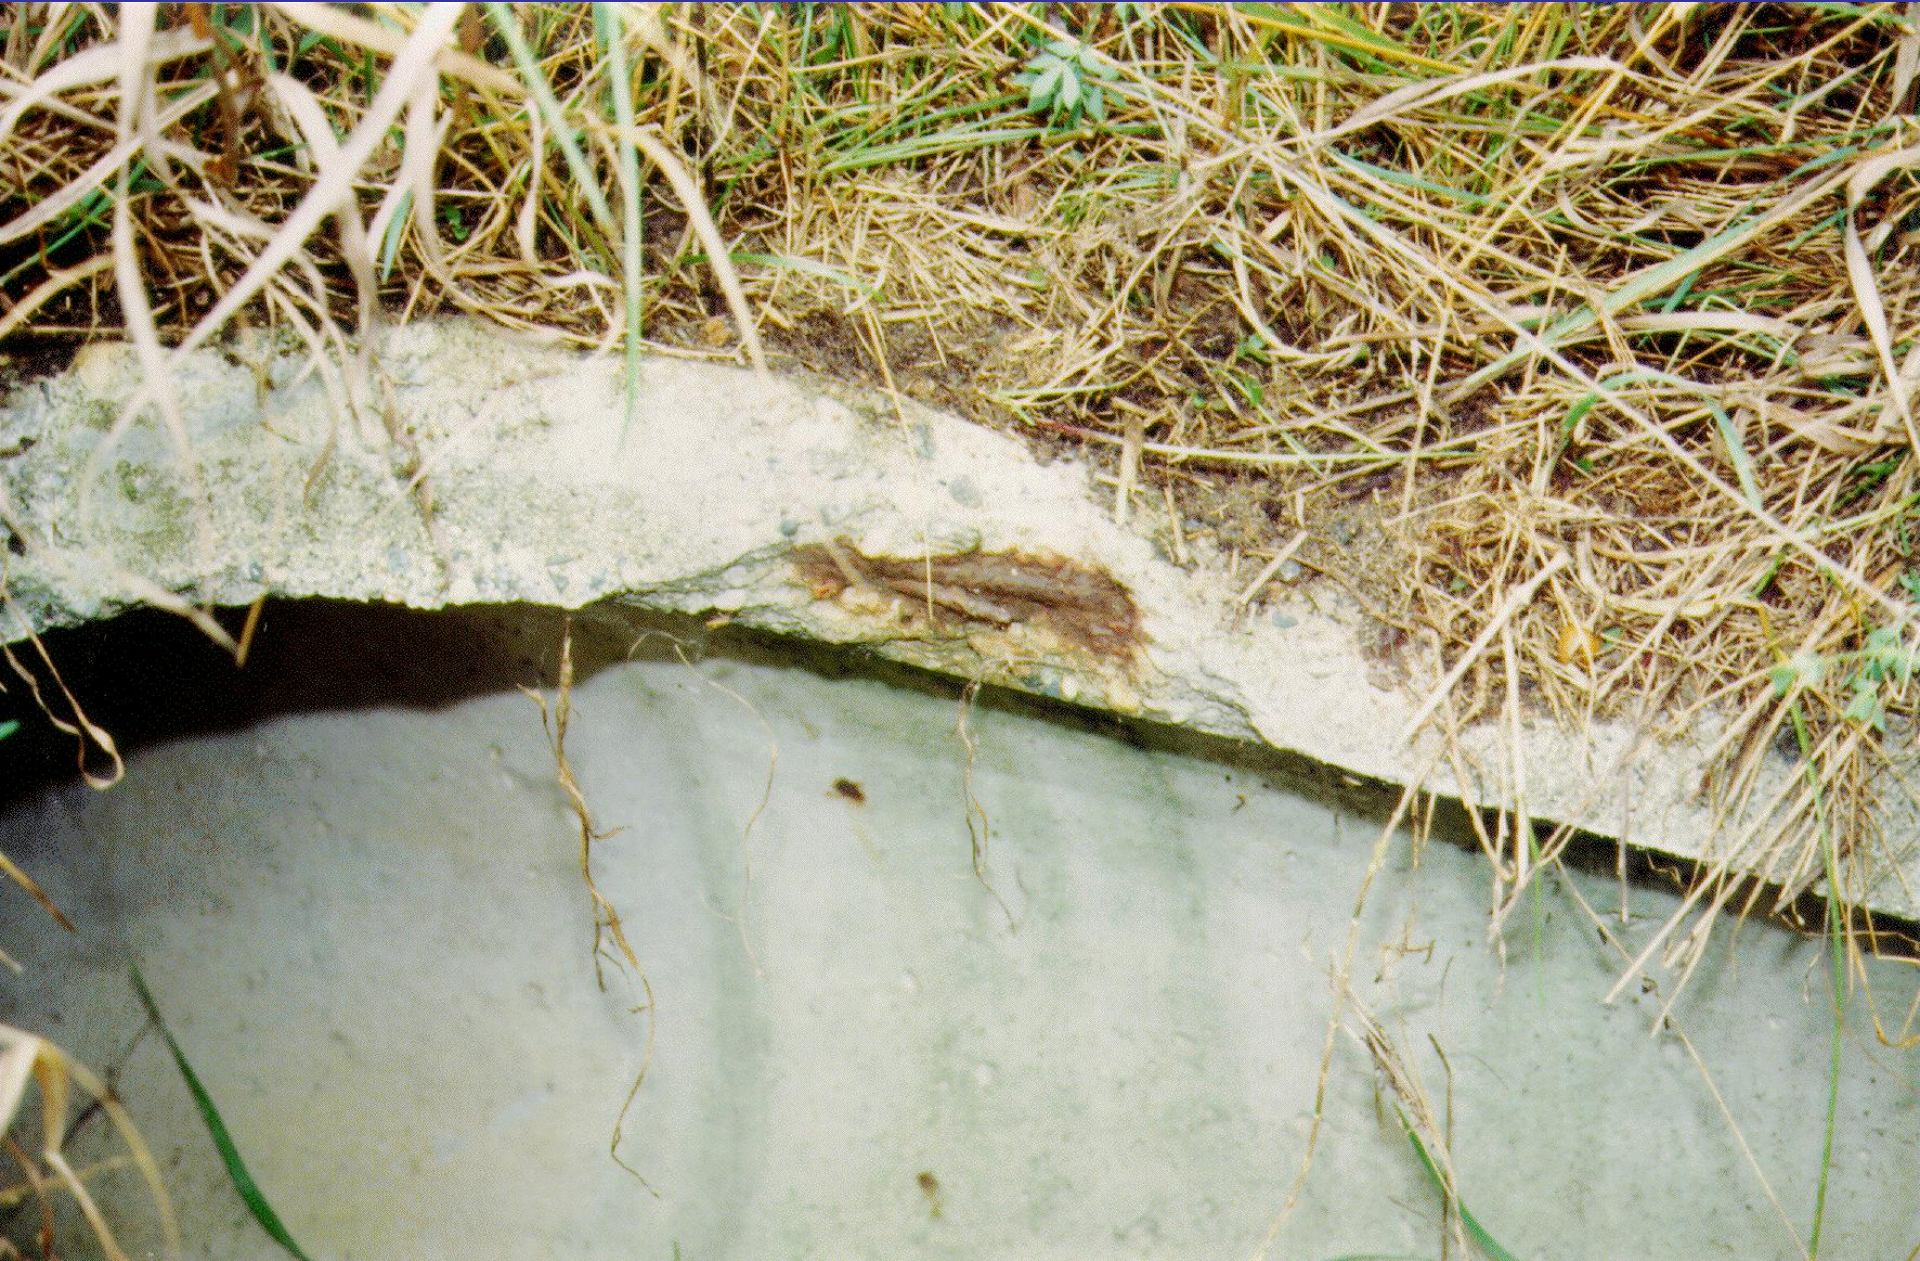
# Concrete Apron - 2 – Repair not required

S.P. 5805-09 (T.H. 361), sta.  
2+70+88, R.P. 9.65, 24" RCP  
x 70', looking westerly.  
ID 2565a

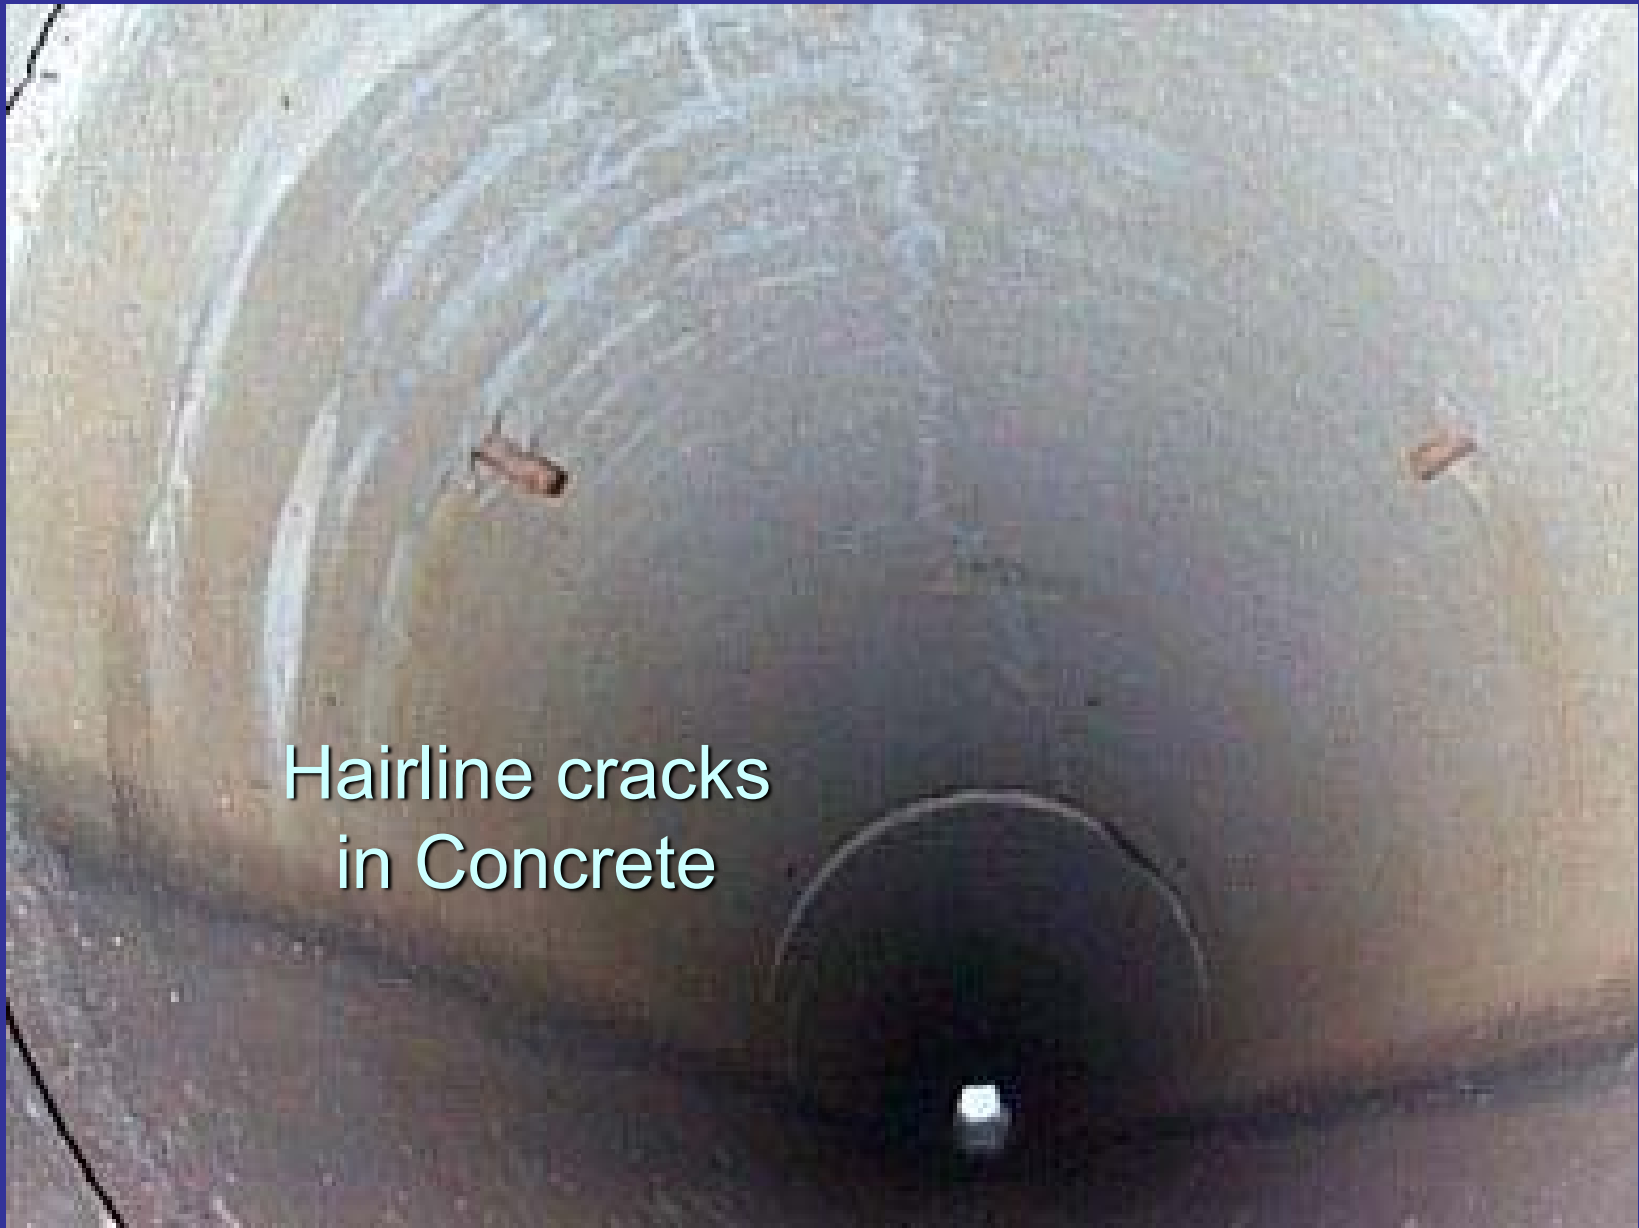
# Condition 2

Hairline cracks  
in Concrete

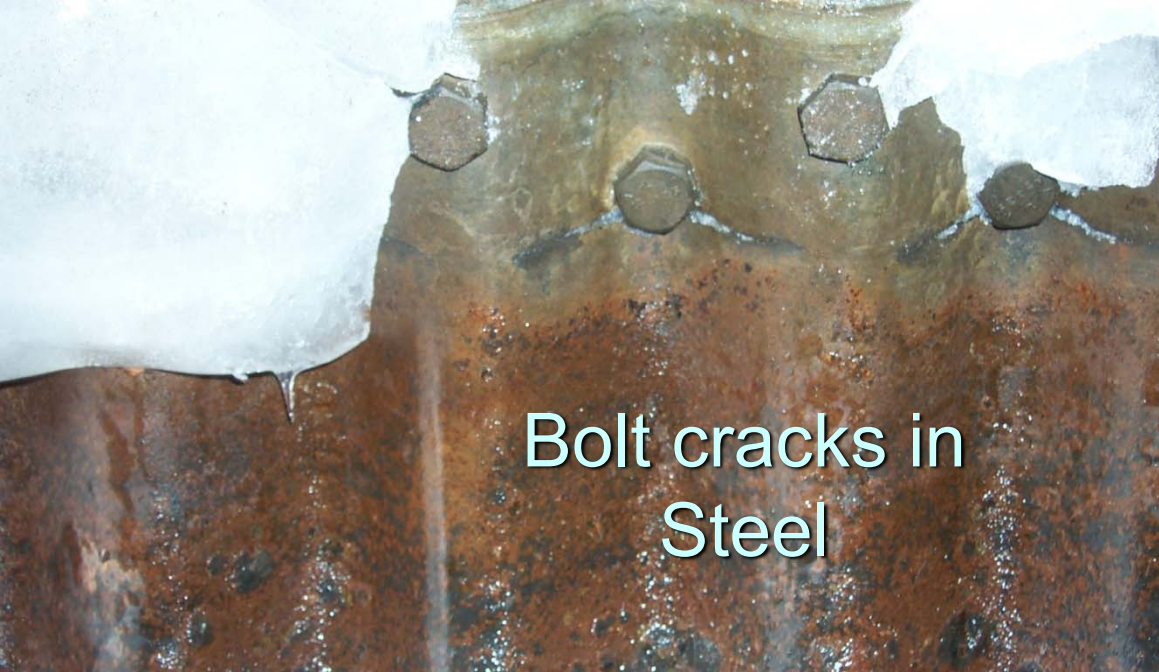
Bolt cracks in  
Steel

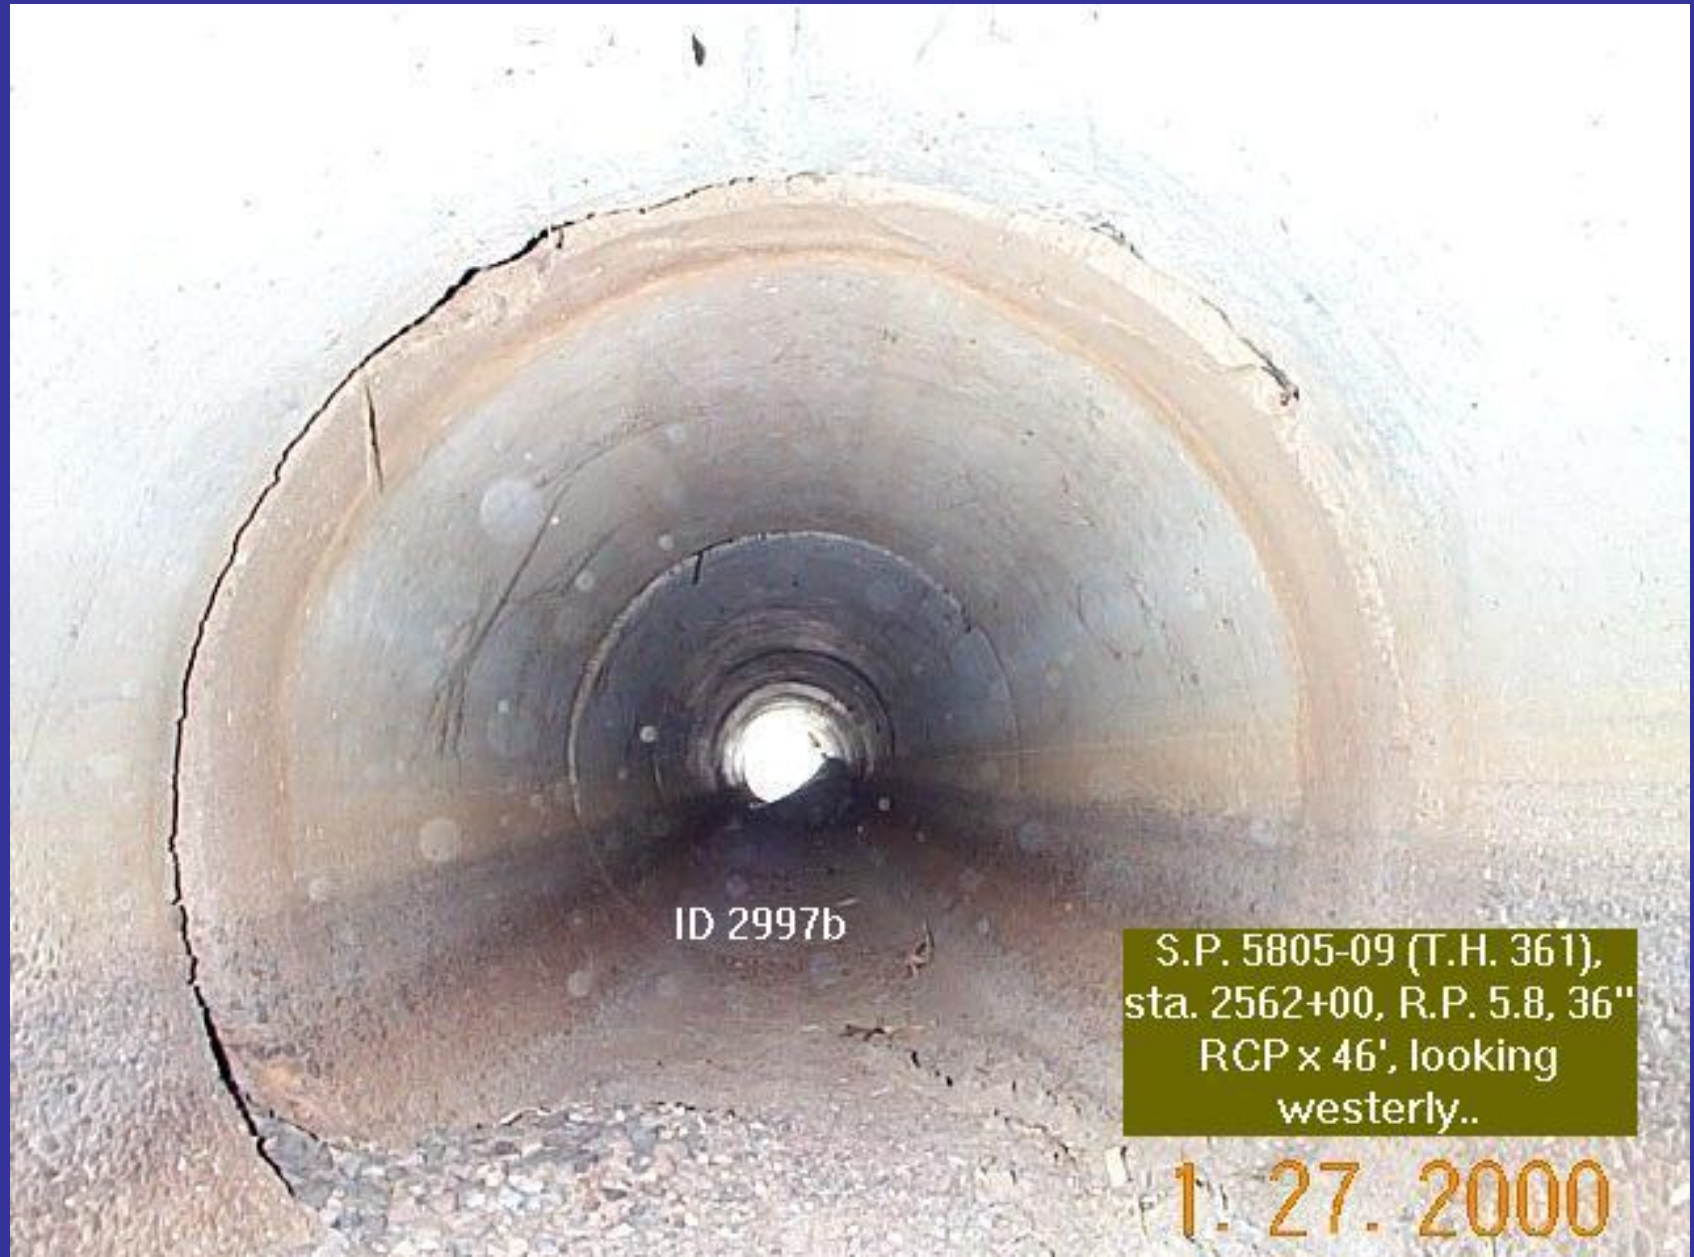
ID 2997b

# Concrete Pipe – 3 or 4?

S.P. 5805-09 (T.H. 361),  
sta. 2562+00, R.P. 5.8, 36"  
RCP x 46', looking  
westerly..

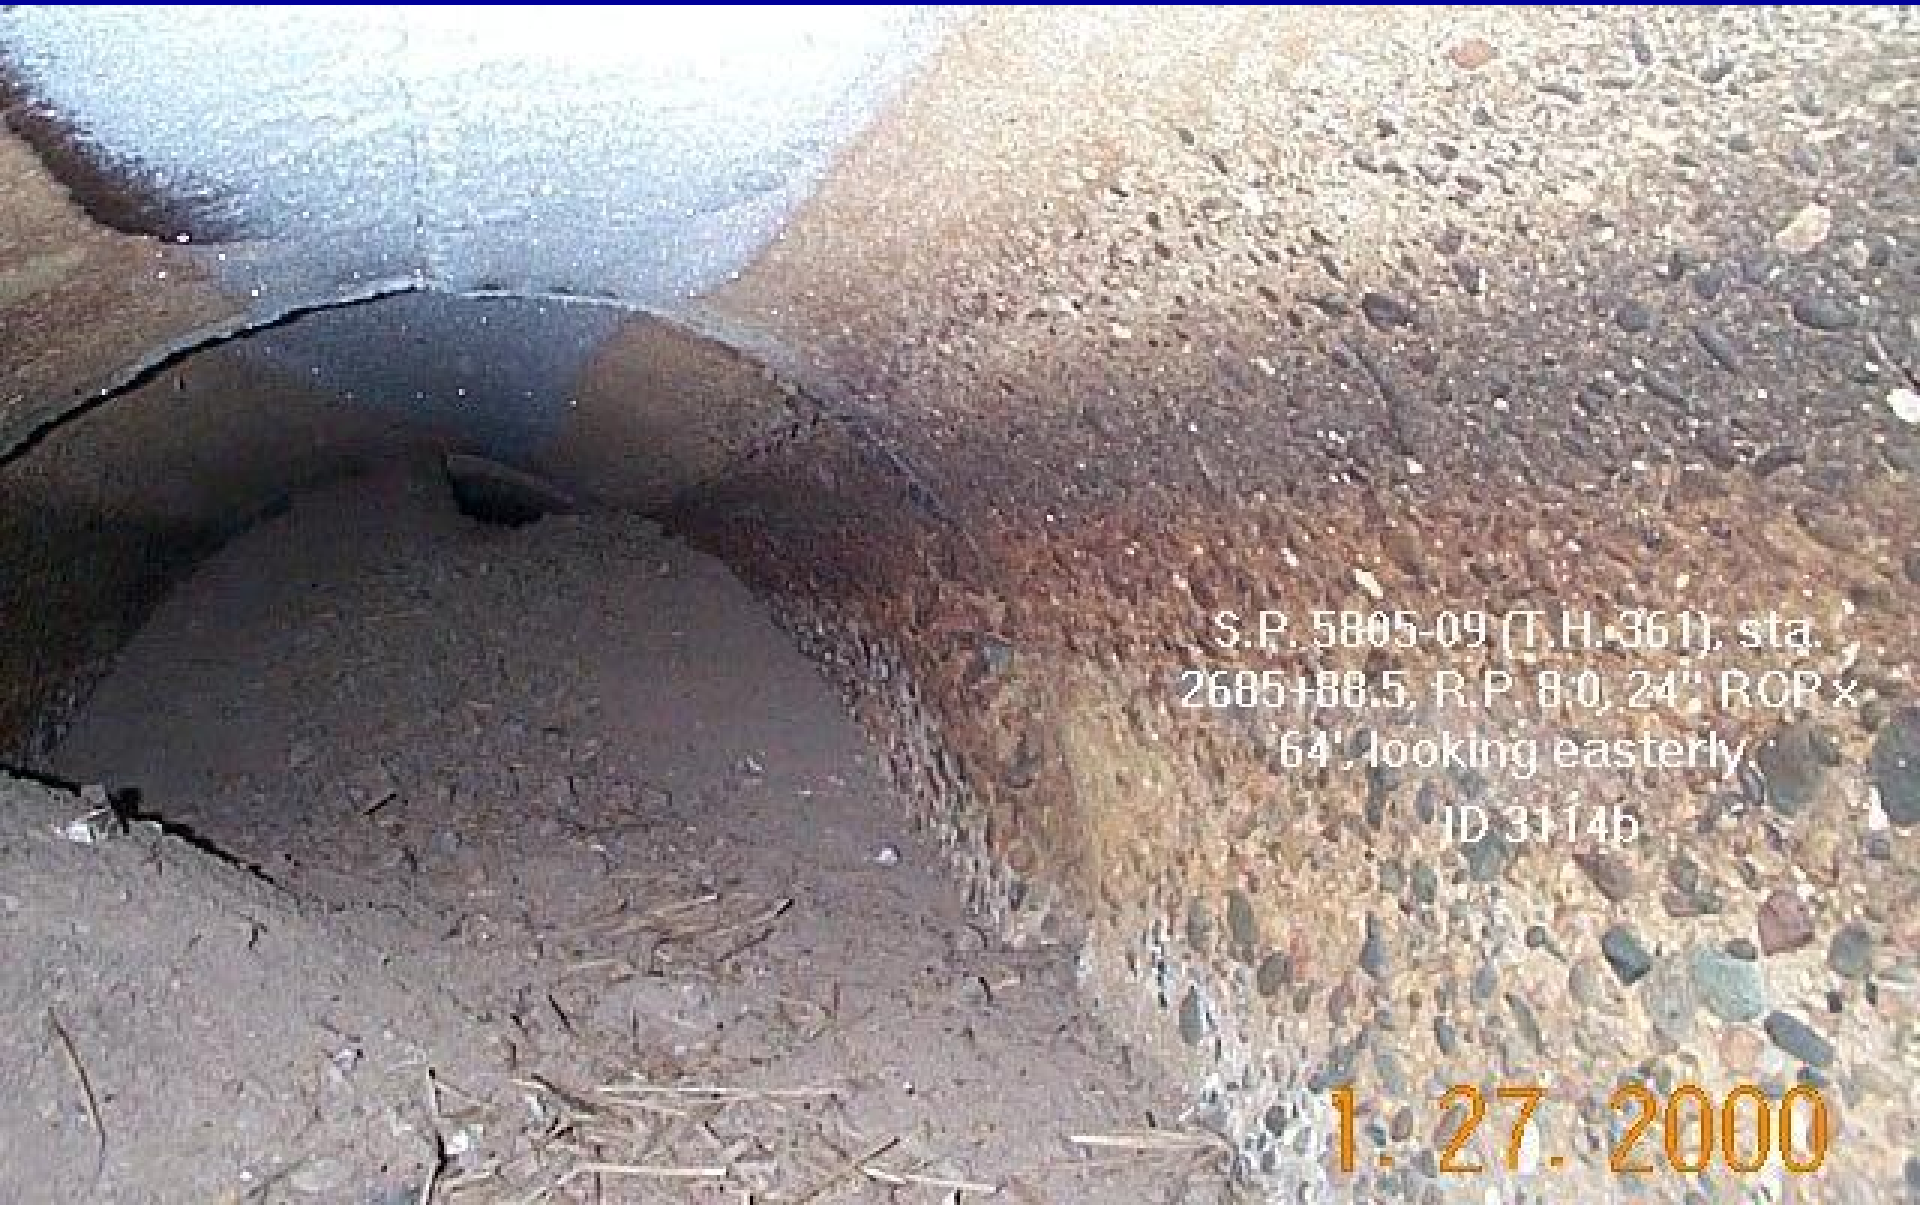
ID 3114b

# Concrete Pipe - 4

S.P. 5805-09 (T.H. 361), sta.  
2685+88.5, R.P. 8+0, 24" ROP x  
64', looking easterly.

- Joints pulled apart or broken (more than 3" at any point along joint)
- Cracking evident with widths  $> 1/4$  inch
- Reinforcement fully exposed in places
- Eroded holes through concrete or bottom gone
- Deformation
- Cracks showing movement – pipe pieces have shifted
- Pipe condition is causing soil loss beneath road surface

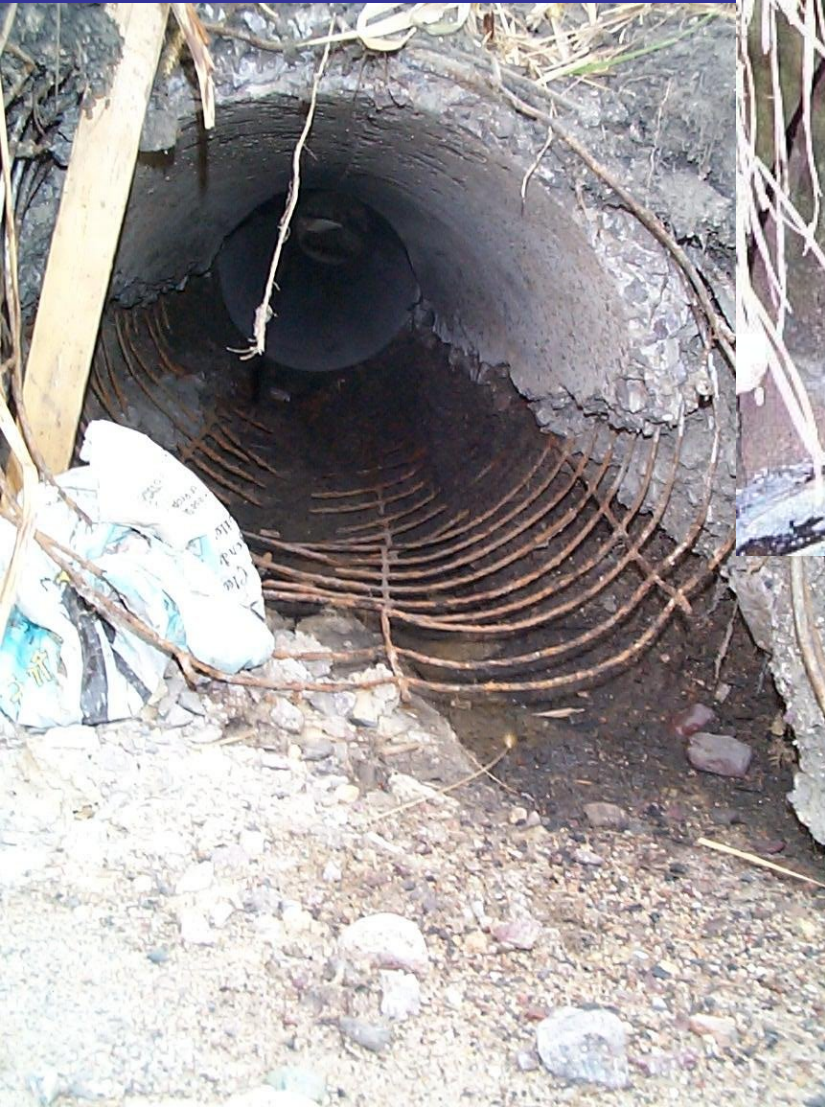
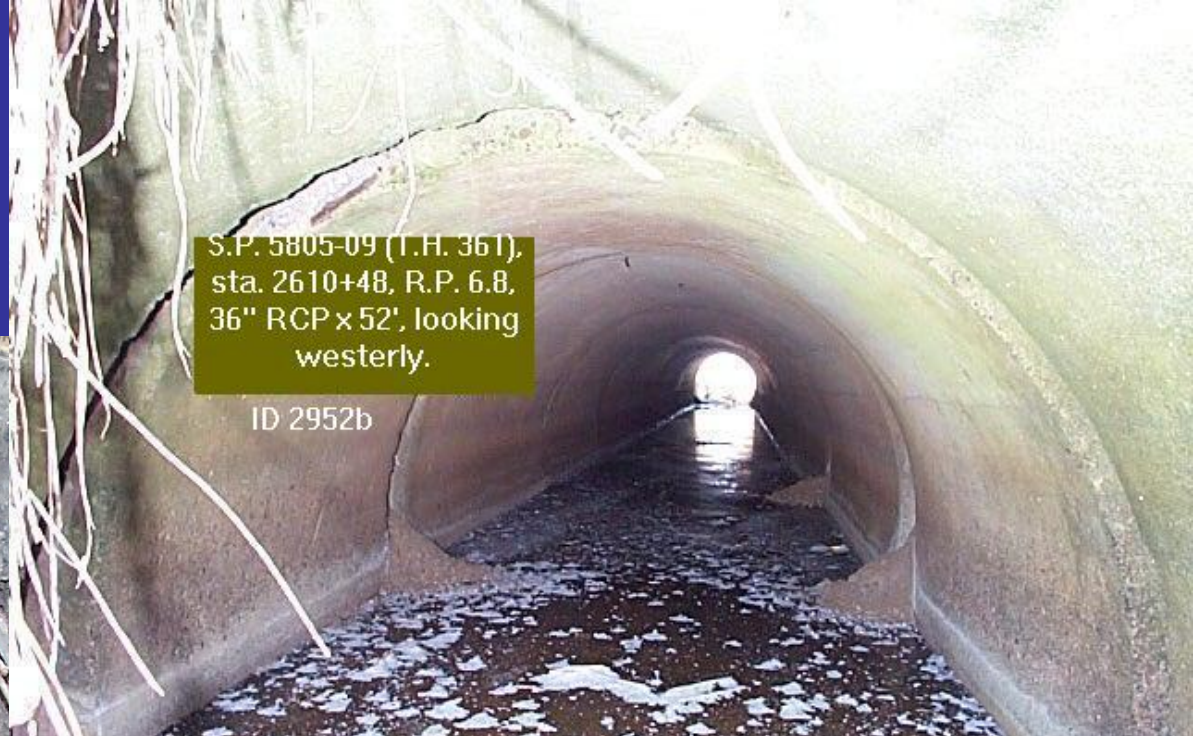
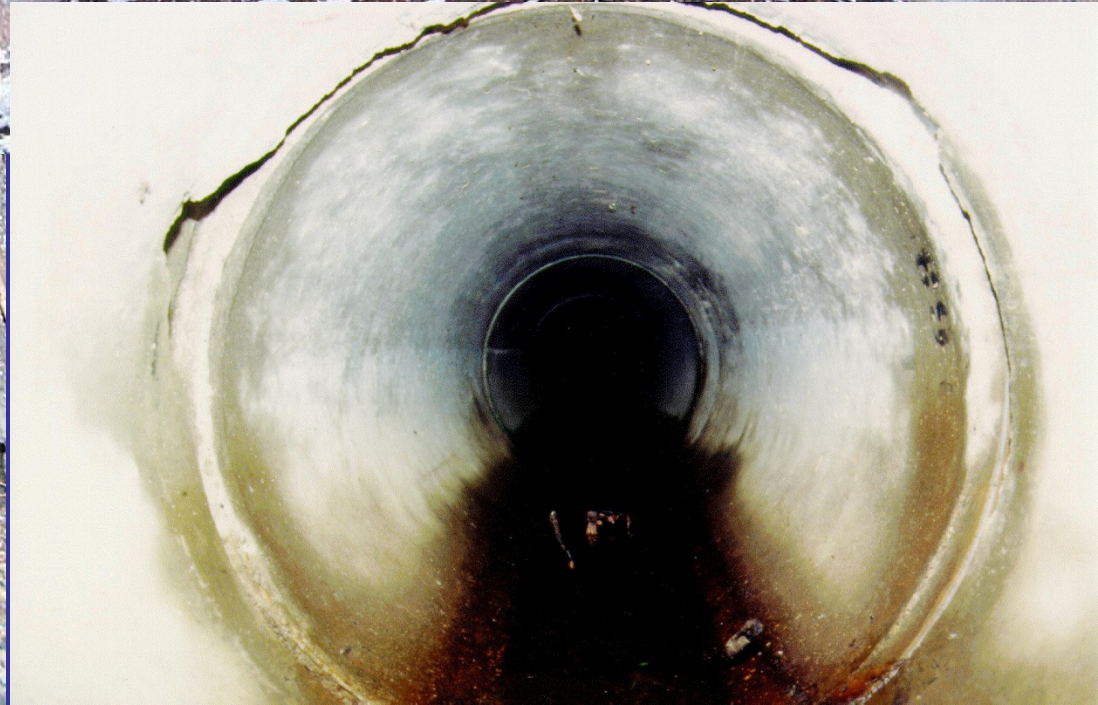
ID 2952b

# Concrete Condition 4

S.P. 5805-09 (I.H. 361),  
sta. 2610+48, R.P. 6.8,  
36" RCP x 52', looking  
westerly.

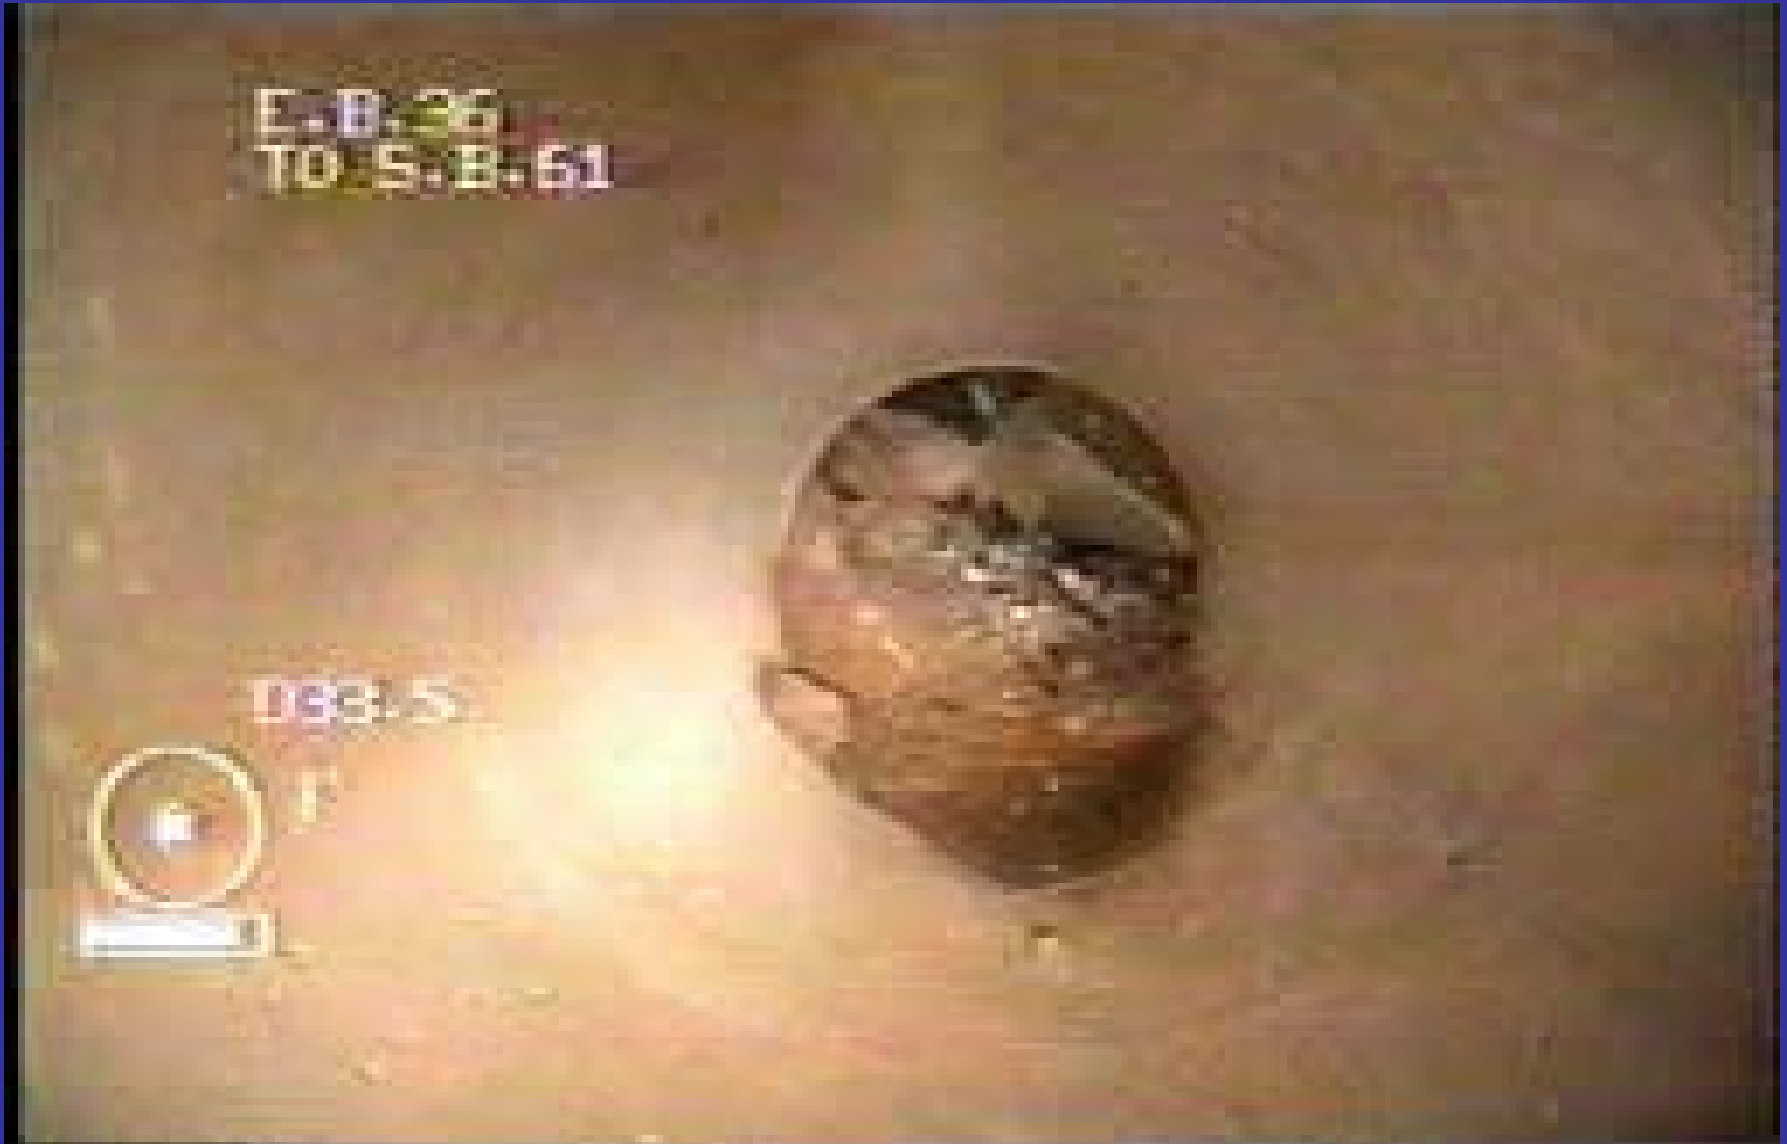
# Concrete plugged. Crushed? - 4
