# HydInfra Condition Ratings and Inspection Terms

# HydInfra

# HydInfra Ratings Guide

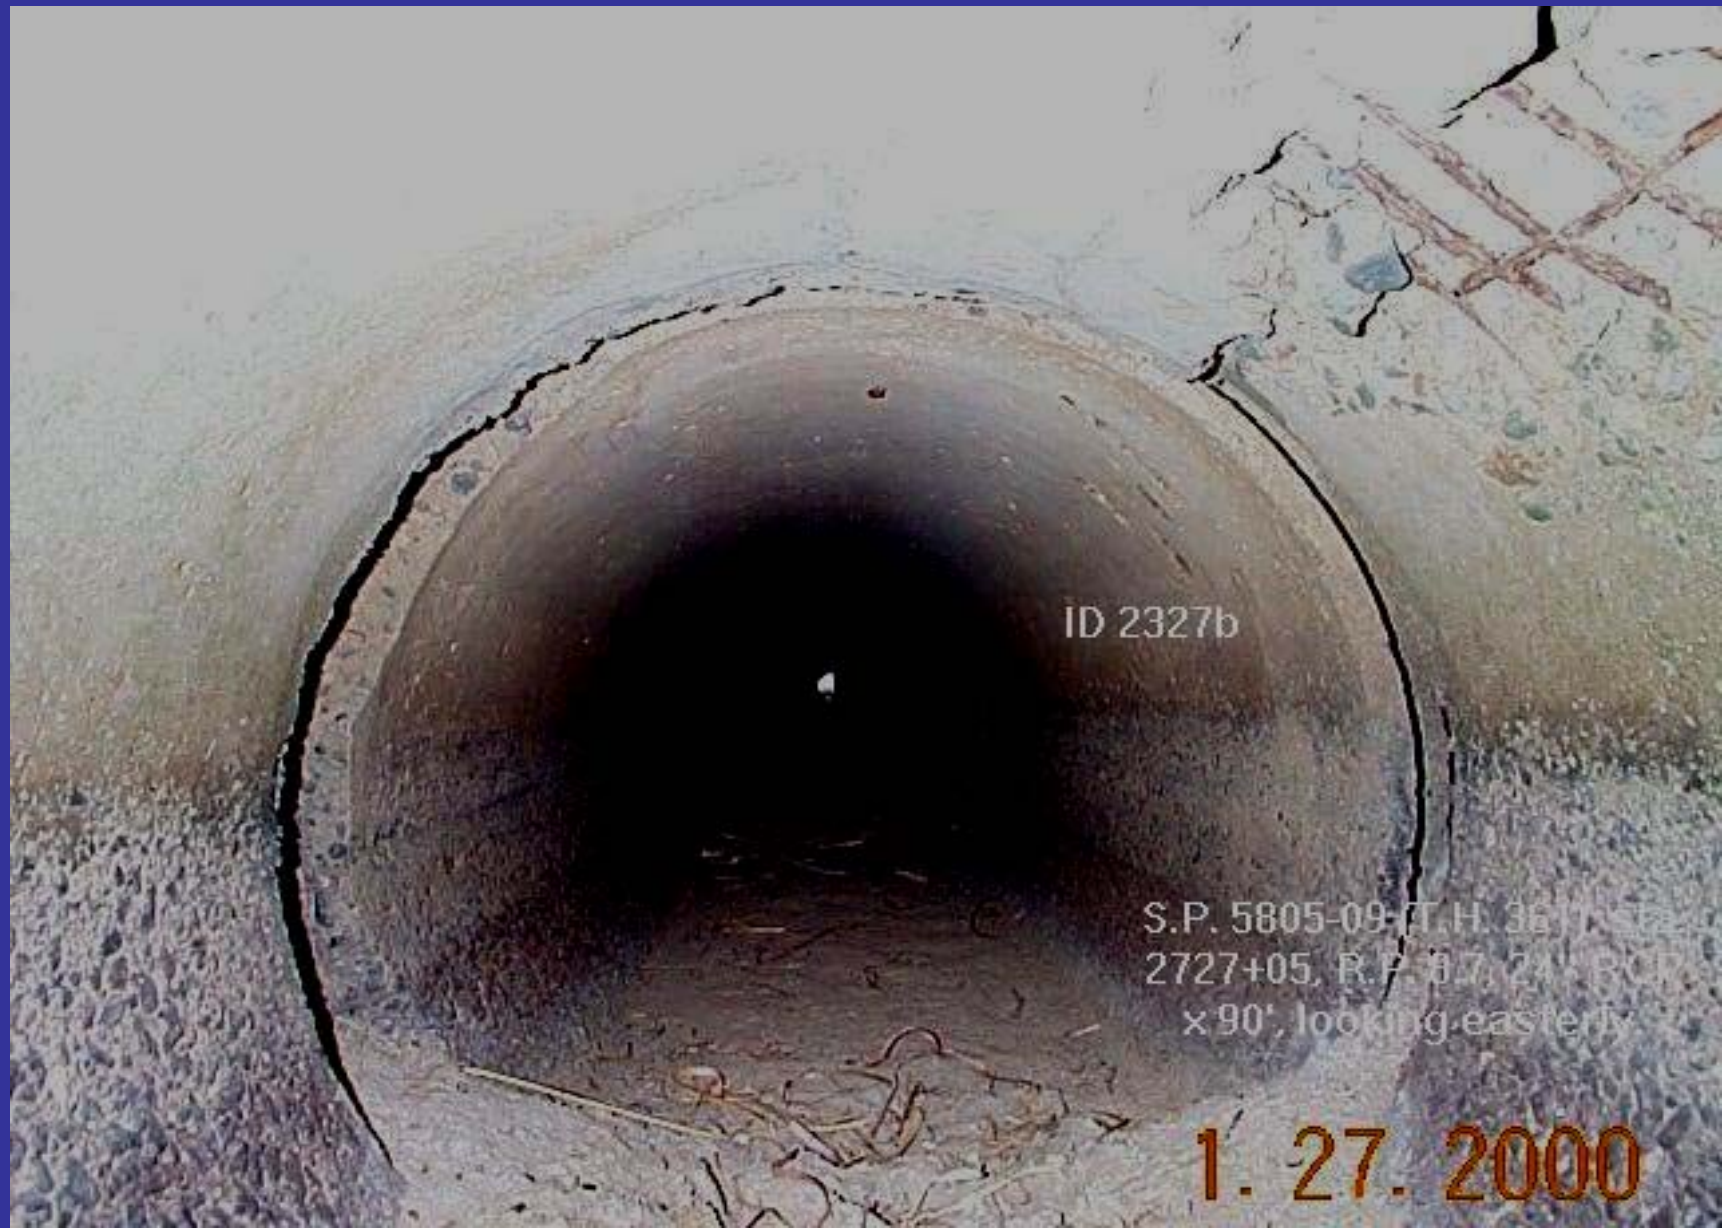
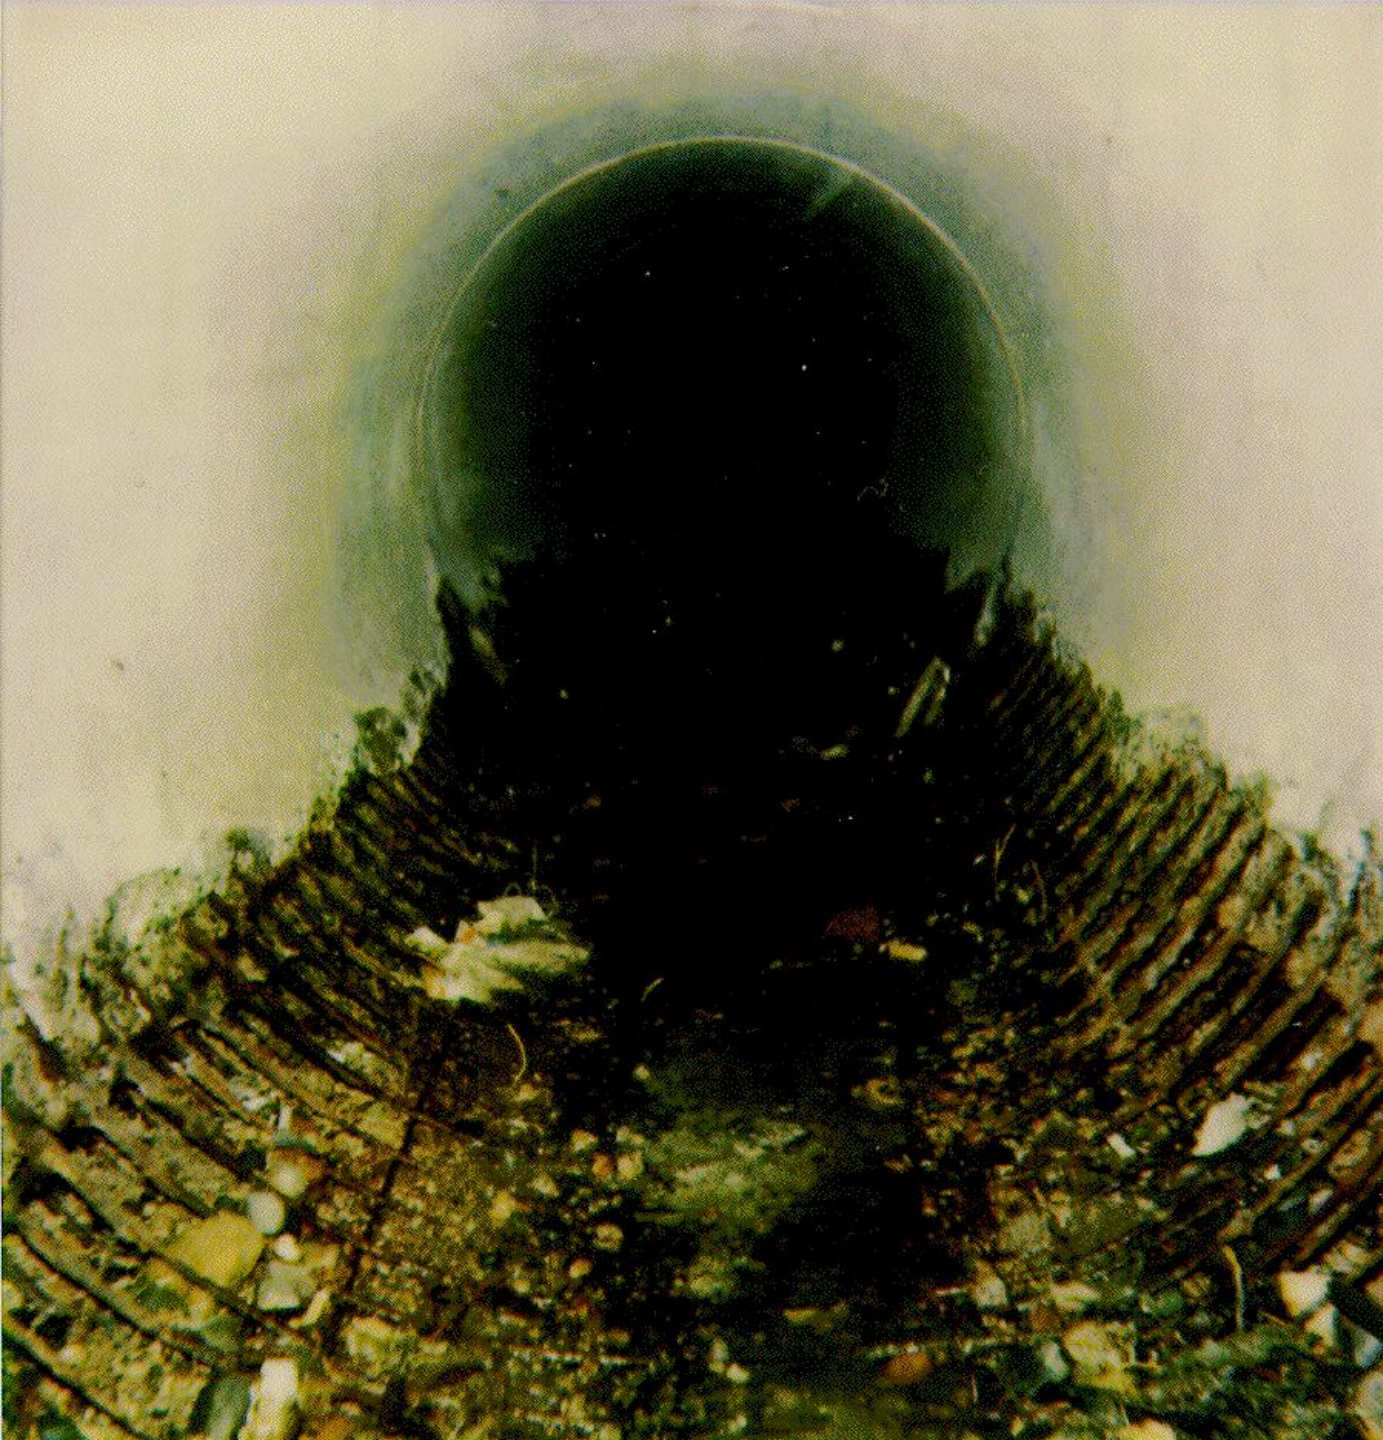
# Concrete Pipe Deformation - 4

Concrete  
Pipe  
I-94 at  
Pascal  
4

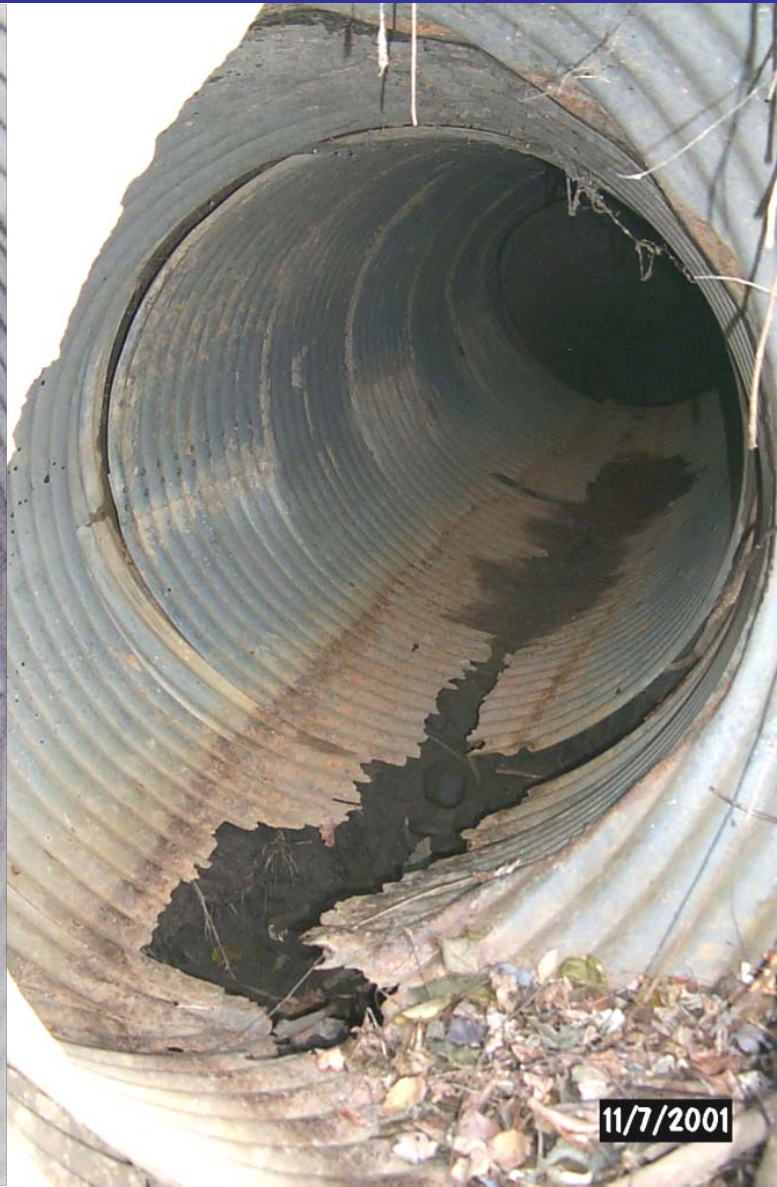
# Steel Condition 4 Pipe Examples
