**3<sup>rd</sup> Ave Bridge 2440 CMGC Kick-off Meeting Agenda – January 23, 2018**

S.P. 2710-47 TH 65 (3rd Avenue Bridge)  
CMGC Kick-Off Meeting  
January 23, 2018

## Bridge 2440 – Historic Bridge Management Plan

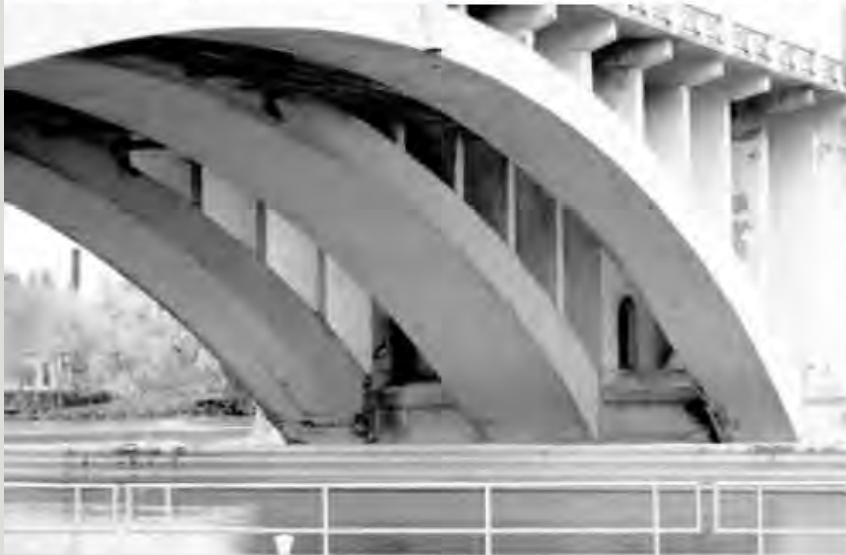
Feature 1. Melan-system reinforced-concrete arches. The Melan system, patented in 1894, uses steel I-beams bent approximately to the shape of the arch axis and laid in a parallel series near the undersurface of the arch. The Third Avenue Bridge has seven large Melan arches, including two barrel arches and five three-rib arches, including the example in this photograph. It is considered to be the last major reinforced-concrete bridge constructed in the Twin Cities using the Melan system.

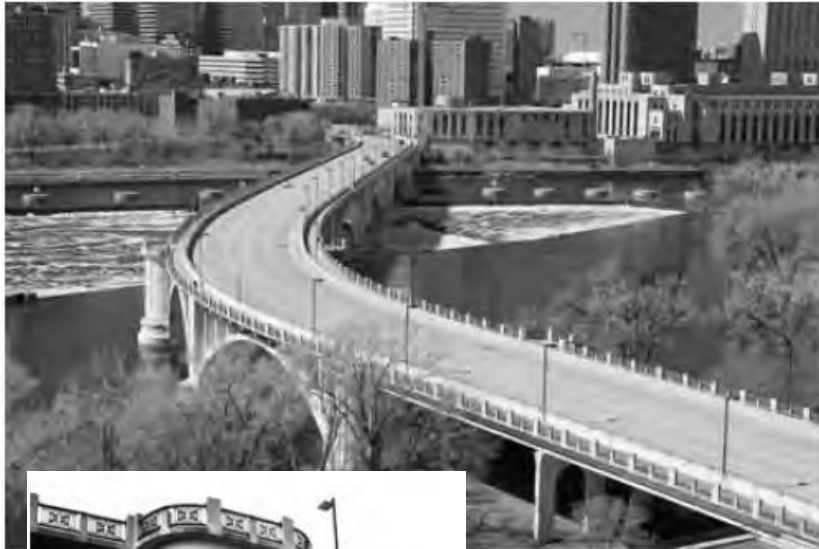
Feature 2. Reverse S-curve alignment. The bridge location lies in an area of the Mississippi River between Nicollet Island and St. Anthony Falls that has an irregular limestone base. The placement of piers and engineering of the spans required considerable engineering analysis to avoid unstable areas. The final plan resulted in a reverse S-curve alignment, which spanned the poor foundation sections and produced an aesthetic form that added to the bridge's overall image as a gateway to downtown Minneapolis.

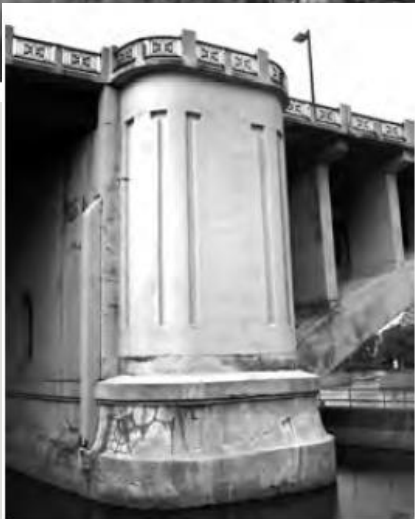
Feature 3. Classical Revival aesthetic treatment. A gateway structure, the Third Avenue Bridge received a Classical Revival aesthetic treatment. Classical elements include piers and the projecting pedestrian bays, which were restored or reconstructed in the 1979-80 deck-replacement project, and the 1939 ornamental railing.

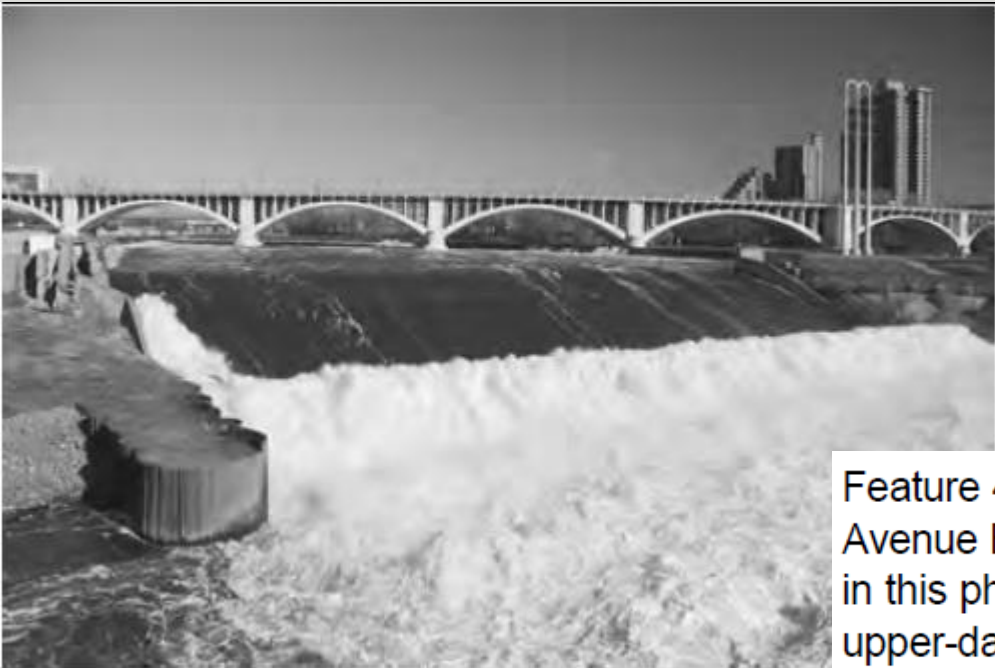
Feature 4. St. Anthony Falls setting. The Third Avenue Bridge is located just above the falls, as visible in this photograph. It spans elements of the V-shaped, upper-dam system that channeled water into east and west mill ponds on the east and west sides of the falls. The ponds provided water to the waterpower canals for the flour-milling district. The bridge is within the St. Anthony Falls Historic District (National Register of Historic Places).

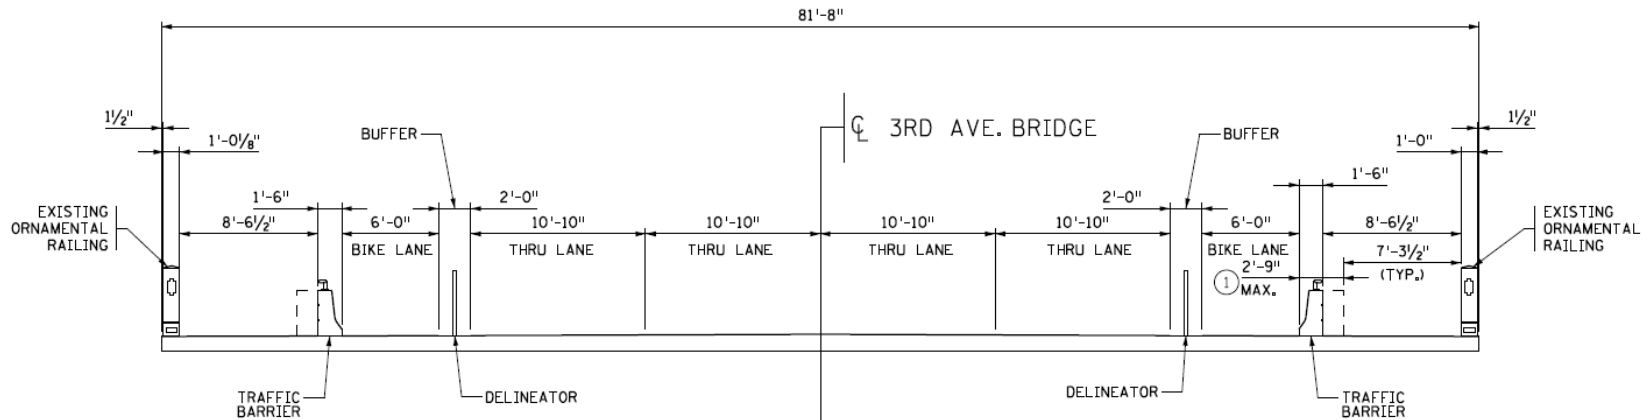
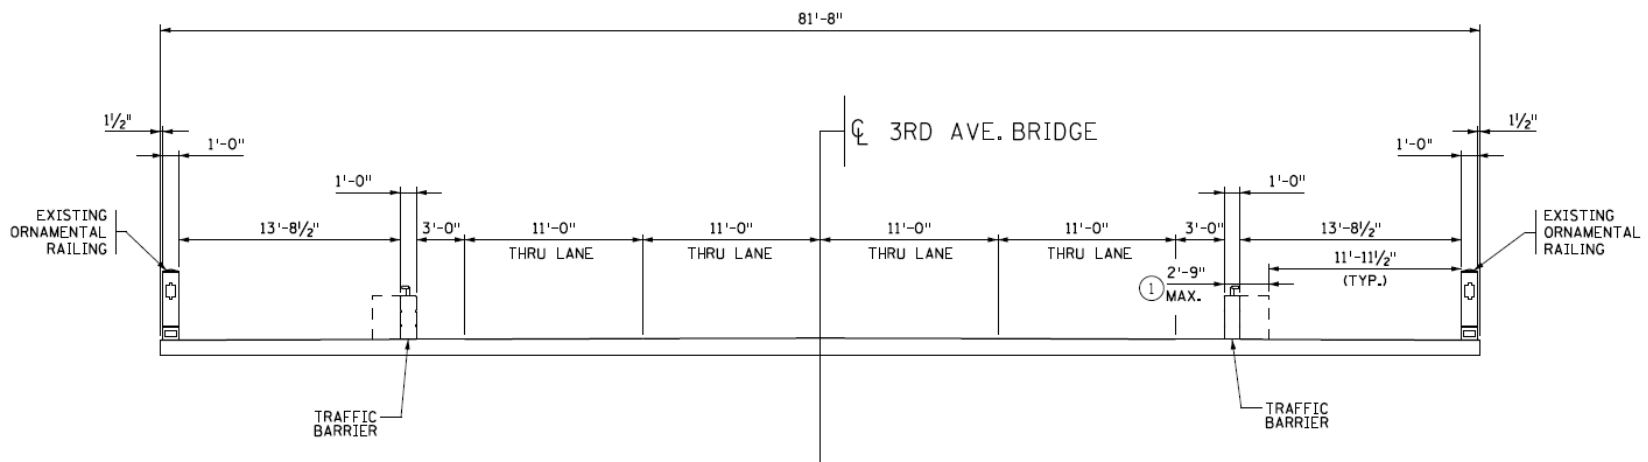
# Cross Section Alternatives

## Bridge Closure/Staged Construction /ABC Alt.

ADDITIONAL X-SECTION

① MAXIMUM LIGHT BLISTER DIMENSION, TO BE FINALIZED IN DESIGN

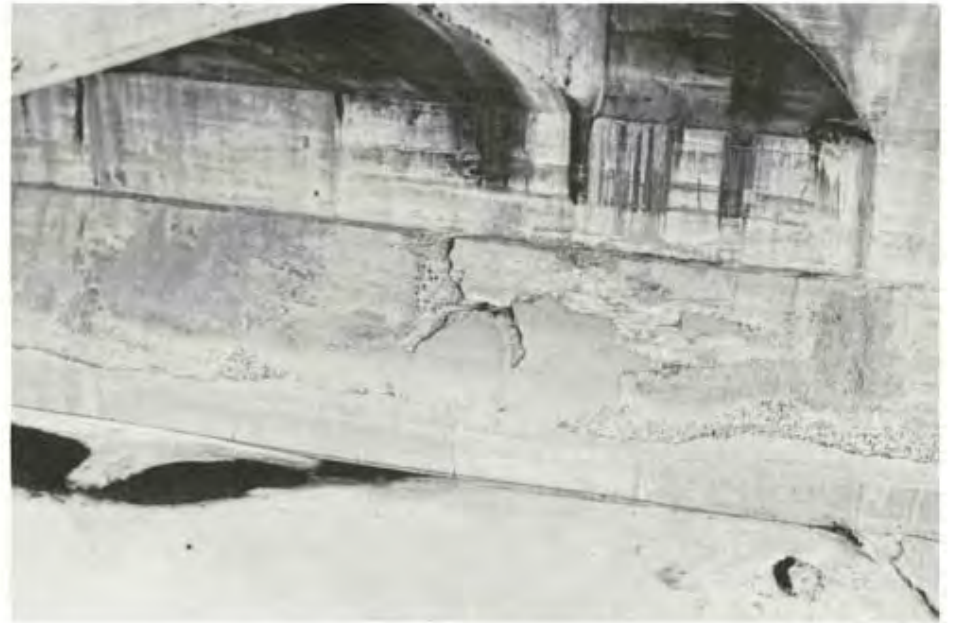
II-29. Deterioration to the south wall of Pier 4.

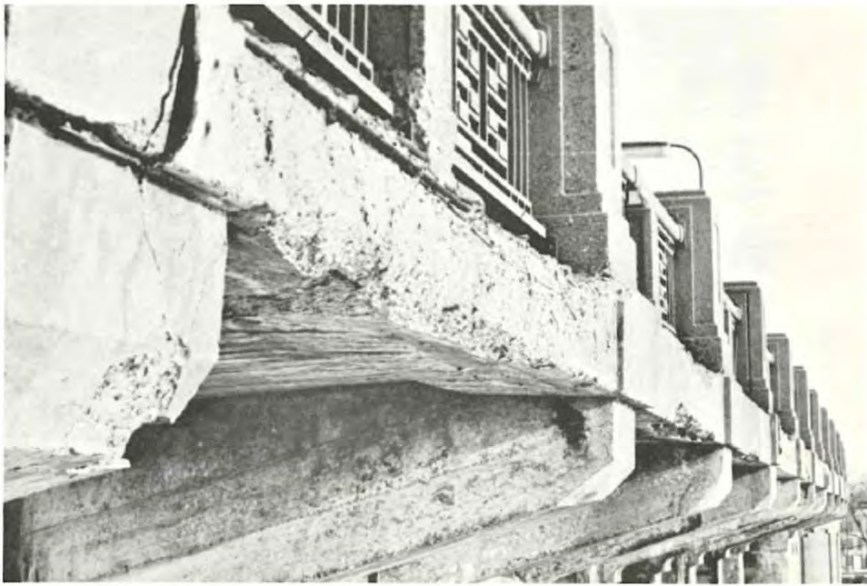
II-14. Areas of spall at the bridge railing posts, sidewalk deck, and spandrel cantilevers.

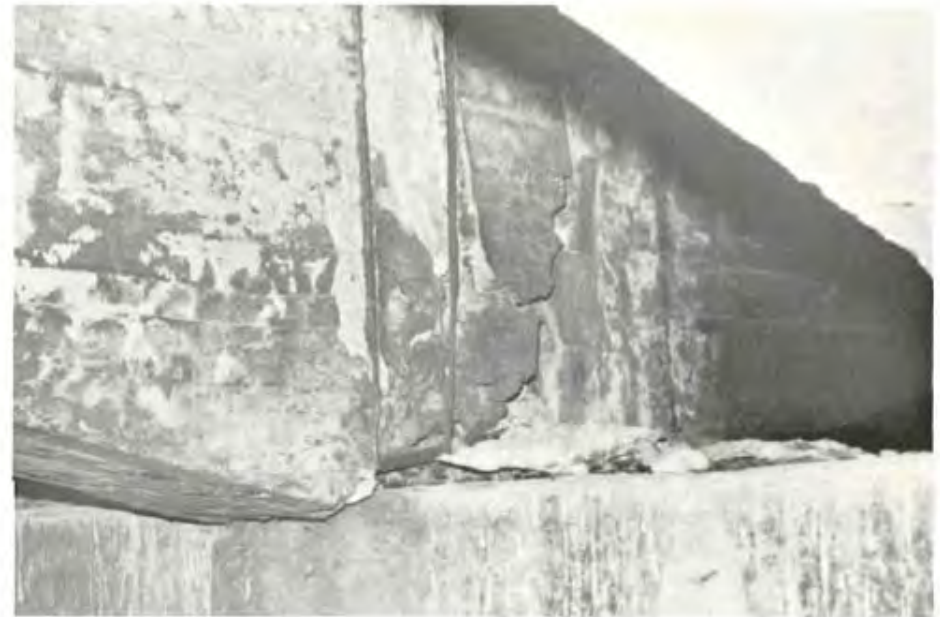
II-19. Crushed concrete at a beam haunch above Bent 5.

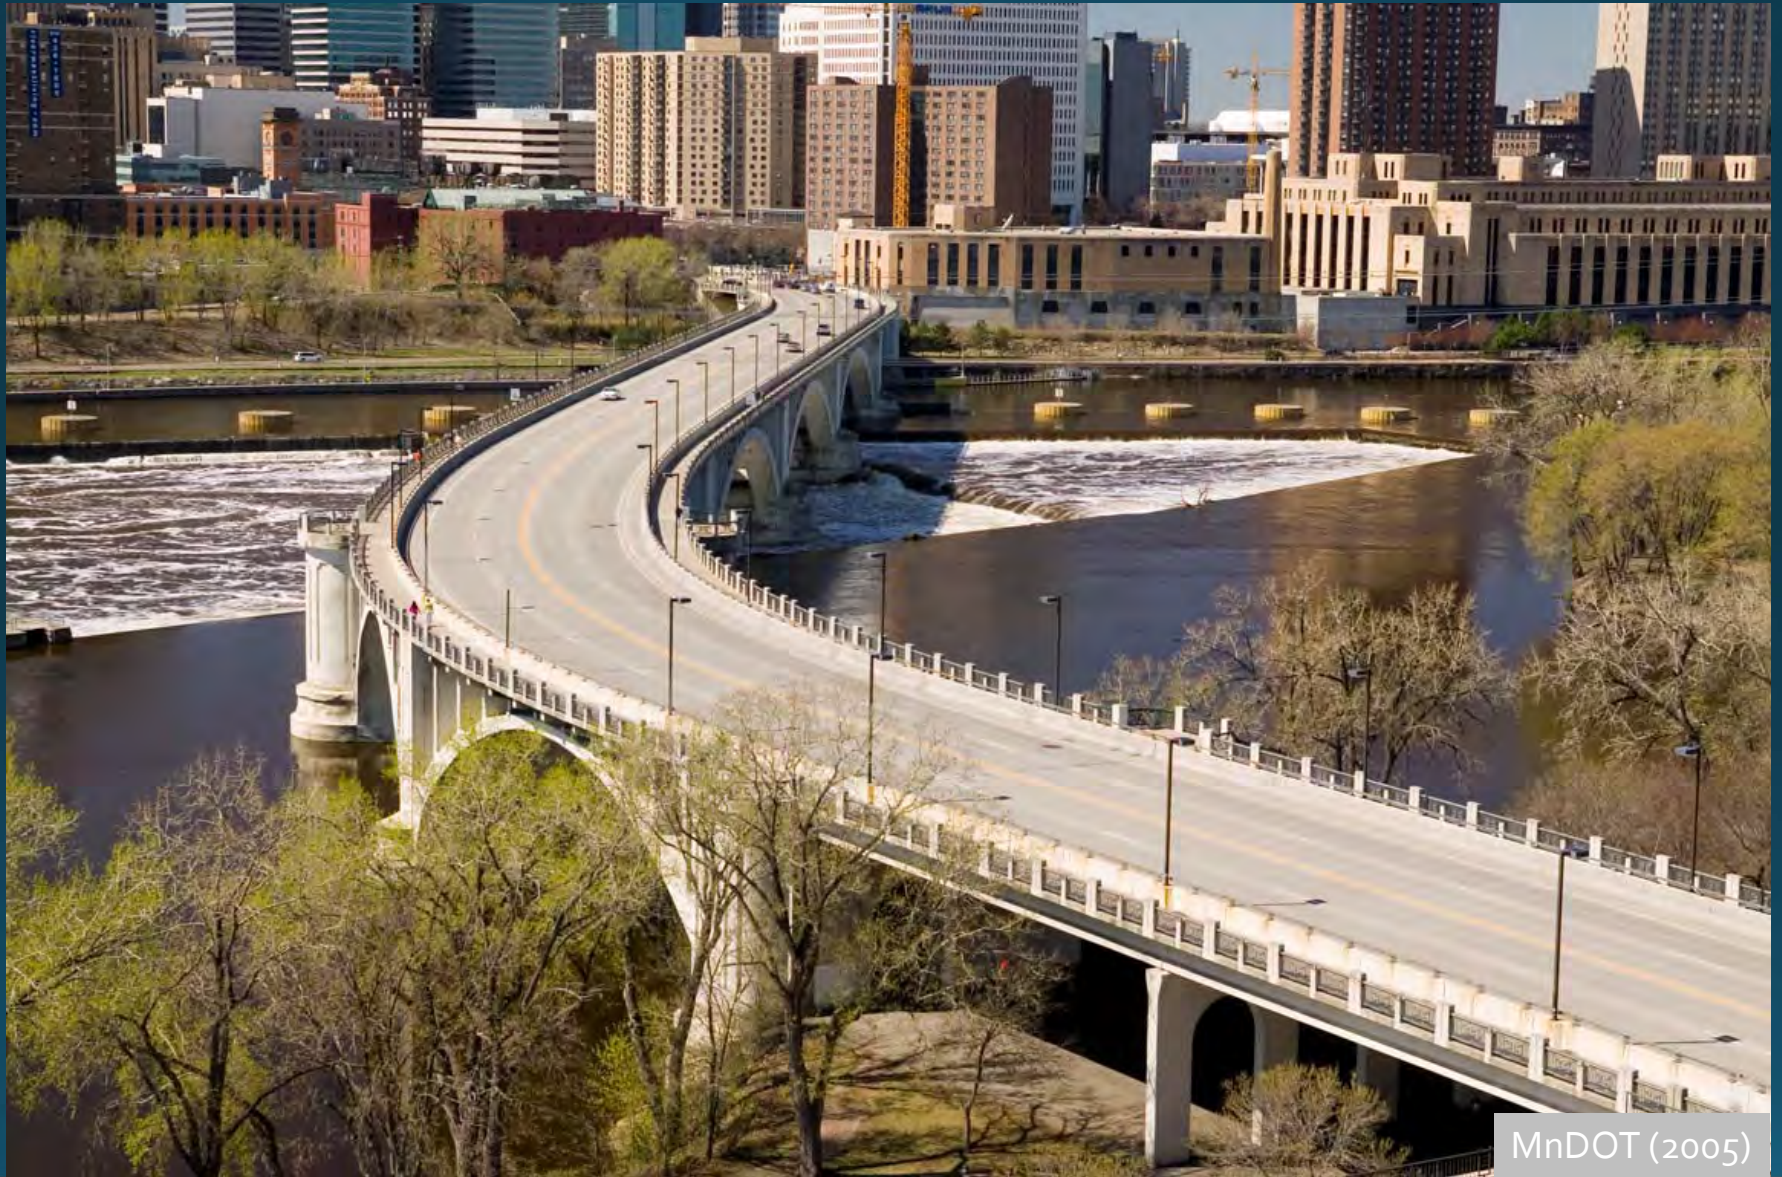
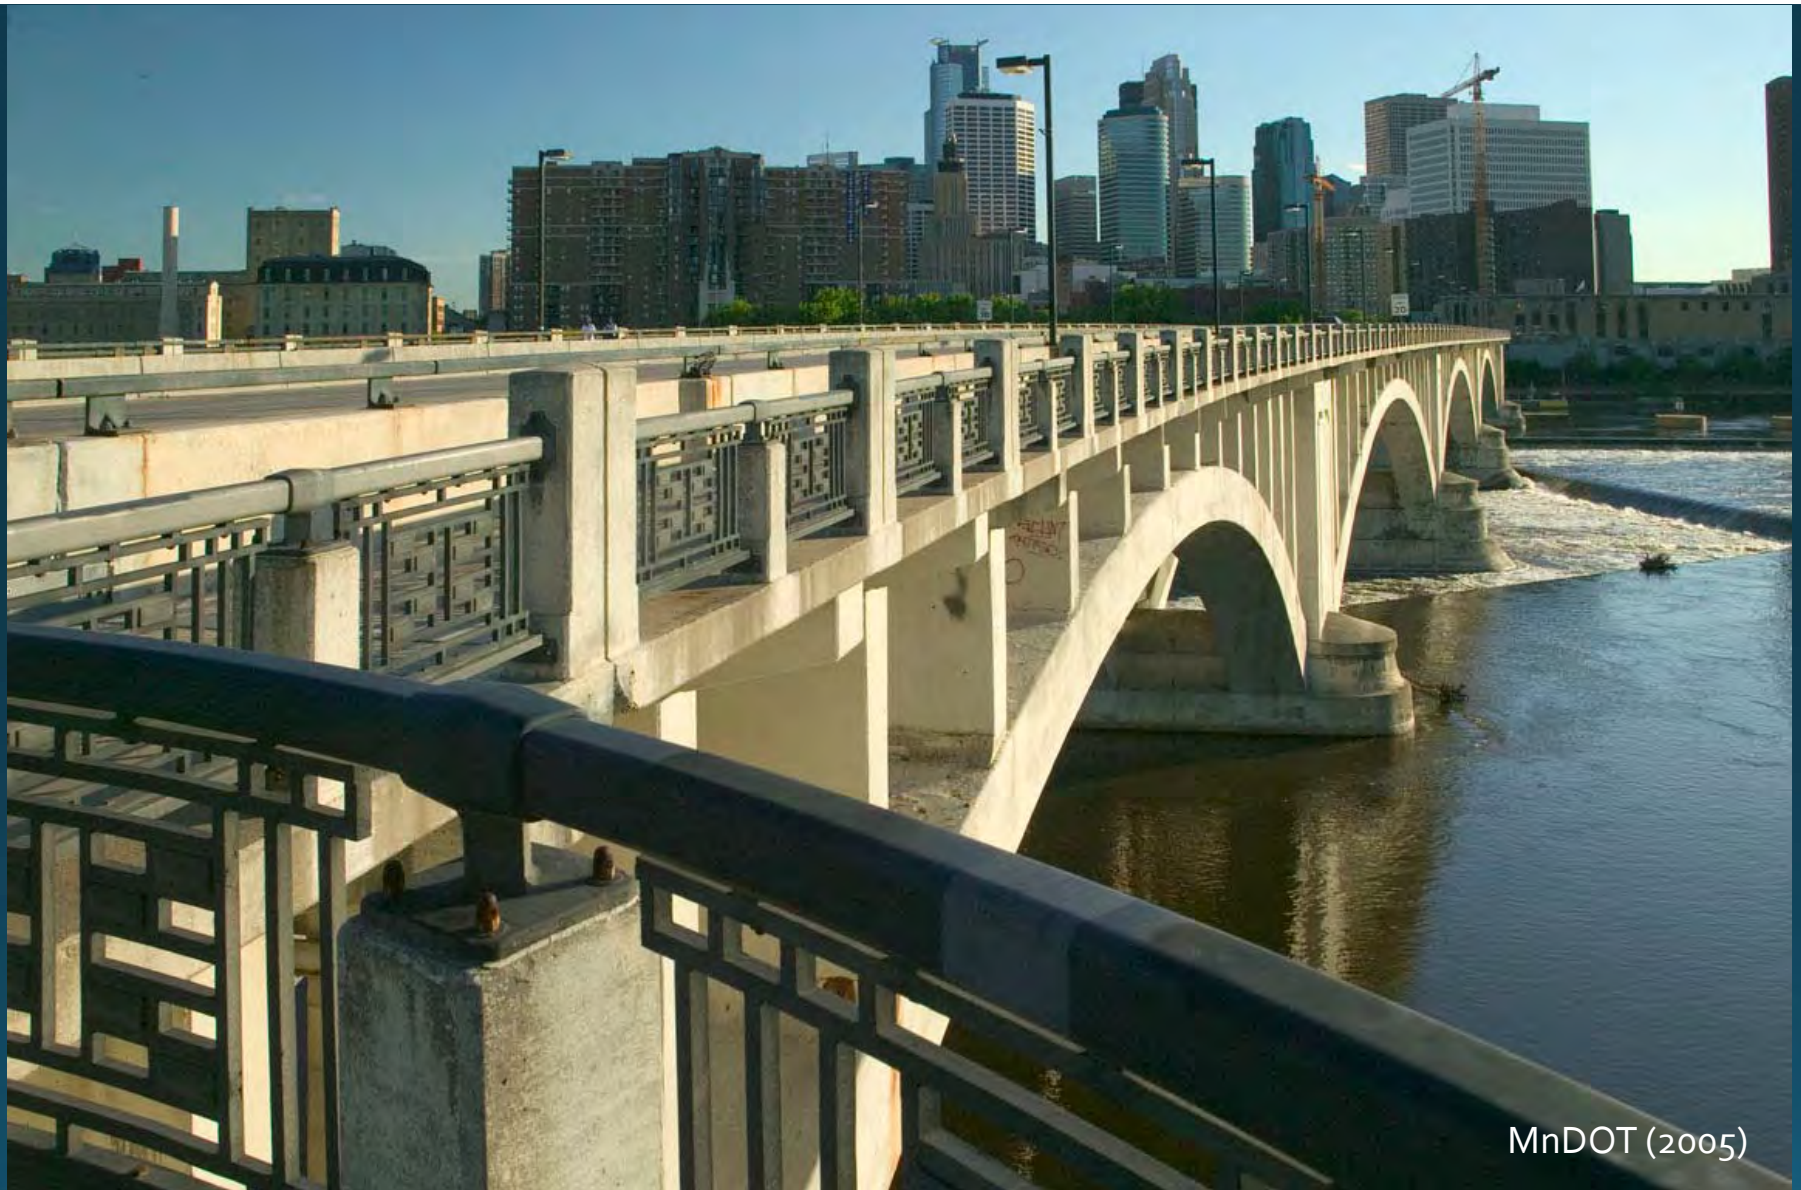
# Major Rehabilitation 2 (1978-1980)

13. Comments Started Aug. 1979, Comp.  
Nov. 1980 Johnson Bros. Const. -  
\$9,000,000 (complete deck removal,  
new lite standards, spandrel columns  
raised, roadway grade raised approx.  
5', new approach pavs, 1939 railing  
cleaned and reinstalled, some pier  
repair)

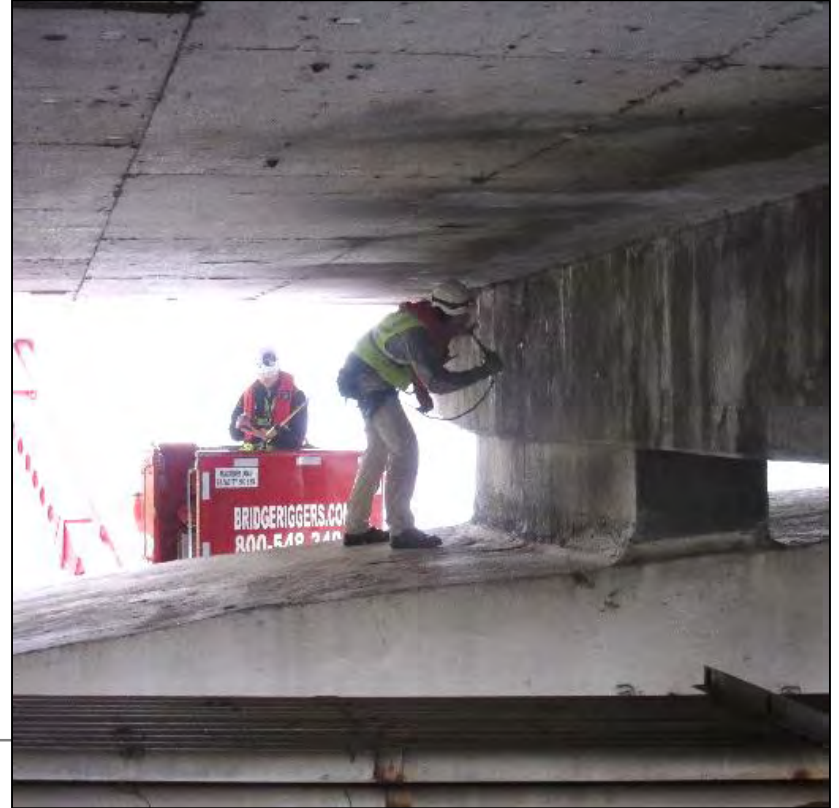
# In-Depth Element Level Bridge Inspection

- Close-up visual inspection and mechanical sounding of all exposed bridge surfaces
- Mapped all distress conditions on scaled drawings
- Documented condition state information according to MnDOT Bridge Inspection Field Manual

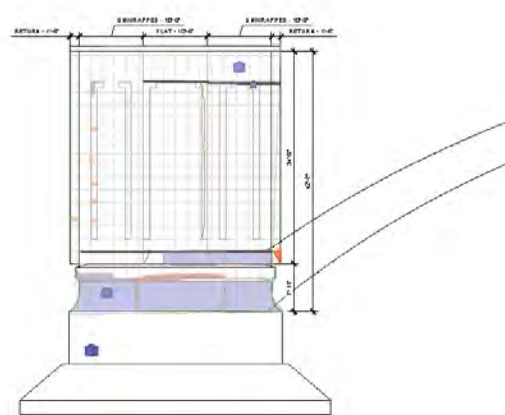
2 ARCH PIER 1 - DOWNSTREAM WALL - EXTERIOR FACE  
SCALE 1/8" = 1'-0"

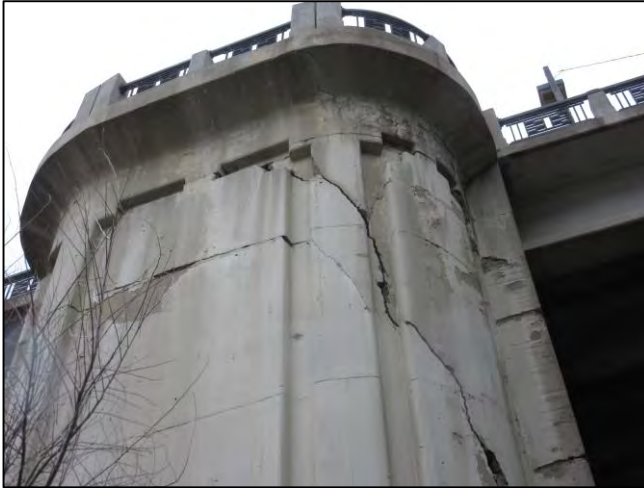
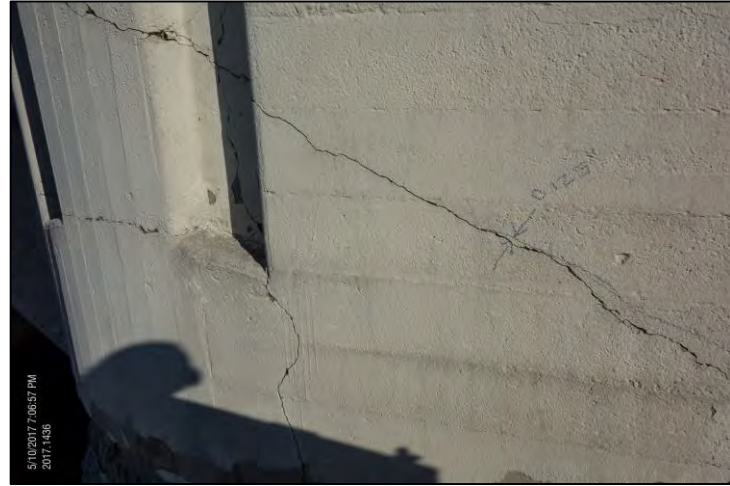
In addition to the deterioration conditions described above, the inspection identified several conditions of significant structural distress caused by unintended volume change movement of the deck and superstructure when subjected to thermal changes. These conditions included the following:

- Pier 8 - Very wide diagonal shear cracking, sliding along horizontal construction joint, fractured and bent reinforcing steel across joint
- Pier 1 - Wide vertical and diagonal shear cracking
  - Spandrel columns and walls, particularly below expansion joints - Structural distress at bases, including wide cracking, diagonal shear cracking, and delamination and spalling, sometimes severe
  - Cap beams below expansion joints - Deep spalling along top corners and shear or torsional cracking
  - South abutment - Missing and fractured anchor bolts at fixed bearings

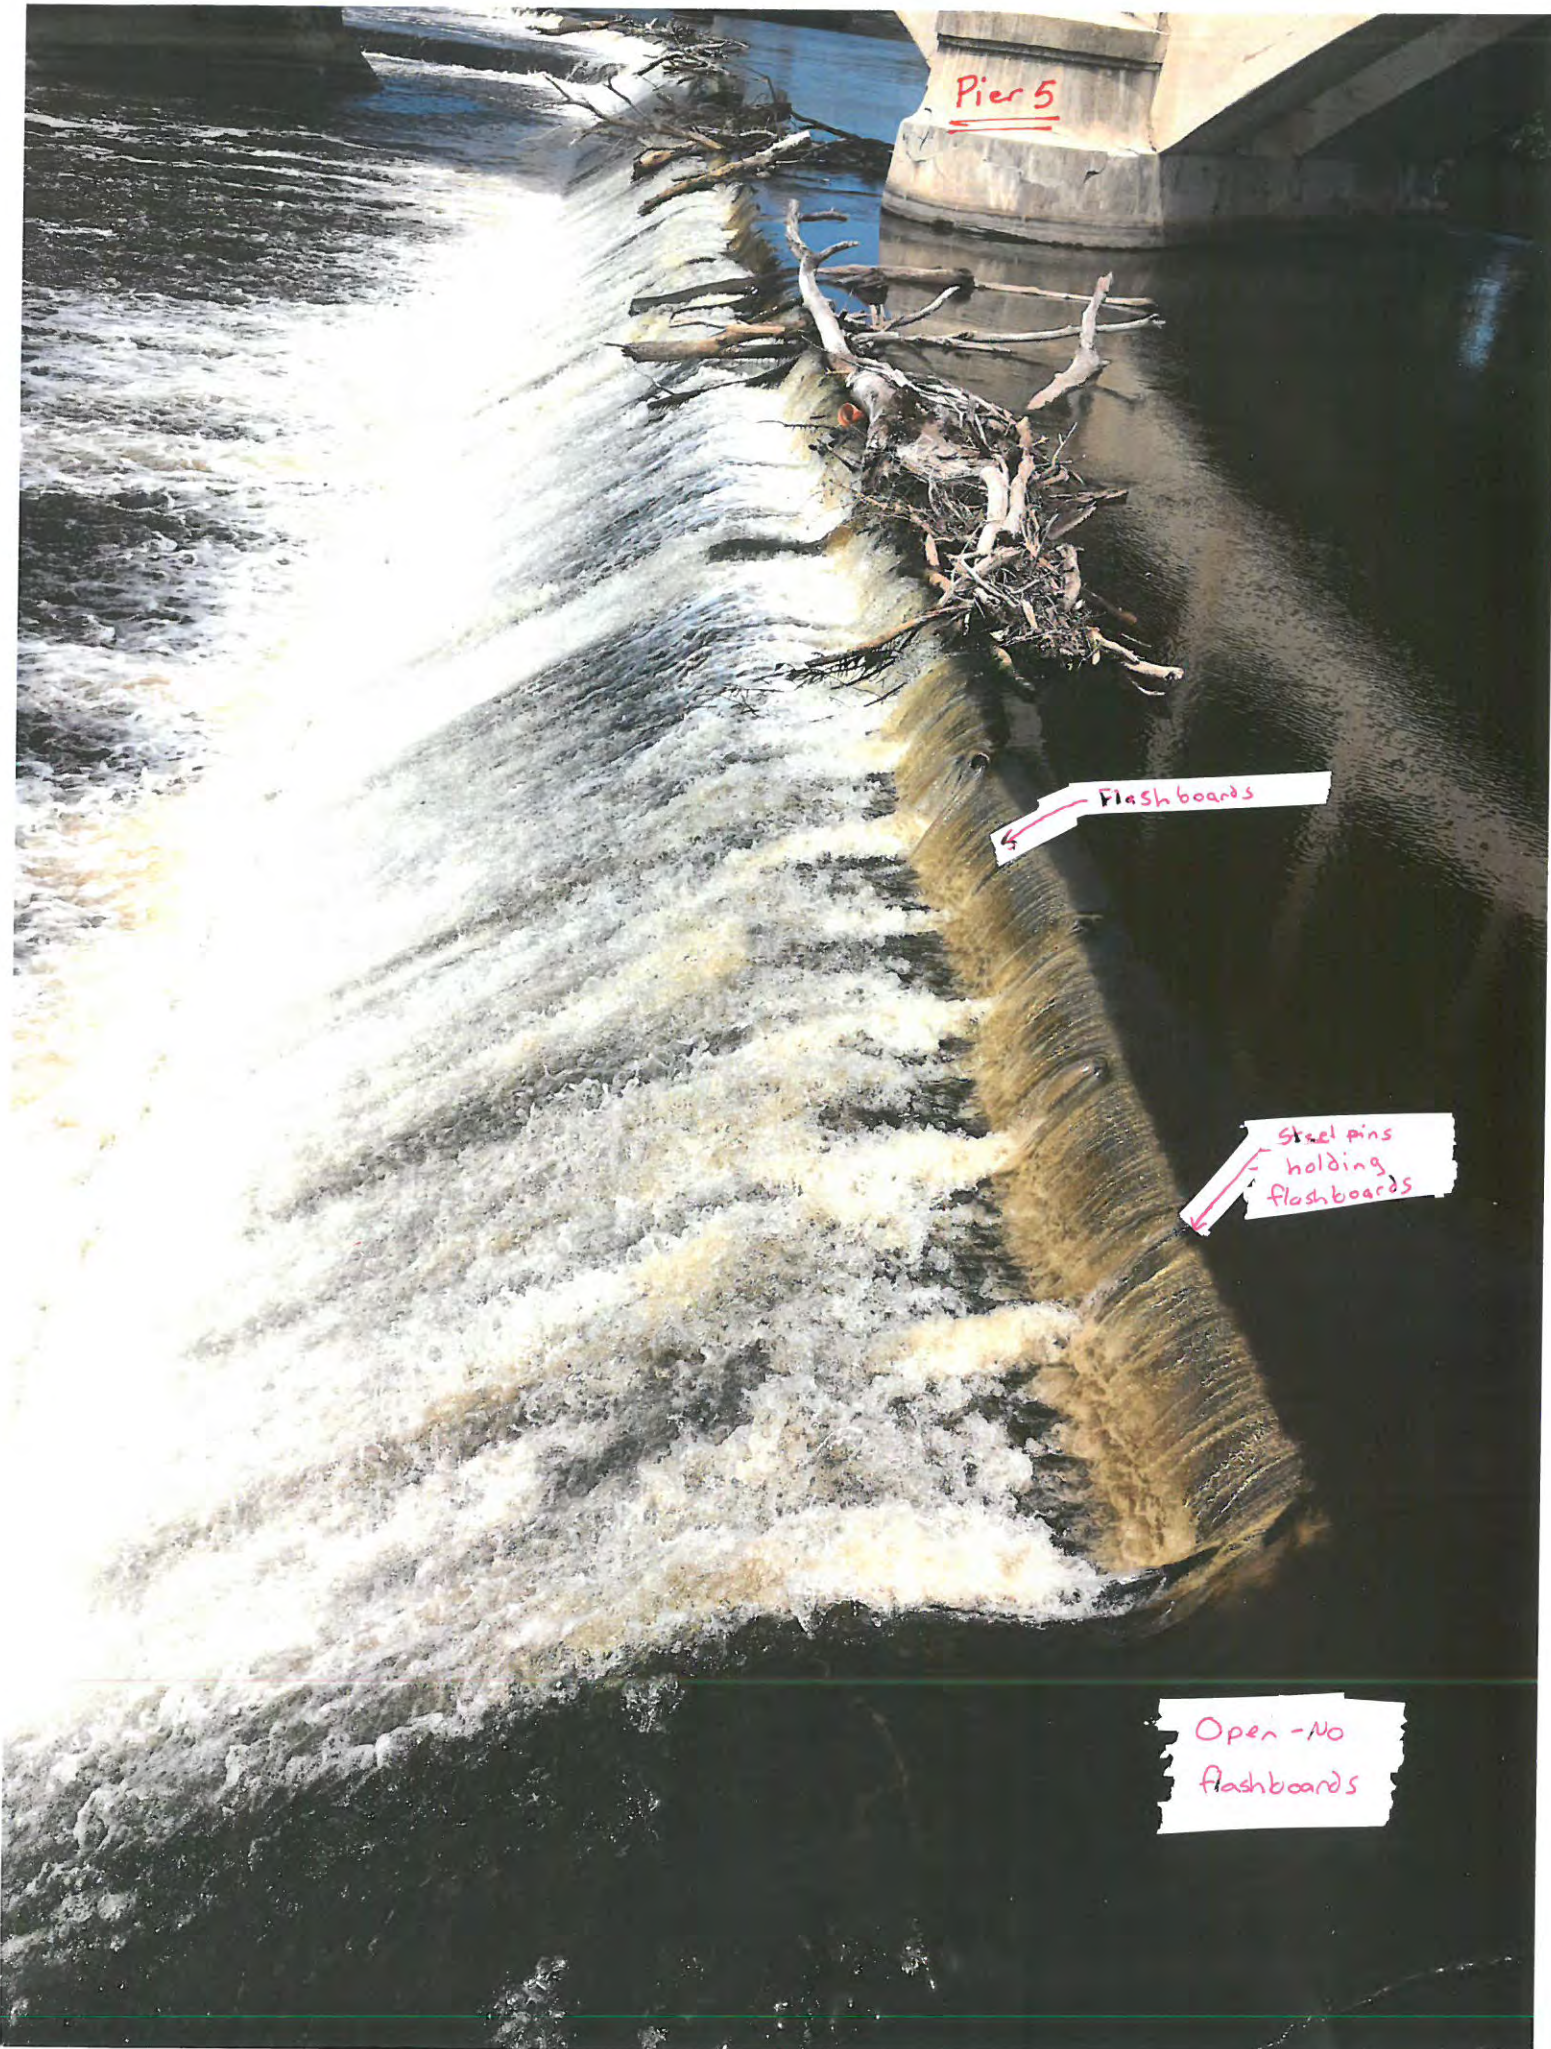
Pier 5

Flash boards

Steel pins  
holding  
flashboards

Open - No  
flashboards

2. Xcel to keep 100 cfs moving over the spillway. This is equivalent to about 1 inch of water over the flashboards.
3. "Flashboards" – are placed on the top side of the spillway to keep water elevation above intakes upstream for Xcel Riverside Plant and other city water intakes. When the water gets between 18" – 24" above flashboards, they are designed to bend over. Once this happens they do not come back up and need to manually be repaired. The flashboards are approximately 2.5 feet tall. See pictures at end of minutes

13. The target water elevation for Xcel to change out the flashboards is when the water is 6 inches below the bottom of the flashboards where they are founded on timbers that make up the spillway.

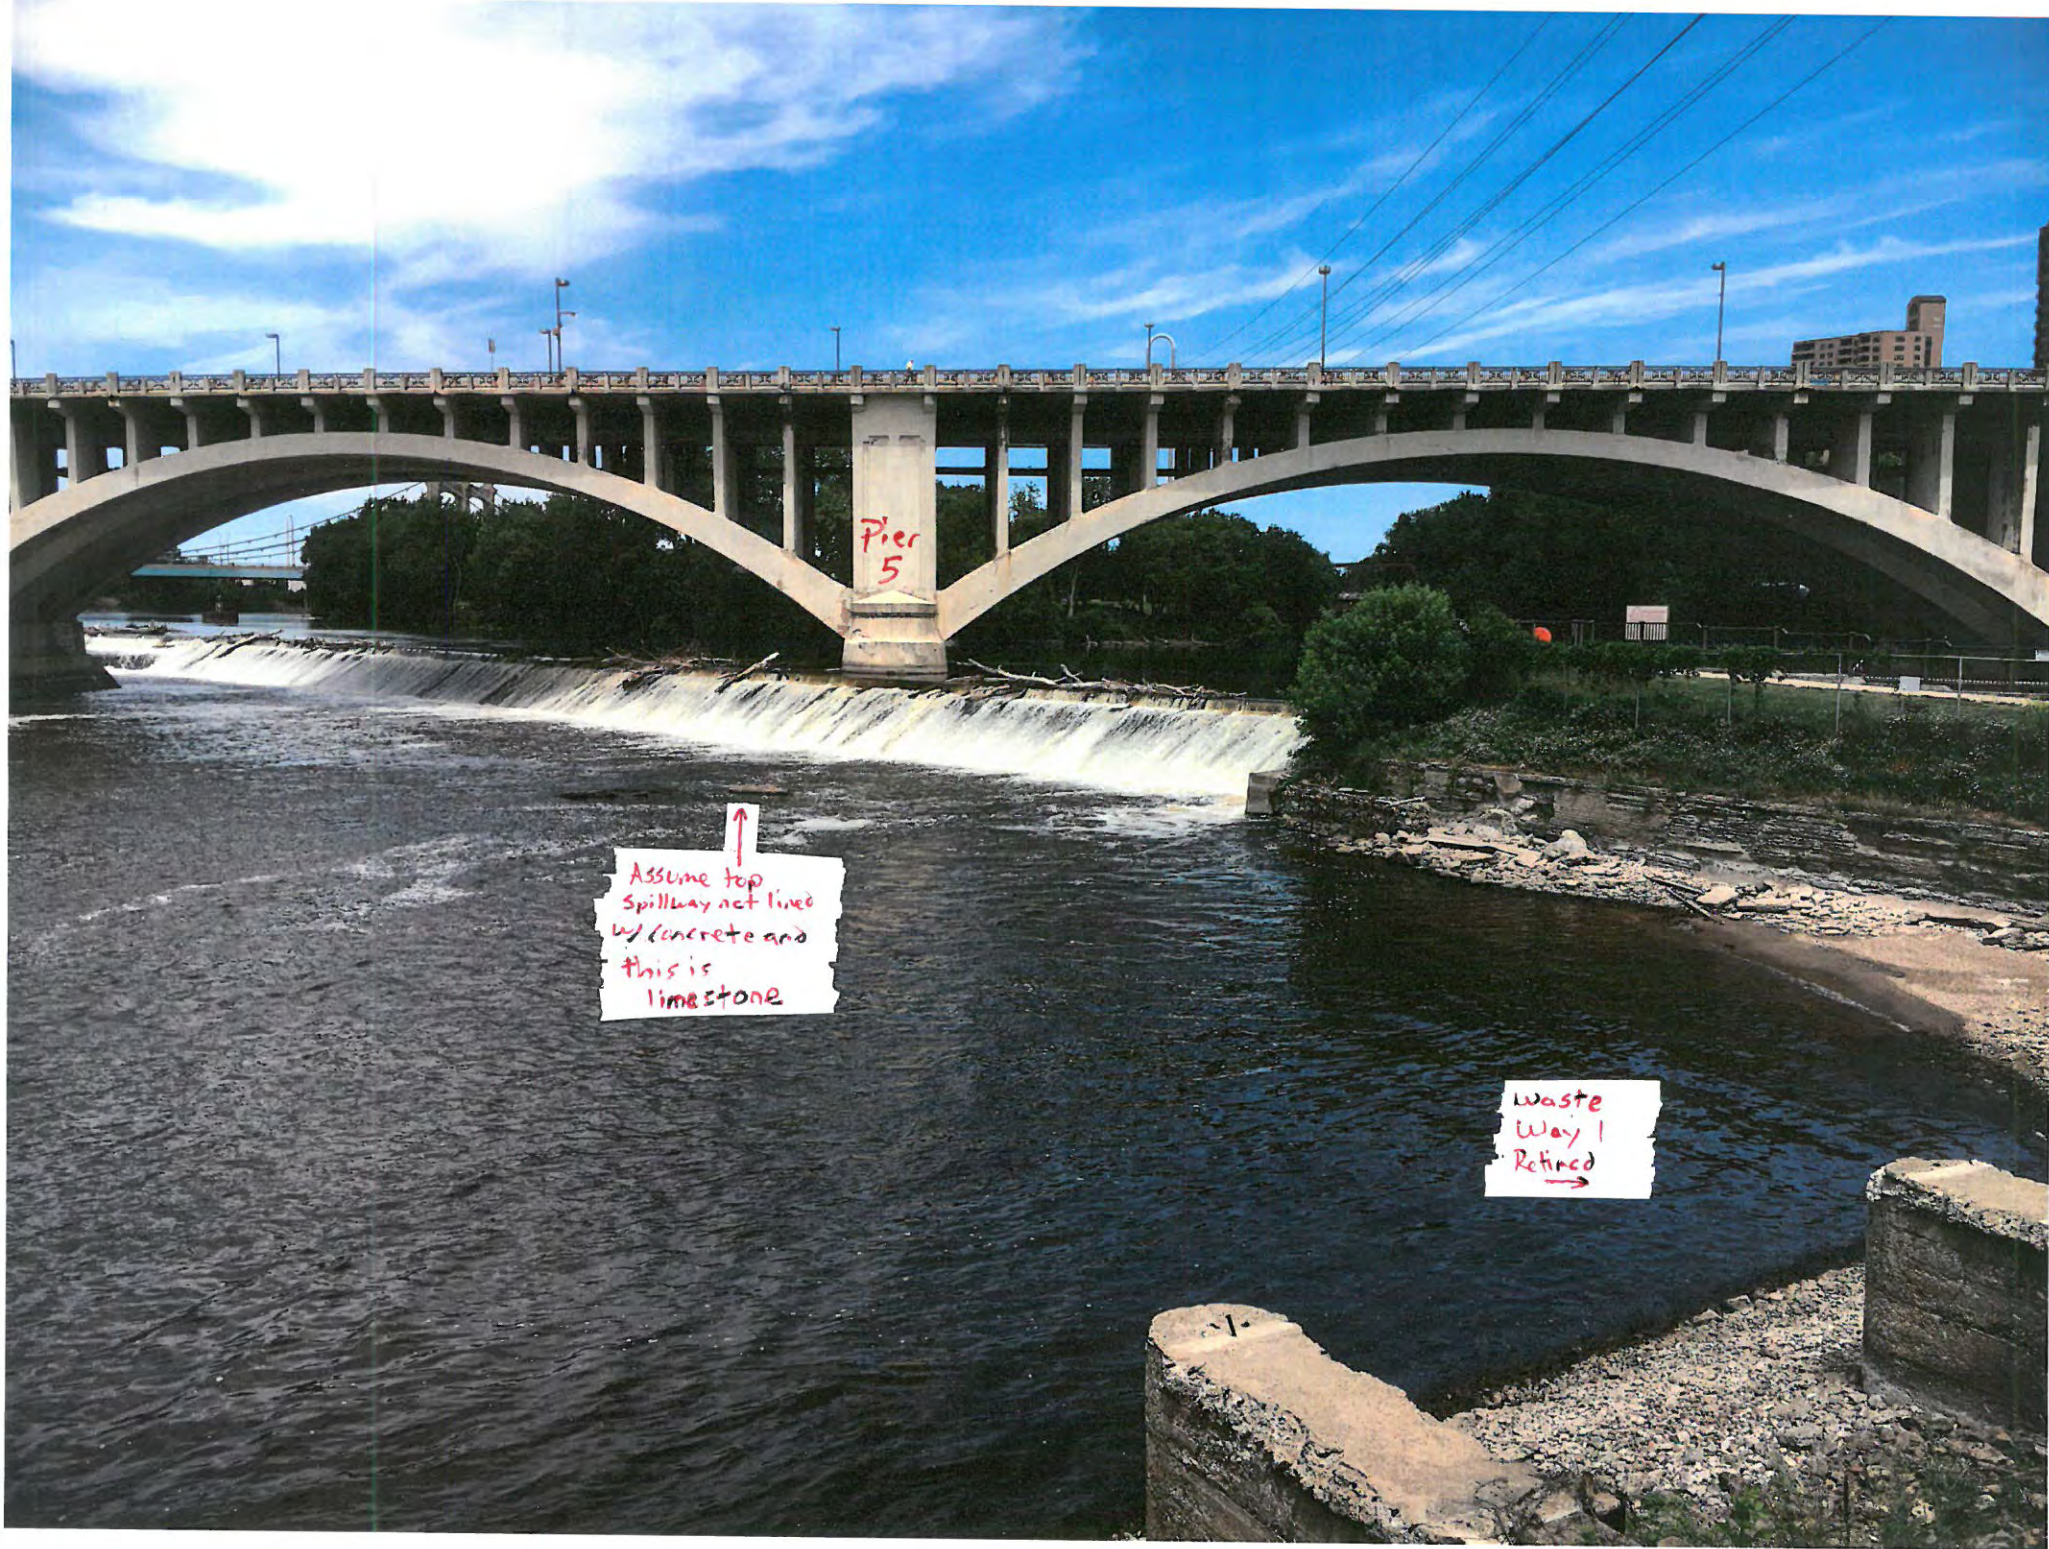
Pier  
5

↑  
Assume top  
Spillway not lined  
w/ concrete and  
this is  
limestone

Waste  
Way 1  
Retired  
→

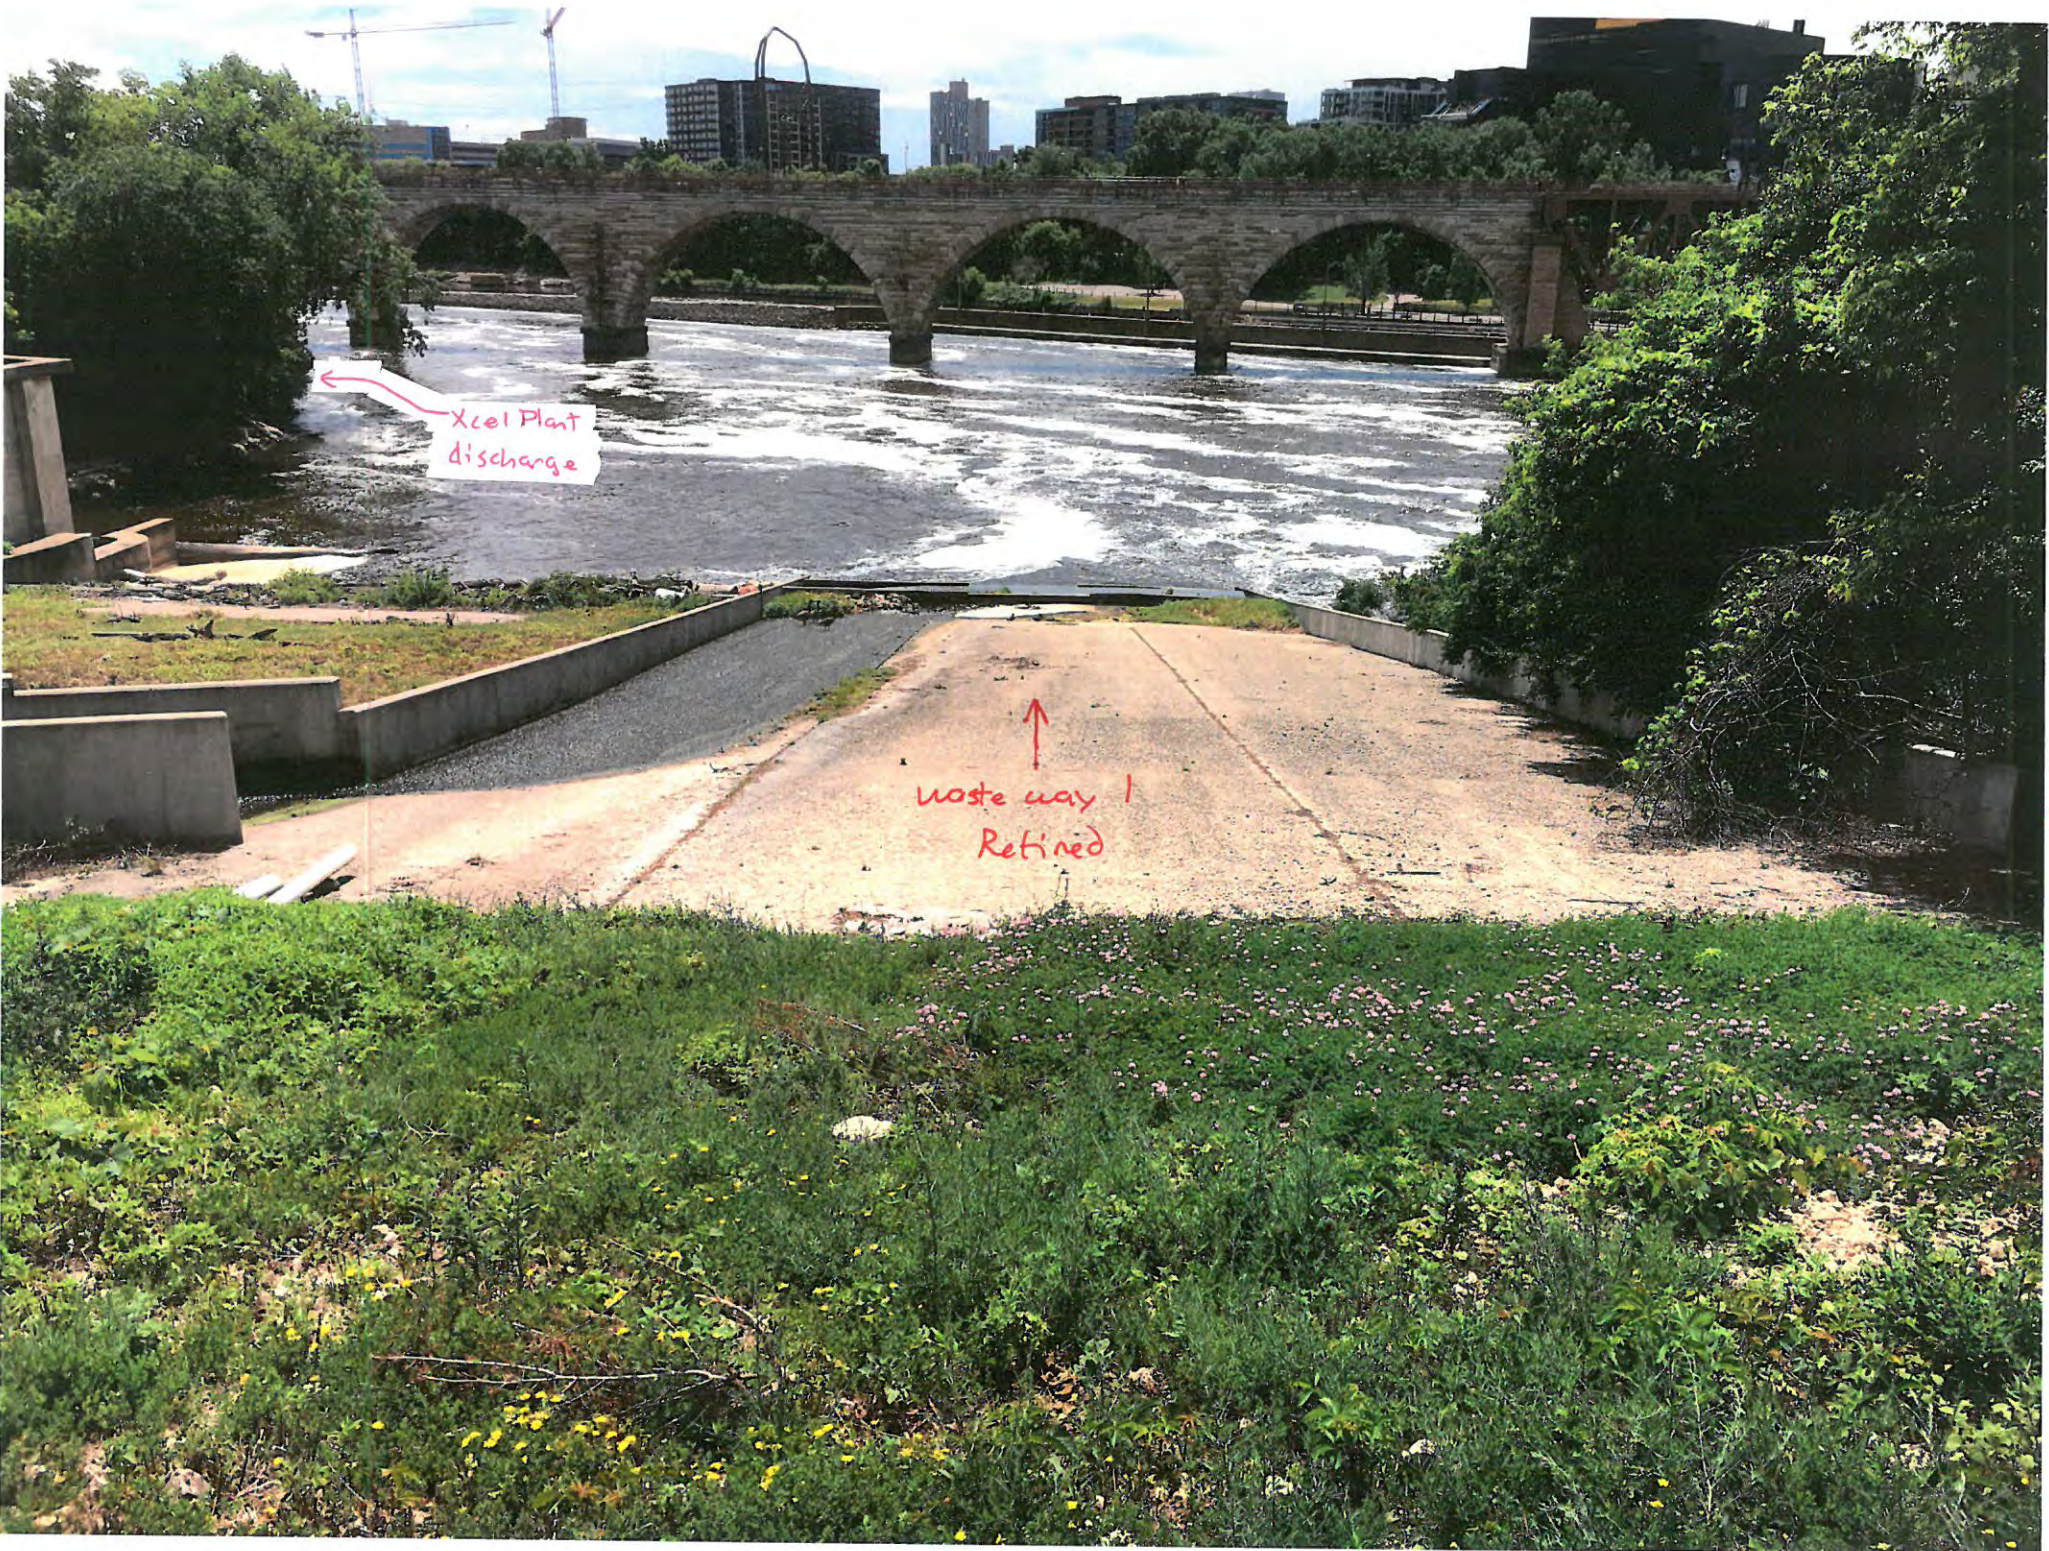
Xcel Plant  
discharge

↑  
waste way 1  
Retined

location of stop  
logs that can  
be removed

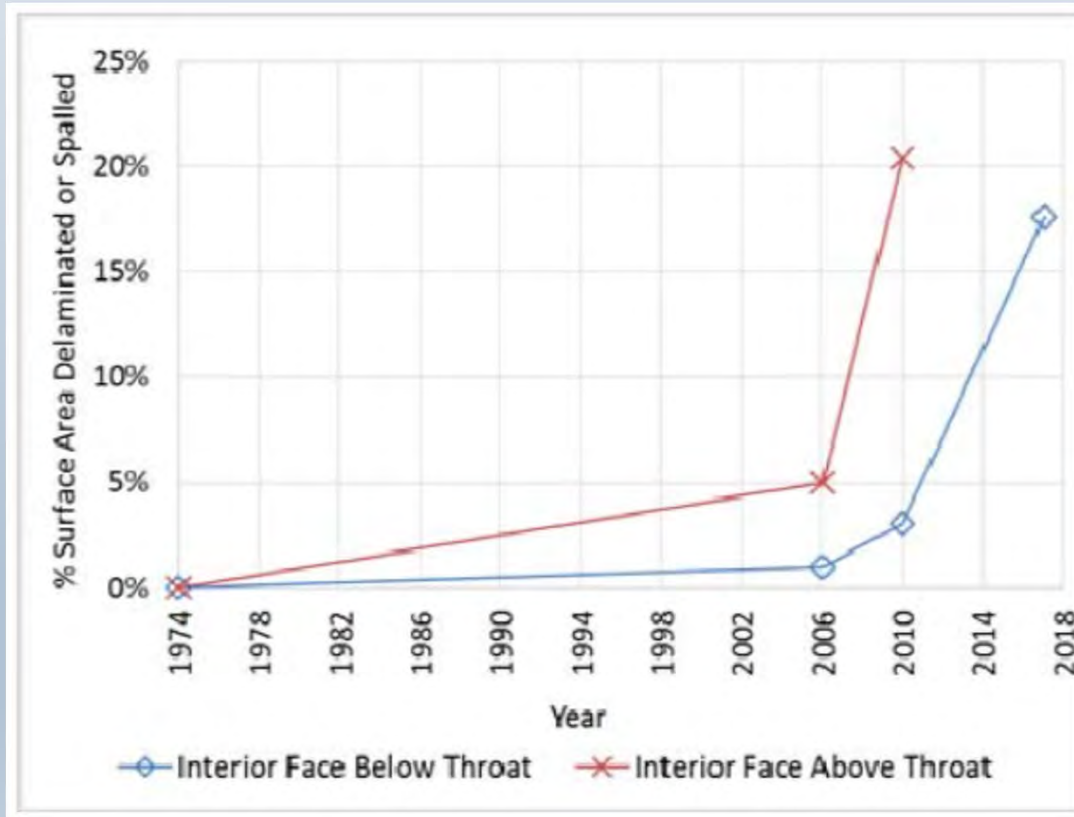
Rehabilitation Alternatives Definition - 25 year condition evaluation - Spandrels / Walls – At current joint:

- Sample curve of damage progression from chlorides

3. Low end of current deterioration state or limit for repair considers extent of chlorides and carbonation noting as elements with chlorides age a point is reached where deterioration increases rapidly, see graph in slides.

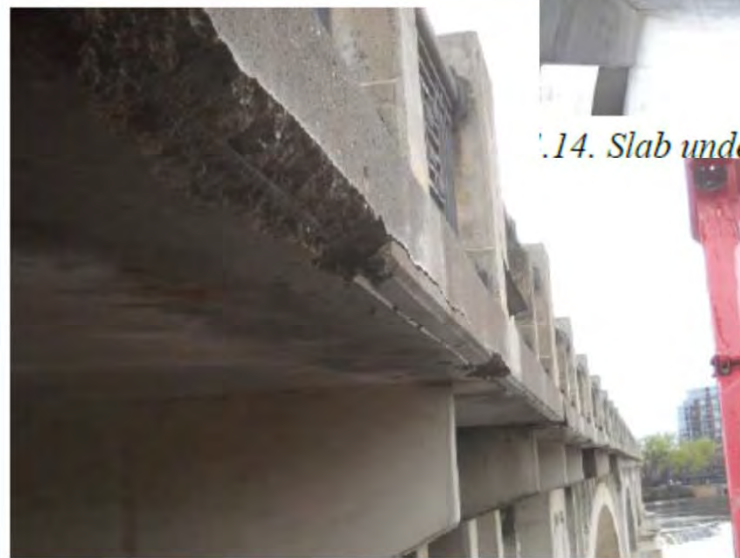
Figure 4.10. Downstream deck edge condition.

- 25 year - Minimum work to achieve 25 years
- Full depth deck repairs photos:
