**3<sup>rd</sup> Ave Bridge 2440 CMGC Kick-off Meeting Agenda – January 23, 2018**

S.P. 2710-47 TH 65 (3rd Avenue Bridge)  
CMGC Kick-Off Meeting  
January 23, 2018

## Bridge 2440 – Historic Bridge Management Plan

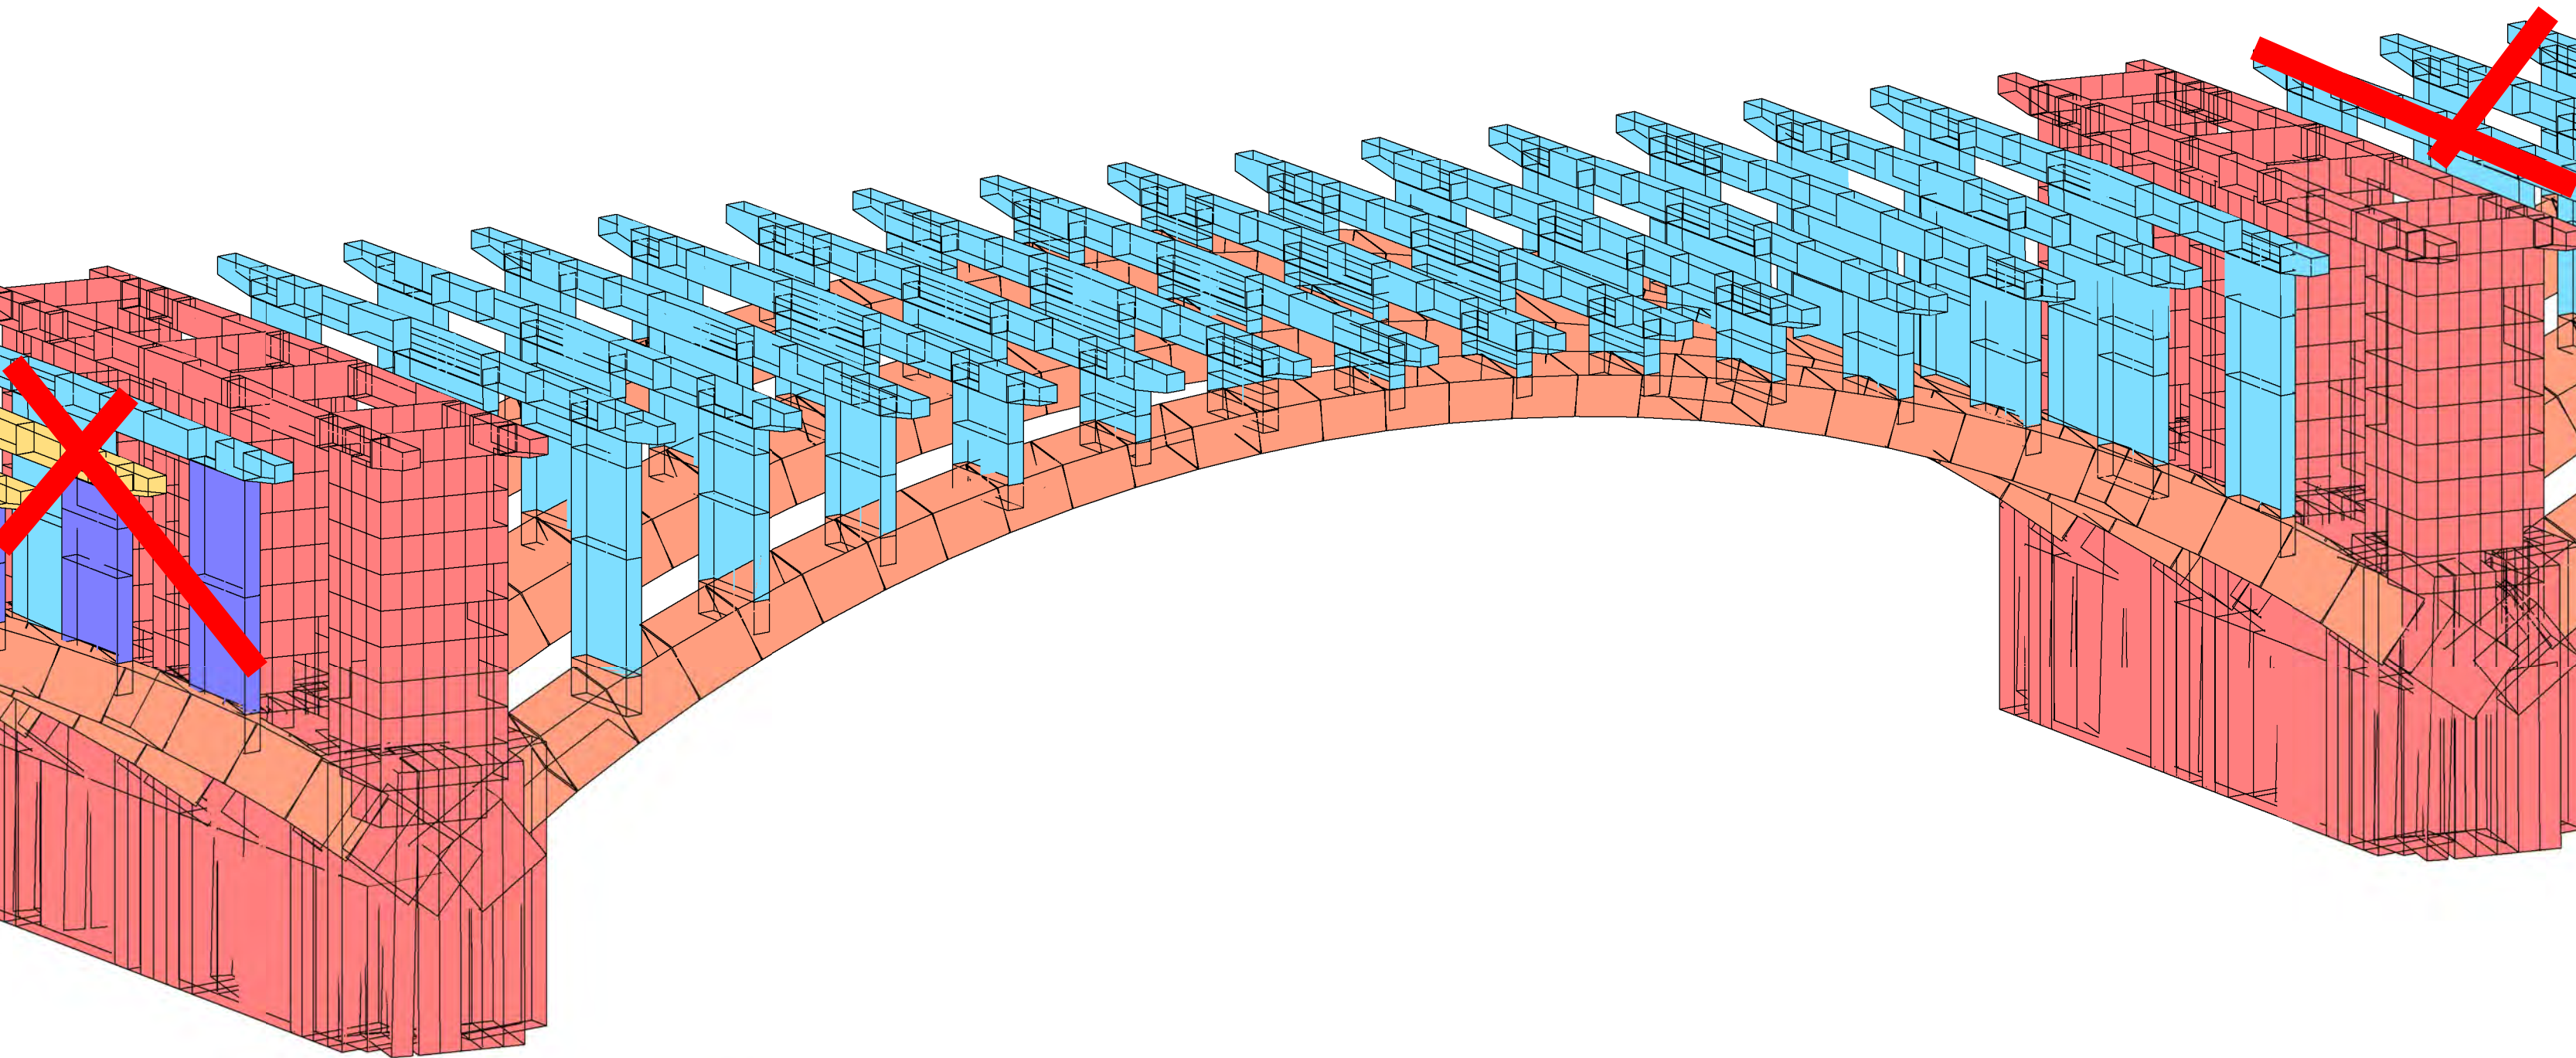
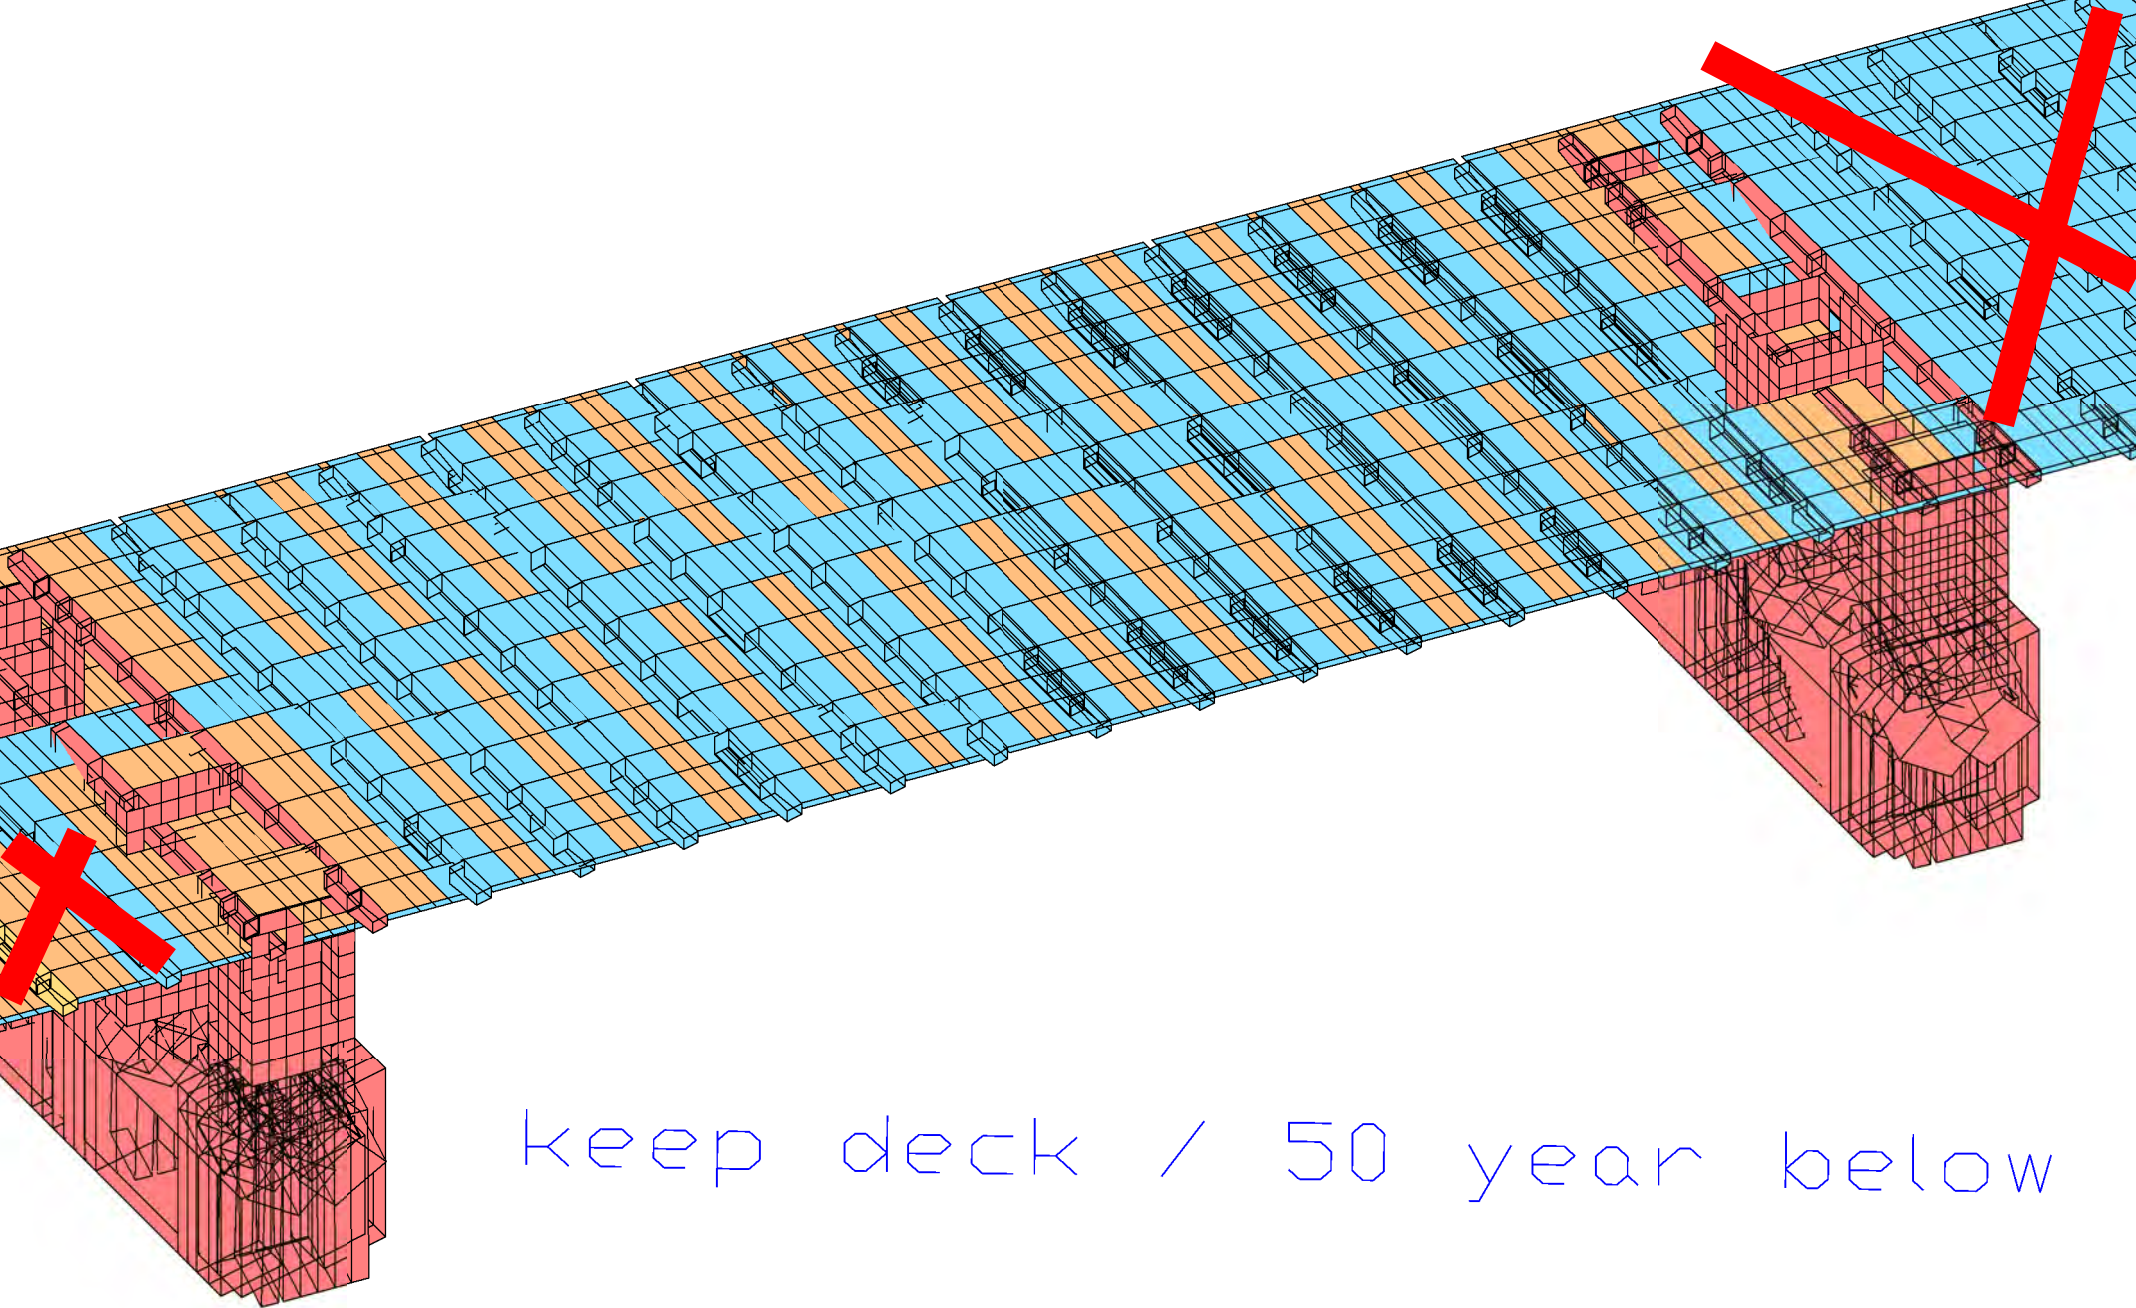
keep deck / 50 year below

- 25 year - keep deck / 50 year repair below deck – See 50 year minimum graphic
  - Full depth deck repairs:
    - 2 ft downstream edge (results in ornamental railing removal)
    - Piers 1, 6 and 8 – upstream 1/3 of deck for manholes
    - 3 ft longitudinal center joint
    - At each cap beam to replace caps/columns for 50-yr fix
    - Mill & overlay

7. This option does not replace the deck and thus the shared use paths will not be changed/widened.
- iii. Keep deck, 50-year repair below deck
1. The 25-year project with a 50-year repair below the deck (i.e. trying to keep the deck) was discussed. The 50-year repair below the deck is discussed and defined later. This option is an effort to focus costs on repairing and protecting the historic elements but results in a lot of deck removal to access the removed items below deck.

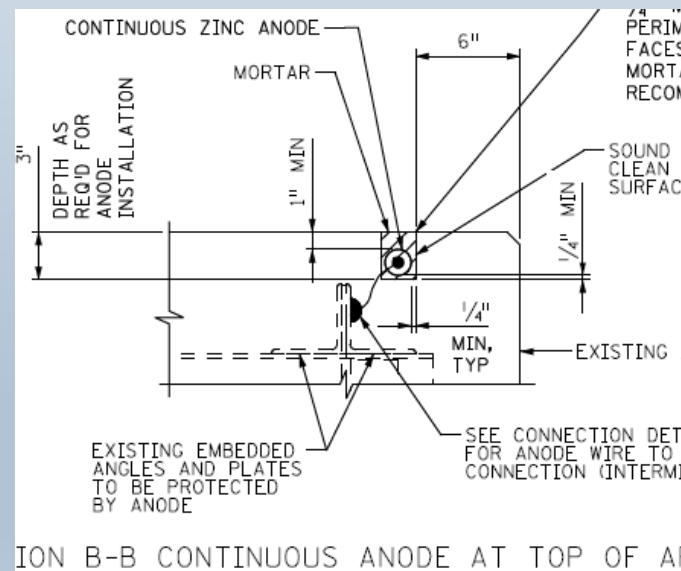
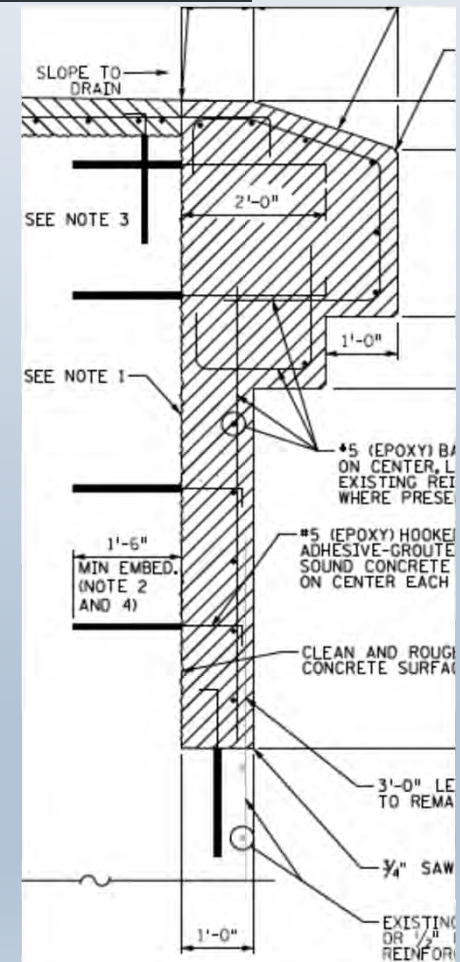
- Rehabilitation Alternatives Definition – Work common to all
  - 50-yr service life repairs on:
    - Piers from deck to water line (and possibly below)
    - Arch ribs and barrel arches
      - Execute surface repairs to all unsound concrete on all arch rib surfaces (details similar to Franklin Avenue).
      - Install zinc strip anodes along all four corners of arch ribs in regions between concrete corner repairs (details similar to Franklin Avenue where ongoing monitoring has verified good performance).
      - Repair longitudinal cracks on top surface (elastomeric sealant).
      - Apply high performance water resistant coating to all surfaces.
  - Piers 1 & 8 (repair cracks)

- Rehabilitation Alternatives Definition – Work common to all
  - Sample 50-yr service life repairs:

- ii. Arches and piers will receive a 50-year repair. Pier repairs will be around the full perimeter of the pier and will not be limited to only at the connection of arches to piers.

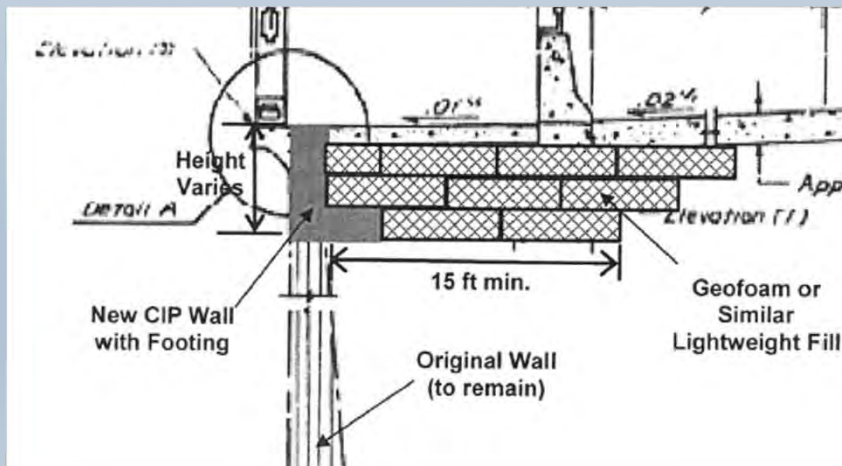
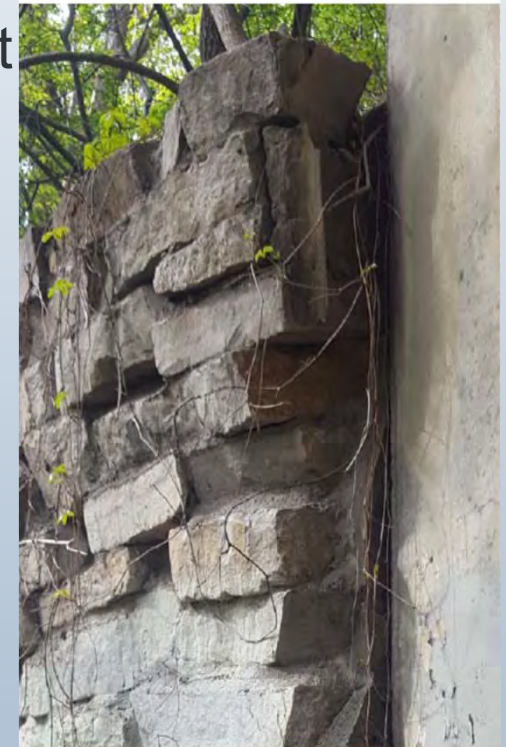
- Rehabilitation Alternatives Definition – Work common to all
  - Stabilize downstream masonry wall at S abut
  - Install drains in N 1918 walls
  - Remove N abut enclosure, repair drains
  - Repair S abut drains
  - Replace top N 1918 walls, repair walls

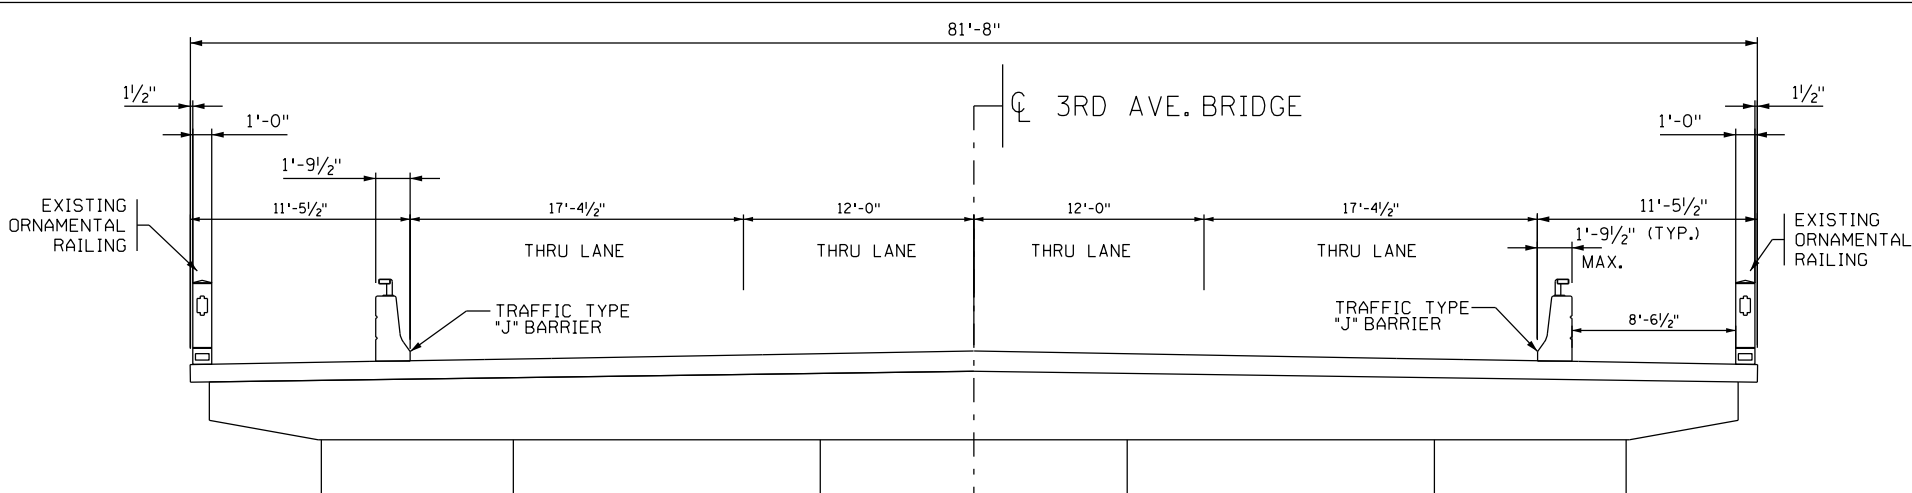
EXISTING TYPICAL CROSS SECTION - ARCH SPANS

- Rehabilitation Alternatives Definition – Work common to all
  - Approach bridges
    - Repair all unsound concrete
    - Replace bearings / anchor rods
    - Repair ends of concrete beams for shear
  - Coat all bridge

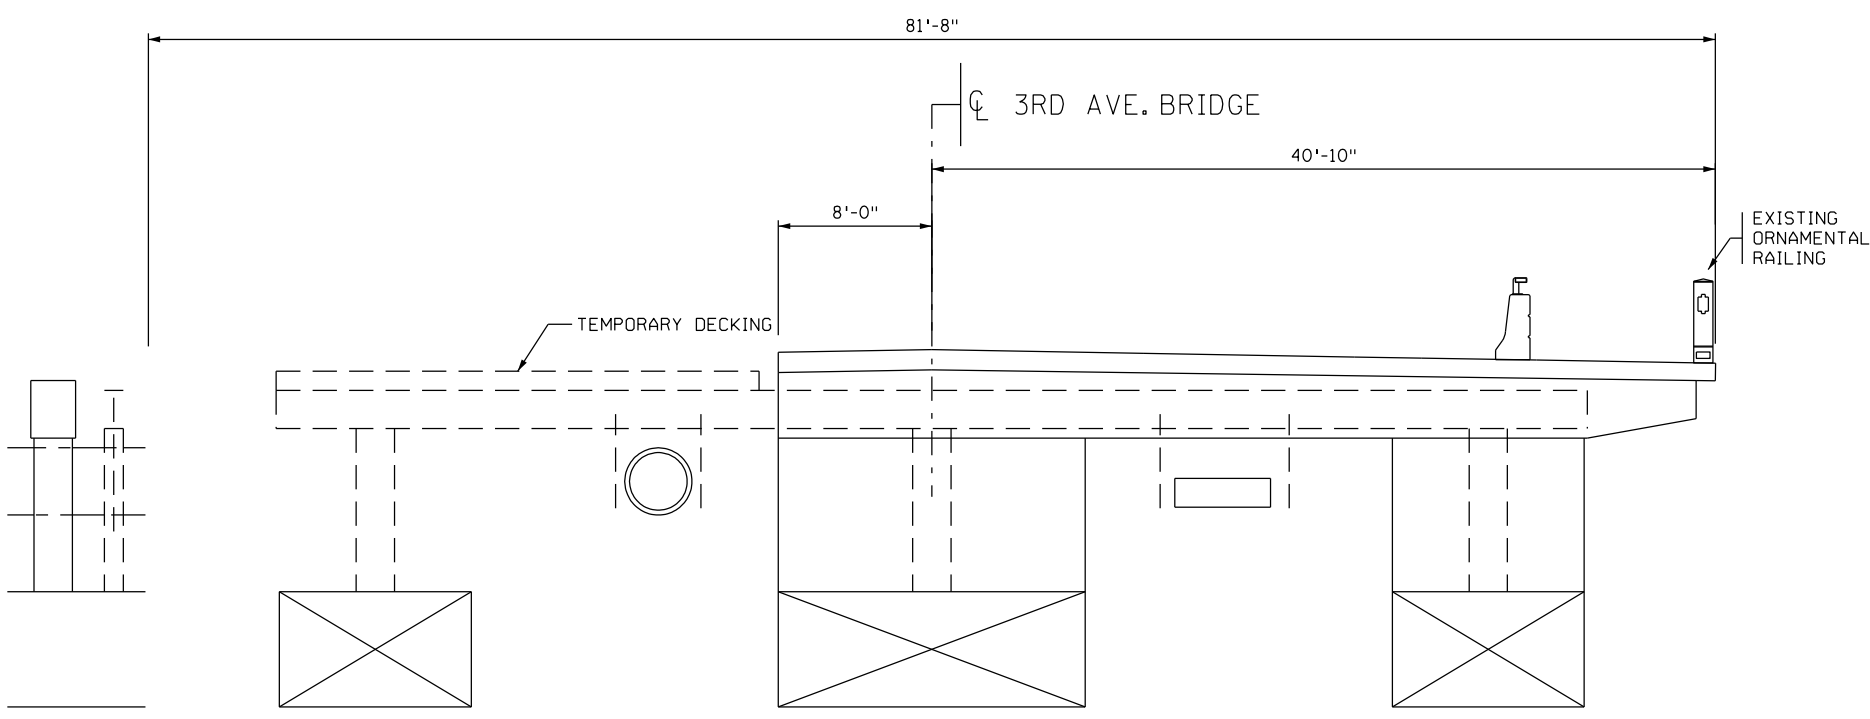
STAGE 2: INSTALL TEMP. WORKS TO SUPPORT UTILITIES

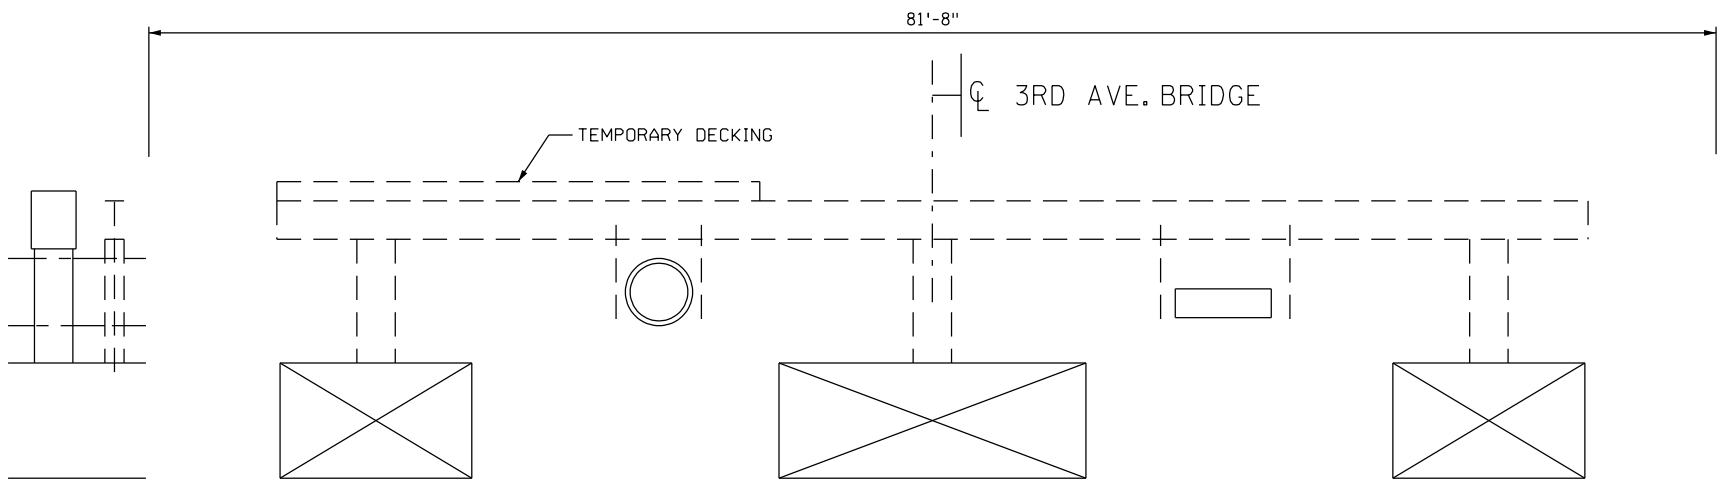
STAGE 3: REMOVE DOWNSTREAM CAP & COLUMN,  
INSTALL TEMP. DECKING

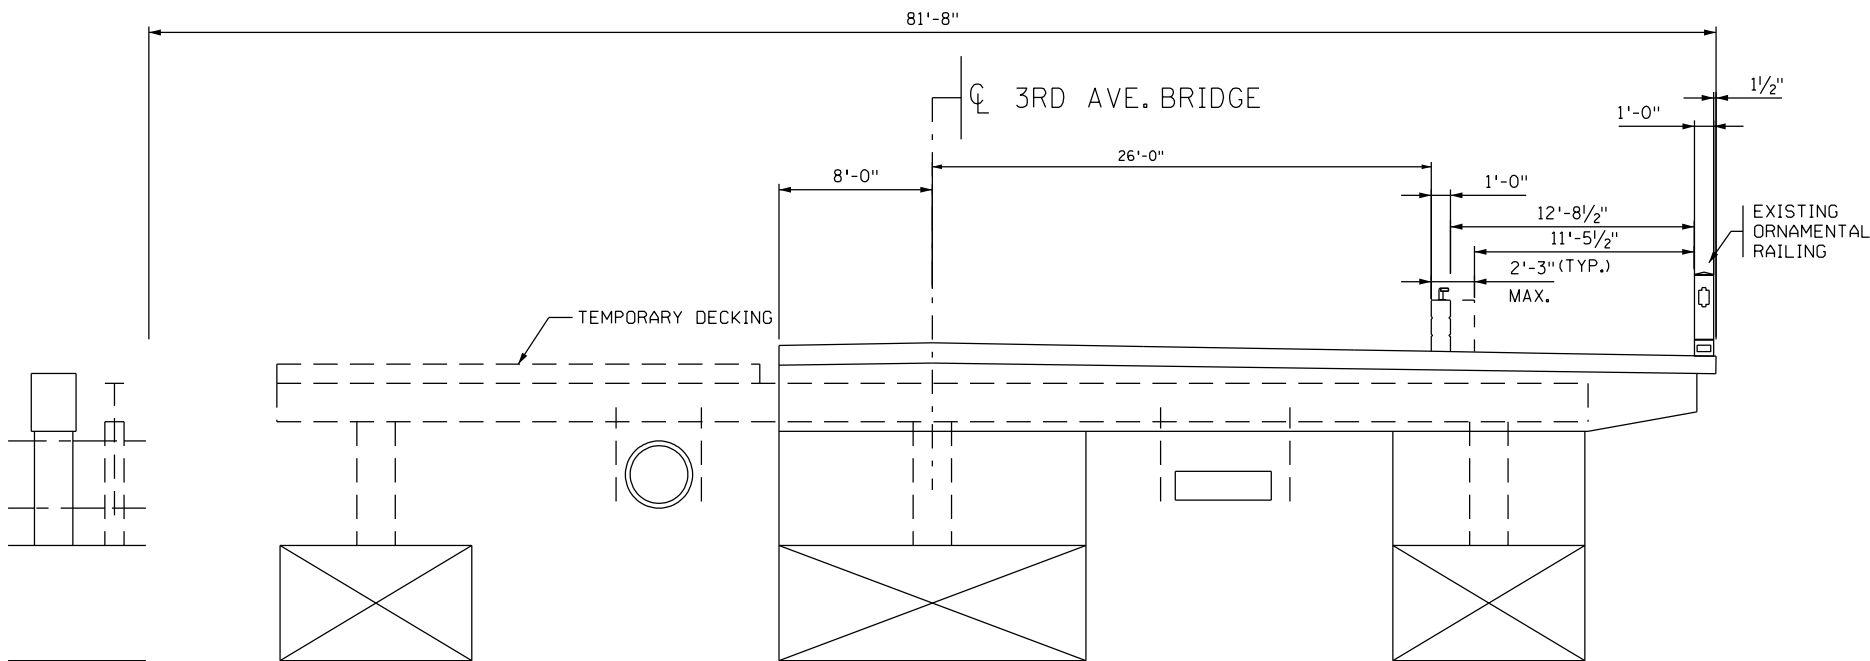
STAGE 4: REMOVE REMAINING CAP & COLUMNS

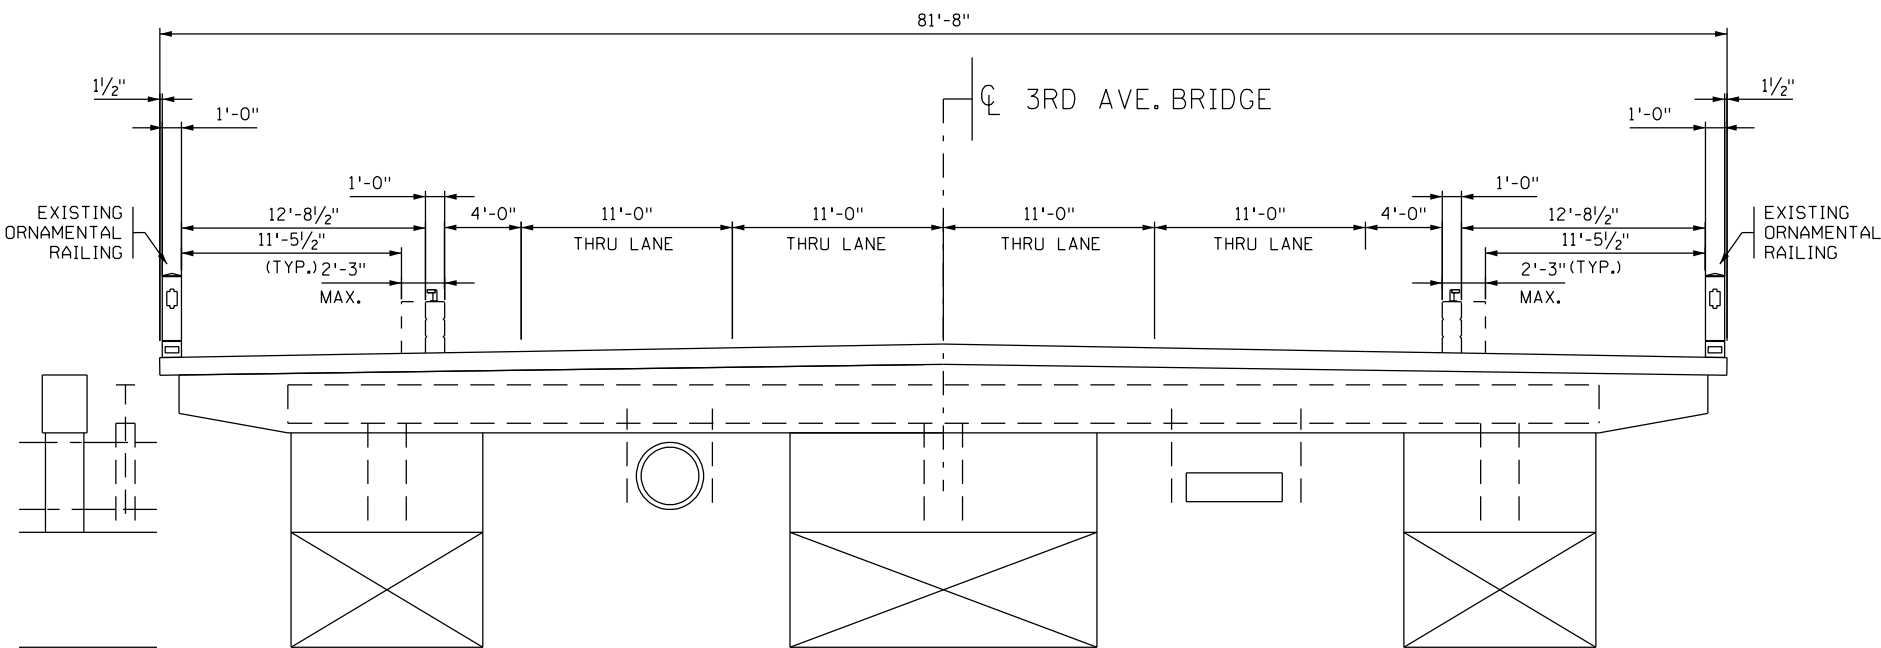
STAGE 5: INSTALL NEW CAP, COLUMNS, DECK & BARRIERS

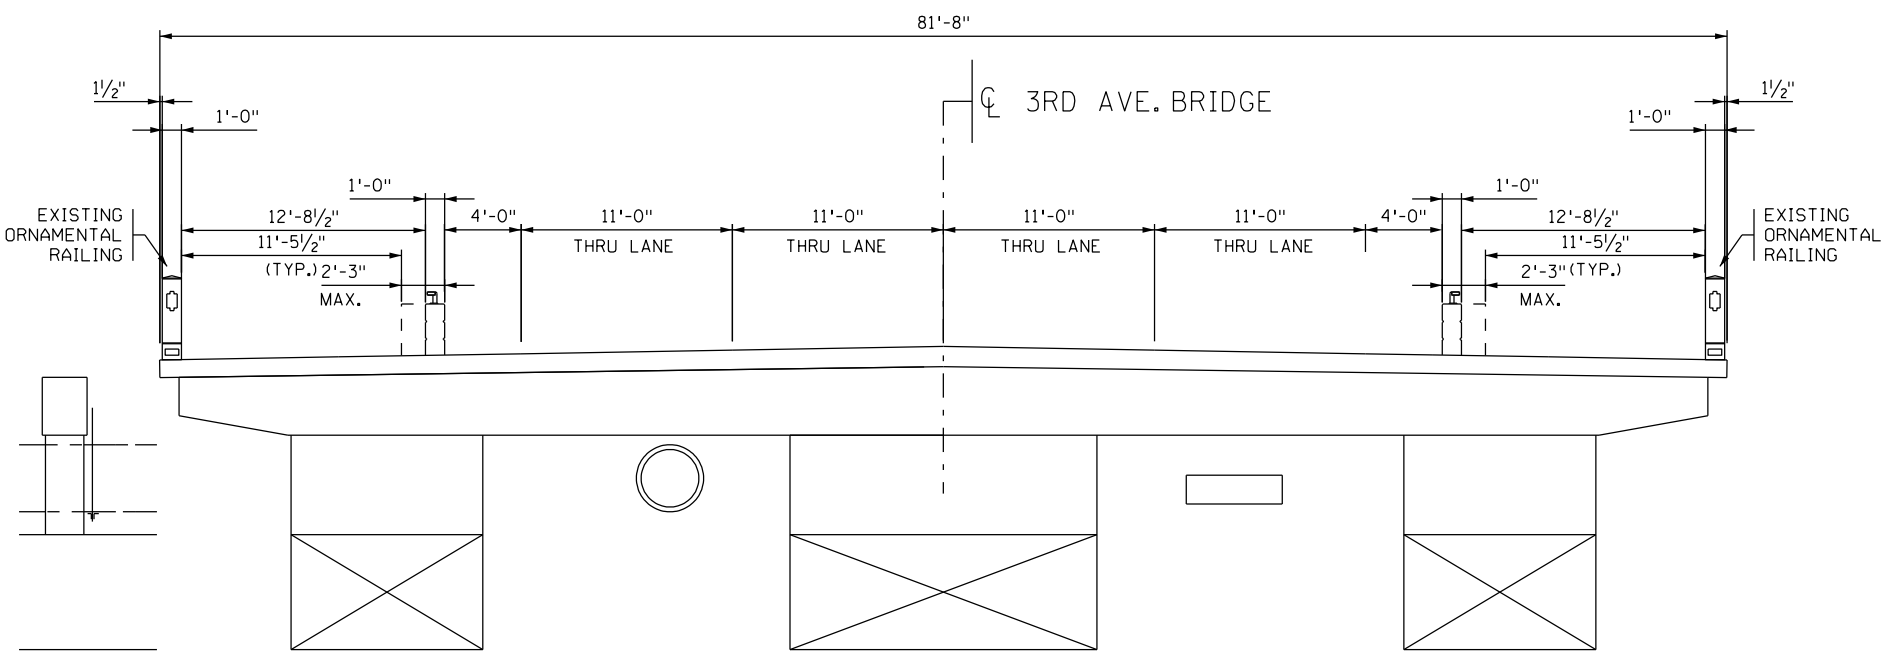
STAGE 6: INSTALL NEW CAP, COLUMNS, DECK & BARRIERS
