# Lac Qui Parle Bridge 5380: Section 106 Evaluation of Rehabilitation Alternatives

**State Project Numbers**  
**SP 1209-22; 3701-23**

**TH 40 Bridge Rehabilitation Study:**  
**Lac Qui Parle Bridge 5380**

Prepared for  
**Minnesota Department  
of Transportation**

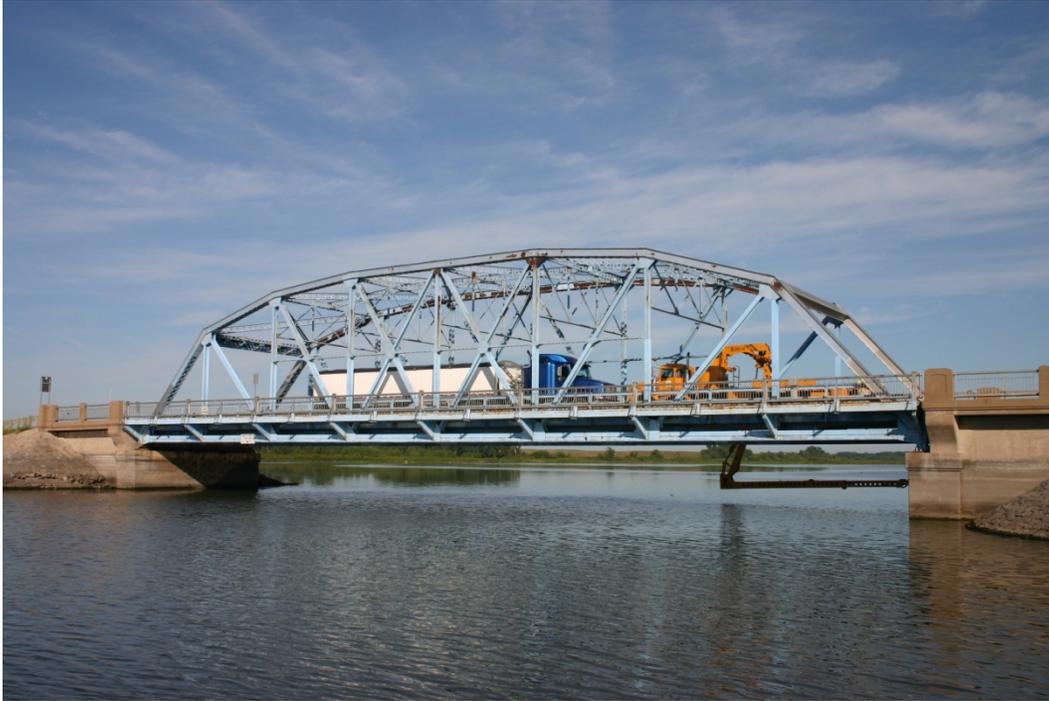
*Figure 1. Perspective view of south side of Bridge 5380. This view illustrates Character Defining Feature 1: Parker truss design and construction.*

1. The Parker truss design and construction (see Figure 1)
2. The two sidewalks with brackets and railings (see Figure 2)
3. Architectural detailing on the railings and abutments (see Figure 3)
4. The WPA stone masonry in the areas around the abutments (see Figure 4)

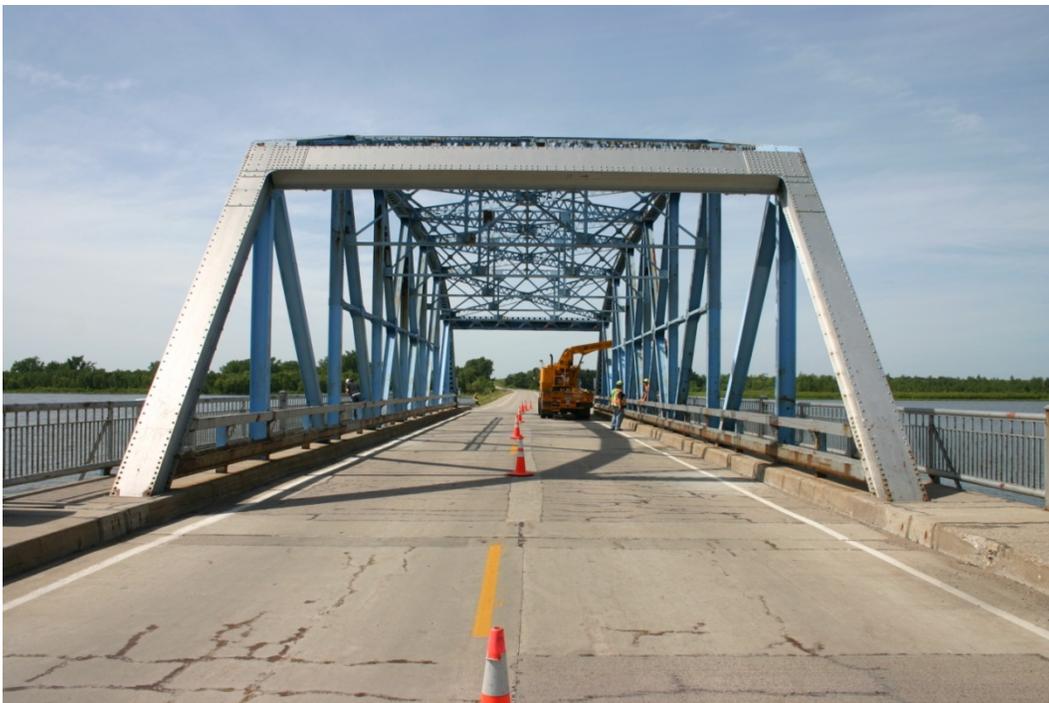
*Figure 2. Deck view of Bridge 5380 looking west from east abutment. This view illustrates Character Defining Feature 2: the two sidewalks with brackets and railings.*

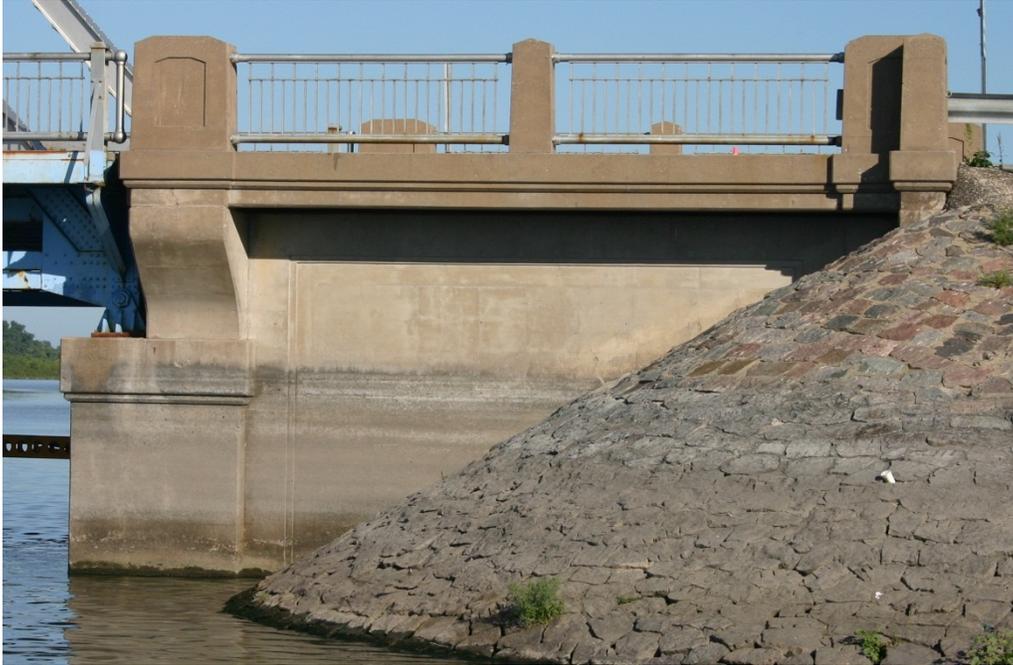
*Figure 3. South side of east abutment of Bridge 5380. This view illustrates Character Defining Feature 3: architectural detailing on the railings and abutments.*

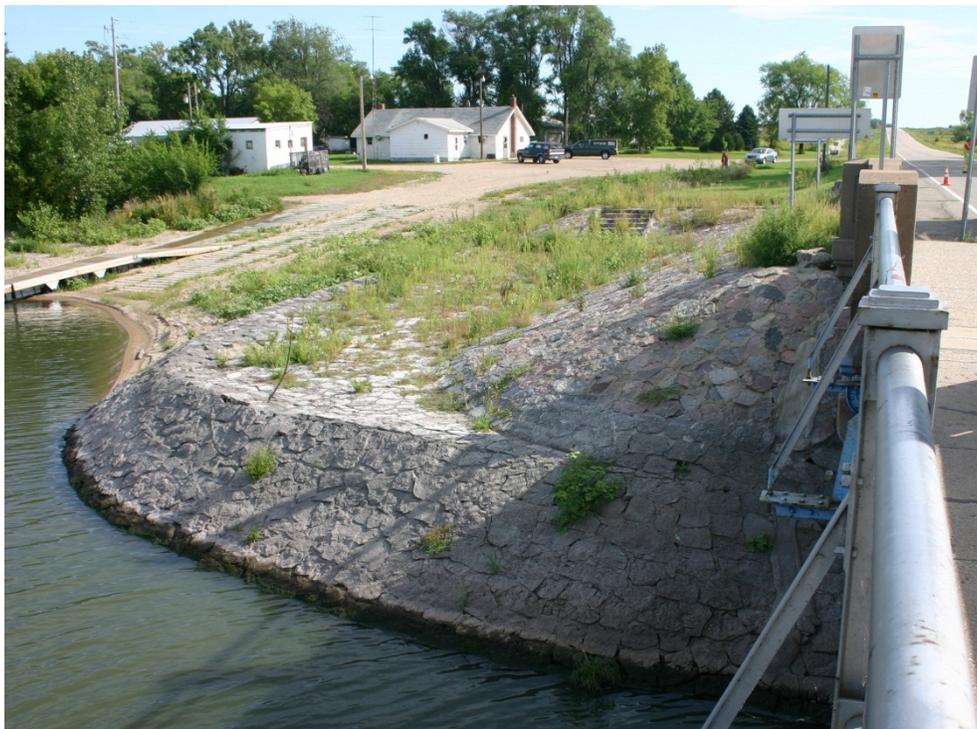
*Figure 4. View of area on northeast side of Bridge 5380, facing east. This view illustrates Character Defining Feature 4: WPA stone masonry in the areas around the abutments.*

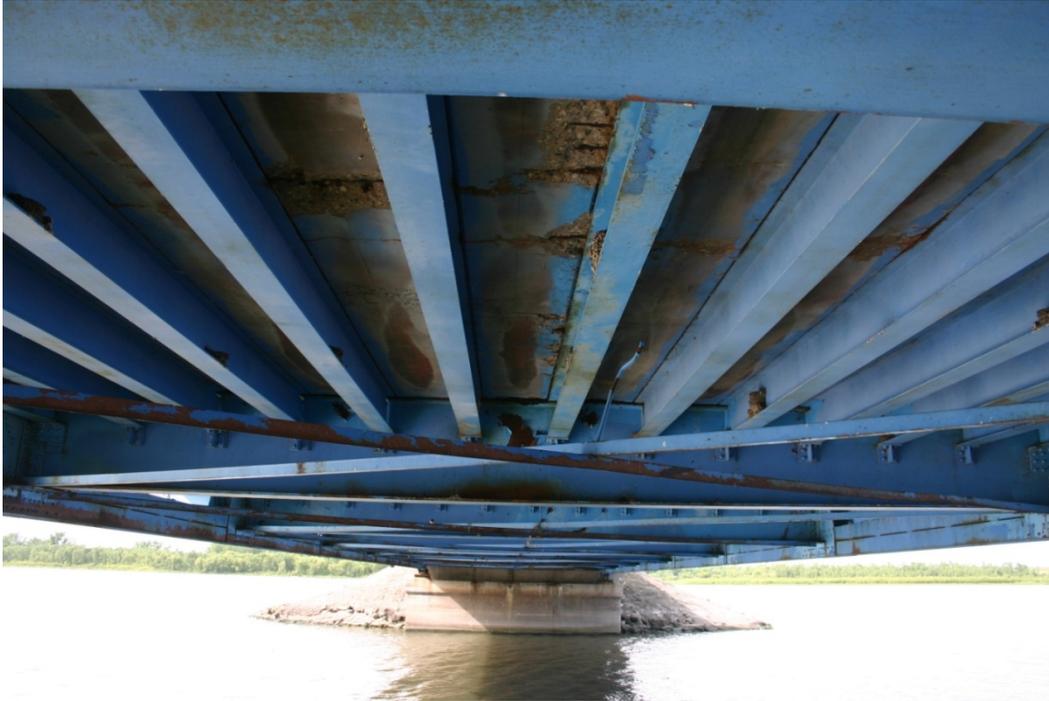
*Figure 5. General view of floor system and underside of deck on the truss span.*

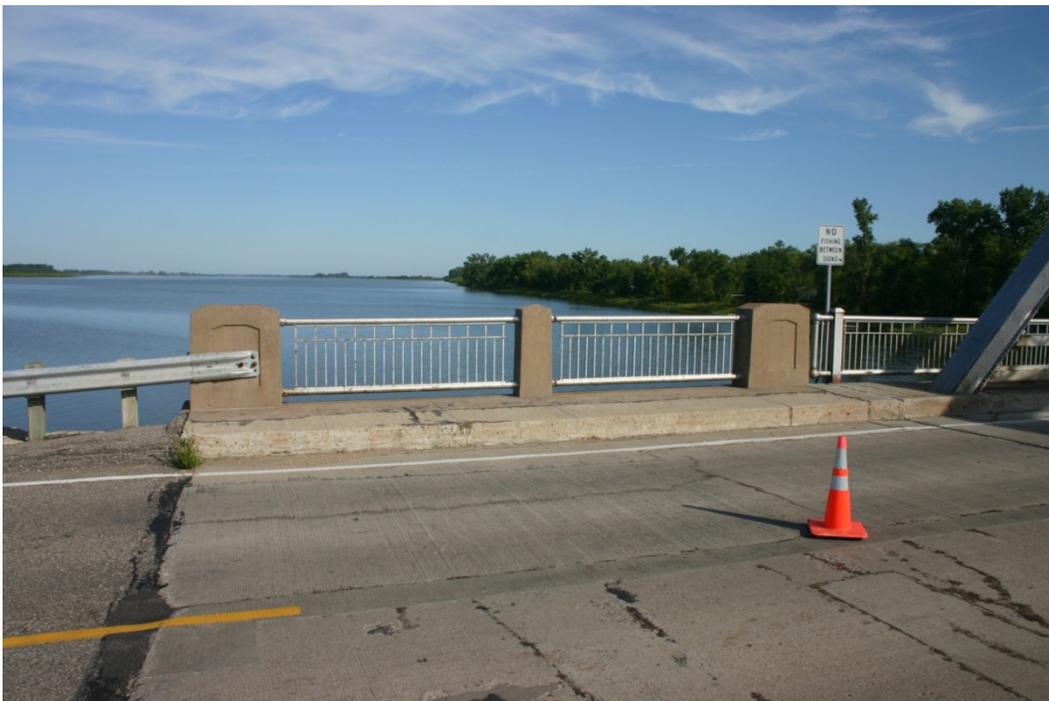
*Figure 6. Deck view of concrete U-shaped west abutment. This view shows the deck (beneath the orange cone), which is the top of the concrete slab to be replaced. The concrete beams (not visible here) are integral with the bottom of the slab and run longitudinally, from left to right.*

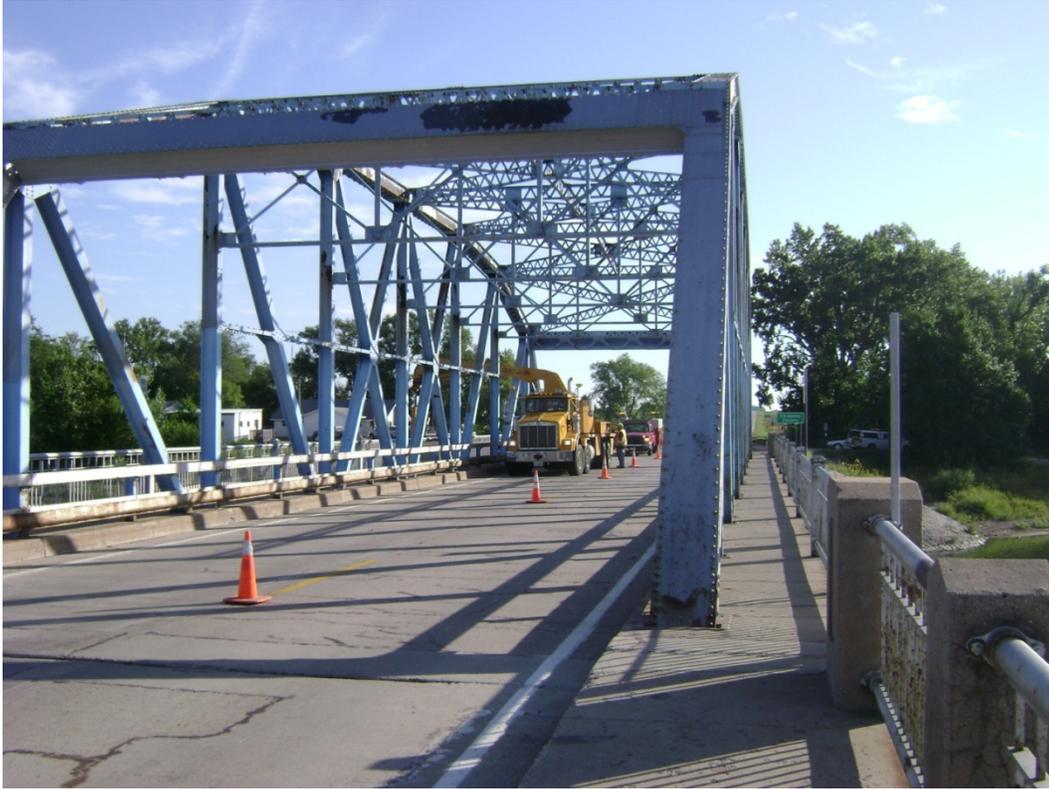
*Figure 7. General view of Bridge 5380 looking east from west abutment. Note lower portion of steel superstructure (splash zone), which has been painted previously.*

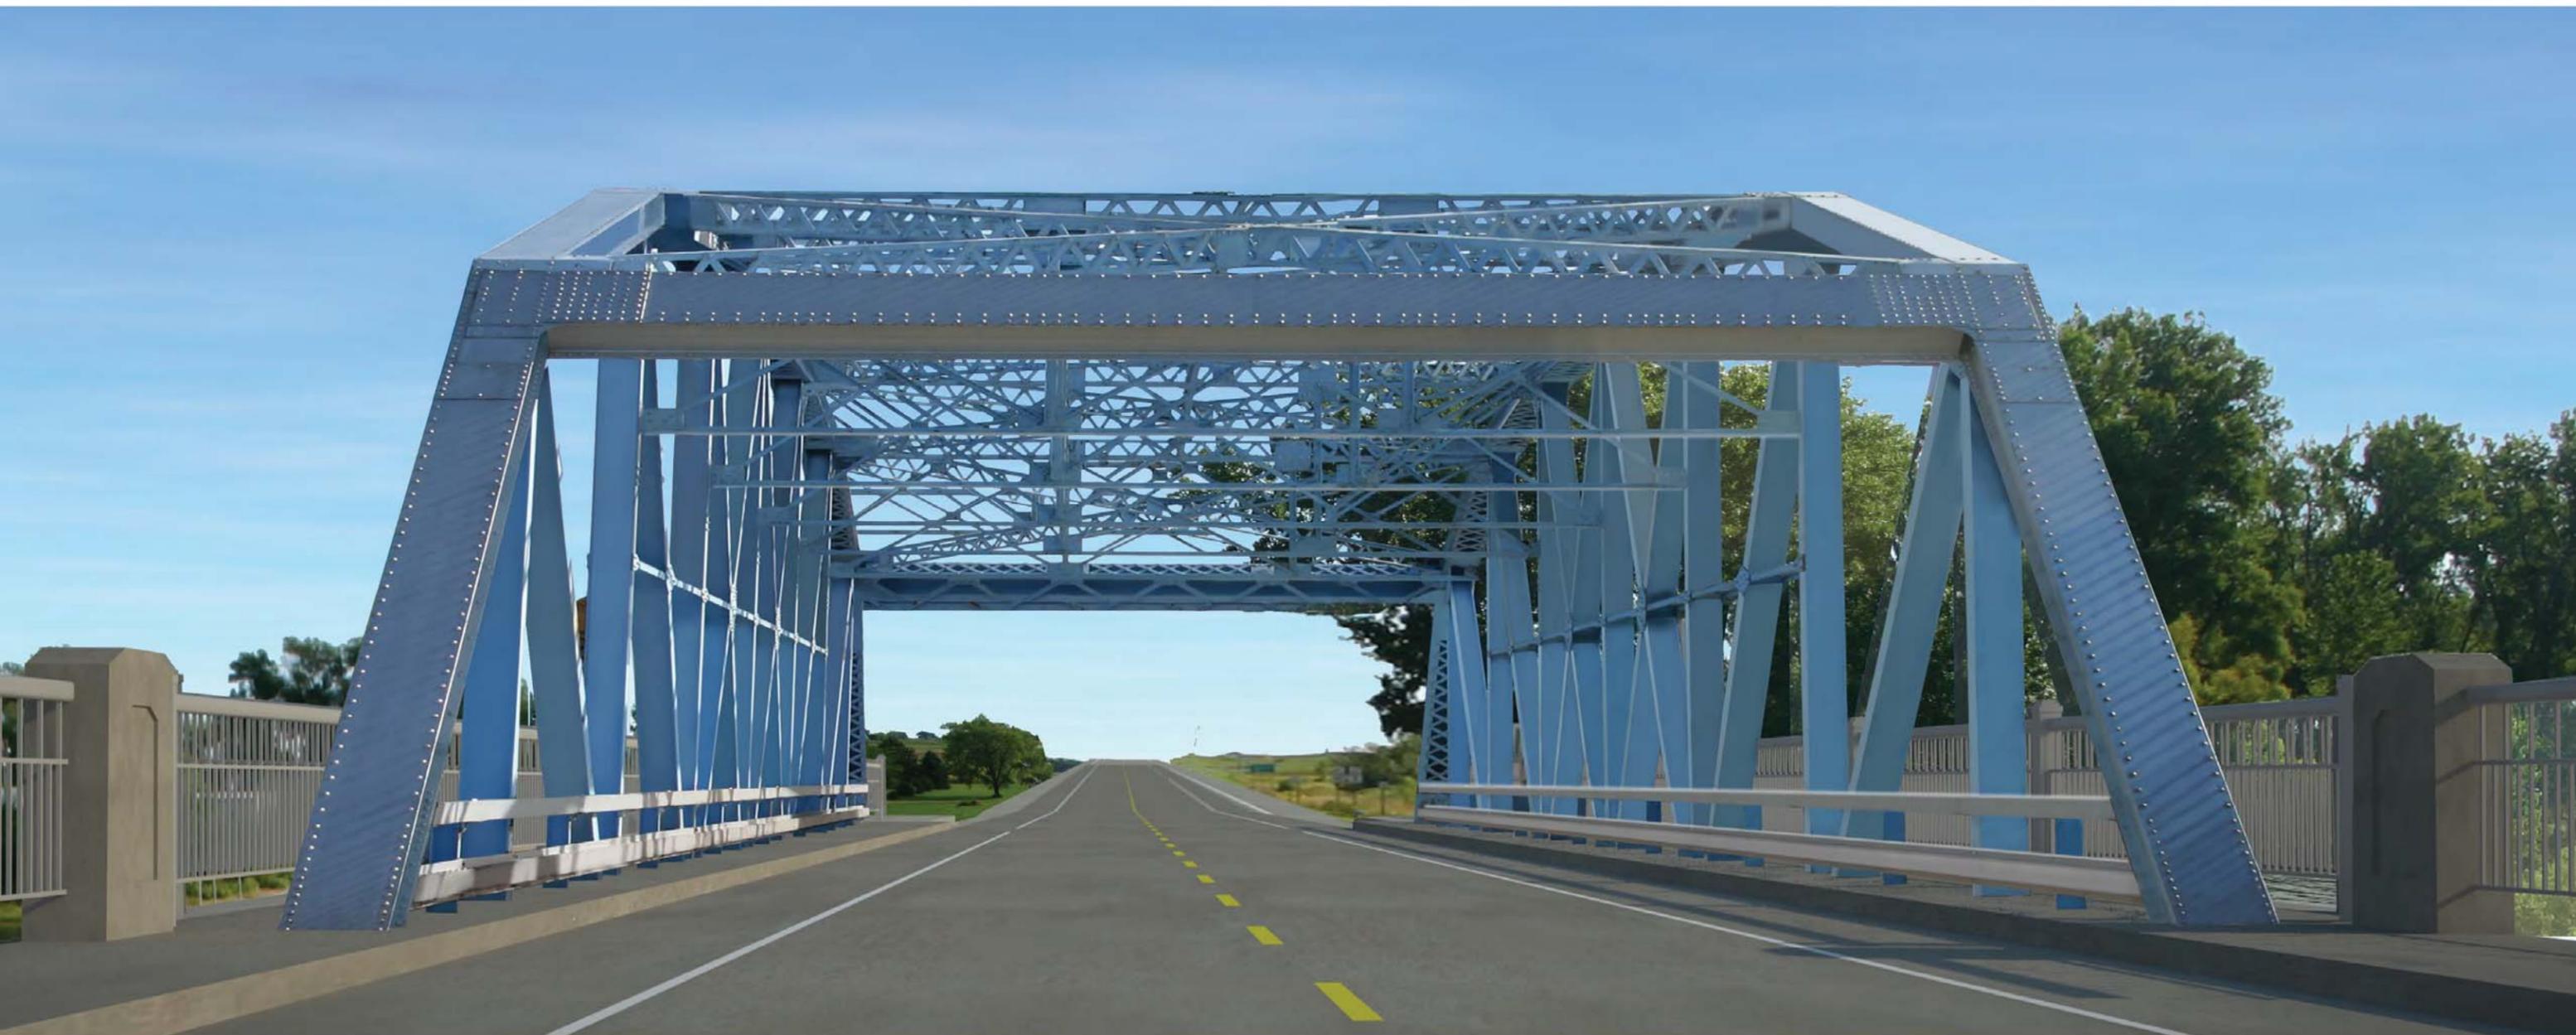
Rendering: Existing Bridge Widened 9'-0"  
(Looking East)

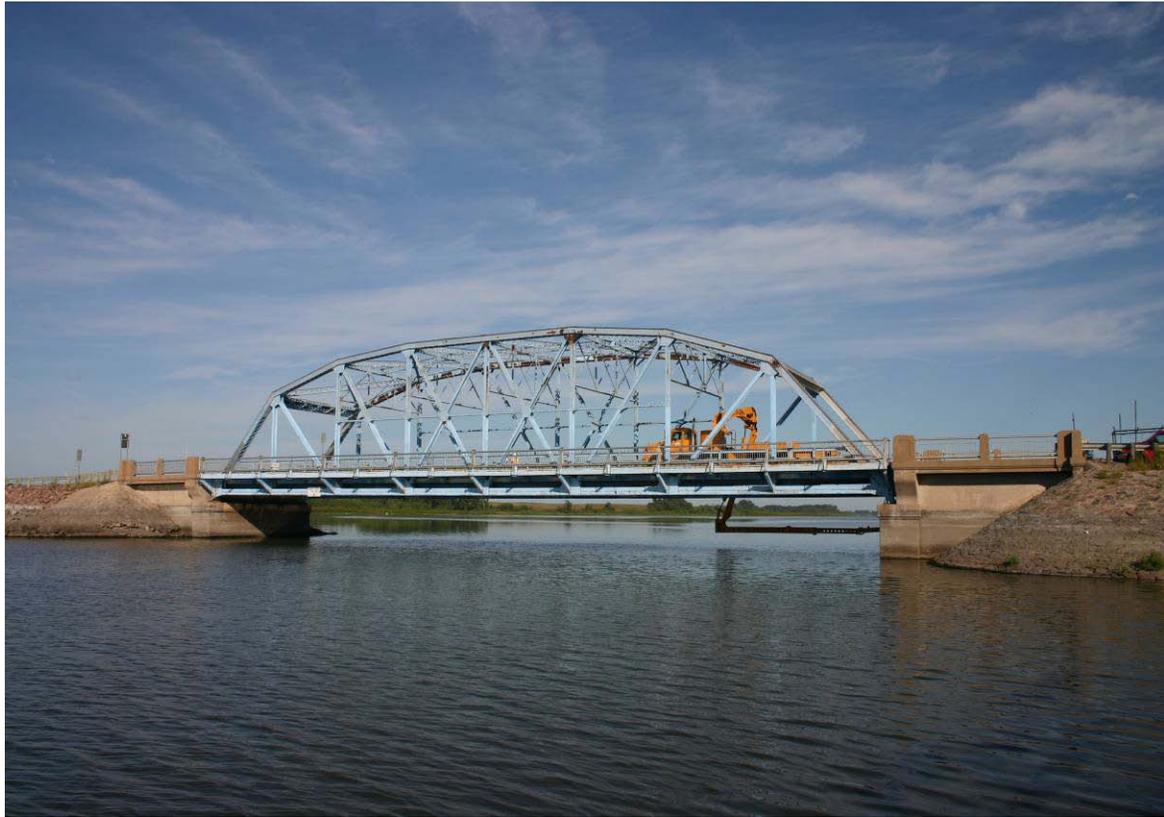
Figure 1. Lac Qui Parle Bridge 5380

*South truss, facing north, 2009*

The Lac Qui Parle Bridge 5380 carries Trunk Highway (TH) 40 over a widening in the Minnesota River known as Lac Qui Parle Lake (see *Figures 1 and 2*). The bridge, built in 1938, is significant as a contributing property to the Lac Qui Parle Flood Control Historic District, which has been determined eligible for the National Register of Historic Places. As such, the bridge is subject to review under Section 106 and Section 4(f) regulatory requirements. Initiated in 1933, the Flood Control Project was completed by the Works Project Administration (WPA) as a major federal relief project during the New Deal era. Bridge 5380 is the only metal truss bridge in the historic district. It replaced an earlier metal truss bridge at the same crossing (see *Figure 3*).

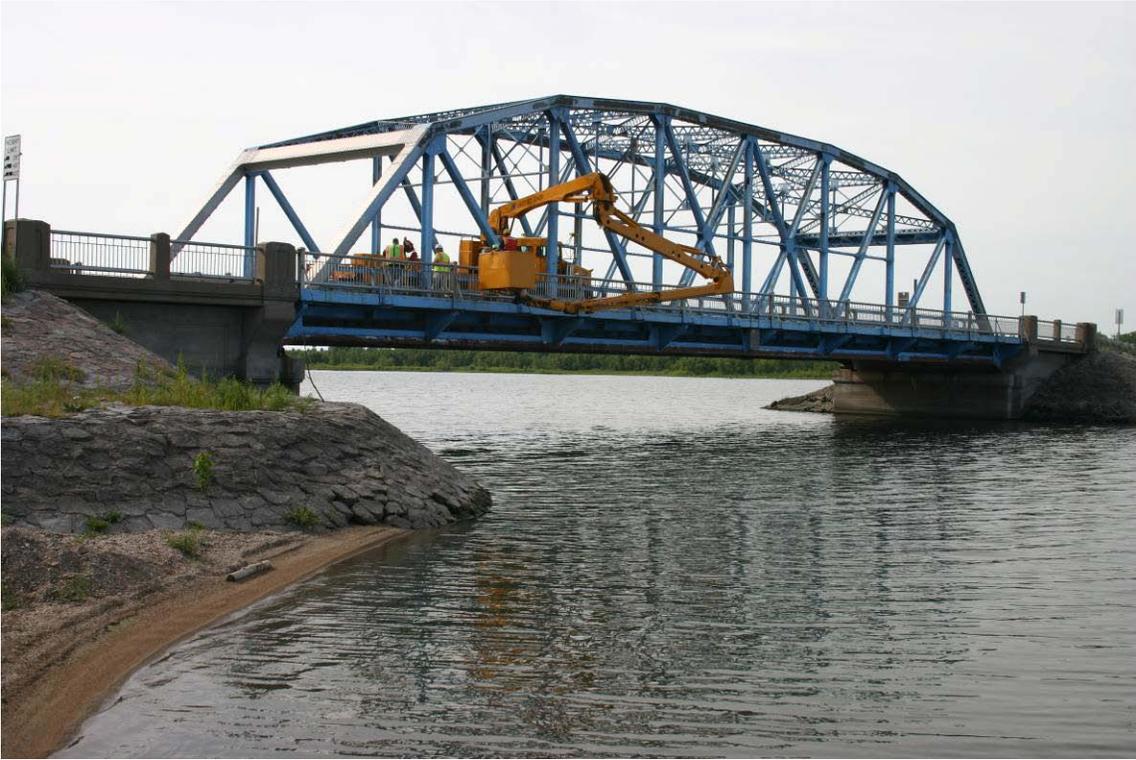
Figure 2. Lac Qui Parle Bridge 5380

*North truss, facing southwest, 2009*

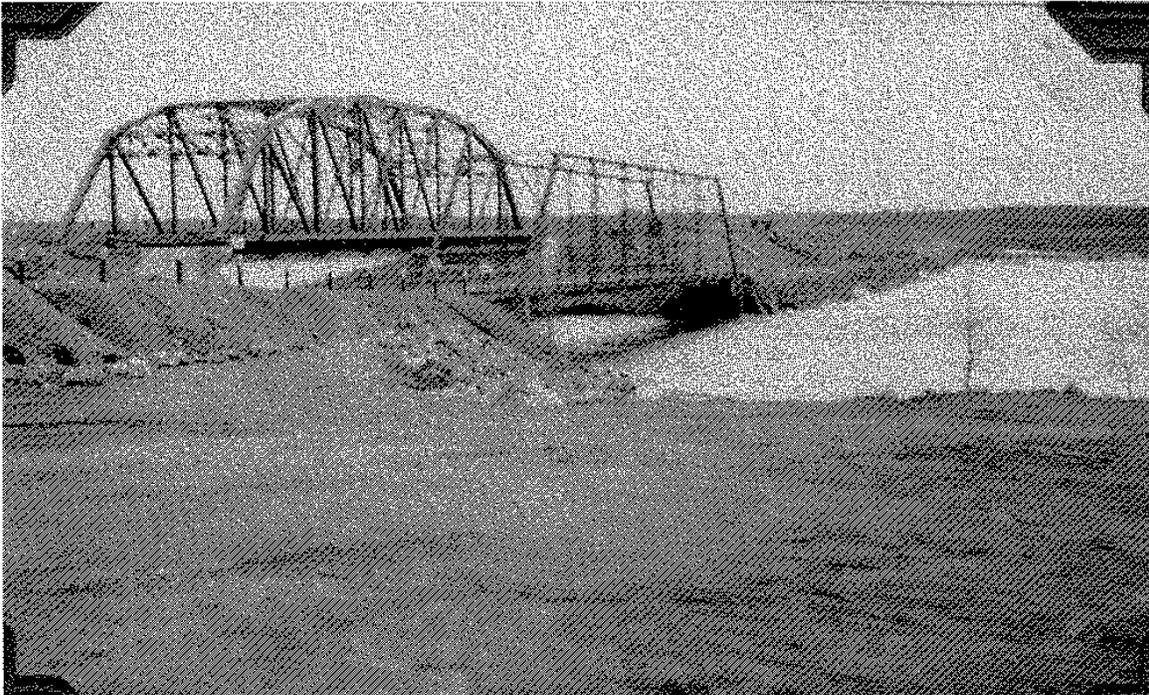
Figure 3. Historic Photo of Bridge 5380

*With predecessor truss, facing southwest, c. 1938*

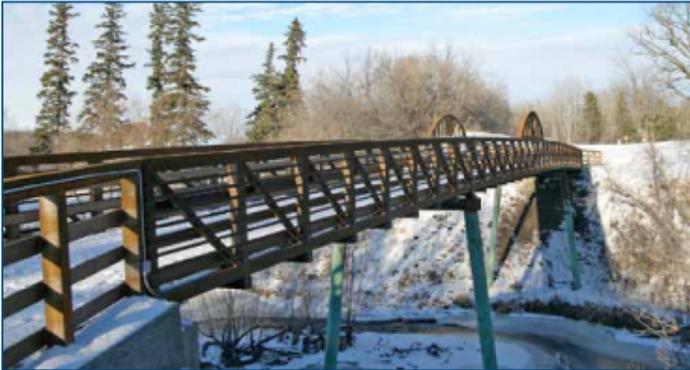
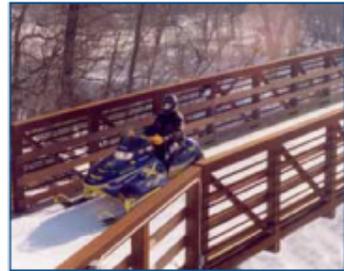
- Width: 12 ft
- Span: 170 ft
- Style: Connector®
- Finish: Weathering Steel
- Decking: Douglas fir, plywood

Site preparation was handled by Ferguson Brodher Excavating, Inc. The 170' x 12' bridge was delivered to the site in two sections. This allowed the contractor to use a smaller crane when moving the bridge sections into position for splicing. The splicing was done in mid-air. The crane positioned one section and then drove around to the other side of the river to set the final piece. This phase of the project was accomplished in just two days.

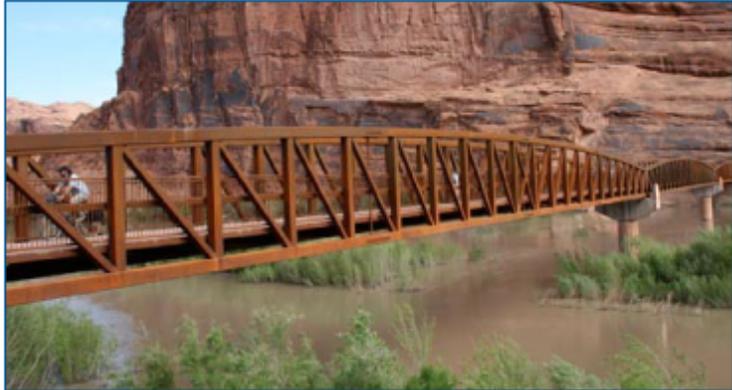
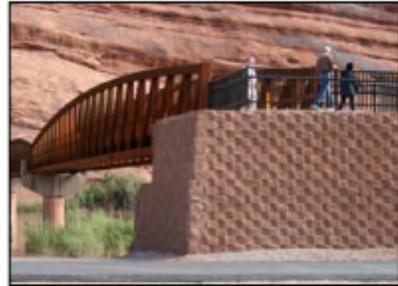
- Width: 11 ft (3)
- Span: 618 ft (3-206 ft spans)
- Style: Capstone®
- Finish: Weathering Steel
- Decking: Concrete
- Installation Date: January 2008

The Continental® pedestrian truss bridge crosses the Colorado River at one of its widest and deepest points. Installation of the Capstone structure occurred in winter of 2007 when the river was at its lowest levels. Sections of the bridge were cantilevered and set with a crane to minimize environmental impact.
