Stillwater Lift Bridge Management Plan – 2020 Update

MnDOT Bridge 4654

Bridge Number: 4654

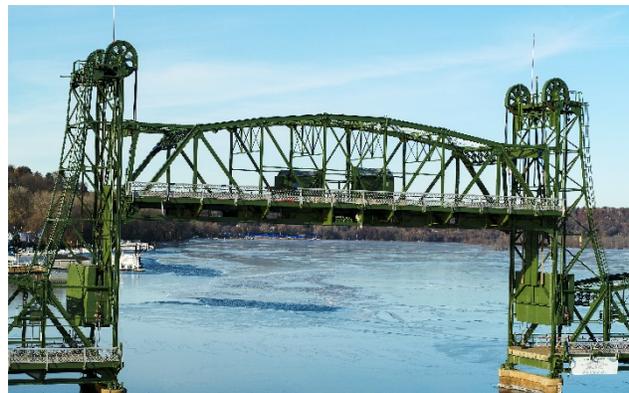
Photo CDF-1

Feature 1. General view of span 4, including lift towers of spans 3 and 5.

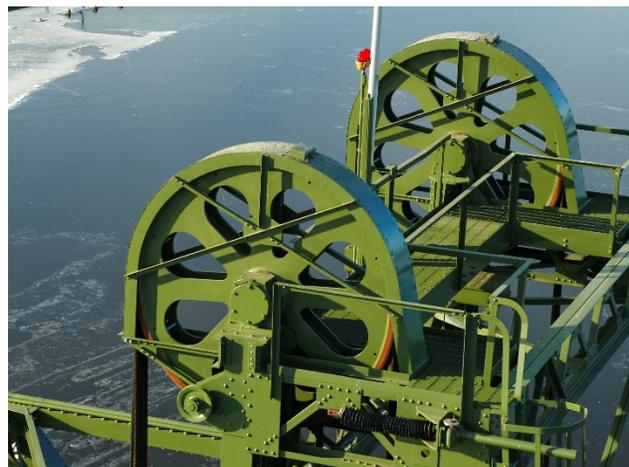
Photo CDF-2

Feature 1. Detail of sheave on lift tower.

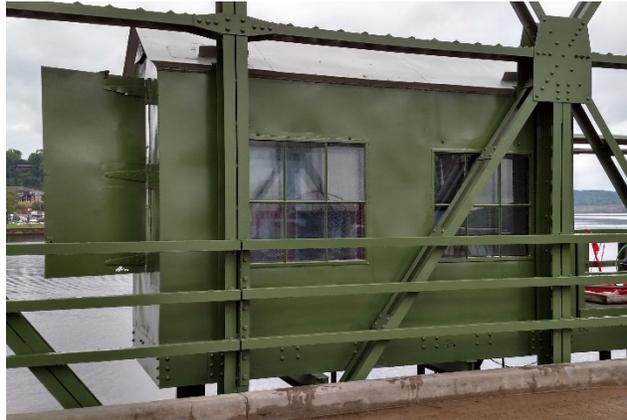
Photo CDF-3

Feature 1. Detail of bridge-tender's house.

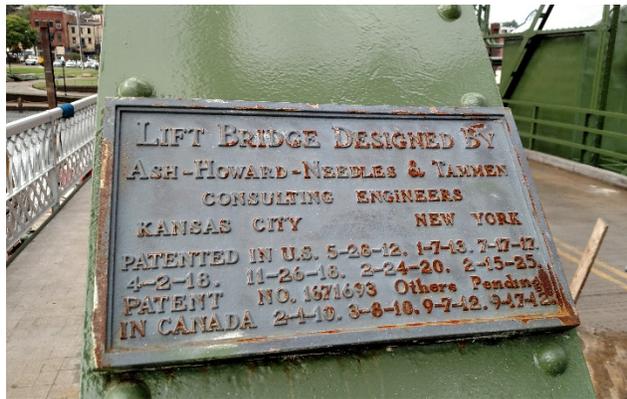
Photo CDF-4

Feature 1. Detail of builder's plate with list of patents.

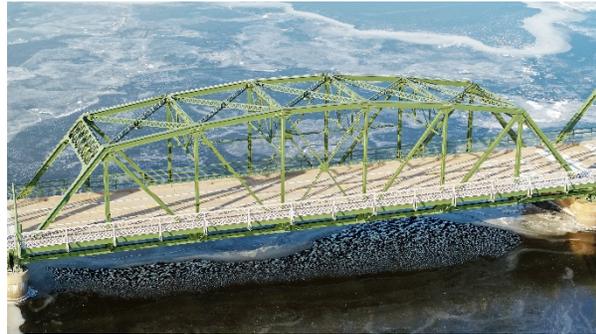
Photo CDF-5

Feature 2. Parker truss span.

The Parker truss design, with riveted connections, is used in the seven main spans of the bridge (spans 3-9). By 1930 the Parker configuration had become widely used for larger, longer-span trusses. Its polygonal upper chord, repeated in each span, gives the overall appearance of the bridge a distinctive, rhythmic profile. This feature includes the polygonal top chord, built-up members, and riveted connections.

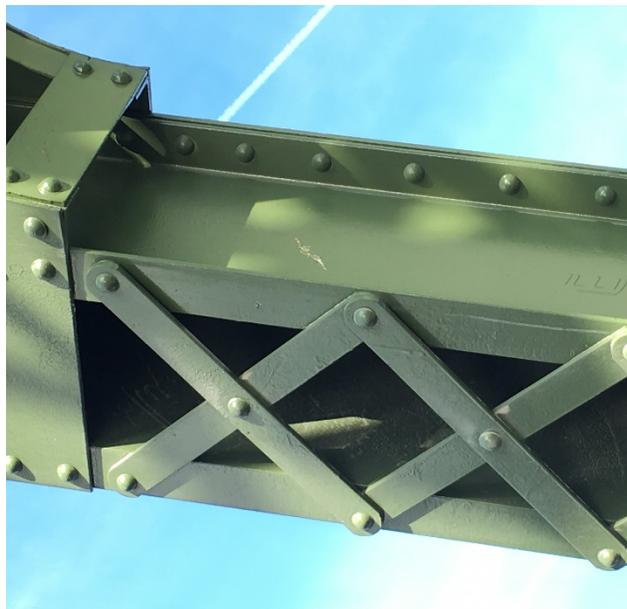
Photo CDF-6

Feature 2. Detail of riveted built-up member.

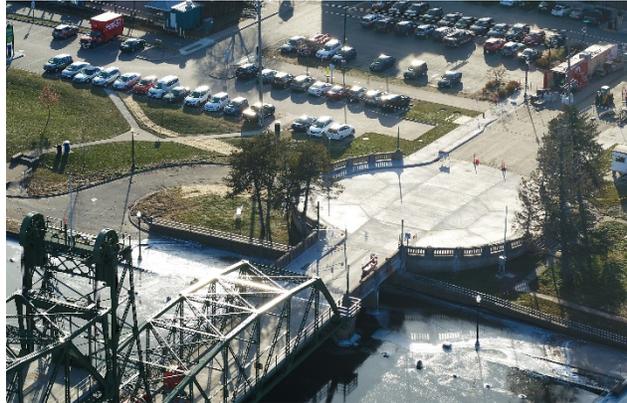
Photo CDF-7

Feature 3. General view of concourse.

The concourse represents the bridge's functional and symbolic connection with downtown Stillwater and the city's cultural and historic landscapes. This feature includes the City Beautiful gateway concept of a circular intersection with its four compass-point openings for the bridge, Chestnut Street, Lowell Park, and Park Drive. It also includes the Classical Revival architectural treatment of the open balustrade, light standards, and other concrete elements, and their seamless integration with the design of the reinforced-concrete approach spans 1 and 2. The concourse's relationship to the surrounding setting of Lowell Park, Park Drive, and the levee is an important extension of this feature.

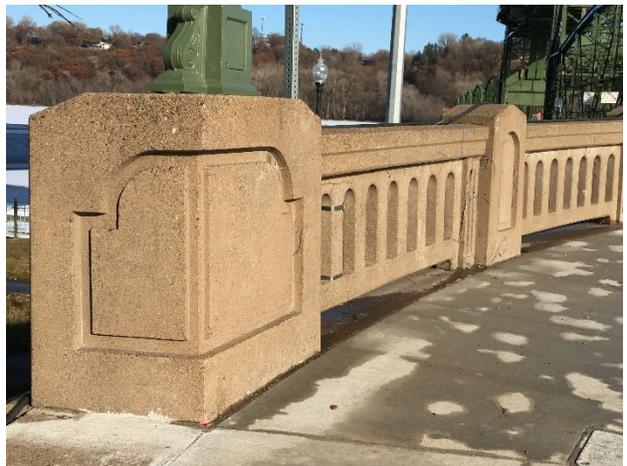
Photo CDF-8

Feature 3. Detail of open balustrade railing.

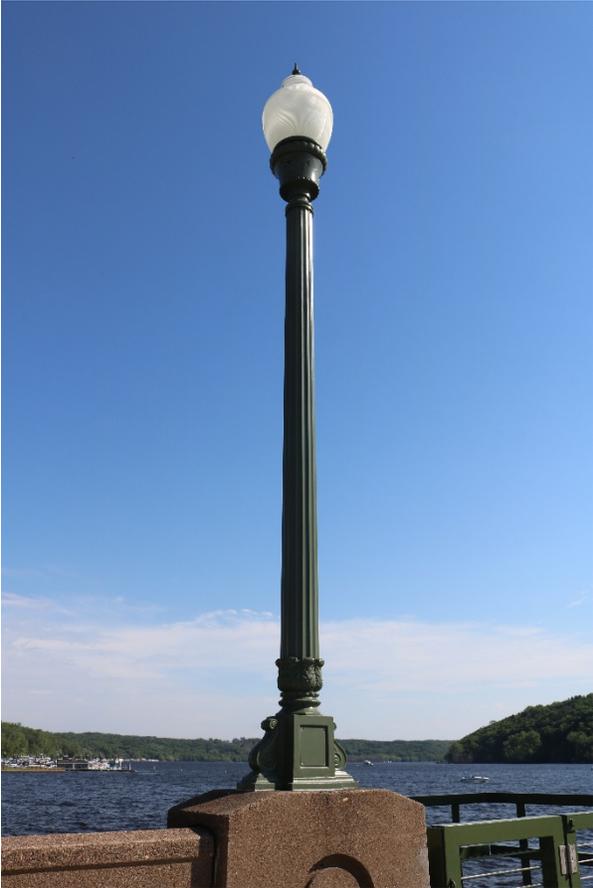
Photo CDF-9

Feature 3. Detail of light standard.

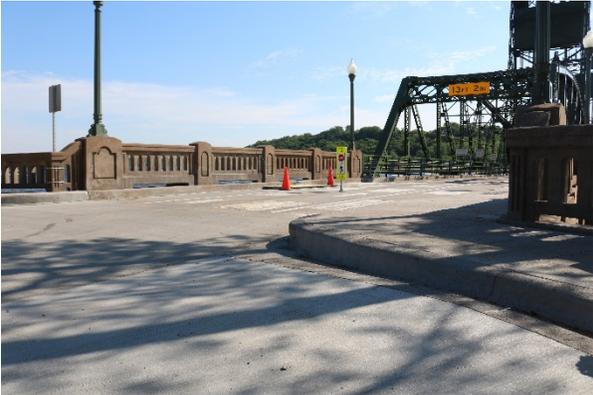
Photo CDF-10

Feature 3. Continuity of design and construction between concourse and spans 1 and 2.

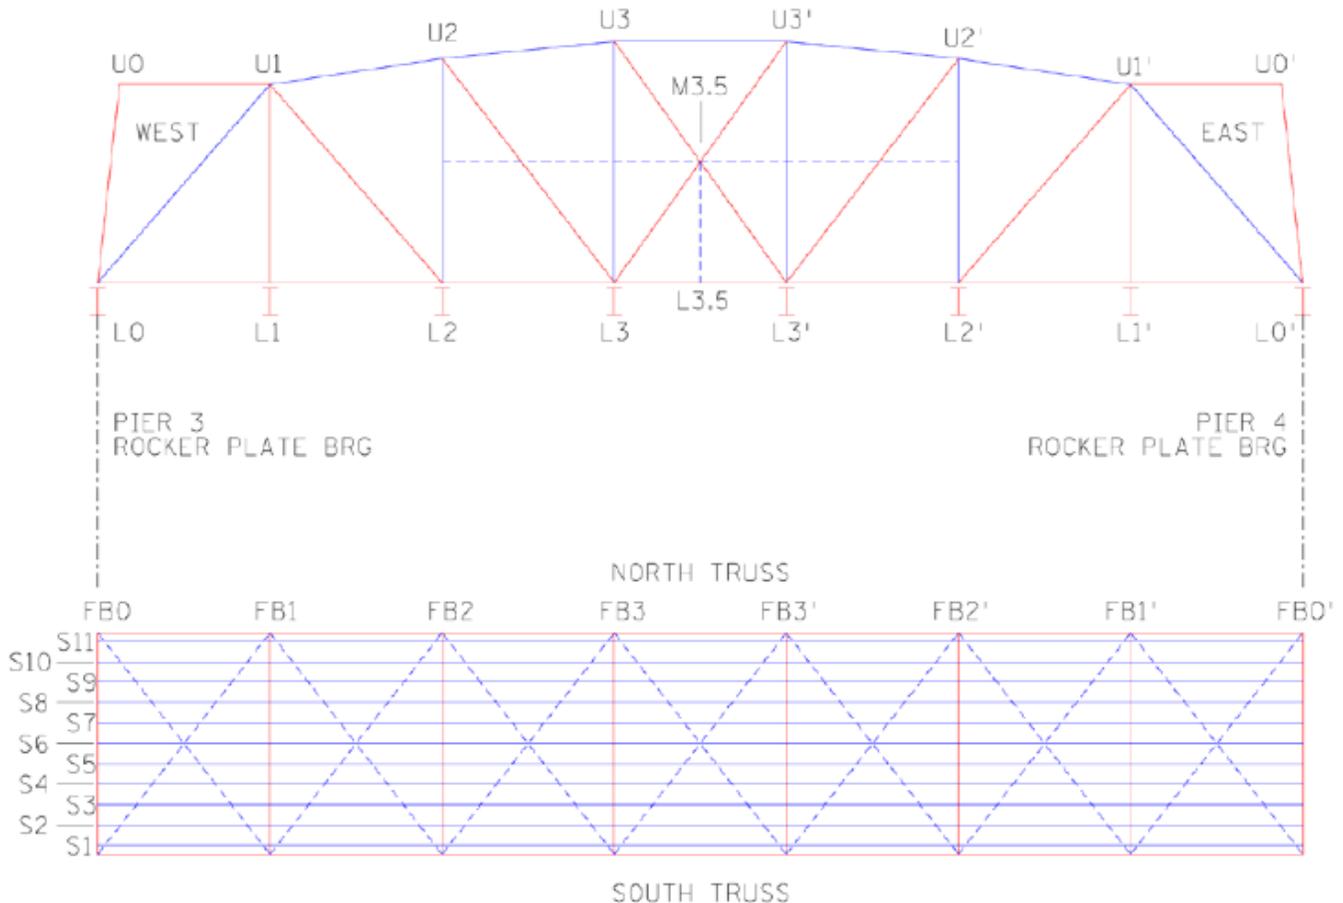
**Figure 1: Span #4 Truss Diagram & Framing Plan
(Panel Point Numbering & Fracture Critical Members)**

Fracture Critical members are shown in red in Figures 1 & 2:

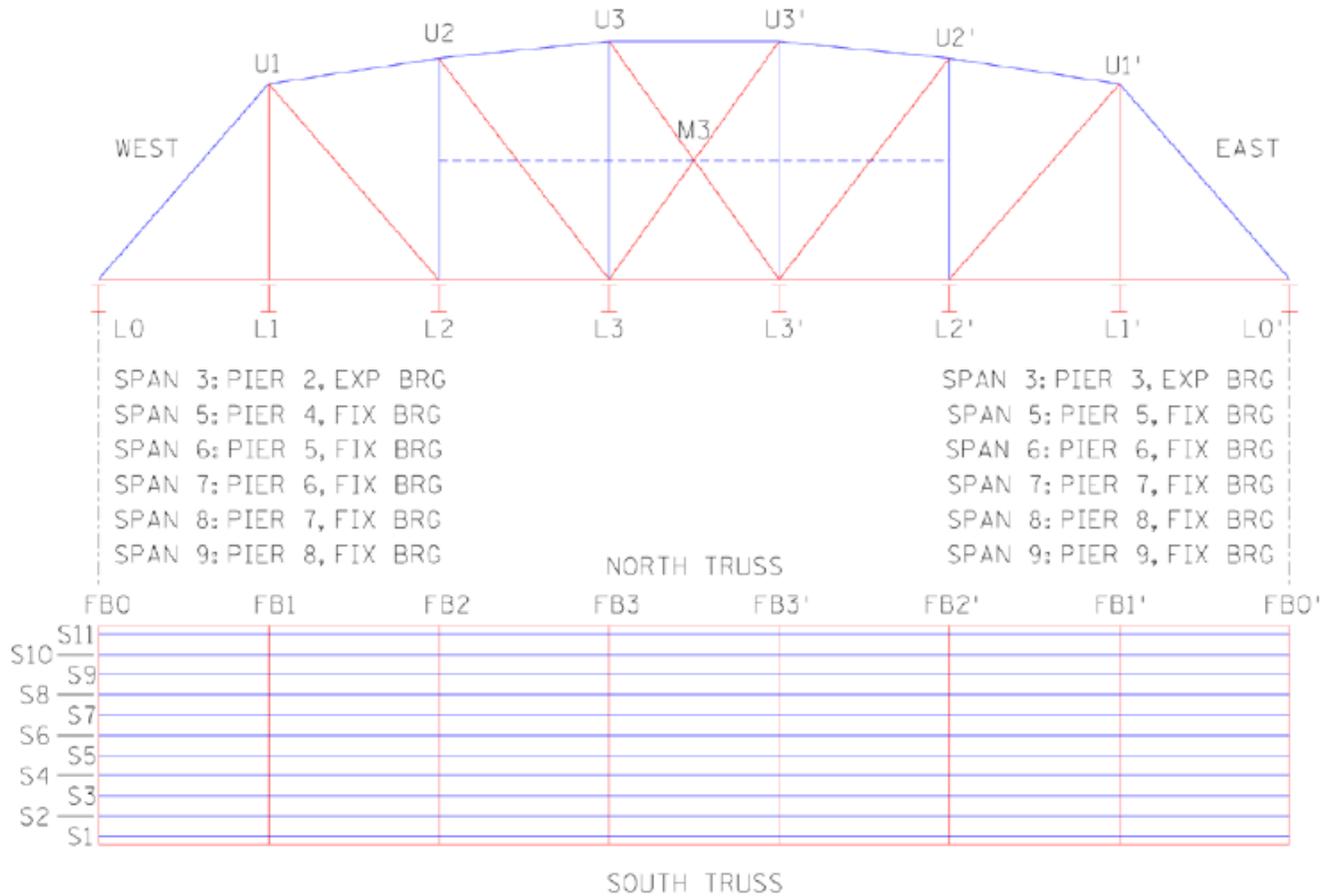
**Figure 2: Spans #3 & #5-9 Truss Diagram & Framing Plan
(Panel Point Numbering & Fracture Critical Members)**
