Pavement Data Quality Management Plan

As required by 23 CFR 490.319(c)

05/10/2018

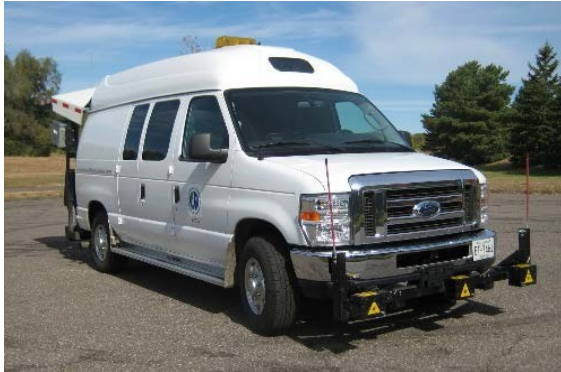
2011 Pathrunner

MnDOT currently owns three Pathrunner vans, built and sold by Pathway Services, Inc. located in Tulsa, Oklahoma. The current fleet of Pathway vans consists of a 2011 Ford Econoline van and two 2016/2017 Ford Transvans each equipped with two laser profiling systems (one in each wheel path) and a 3D laser/camera system for measuring rutting/faulting and capturing pavement distress.

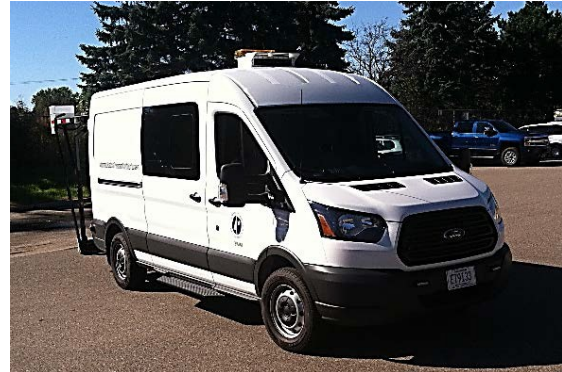
2016/2017 Pathrunner

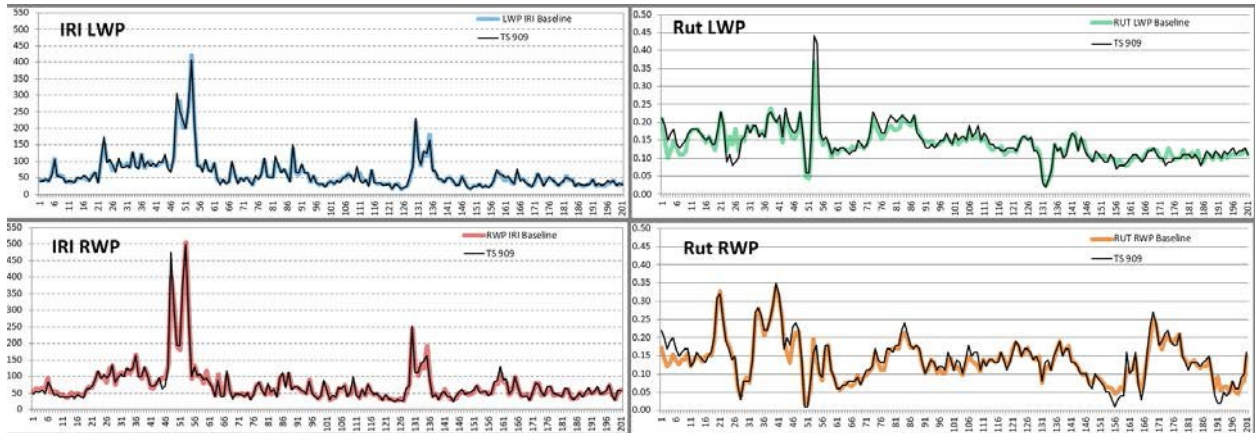
Example of graphs comparing a verification run to a baseline on 52.8 foot intervals:

Once the vans get officially certified, the verification course is driven to establish a baseline. The verification course is an 8 mile long loop on various state highways located near the Office of Materials and Road Research in Maplewood, Minnesota. Measurements are taken on a 2 mile bituminous section of MN 36 and 2 mile concrete section on I-694. The newly certified van is driven over the course five times, to establish a baseline for each section. The data is processed at 52.8 foot intervals. An Excel spreadsheet, with imbedded macros, is used to generate a plot of IRI and rutting in each wheel path, and GPS compass heading. Approximately every two weeks, the vans drive over the verification course and the resulting plots of IRI, rutting and compass heading are overlaid on top of the baseline plot. While no statistical analysis is done, the user ensures that the data from the current run is consistent with the baseline data. The data will never be exactly the same as the baseline due to vehicle wander, changes in pavement condition, temperature/weather effects, etc. However, if any of the lasers, accelerometers, or DMI were malfunctioning or out of calibration, it would be easily detected by the plots. All runs over the course of the season are saved in the annual verification spreadsheets. A separate verification file is kept for each van.
