Rob Coughlin
Water Resources Inspector
MnDOT, District 6
507-286-7564
robert.coughlin@state.mn.us

Hydraulics Inspection Vehicle Explorer (HIVE)

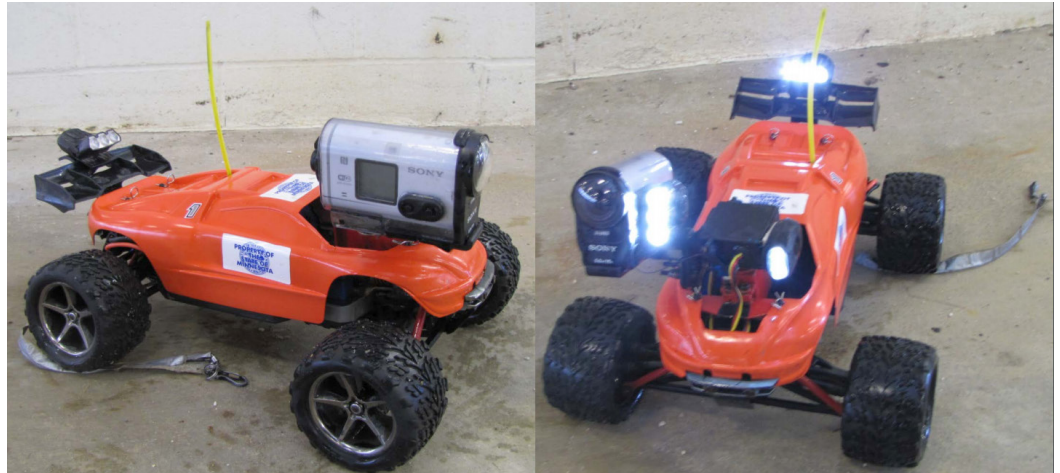
- Waterproof
- Wi-Fi transmission
- 4x4 drive
- \$1,200 vehicle/camera
- \$300 tablet
- Transported in 11"x17" box

The Hydraulic Inspection Vehicle Explorer (HIVE) is an enhanced radio-operated car, which allows MnDOT to inspect culverts and pipes to determine if any repairs or replacement is needed. Often the culverts and pipes are too small or difficult for a person to enter to visually inspect it, so the vehicle is operated via radio control with a camera and lights to record and view conditions with just one specialist at the site. It has discovered damage in culverts underneath roads long before the problem becomes an emergency. The device was modified by Rochester MnDOT workers in the inventory department, who are experienced radio-operated car hobbyists. They are building similar devices for other MnDOT districts and creating an online guide for parts, repairs and operation to allow all MnDOT users to access the information when issues arise.

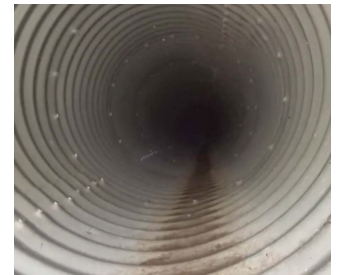
End of pipe inspection

In one case study, an end-of-pipe inspection showed significant pipe damage that would typically result in a full replacement costing about \$45,000. However, HIVE video footage showed that the damage was limited to just 12 feet of the pipe near the end. Instead of replacing the entire pipe, a \$1,000 repair was implemented resulting in \$44,000 savings.

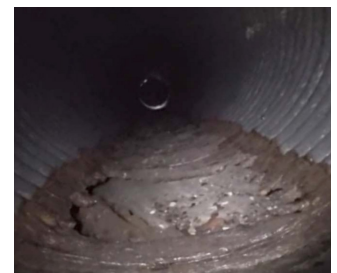
HIVE video 55 feet into pipe

By using the HIVE unit, eight culverts changed from no work needed to repair needed, because large joint separations or broken flanges with exposed soil visible were detected by video far into the pipe.
