Introduction:

The Passage Bench is a gravel bench incorporated into bridge riprap. Its primary function is to allow wildlife to pass beneath bridges uninterrupted as they travel along the streambank. In 2005 the Passage Bench was considered an 'experimental design'. This was a collaborative effort of the Minnesota Department of Natural Resources (MnDNR), the US Fish and Wildlife Service (USFWS Twin Cities Field Office), and the Minnesota Department of Transportation (MnDOT). Early designs were installed at several bridge locations around Minnesota. These experimented with design parameters such as bench width, vertical clearance, and location. Initial study and continued observations have shown that this feature is utilized successfully by wildlife throughout Minnesota and in a variety of settings. Simultaneously, other benefits were realized for MnDOT, such as ease in bridge inspection, a riprap design change from aggregate base to a geotextile base, and flexibility in design for defining the cross-section of the normal channel and its flood profile. Bridge length also is not necessarily increased with this design. While the initial design of the Passage Bench was primarily for w

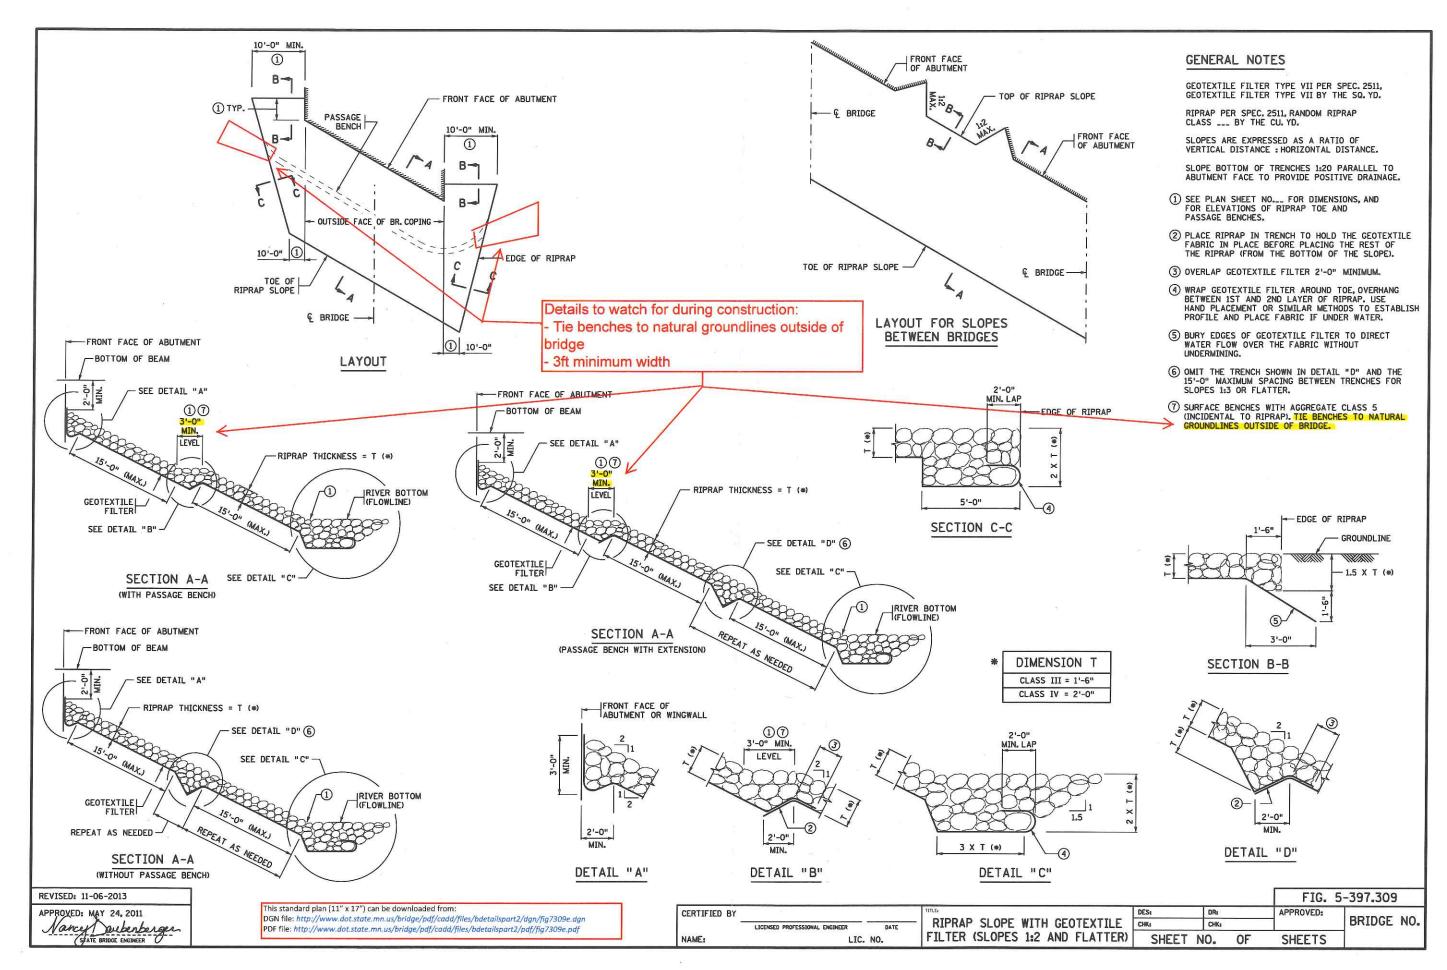
Standard Plan

Two critical plan details during installation:

- 3ft minimum width
- Tie benches to natural ground lines outside of bridge

PDF file: dot.state.mn.us/bridge/pdf/cadd/files/bdetailspart2/pdf/fig7309e.pdf DGN file: dot.state.mn.us/bridge/pdf/cadd/files/bdetailspart2/dgn/fig7309e.dgn
