MINNESOTA DEPARTMENT OF TRANSPORTATION
T.H. 60
 FROM WINDOM TO ST. JAMES

BUILD ALTERNATIVE

MIDDLE GAP

FIGURE
A7

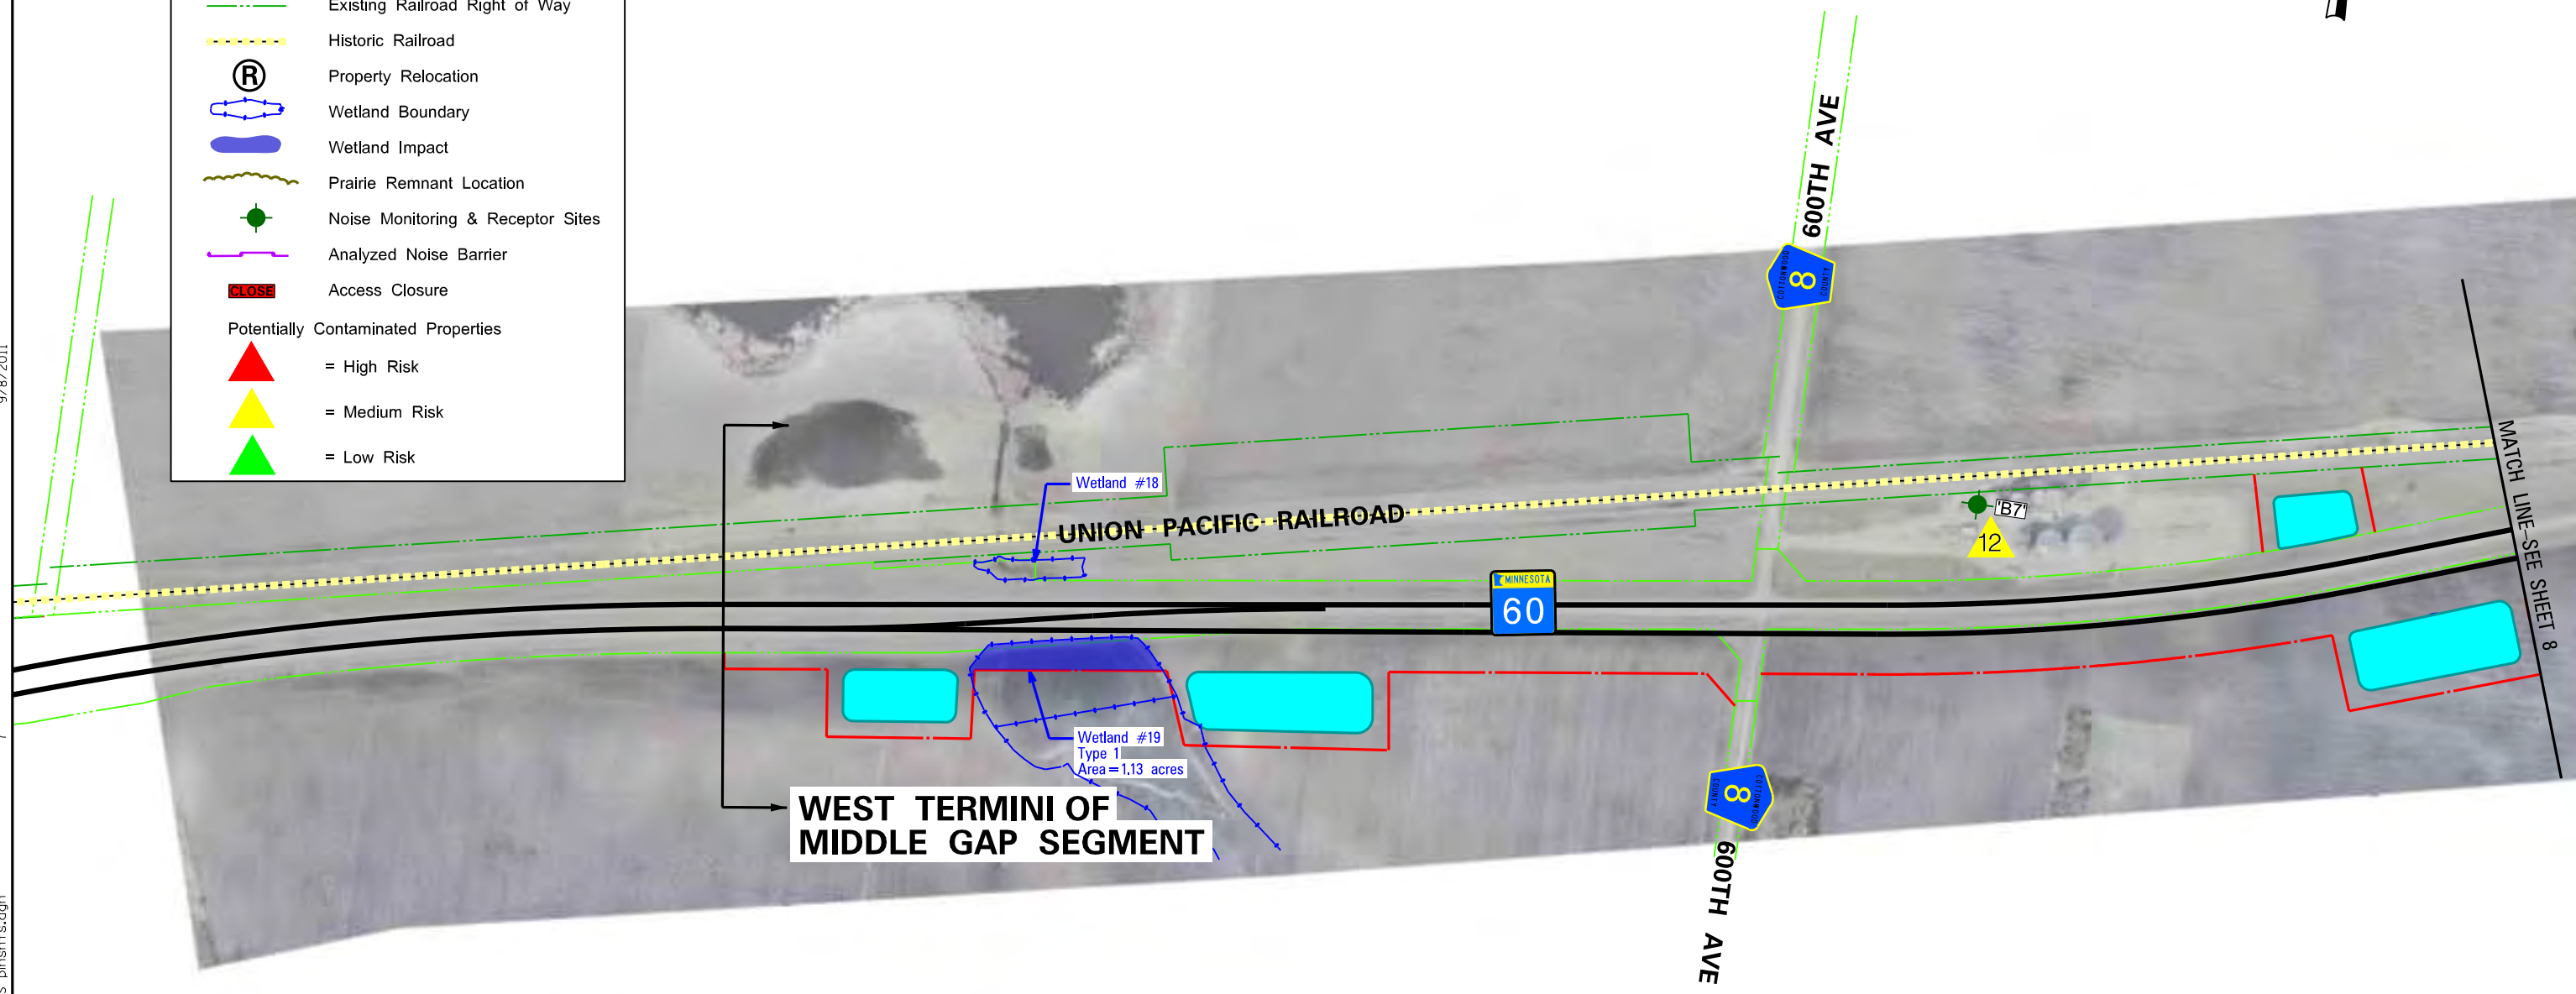
WEST TERMINI OF MIDDLE GAP SEGMENT

MATCH LINE-SEE SHEET 8
