Statewide Vinyl Bridge Paint Testing

Statewide Environmental Study Report

**Minnesota Department of Transportation
The Office of Environmental Stewardship
Environmental Modeling and Testing Unit**

July 2013

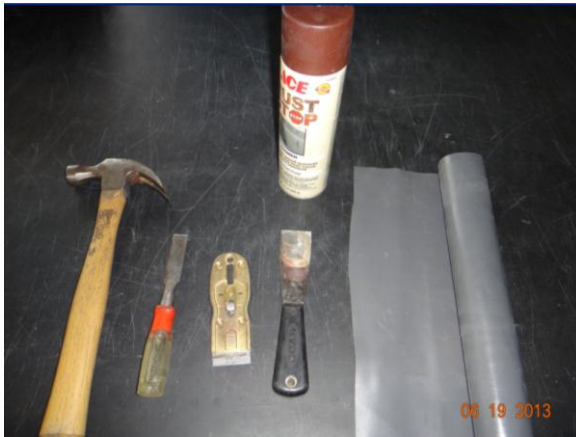
Tools displayed in Figure 2.2.1 were utilized in collecting each vinyl paint sample. A total of ten grams of paint sample was collected at each bridge location. However, there were a few bridges where the paint was too thin to collect ten grams. In this instance, we either utilized the paint that we had collected for laboratory analysis or we chose another alternative bridge for sampling. After the vinyl paint was removed, the area was repainted with a spray paint primer displayed in Figure 2.2.1. This was done to prevent future bridge corrosion. In some cases no paint was available for sampling, resulting in the next bridge on the list to be selected as an alternative. A minimum of five grams of paint was weighed and sent to the Minnesota Department of Health for chemical analysis with the remaining paint being retained for further analysis if necessary. Figure 2.2.2 shows an example of a typical vinyl paint sample location after the paint removal was completed.

Figure 2.2.1: Vinyl paint sampling tools (spray paint, hammer, chisel, razor scraper, putty knife, and paint collection mat)

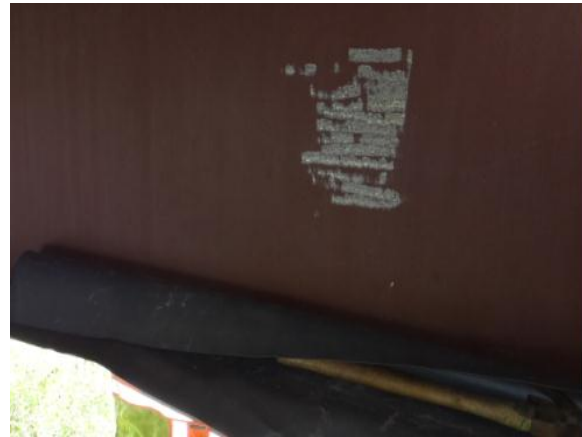
Figure 2.2.2: Example of a sampled bridge location

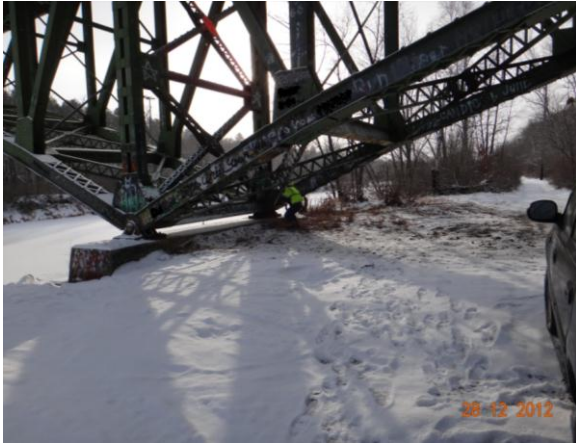
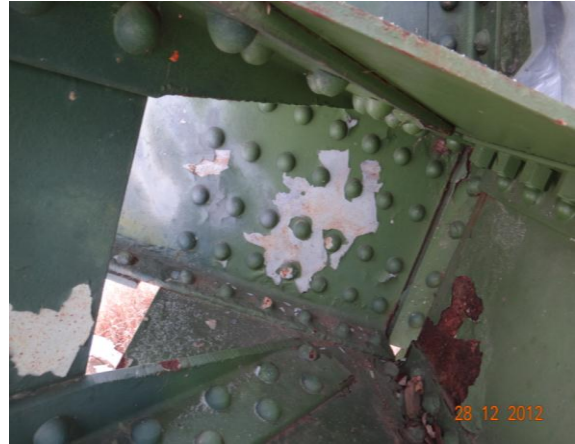
Figure 3.1.1: Bridge #5718 with waterway

Figure 3.1.2: Bridge #5718 sampling location

No chromium, mercury, selenium, or silver was detected for Bridge #5718. The reported level of 0.14 mg/L for arsenic, 0.15 mg/L for barium, 0.25 mg/L for cadmium, and 1.4 mg/L for lead were all below regulatory maximum concentrations.

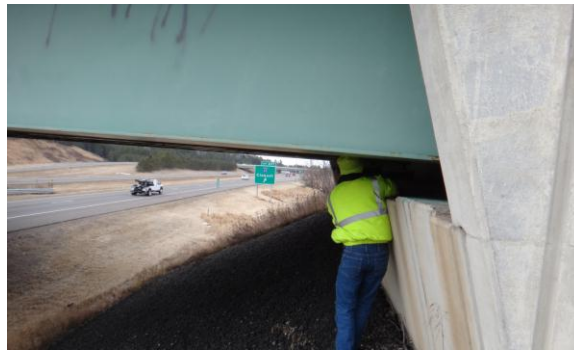
Figure 3.1.3: Bridge #9837 sampling location with roadway

No arsenic, chromium, lead, mercury, selenium, or silver was detected for Bridge #9837. Barium reported 0.18 mg/L and cadmium reported 0.22 mg/L; both are below the regulatory maximum concentrations.

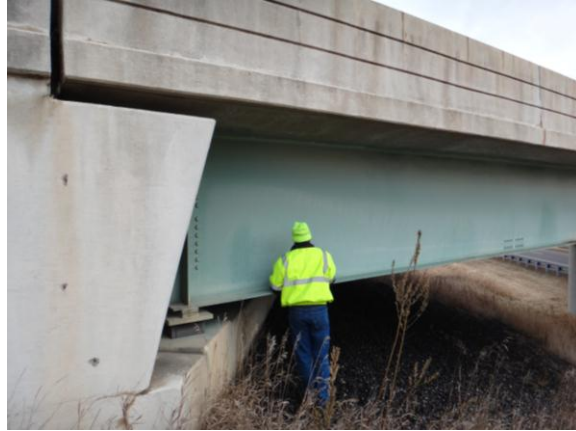
Figure 3.1.4: Bridge #9838 sampling location with roadway

No arsenic, chromium, mercury, selenium, or silver was detected for Bridge #9838. Barium reported 0.082 mg/L and lead reported 0.12 mg/L; both are below the regulatory maximum concentrations. Cadmium reported 0.74 mg/L which is within 0.26 mg/L of the regulated levels, but remained below the regulatory maximum concentration of 1.0 mg/L.

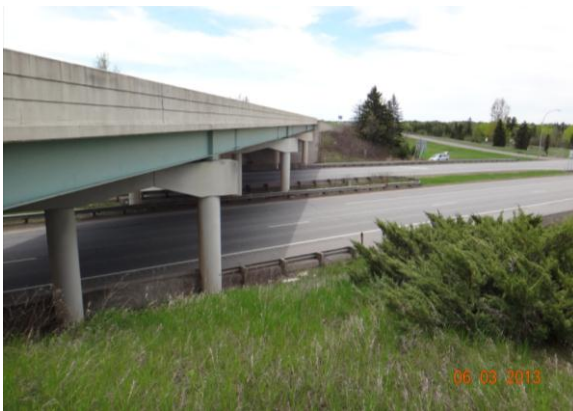
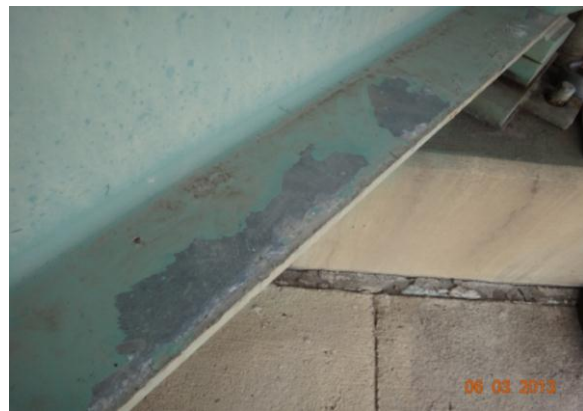
Figure 3.1.5: Bridge #9188 with roadway

Figure 3.1.6: Bridge #9188 sampling location

No arsenic, chromium, mercury, selenium, or silver was detected for Bridge #9188. The reported level of 0.31 mg/L for barium and 0.072 mg/L for cadmium were both below regulatory maximum concentrations.

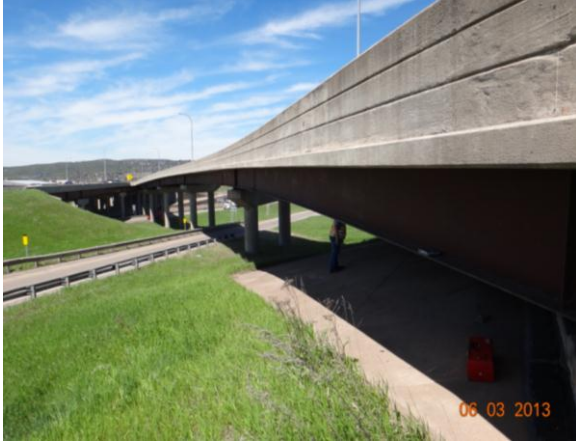
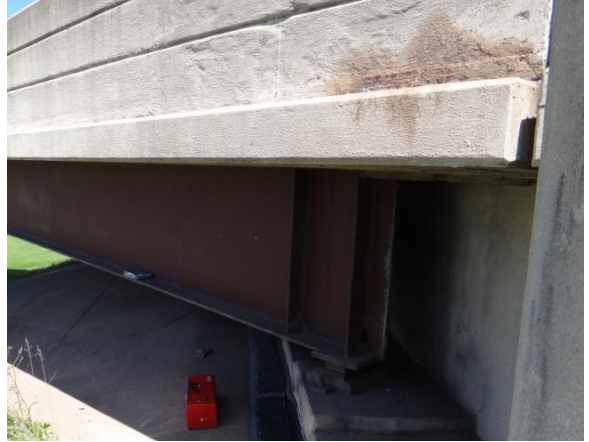
Figure 3.1.7: Bridge #69808A with roadway

Figure 3.1.8: Bridge #69808A sampling location

No arsenic, chromium, mercury, selenium, or silver was detected for Bridge #69808A. The reported level of 1.3 mg/L for barium, 0.10 mg/L for cadmium, and 1.0 mg/L for lead were all below regulatory maximum concentrations.

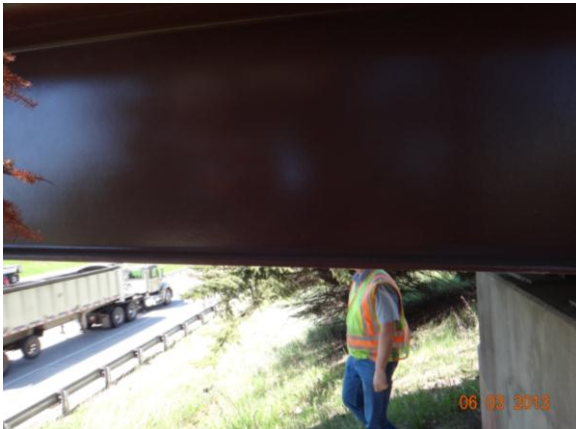
Figure 3.1.9: Bridge #69811 with roadway

No arsenic, chromium, mercury, selenium, or silver was detected for Bridge #69811. The reported level of 0.53 mg/L for barium, 0.12 mg/L for cadmium, and 0.12 mg/L for lead were all below regulatory maximum concentrations.

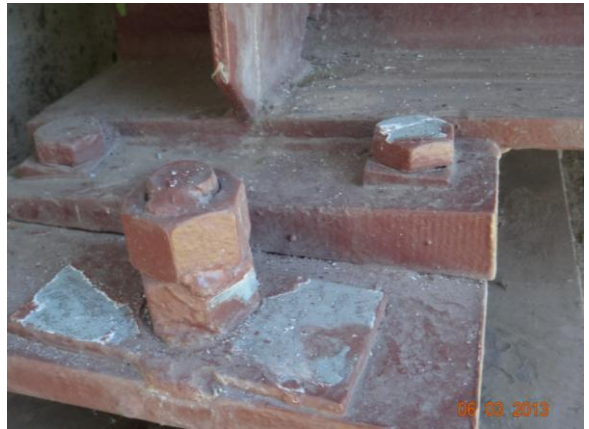
Figure 3.1.10: Bridge #69811 sampling location

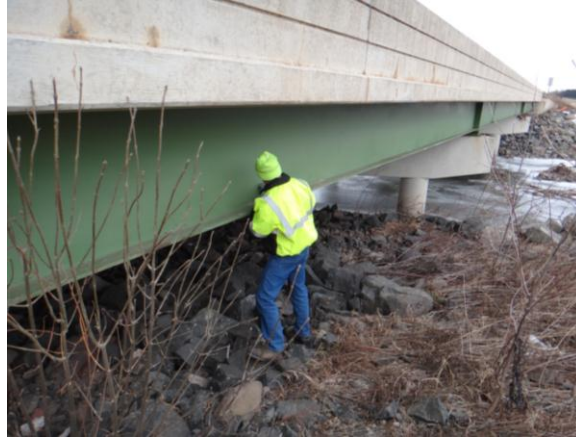
Figure 3.1.11: Bridge #9339 sampling location with waterway

No chromium, mercury, selenium, or silver was detected for Bridge #9339. The reported level of 0.17 mg/L for arsenic, 0.27 mg/L for barium, 0.031 mg/L for cadmium, and 0.15 mg/L for lead were all below regulatory maximum concentrations.

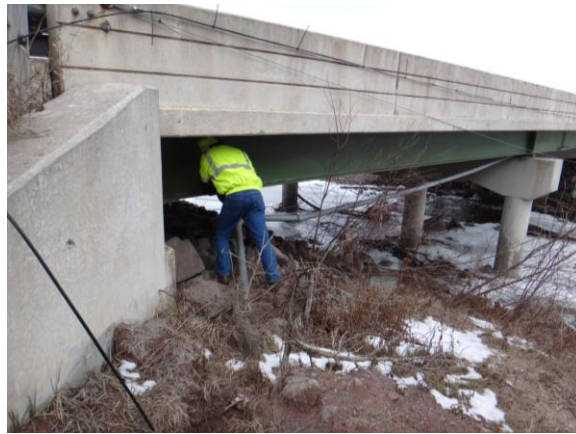
Figure 3.1.12: Bridge #9341 sampling location with waterway

No cadmium, chromium, mercury, selenium, or silver was detected for Bridge #9339. The reported level of 0.15 mg/L for arsenic, 0.11 mg/L for barium, and 0.045 mg/L for lead were all below regulatory maximum concentrations.

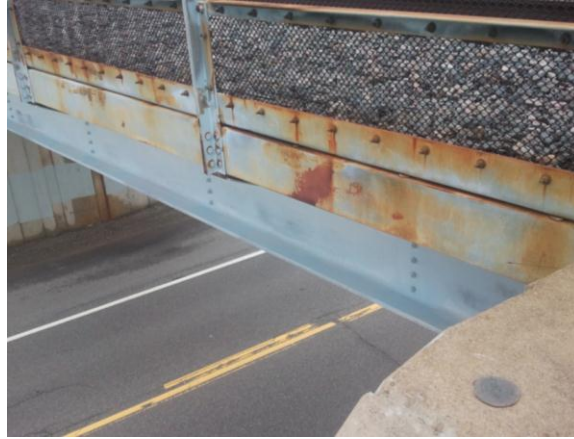
Figure 3.1.13: Bridge #9186 with roadway

No cadmium, chromium, mercury, selenium, or silver were detected for Bridge #9186. There were reported levels of 0.085 mg/L for barium, and 0.048 mg/L for cadmium. In contrast, 59.8 mg/L was detected for lead. This sample exceeded the maximum federal standard of 5.0 mg/L for lead.

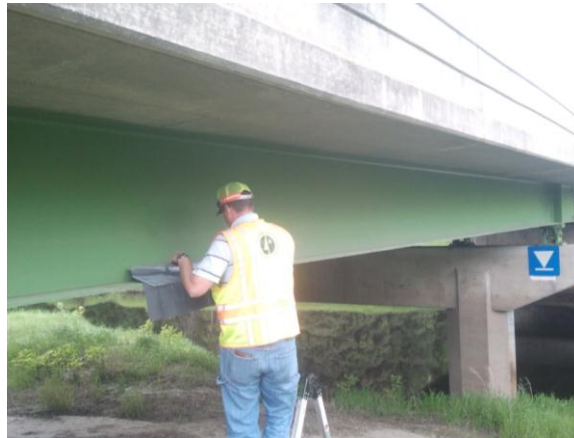
Figure 3.1.14: Bridge #6503 sampling location with waterway

No cadmium, chromium, mercury, selenium, or silver were detected for Bridge #6503. There were reported levels of 0.085 mg/L, 0.048 mg/L, and 0.15 mg/L for barium, cadmium and lead, respectively. All of these concentrations were below the regulatory maximum concentration.

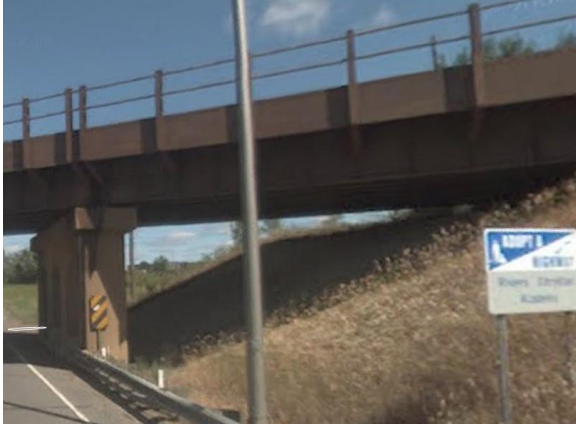
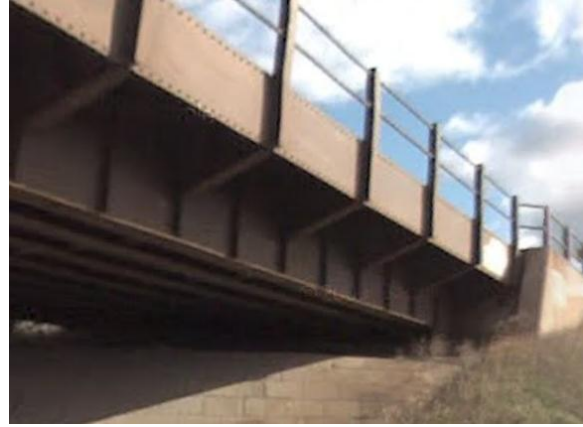
Figure 3.2.1: Bridge #9480 with roadway

Figure 3.2.2: Bridge #9480 sample location

No arsenic, barium, cadmium, chromium, mercury, selenium or silver was detected for Bridge #9480. However, lead concentrations were reported at 224 mg/L. This concentration is more than forty-five times greater than the USEPA regulatory maximum concentrations of 5.0 mg/L.

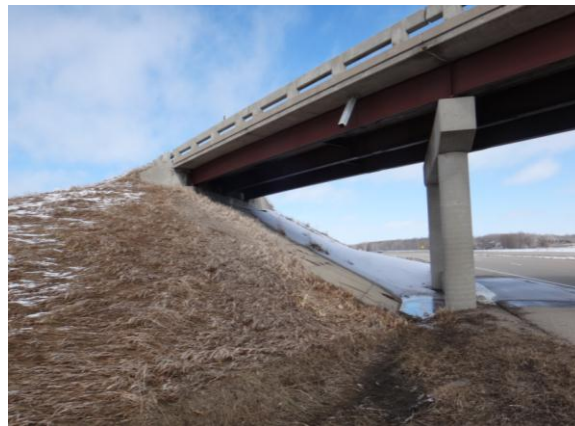
Figure 3.2.3: Bridge #73818 with roadway

No arsenic, chromium, mercury, selenium, or silver was detected for Bridge #73818. The reported level of 0.14 mg/L for barium, 0.089 mg/L for cadmium, and 1.1 mg/L for lead were all below regulatory maximum concentrations.

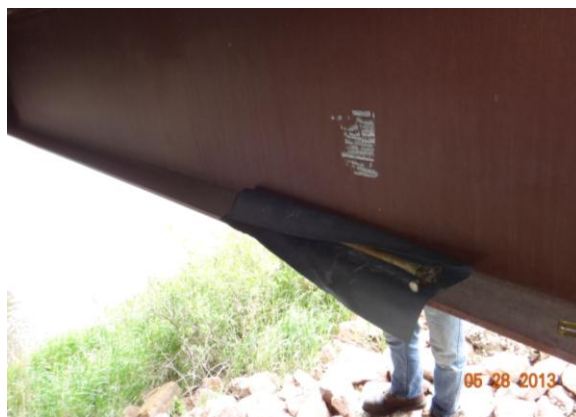
Figure 3.3.1: Bridge #67806 sampling location with waterway

No arsenic, chromium, mercury, selenium, or silver was detected for Bridge #67806. The reported level of 0.13 mg/L for barium, 0.26 mg/L for cadmium, and 1.0 mg/L for lead were all below regulatory maximum concentrations.

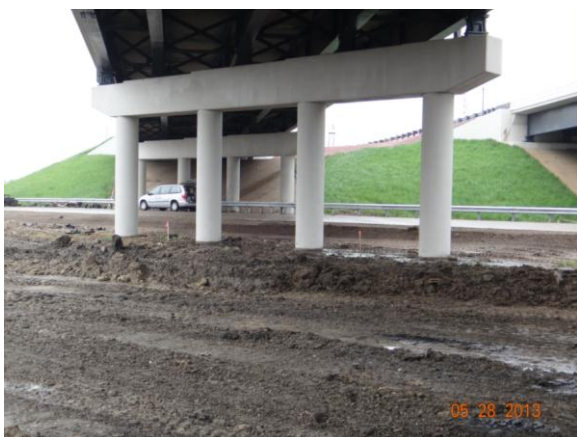
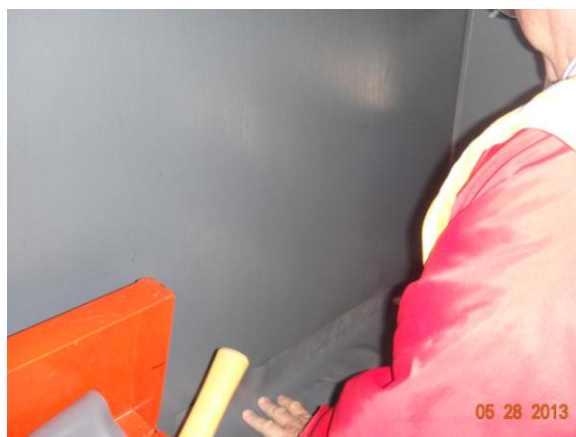
Figure 3.3.2: Bridge #53820 with roadway

Figure 3.3.3: Bridge #53820 sampling location

No arsenic, cadmium, chromium, mercury, selenium, or silver was detected for Bridge #53820. The reported level of 0.057 mg/L for barium and 0.057 mg/L for lead were both below regulatory maximum concentrations.

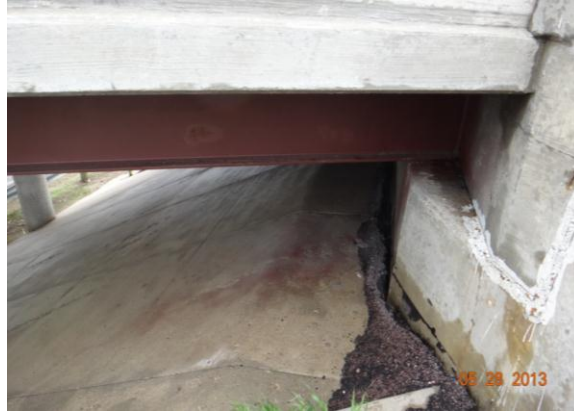
Figure 3.3.4: Bridge #67801 sampling location with roadway shoulder

No arsenic, chromium, mercury, selenium, or silver was detected for Bridge #67801. The reported level of 0.17 mg/L for barium, 0.21 mg/L for cadmium, and 0.83 mg/L for lead were all below regulatory maximum concentrations.

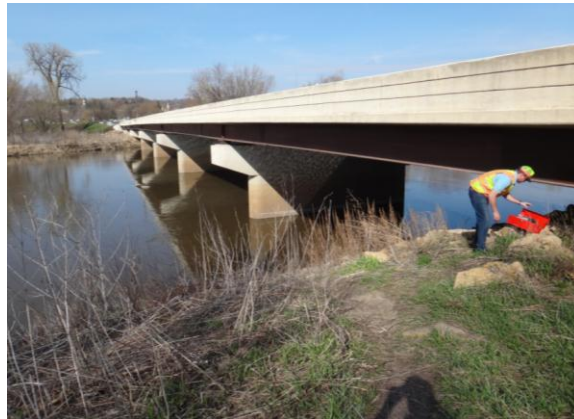
Figure 3.3.5: Bridge #40001 sampling location with waterway

No arsenic, chromium, mercury, selenium, or silver was detected for Bridge #40001. The reported level of 0.14 mg/L for barium, 0.046 mg/L for cadmium, and 0.66 mg/L for lead were all below regulatory maximum concentrations.

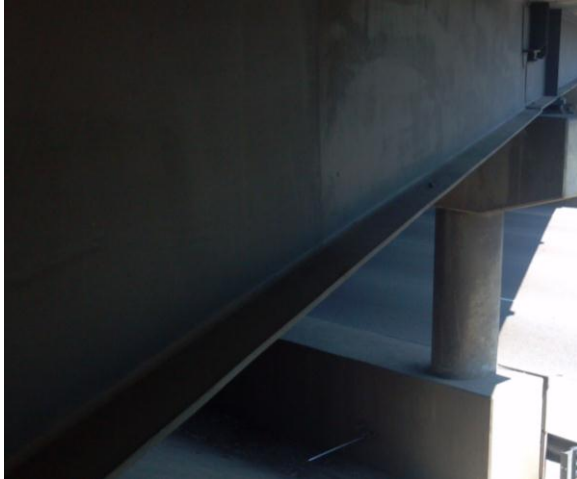
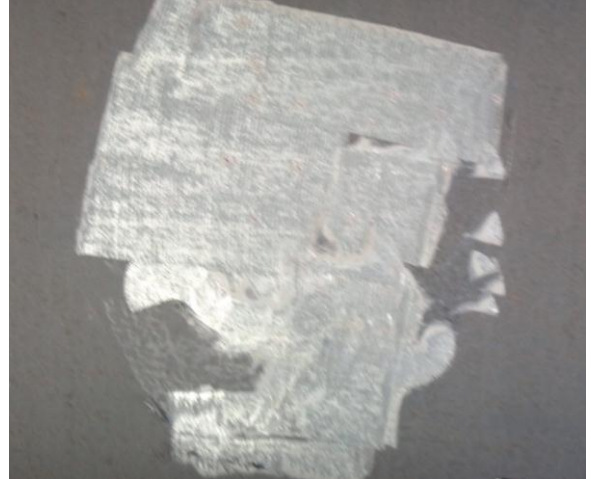
Figure 3.4.1: Bridge #27869 with roadway

Figure 3.4.2: Bridge #27869 sampling location

No arsenic, chromium, mercury, selenium, or silver was detected for Bridge #27869. Reported level of 0.49 mg/L for barium, 0.16 mg/L for cadmium, and 0.69 mg/L for lead were below the regulatory maximum concentration.

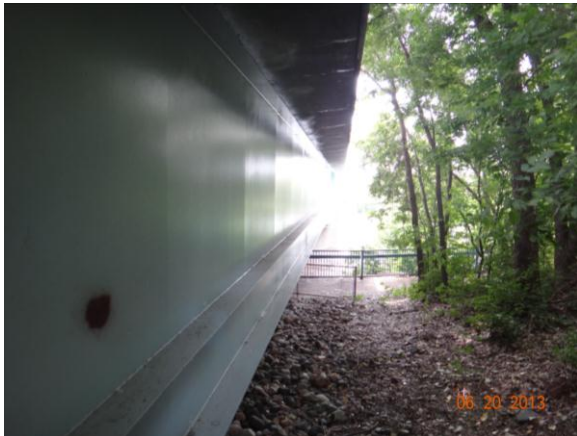
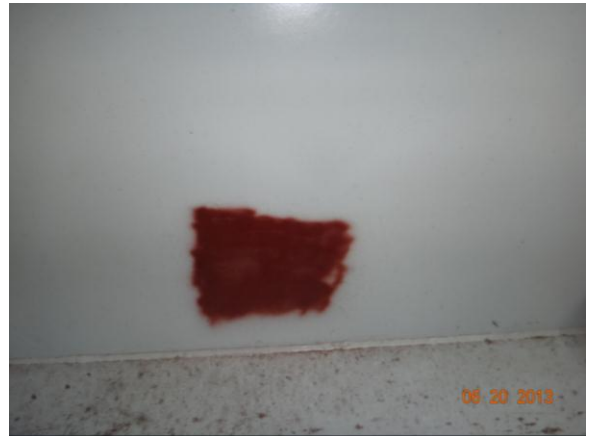
Figure 3.4.3: Bridge #27549A with waterway

Figure 3.4.4: Bridge #27549A sampling location

No arsenic, cadmium, chromium, lead, mercury, selenium, or silver was detected for Bridge #27549A. The reported level of 4.9 mg/L for barium is below the regulatory maximum concentration.

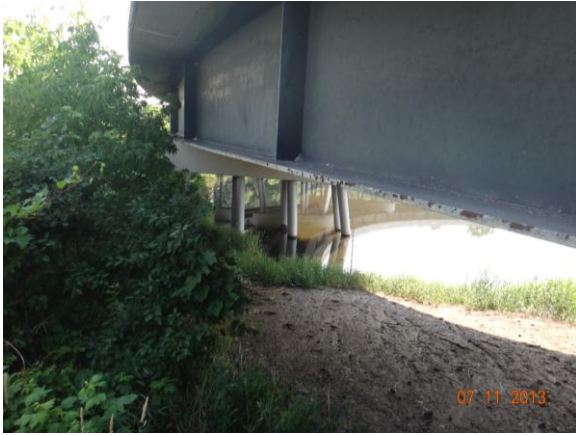
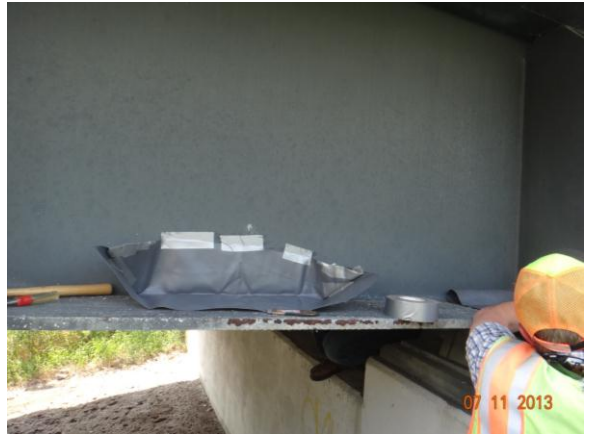
Figure 3.4.5: Bridge #27031A with roadway

Figure 3.4.6: Bridge #27031A sampling location

No arsenic, chromium, mercury, selenium, or silver was detected for Bridge #27031A. The reported levels of 0.37 mg/L for barium, 0.19 mg/L for cadmium, and 0.44 mg/L for lead were below the regulatory maximum concentration.

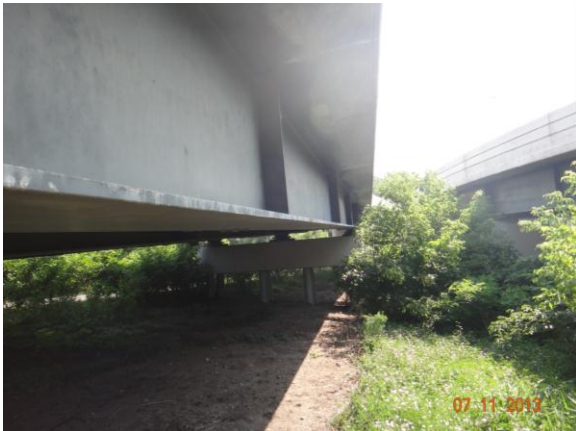
Figure 3.4.7: Bridge #27031B

No arsenic, chromium, mercury, selenium, or silver was detected for Bridge #27031B. The reported levels of 0.30 mg/L for barium, 0.90 mg/L for cadmium, and 0.40 mg/L for lead were below the regulatory maximum concentration.

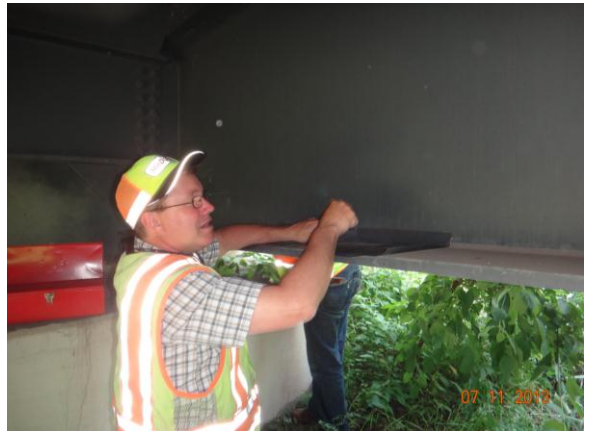
Figure 3.4.8: Bridge #27031B sampling location

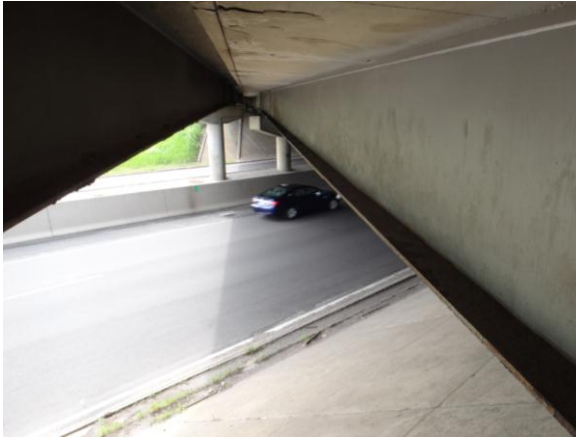
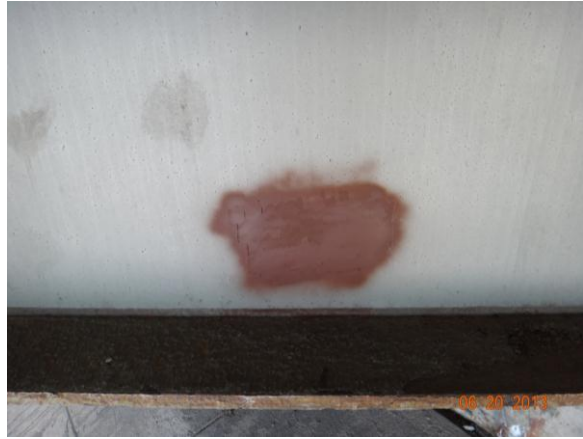
Figure 3.4.9: Bridge #27038 with roadway

Figure 3.4.10: Bridge #27038 sampling location

No arsenic, chromium, mercury, selenium, or silver was detected for Bridge #27038. The reported level of 0.12 mg/L for barium 0.31 mg/l for lead and 0.13 mg/L for cadmium were both below regulatory maximum concentrations.

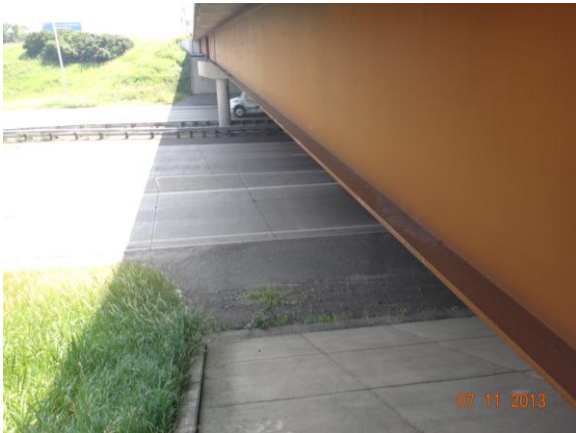
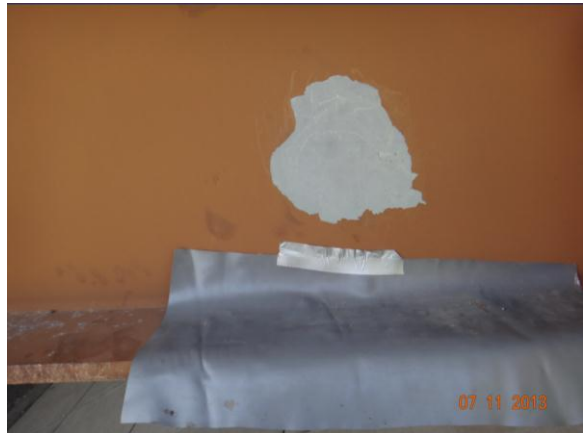
Figure 3.4.11: Bridge #27033 with roadway

Figure 3.4.12: Bridge #27033 sampling location

No arsenic, mercury, selenium, or silver was detected for Bridge #27033. The reported levels of 0.40 mg/L for barium, 0.15 mg/L for cadmium, 0.079 mg/l for chromium, and 0.19 mg/L for lead were below regulatory maximum concentrations.

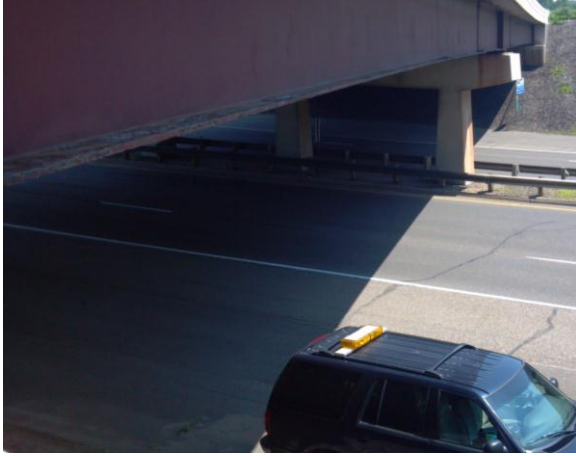
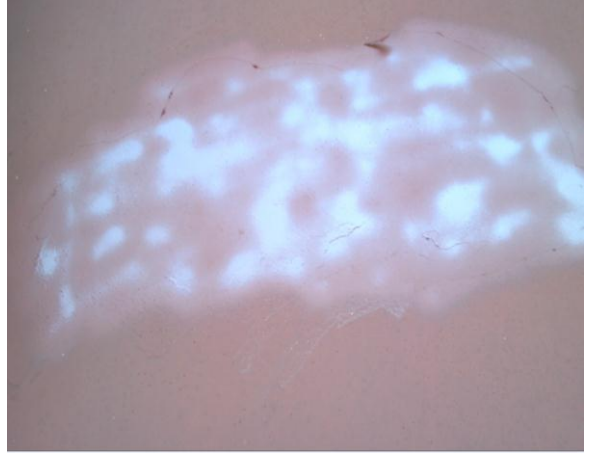
Figure 3.4.13: Bridge #82849 with roadway

Figure 3.4.14: Bridge #82849 sampling location

No arsenic, chromium, mercury, selenium, or silver was detected for Bridge #82849. The reported levels of 0.83 mg/L for barium, 0.17 mg/L for cadmium, and 0.13 mg/L for lead were below regulatory maximum concentrations.

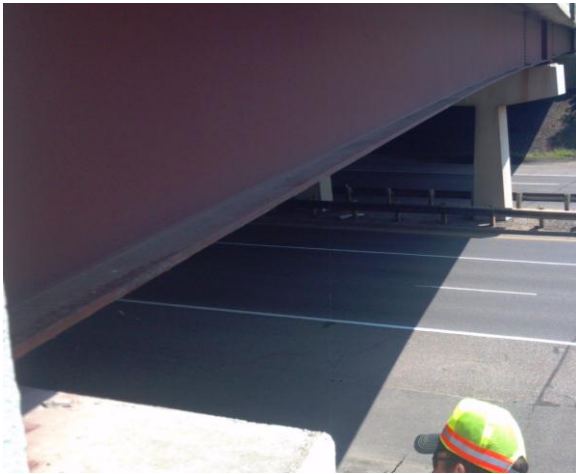
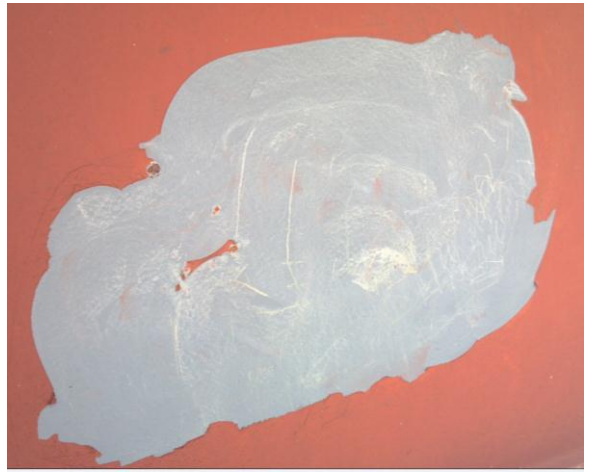
Figure 3.4.15: Bridge #82850 with roadway

Figure 3.4.16: Bridge #82850 sampling location

No arsenic, chromium, mercury, selenium, or silver was detected for Bridge #82850. The reported levels of 0.72 mg/L for barium, 0.091 for cadmium, and 0.13 for lead were below regulatory maximum concentrations.

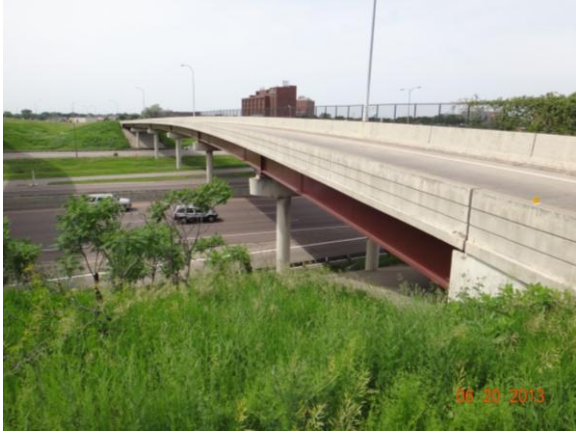
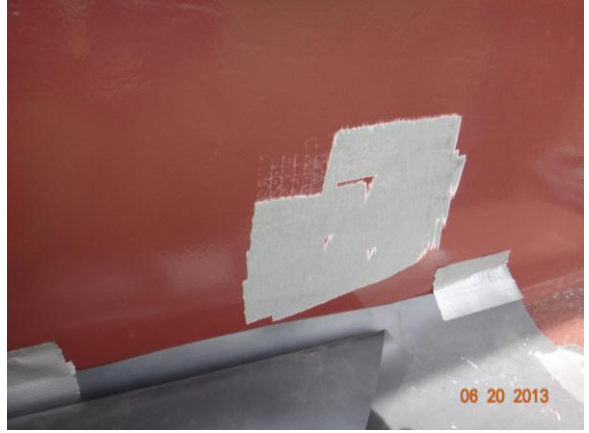
Figure 3.4.17: Bridge #27913 with roadway

Figure 3.4.18: Bridge #27913 sampling location

No arsenic, cadmium, chromium, lead, mercury, selenium, or silver was detected for Bridge #27913. The reported level of 0.055 mg/L for barium is below the regulatory maximum concentration.

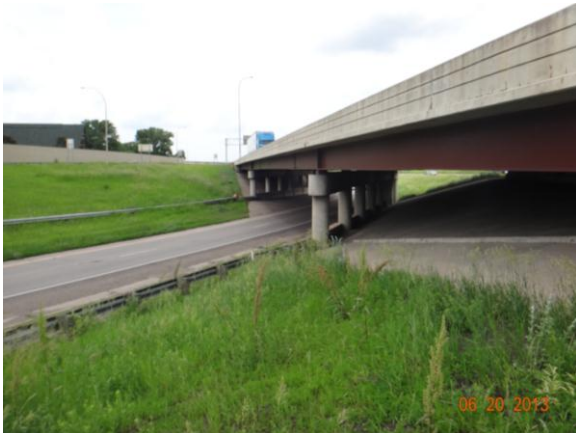
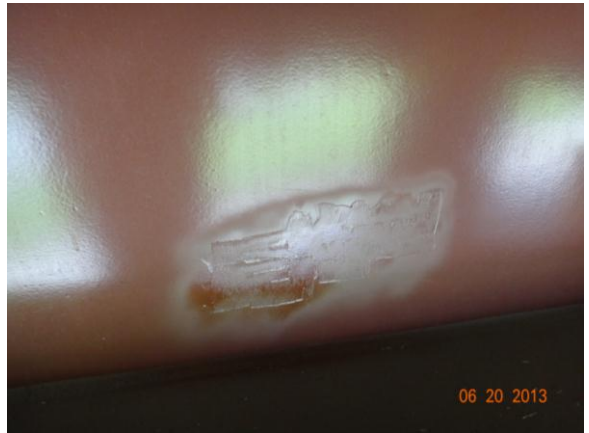
Figure 3.4.19: Bridge #27734 with roadway

Figure 3.4.20: Bridge #27734 sampling location

No arsenic, chromium, mercury, selenium, or silver was detected for Bridge #27734. The reported level of 10.3 mg/L for barium, 0.029 mg/L for cadmium, and 0.22 mg/L for lead were below regulatory maximum concentrations.

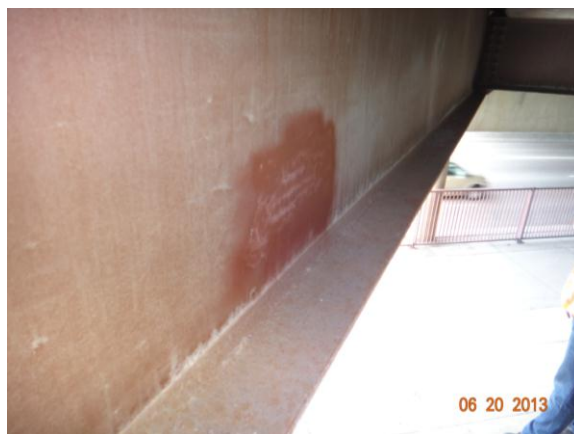
Figure 3.4.21: Bridge #27924 sampling location with roadway

No arsenic, chromium, mercury, selenium, or silver was detected for Bridge #27924. The reported level of 0.18 mg/L for barium, 0.087 mg/L for cadmium, and 0.60 mg/L for lead were below regulatory maximum concentrations.

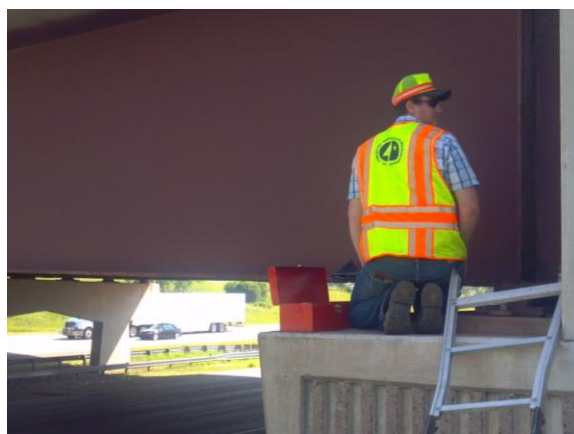
Figure 3.4.22: Bridge #82846 sampling location with roadway

No arsenic, chromium, mercury, selenium, or silver was detected for Bridge #82846. The reported level of 0.45 mg/l for barium, 0.21 mg/l for cadmium, 0.61 mg/L for lead were below regulatory maximum concentrations.

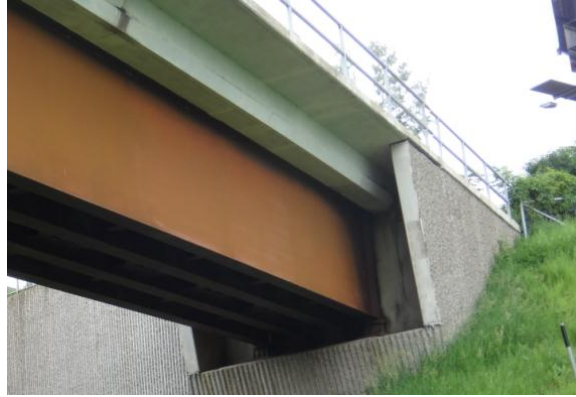
Figure 3.4.23: Bridge #19829 sampling location

No arsenic, chromium, mercury, selenium, or silver was detected for Bridge #19829. The reported level of 0.54 mg/L for barium, 0.099 mg/L for cadmium, and 0.057 mg/L for lead were below regulatory maximum concentrations.

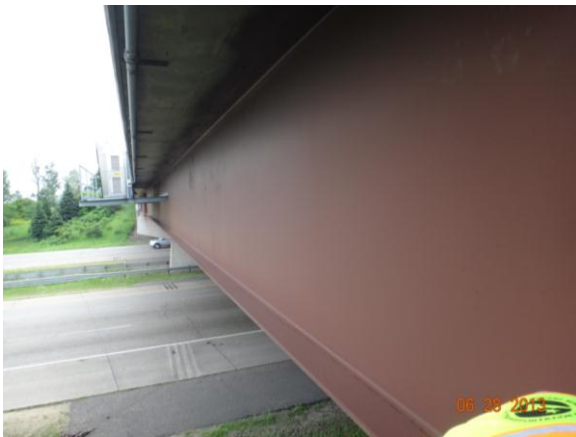
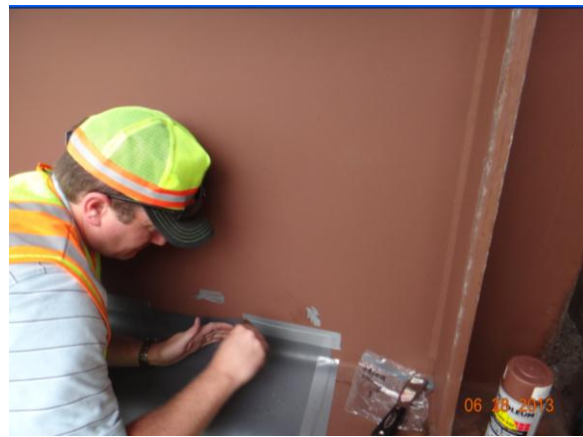
Figure 3.4.24: Bridge #82844 with roadway

Figure 3.4.25: Bridge #82844 sampling location

No arsenic, chromium, mercury, selenium, or silver was detected for Bridge #82844. The reported level of 0.19 mg/L for barium, 0.27 mg/L for cadmium, and 0.96 mg/L for lead were below regulatory maximum concentrations.

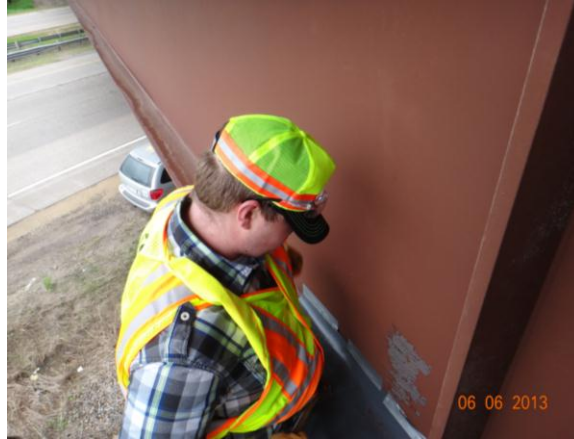
Figure 3.4.26: Bridge #82848 sampling location with roadway

No arsenic, chromium, mercury, selenium, or silver was detected for Bridge #82848. The reported level of 0.32 mg/L for barium, 0.43 mg/L for cadmium, and 1.5 mg/L for lead were below regulatory maximum concentrations.

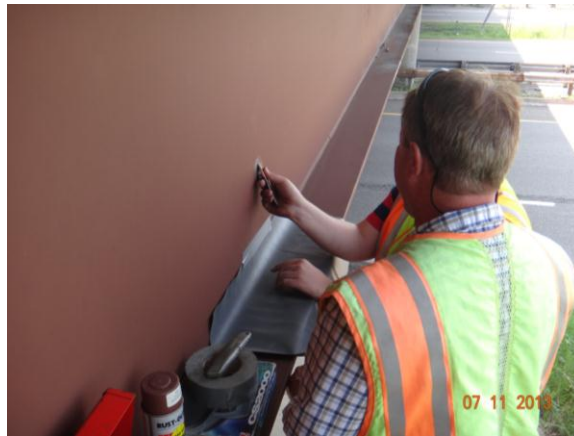
Figure 3.4.27: Bridge #27079 with roadway

No arsenic, chromium, mercury, selenium, or silver was detected for Bridge #27079. The reported level of 0.42 mg/L for barium, 0.23 mg/L for cadmium, and 2.7 mg/L for lead were below regulatory maximum concentrations.

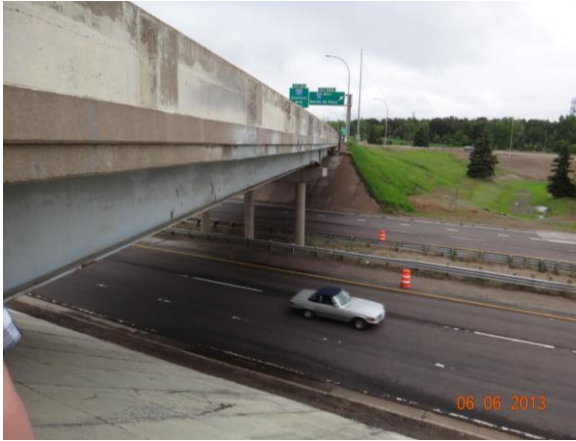
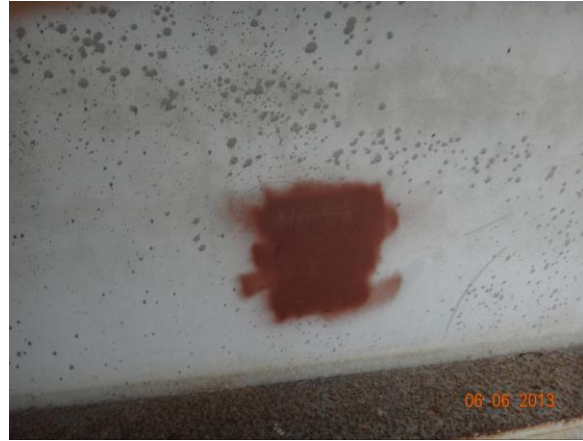
Figure 3.4.28: Bridge #82814 with roadway

Figure 3.4.29: Bridge #82814 sampling location

No arsenic, chromium, mercury, selenium, or silver was detected for Bridge #82814. The reported level of 0.16 mg/L for barium, 0.16 mg/L for cadmium, and 0.18 mg/L for lead were below regulatory maximum concentrations.

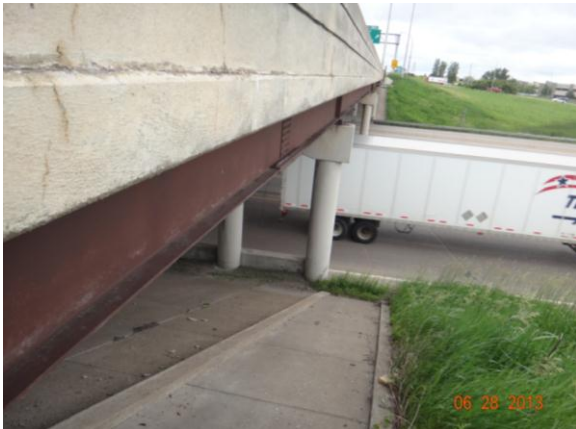
Figure 3.4.30: Bridge #82832 with roadway

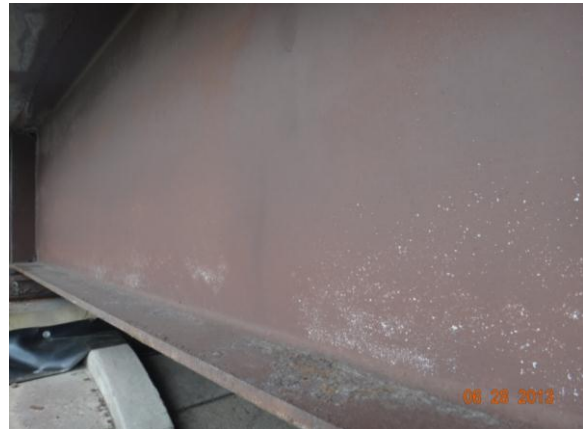
Figure 3.4.31: Bridge #82832 sampling location

No arsenic, chromium, mercury, selenium, or silver was detected for Bridge #82832. The reported level of 0.65 mg/L for barium, 0.029 mg/L for cadmium, and 0.66 mg/L for lead were below regulatory maximum concentrations.

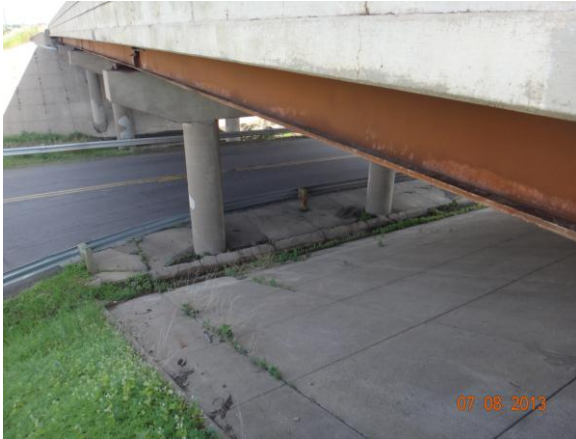
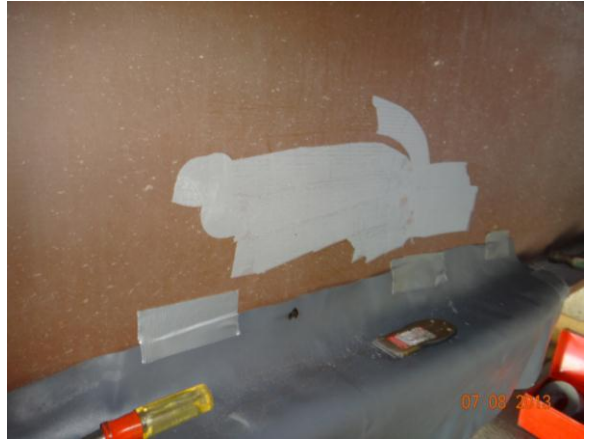
Figure 3.4.32: Bridge #9351 with roadway

Figure 3.4.33: Bridge #9351 sampling location

No arsenic, mercury, selenium, or silver was detected for Bridge #9351. The reported level of 0.31 mg/L for barium, 0.11 mg/L for cadmium, 0.066 mg/L for chromium, and 0.34 mg/L for lead were below regulatory maximum concentrations.

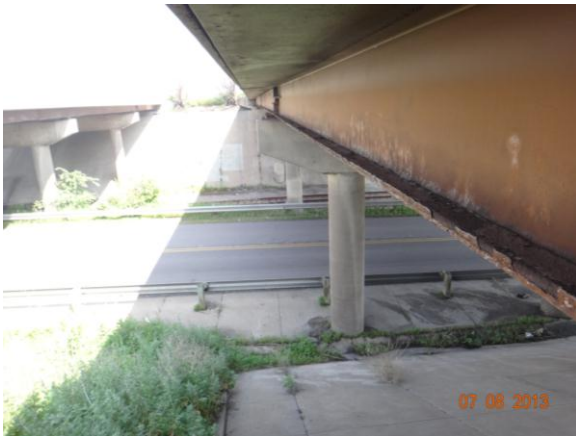
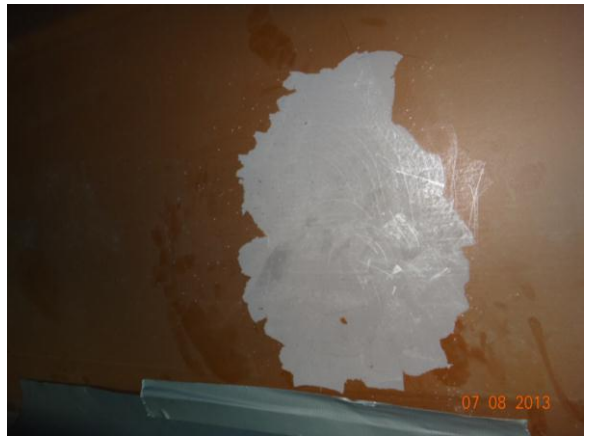
Figure 3.4.34: Bridge #9352 with roadway

Figure 3.4.35: Bridge #9352 sampling location

No arsenic, mercury, selenium, or silver was detected for Bridge #9352. The reported level of 0.63 mg/L for barium, 0.30 mg/L for cadmium, 0.18 mg/L for chromium, and 0.41 mg/L for lead were below regulatory maximum concentrations.

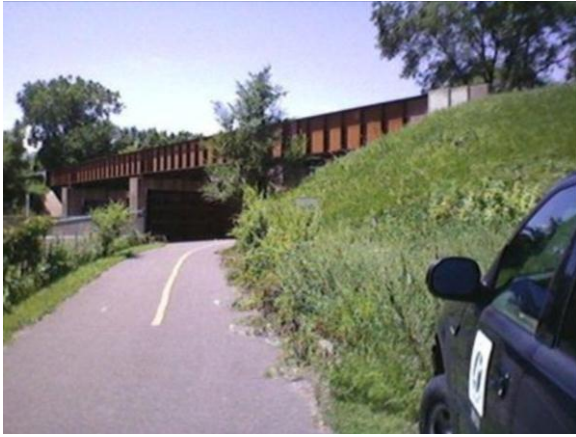
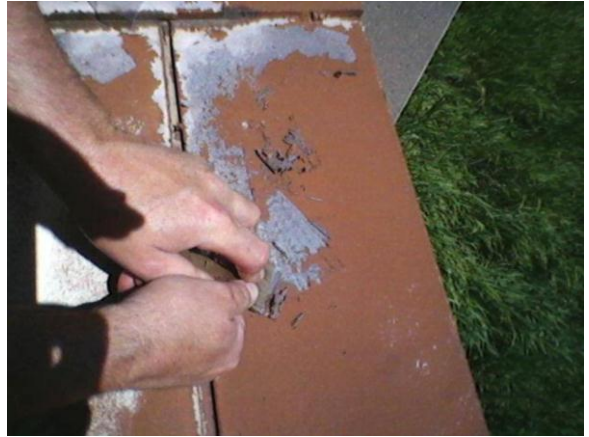
Figure 3.4.36: Bridge #9390 with roadway

Figure 3.4.37: Bridge #9390 sampling location

No arsenic, chromium, mercury, selenium, or silver were detected for Bridge #9390. The reported levels of 0.29 mg/L for barium, 0.11 mg/L for cadmium, and 0.41 mg/L for lead were below regulatory maximum concentrations.

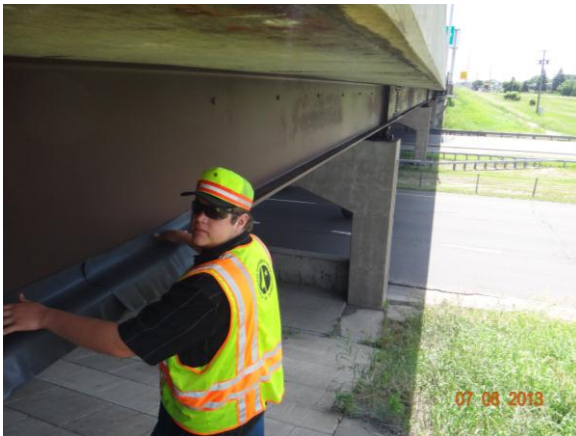
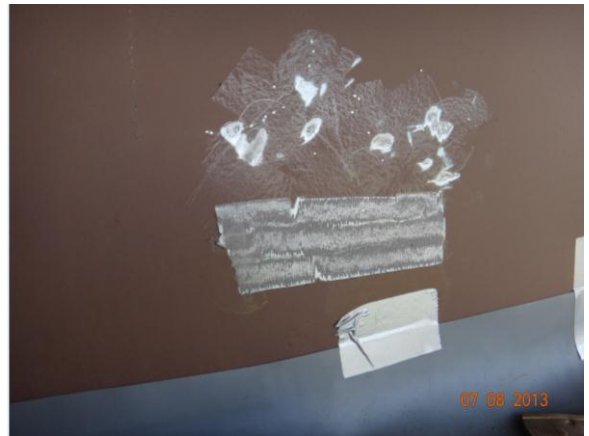
Figure 3.4.38: Bridge #9012 with roadway

Figure 3.4.39: Bridge #9012 sampling location

No arsenic, chromium, mercury, selenium, or silver were detected for Bridge #9012. The reported levels of 0.32 mg/L of barium, 0.35 mg/L of cadmium, and 0.24 mg/L of lead were below regulatory maximum concentrations.

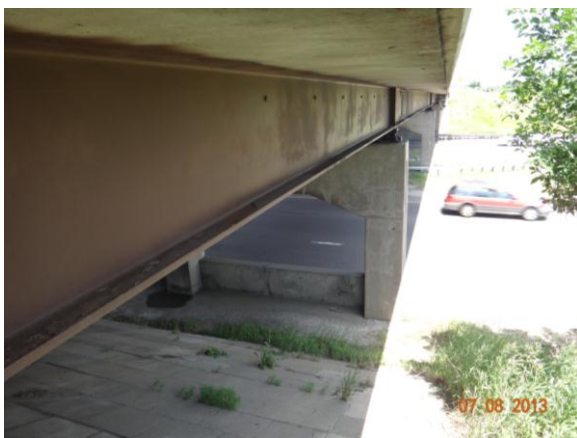
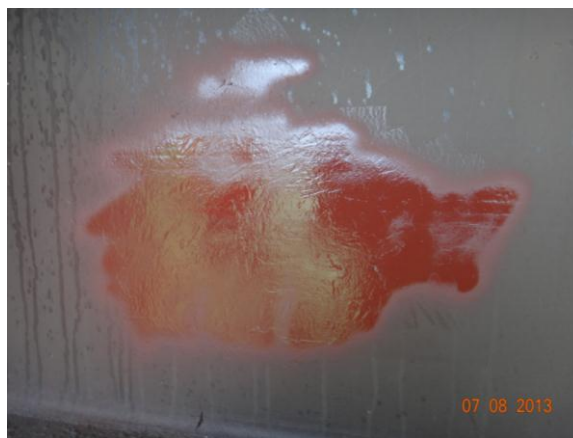
Figure 3.4.40: Bridge #9013 with roadway

Figure 3.4.41: Bridge #9013 sampling location

No arsenic, chromium, mercury, selenium, or silver was detected for Bridge #9013. The reported level of 0.56 mg/L for barium, 0.68 mg/L for cadmium, and 0.19 mg/L for lead were below regulatory maximum concentrations.

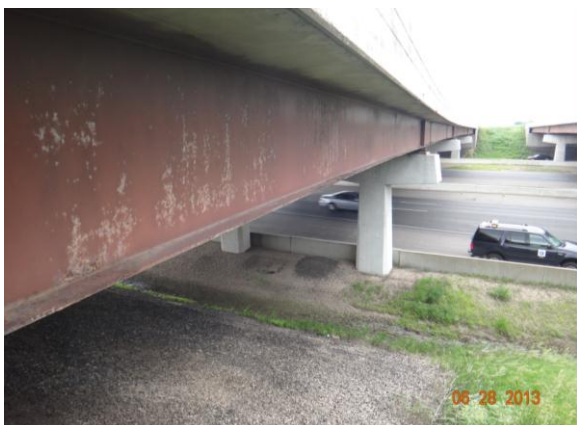
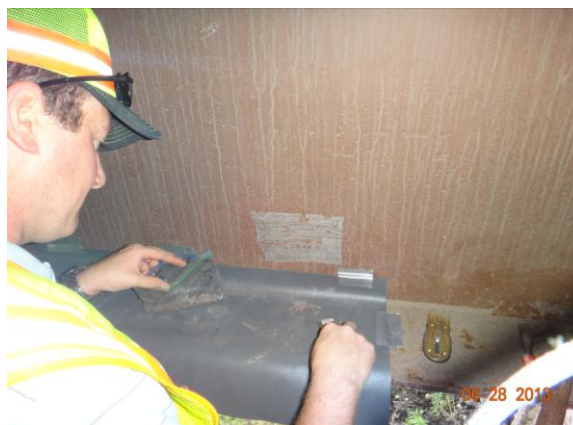
Figure 3.4.42: Bridge #19823 with roadway

Figure 3.4.43: Bridge #19823 sampling location

No arsenic, chromium, mercury, selenium, or silver was detected for Bridge #19823. The reported level of 0.74 mg/L for barium, 0.13 mg/L for cadmium, and 0.19 mg/L for lead were below regulatory maximum concentrations.

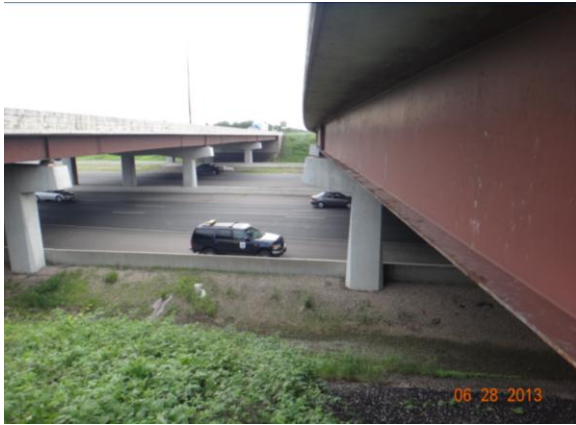
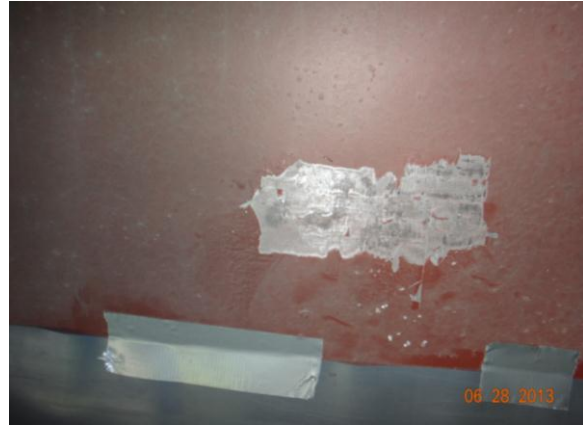
Figure 3.4.44: Bridge #19824 with roadway

Figure 3.4.45: Bridge #19824 sampling location

No arsenic, chromium, mercury, selenium, or silver was detected for Bridge #19824. The reported level of 0.67 mg/L for barium, 0.11 mg/L for cadmium, and 0.26 mg/L for lead were below regulatory maximum concentrations.

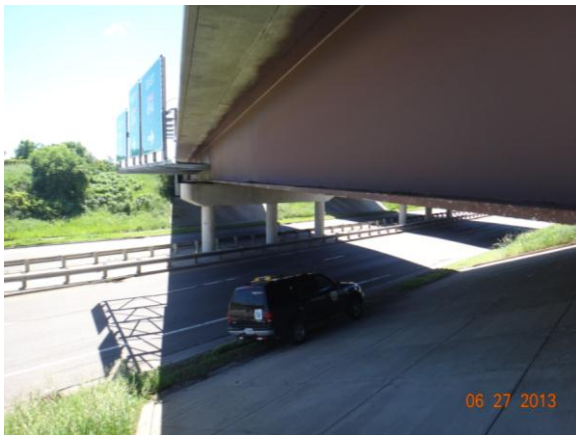
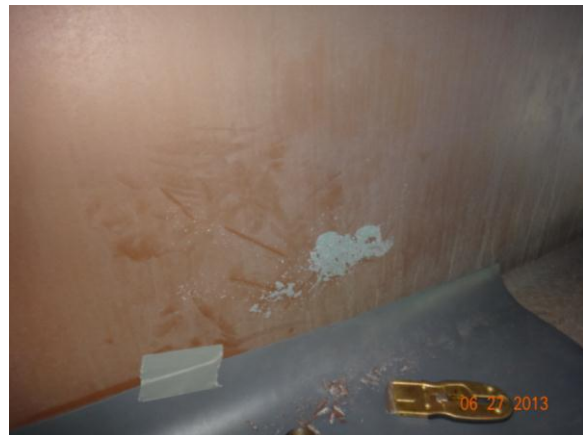
Figure 3.4.49: Bridge #19037 with roadway

Figure 3.4.50: Bridge #19037 sampling location

No arsenic, chromium, mercury, selenium, or silver was detected for Bridge #19037. The reported level of 0.14 mg/L for barium, 0.020 mg/L for cadmium, and 0.84 mg/L for lead were below regulatory maximum concentrations.

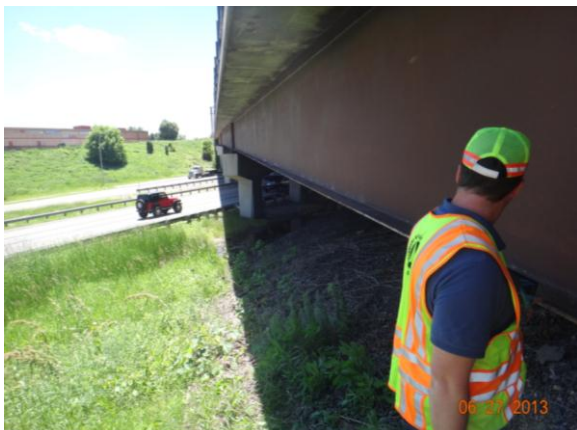
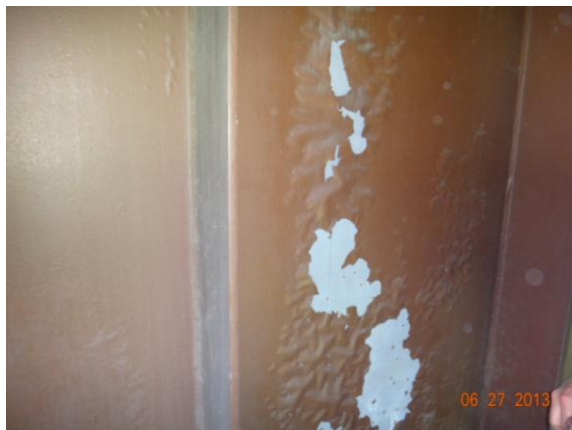
Figure 3.4.51: Bridge #19832 with roadway

Figure 3.4.52: Bridge #19832 sampling location

No arsenic, chromium, mercury, selenium, or silver was detected for Bridge #19832. The reported level of 0.059 mg/L for barium, 0.023 mg/L for cadmium, and 0.84 mg/L for lead were below regulatory maximum concentrations.
