Statewide Vinyl Bridge Paint Testing

Statewide Environmental Study Report

**Minnesota Department of Transportation
The Office of Environmental Stewardship
Environmental Modeling and Testing Unit**

July 2013

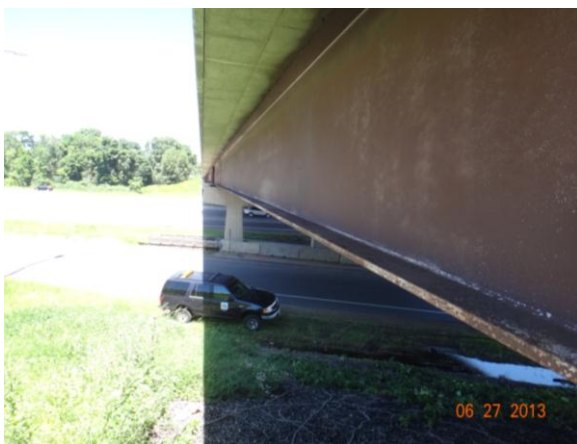
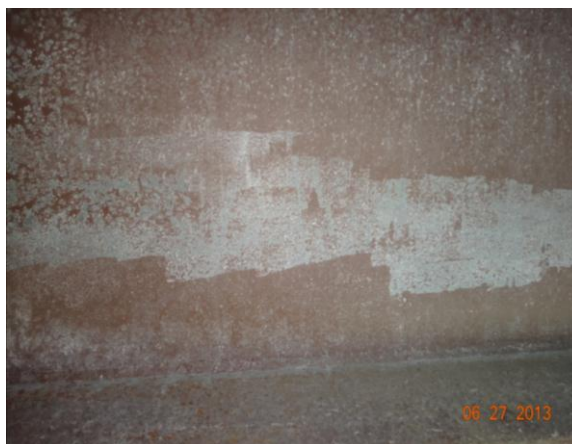
Figure 3.4.53: Bridge #19854 with roadway

Figure 3.4.54: Bridge #19854 sampling location

No arsenic, cadmium, chromium, mercury, selenium, or silver was detected for Bridge #19854. The reported level of 0.18 mg/L for barium and 0.17 mg/L for lead were below regulatory maximum concentrations.

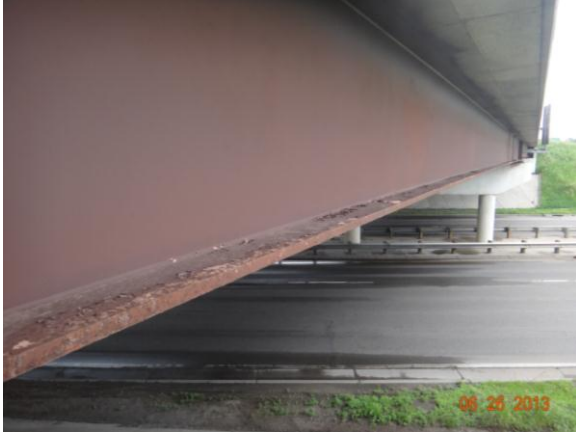
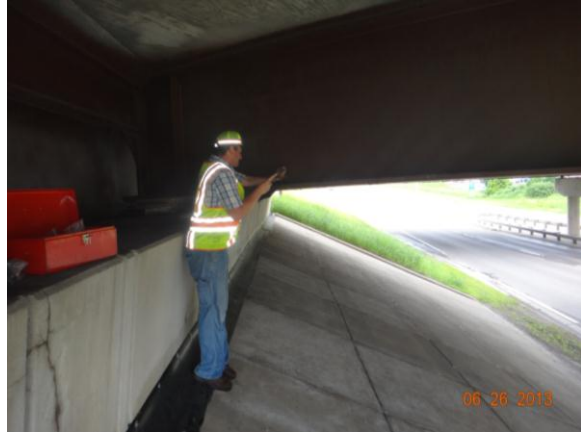
Figure 3.4.55: Bridge #19038 with roadway

Figure 3.4.56: Bridge #19038 sampling location

No arsenic, chromium, mercury, selenium, or silver was detected for Bridge #19038. The reported level of 0.25 mg/L for barium, 0.028 mg/L for cadmium, and 0.55 mg/L for lead were below regulatory maximum concentrations.

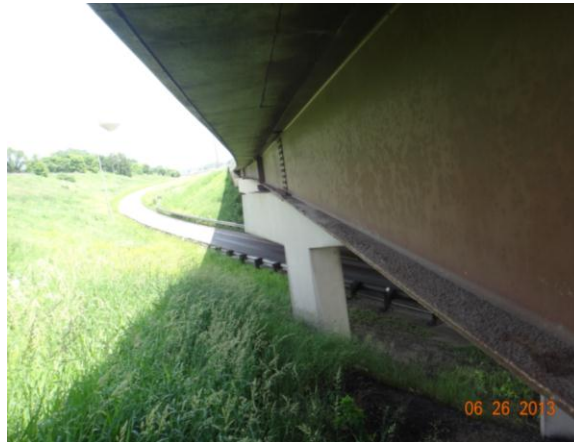
Figure 3.4.57: Bridge #19884 sampling location with roadway

No arsenic, chromium, mercury, selenium, or silver was detected for Bridge #19884. The reported level of 0.19 mg/L for barium, 0.026 mg/L for cadmium, and 0.53 mg/L for lead were below regulatory maximum concentrations.

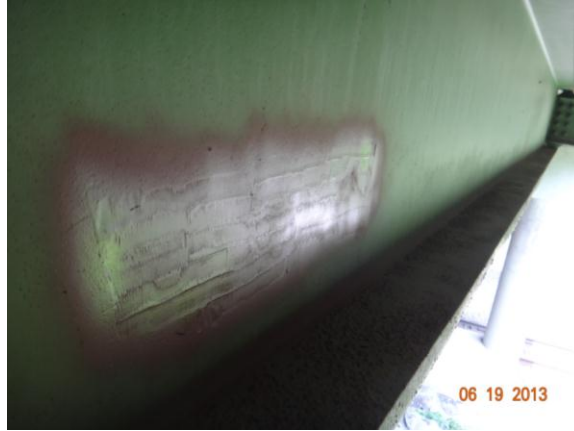
Figure 3.4.58: Bridge #27513 sampling location with roadway

No arsenic, chromium, mercury, selenium, or silver was detected for Bridge #27513. The reported level of 0.14 mg/L for barium, 0.15 mg/L for cadmium, and 0.093 mg/L for lead were below regulatory maximum concentrations.

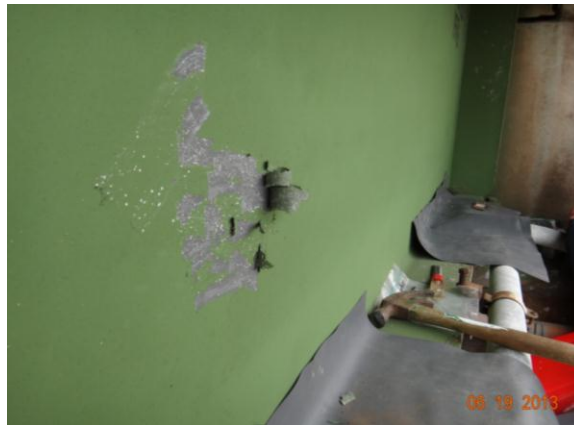
Figure 3.4.59: Bridge #27517 sampling location

No arsenic, chromium, mercury, selenium, or silver was detected for Bridge #27517. The reported level of 0.41 mg/L for barium, 0.18 mg/L for cadmium, and 0.25 mg/L for lead were below regulatory maximum concentrations.

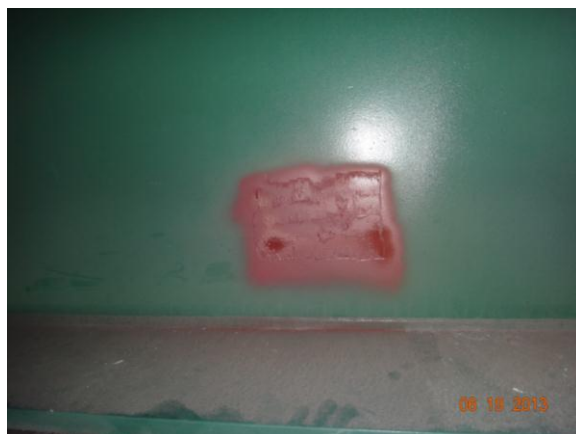
Figure 3.4.60: Bridge #27106 sampling location

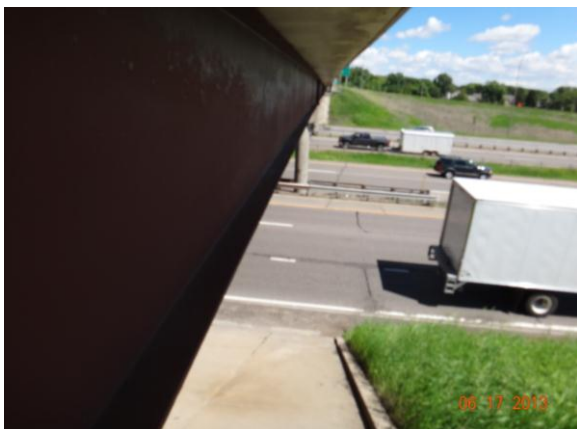
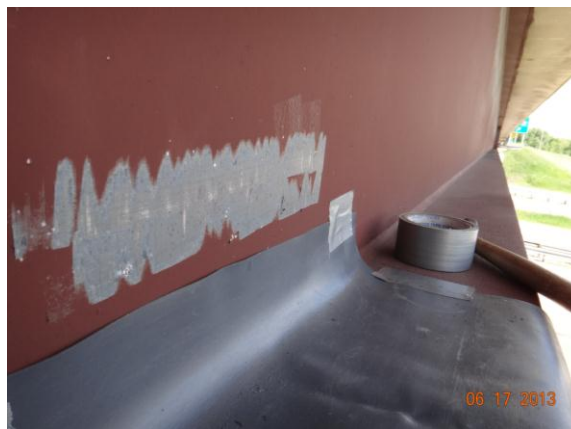
Figure 3.4.61: Bridge #27080 with roadway

Figure 3.4.62: Bridge #27080 sampling location

No arsenic, chromium, mercury, selenium, or silver was detected for Bridge #27080. The reported level of 0.18 mg/L for barium, 0.57 mg/L for cadmium, and 0.28 mg/L for lead were below regulatory maximum concentrations.

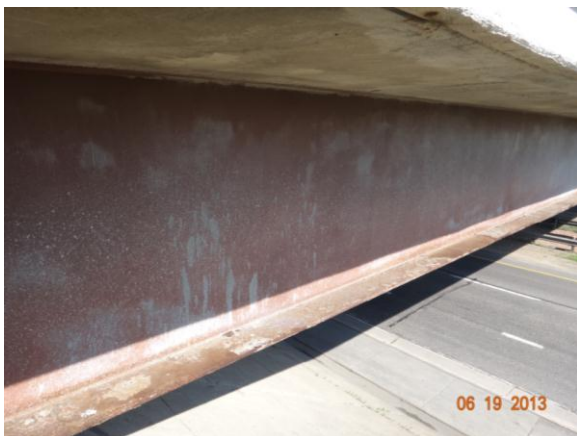
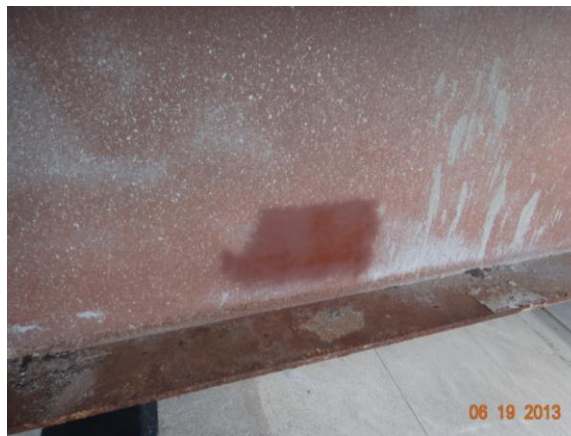
Figure 3.4.63: Bridge #27014 with roadway

Figure 3.4.64: Bridge #27014 sampling location

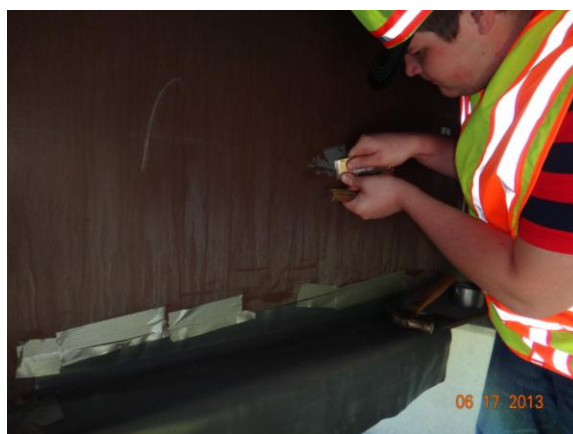
Figure 3.4.65: Bridge #27573 sample location
