FIELD EVALUATION OF NEW TECHNOLOGIES FOR MEASURING PAVEMENT QUALITY

Report 0-4774-2
Project 0-4774

Project Title: New Technologies and Approaches to Controlling the Quality
of Flexible Pavement Construction

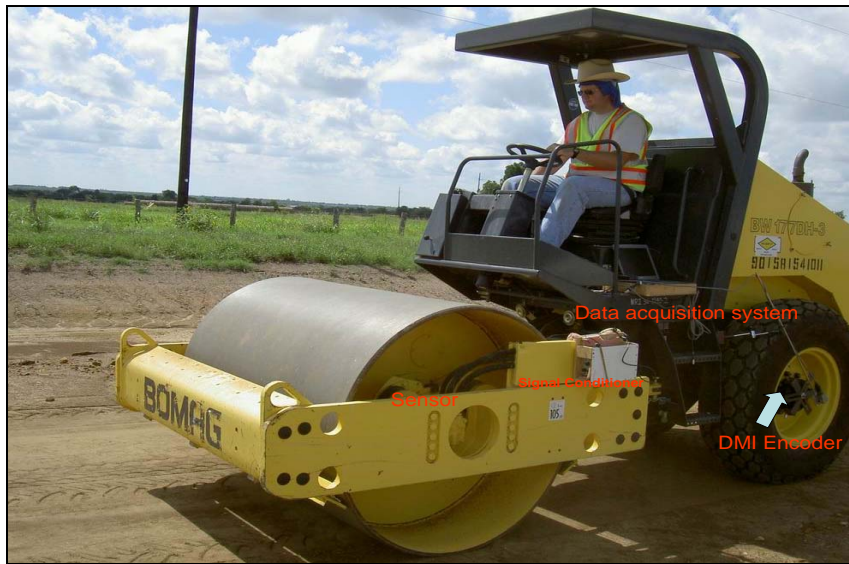
During the course of TxDOT Project 0-4774, the prototype system shown in [Figure 1](#) was developed. This accelerometer-based system permits the measurement of drum movements as the drum traverses soil or base material. The system will allow for evaluation of approximately 100 percent of each lift of material for potential compliance with the compaction specifications. A brief description of each of the system components follows.

Figure 1. Prototype Compaction System.

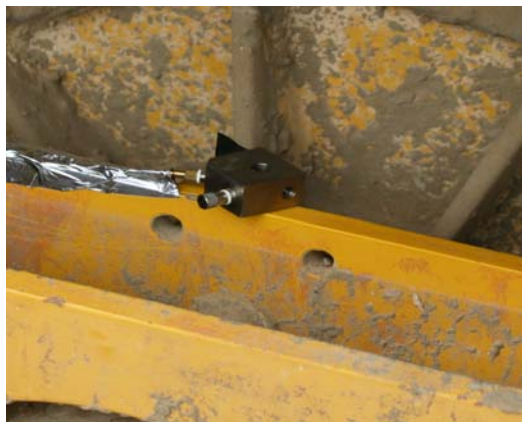
An accelerometer is mounted onto the roller frame, as shown in [Figure 2](#). The accelerometer is positioned between the vibrating drum and the rubber isolation mounts so that only the deflection of the drum is measured.

Figure 2. Accelerometer Mounted on Roller Frame.

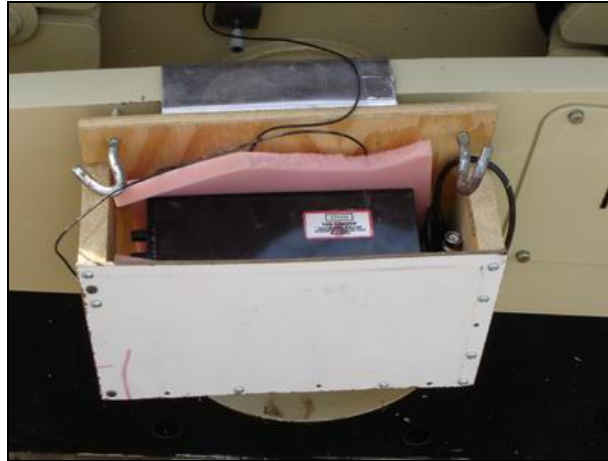
In the field, the accelerometer is attached as shown in [Figure 3](#). The signal conditioner is housed in a padded box attached to the roller as shown in [Figure 4](#). This is a temporary arrangement which will be modified in future development efforts.

Figure 4. Mounting of Signal Conditioner on Body of Roller.

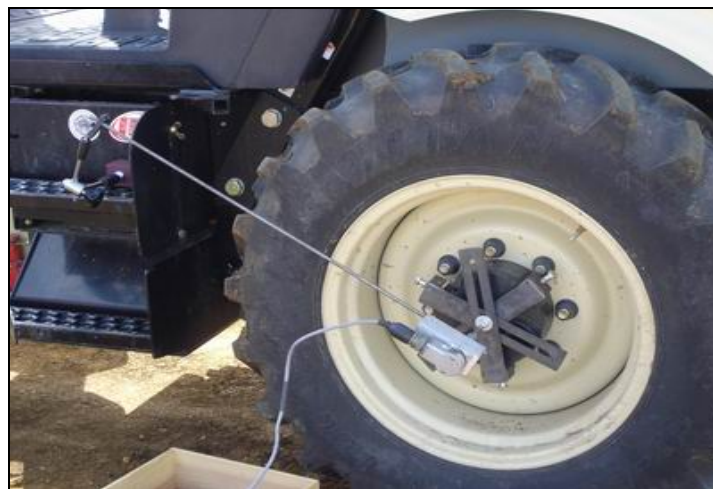
The position of the roller along each test path is tracked by a distance measuring instrument (DMI) attached to one of the drive wheel hubs ([Figure 5](#)). Calibration of the DMI is required at the start of testing and is accomplished by running the roller along a known distance. Several methods of attaching the DMI have been attempted, with varying degrees of success. Differences in the design of wheel hubs between roller manufacturers limit the development of a standard mounting bracket. Other mounting methods, which do not involve the wheel hub, are being pursued.

Figure 5. Distance Measuring Device.

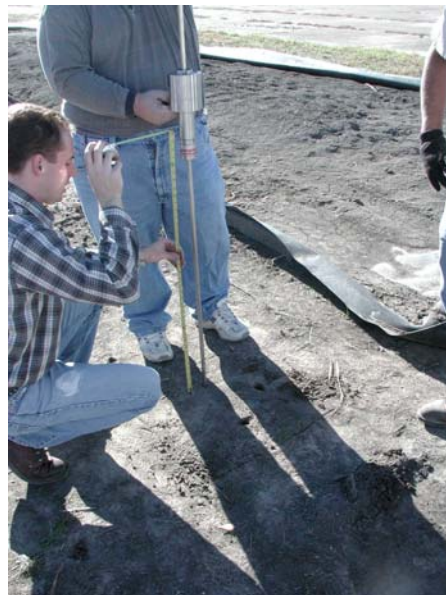
1. Dynamic Cone Penetrometer (DCP): The DCP, shown in [Figure 11](#), measures the soil's resistance to penetration for a calibrated amount of impact energy provided by a falling weight. Analysis of the data defines layers within the test depth by revealing break points or changes in the slope of the penetration rate.

Figure 11. DCP Testing.

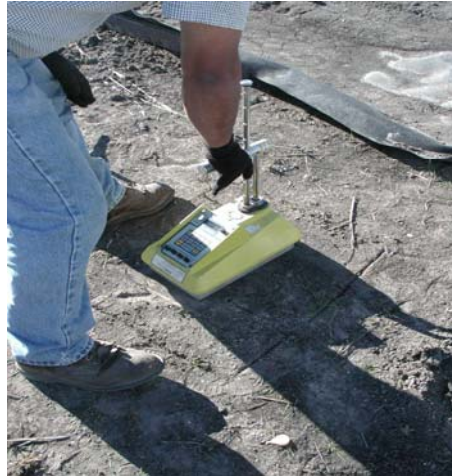
2. Nuclear gauge: The nuclear gauge, shown in [Figure 12](#), measures wet and dry density and moisture content of the soil down to approximately 12 inches below the soil surface by means of a radioactive source.

Figure 12. Nuclear Testing.

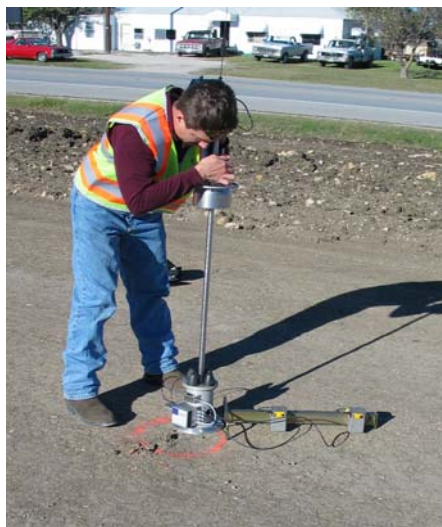
3. Portable Falling Weight Deflectometer (pFWD): The pFWD, shown in [Figure 13](#), is a much smaller version of the FWD that measures vertical displacement of the soil surface at three points due to a vertical impact load. A back calculated modulus is also determined.

Figure 13. Portable FWD Used for Soil Stiffness Determination.

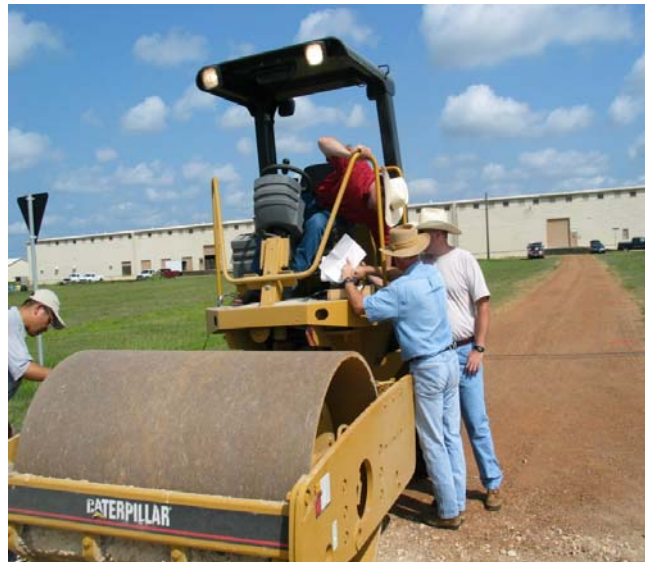
On June 24, 2005, the system was tested on a section of gravel road that ran perpendicular to Warehouse Road at Texas A&M's Riverside Campus. [Figure 14](#) shows the section.

Figure 14. Preliminary Field Testing of Instrumented Roller.

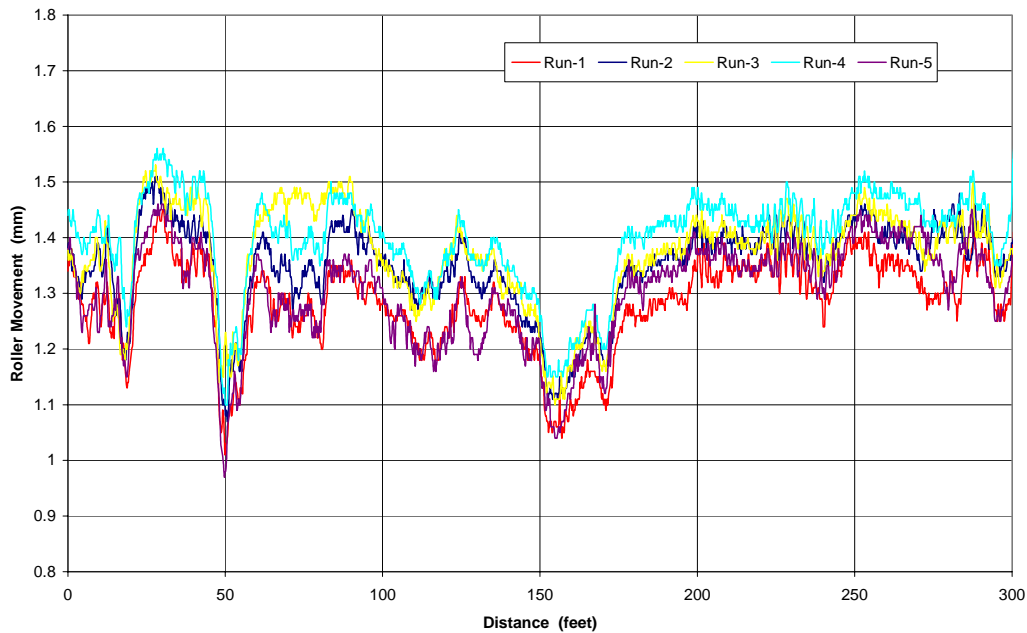
The main purpose of the testing was to determine how to install the system onto a vibratory smooth drum roller (CAT CS 433E—operating at 30 HZ) and to make sure that the system would collect data. Multiple passes were made across the same section of road with good repeatability (see [Figure 15](#)). The graphs of drum displacement with distance had very similar shapes, which indicated that the system was consistently measuring the same soil property. Additionally, the roller displacement at each point generally increased with each pass, which was consistent with an improvement in the strength of the material.

Figure 15. Roller Movements from Five Replicate Runs on Warehouse Road.

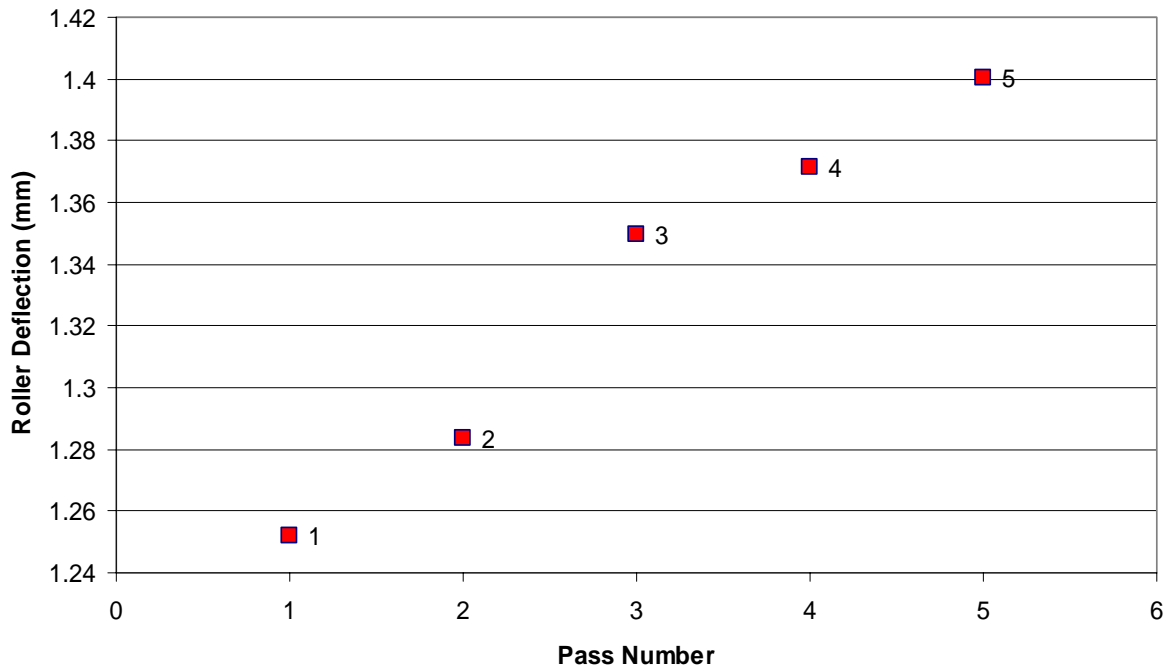
As shown in [Figure 16](#), the average movement of the roller increased with each pass. It was initially assumed that the drum of the instrumented roller would move more when it was testing softer soils, which turned out not to be the case. It was determined that at these high frequencies of loading (30 Hz) the softer the soil the lower the amplitude of roller movement. At the extreme case of very stiff sections, the roller will actually come close to bouncing off the ground. At these spots, the amplitude of motion will be very large. On weak soils the roller stays in full contact with the soil, and most of the energy of the roller is transferred into the soil. This relationship between roller motion and soil stiffness was found on all sections tested in this project when the roller was operating at a frequency of around 30 Hz, which is the normal operating frequency for most vibratory rollers. However, limited work was conducted with a low-frequency roller, operating at 8 Hz, and in that case the relationship reversed. Softer soil had more roller movement. It is assumed that below the resonant frequency of soil that one relationship exists, with a different relationship above the resonant frequency. More work is needed in this area. However, as most existing rollers operate in the frequency range of 25 to 35 Hz, the relationship of increasing roller movement with increasing soils stiffness can be assumed.

Figure 16. Average Roller Displacement for Each Pass.

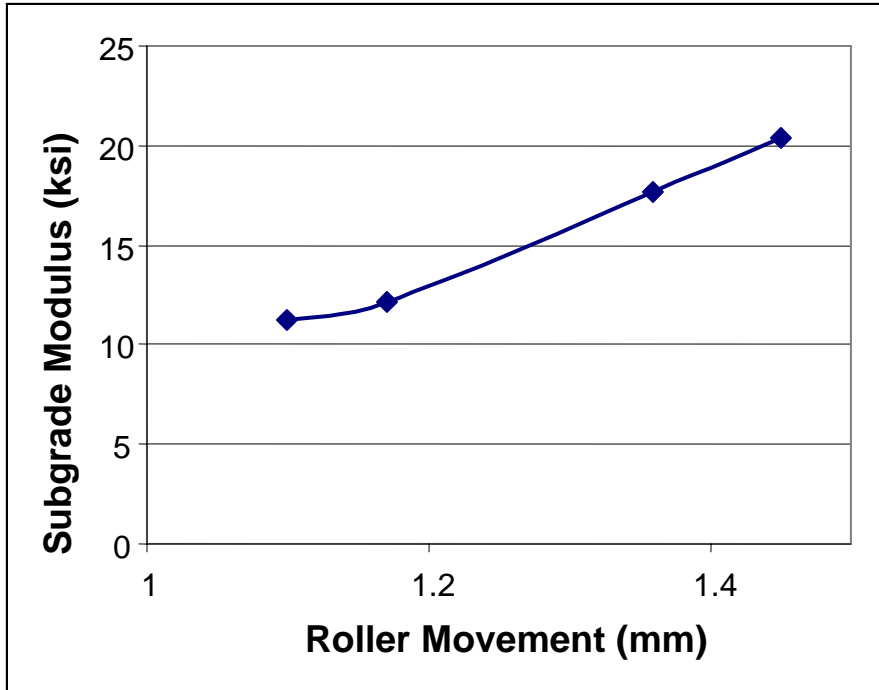
From the results given in Table 2 it appears that the roller movements are correlated with subgrade modulus values. The relationship from Table 2 is shown graphically in Figure 17.

Figure 17. Relationship between Roller Movement and Back calculated Subgrade Modulus.

To be used on any project it will be necessary to develop a relationship such as that shown in [Figure 17](#). The designer would specify a minimum acceptable subgrade modulus (say 12 ksi) and from [Figure 17](#) the equivalent roller movement would be define (for example 1.1mm). It would then be possible to run the entire project and investigate all potential problem areas where the roller movements were less than 1.1 mm. At these locations DCP testing could be undertaken to identify the cause of the low support values.

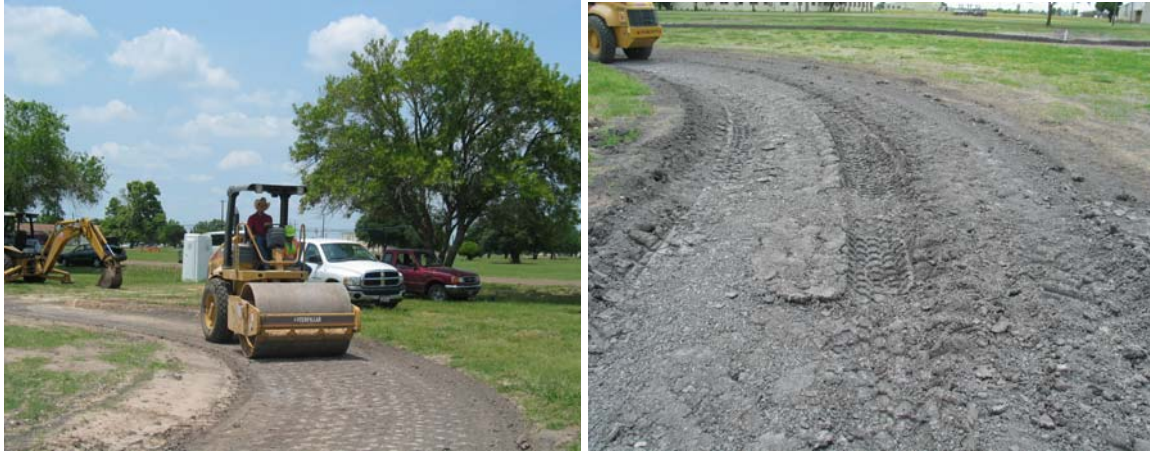
A 1/4 mile long running track was under construction during the testing. The contractor gave TTI permission to test the system on the partially compacted subgrade. As shown in [Figure 19](#) evidence of the weak areas included: shoving of the soil by the roller drum, imprint of roller's tires into the surface, and imprint of the testing staff's boot heels into the surface. The first test of the system was conducted on low amplitude vibration mode, and the second was tested on high amplitude vibration mode. The system easily distinguished between the visibly weaker and stronger areas as evidenced by the magnitude of the roller drum displacements regardless of the mode, as shown below in [Figure 20](#). The photographs show two stronger areas and one clearly weaker area; again it was found that the low roller displacement correlates with the poor soil support.

Figure 19. Second Test Location at Riverside Campus.

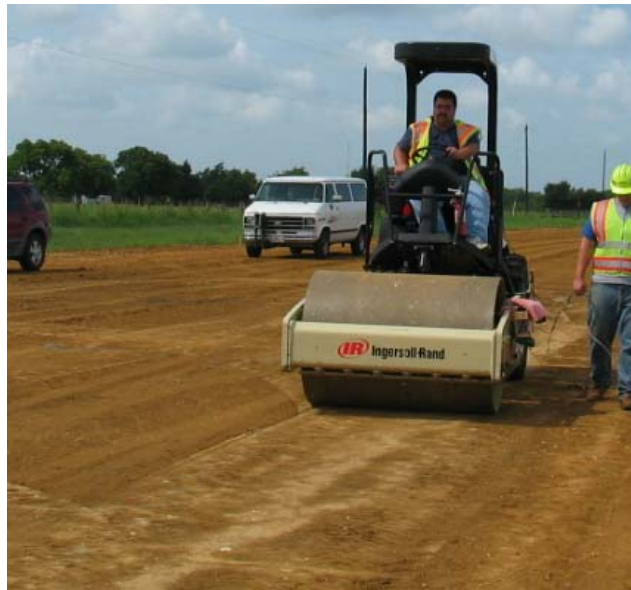
A series of tests on SH 21 near Caldwell were undertaken with the intent of determining if the instrument roller could be used to detect areas with poor subgrade support. Secondary tests with DCP, pFWD, and traditional density measuring systems were also performed, and soil samples were taken for laboratory testing. The test site was part of a TxDOT road-widening project conducted by Young Brothers Construction and was located west of the intersection of SH 21 and 60. [Figure 22](#) shows the test area.

Figure 22. Testing of TxDOT Construction Project on SH 21.

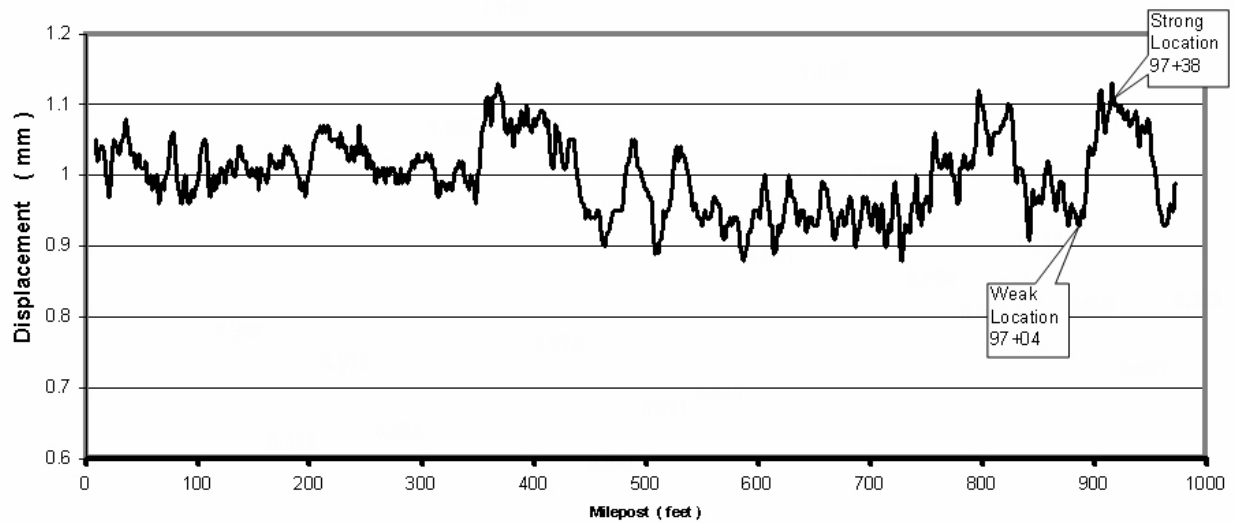
The test area was approximately 8 feet wide and extended approximately 1000 feet. The test area was located within a cut section that was to be lime stabilized. The roller movement over the test strip is shown in [Figure 23](#).

Figure 23. Roller Displacement Along the Length of Test Section.

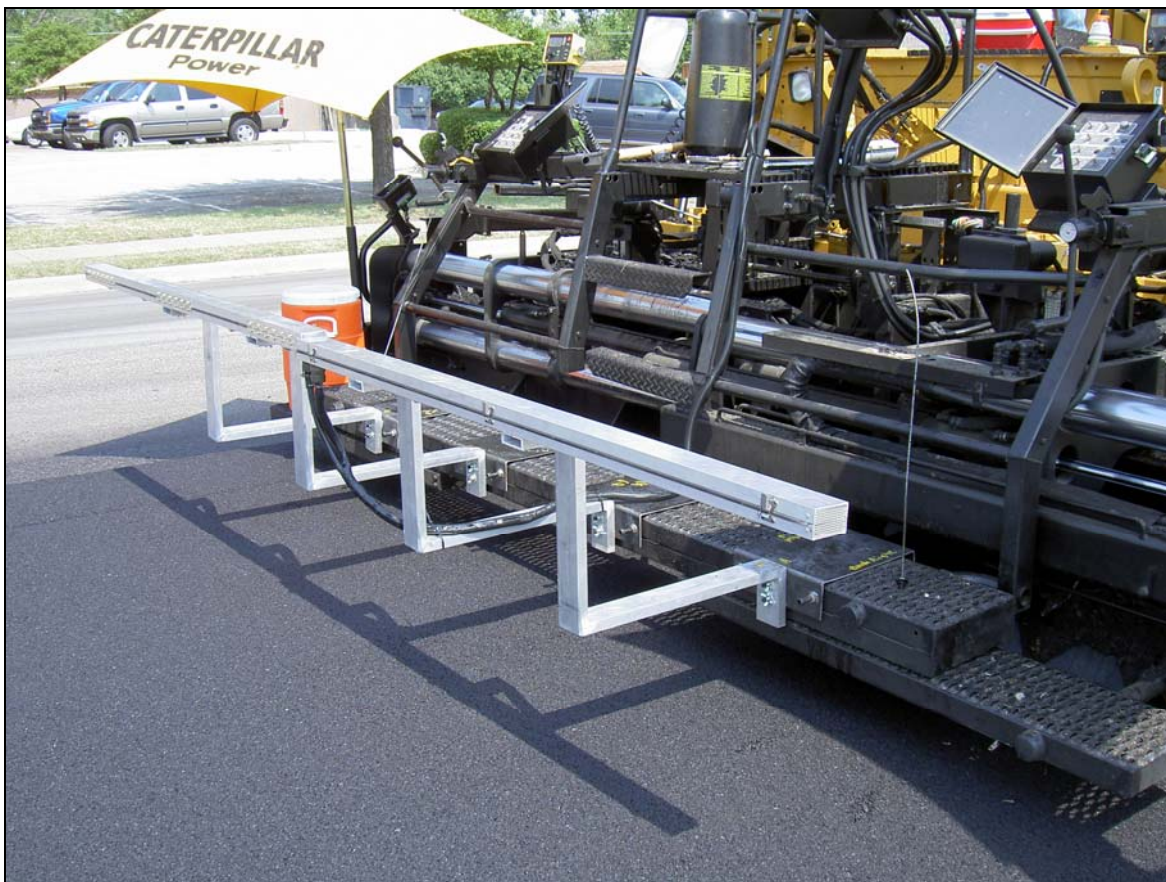
[Figure 26](#) shows the current Pave-IR system in use on a paving project. The two cables coming from the temperature bars at the middle of the paver merge into one cable before connecting to the master control box.

Figure 26. TTI's Current Pave-IR System Collecting Project Data.

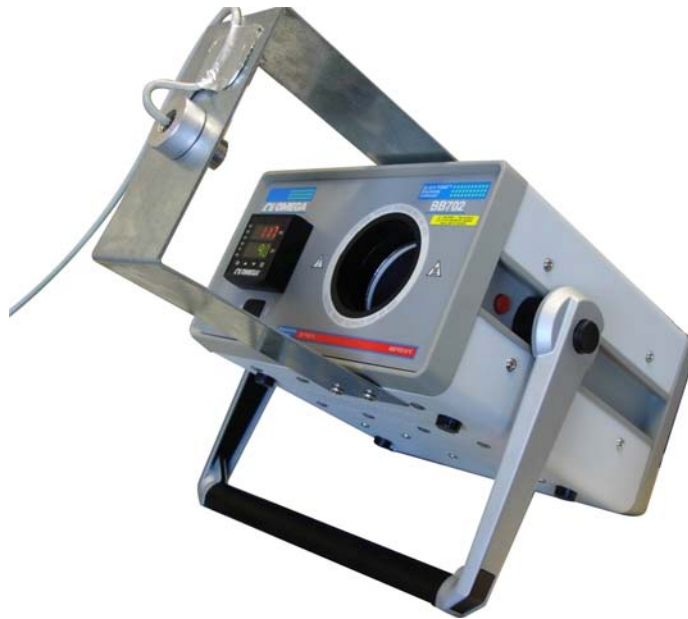
To ensure accuracy of the infrared sensors, Pave-IR software includes a module for calibration of the infrared sensors. The calibration is performed in the lab with a blackbody source with an accuracy of $\pm 0.9\text{ }^{\circ}\text{F} \pm 0.25$ percent of reading and a stability of $\pm 0.2\text{ }^{\circ}\text{F}$. [Figure 27](#) illustrates the basic calibration setup.

Figure 27. Infrared Sensor Installed in Blackbody Source for Calibration.

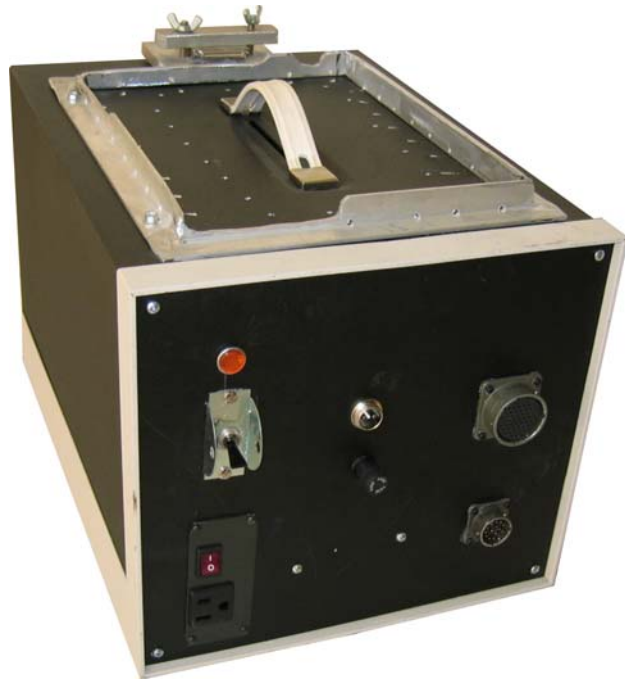
Figure 28 shows the master control box previously described. This box weighs approximately 18 lb and measures approximately 15 x 11 x 10 inches. The control box helps ensure easy setup and transportability of many required Pave-IR components while also providing the components protection from damage. This box also contains an inverter to provide 120 VAC power to eliminate dependency on laptop batteries for running the computer. The paver battery provides power to the master control box to run the system. If in need of servicing, the box can be disassembled by simple removal of sheet metal screws. This control box replaced the operator-propelled carts used in previous systems.

Figure 28. Master Control Box for Pave-IR.

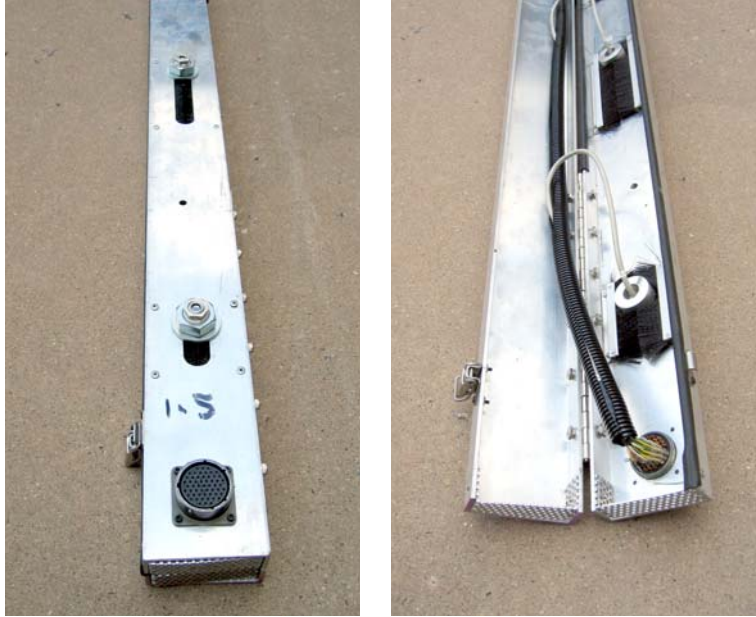
The current Pave-IR temperature bars contain the infrared sensors already mounted and pre-wired for easy connection to the master control box. Each bar opens along a hinged joint for access to the sensors and internal wiring. When closed and secured shut, the bars provide protection to the sensors and wiring. Slots in the bars allow adjustment of sensor spacing to measure paving widths ranging from 10 to 12 ft. [Figure 29](#) shows the sensor side and the internal side of a temperature bar.

Figure 29. Sensor Side and Internal Sides of Temperature Bar.
