TH-5 at Stieger Lake Ln-78th St  
City: Victoria  
Data By: Spack Solutions  
TURN MOVEMENT COUNT

File Name : 08\_TH-5-at-Stieger-Lake-Ln-and-78th-St  
Site Code : 00000000  
Start Date : 3/17/2021  
Page No : 1

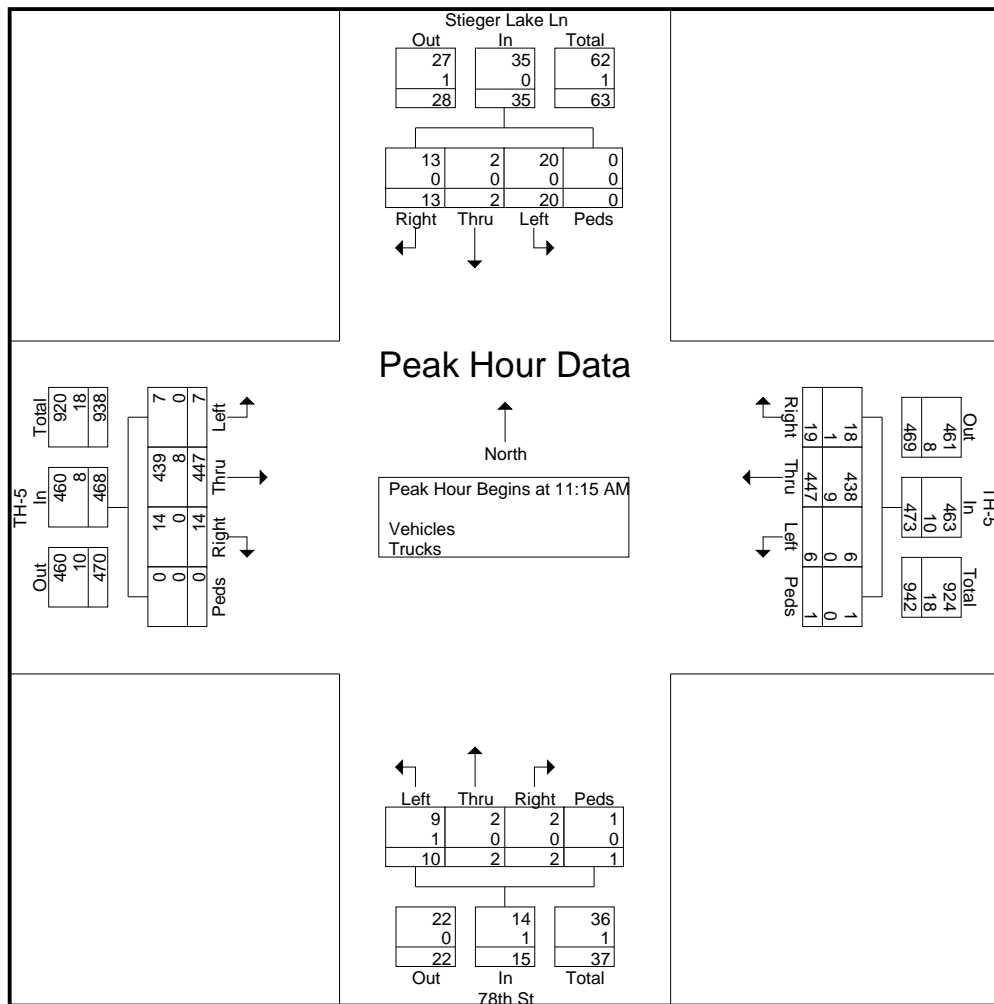
Start Time	Stieger Lake Ln Southbound					TH-5 Westbound					78th St Northbound					TH-5 Eastbound					Int. Total
	Right	Thru	Left	Peds	App. Total	Right	Thru	Left	Peds	App. Total	Right	Thru	Left	Peds	App. Total	Right	Thru	Left	Peds	App. Total	
Peak Hour Analysis From 06:00 AM to 12:00 PM - Peak 1 of 1																					
Peak Hour for Entire Intersection Begins at 11:15 AM

12:00 PM	4	2	5	0	11	3	89	2	1	95	1	1	3	1	6	4	109	1	0	114	226
Total Volume	13	2	20	0	35	19	447	6	1	473	2	2	10	1	15	14	447	7	0	468	991
% App. Total	37.1	5.7	57.1	0		4	94.5	1.3	0.2		13.3	13.3	66.7	6.7		3	95.5	1.5	0		
PHF	.464	.250	.714	.000	.625	.792	.880	.375	.250	.889	.500	.500	.500	.250	.625	.583	.873	.583	.000	.886	.935
Vehicles	13	2	20	0	35	18	438	6	1	463	2	2	9	1	14	14	439	7	0	460	972
% Vehicles	100	100	100	0	100	94.7	98.0	100	100	97.9	100	100	90.0	100	93.3	100	98.2	100	0	98.3	98.1
Trucks	0	0	0	0	0	1	9	0	0	10	0	0	1	0	1	0	8	0	0	8	19
% Trucks	0	0	0	0	0	5.3	2.0	0	0	2.1	0	0	10.0	0	6.7	0	1.8	0	0	1.7	1.9

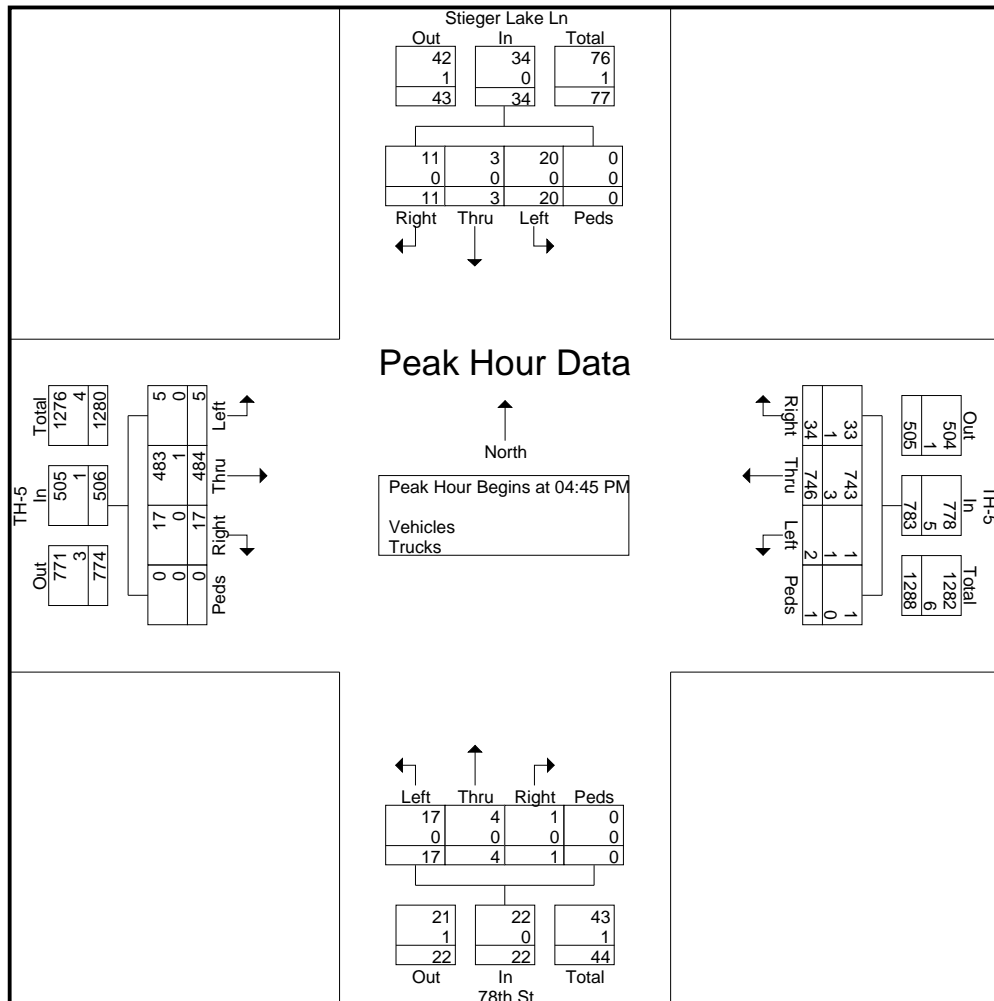
Start Time	Stieger Lake Ln Southbound					TH-5 Westbound					78th St Northbound					TH-5 Eastbound					Int. Total
	Right	Thru	Left	Peds	App. Total	Right	Thru	Left	Peds	App. Total	Right	Thru	Left	Peds	App. Total	Right	Thru	Left	Peds	App. Total	
Peak Hour Analysis From 12:15 PM to 05:45 PM - Peak 1 of 1																					
Peak Hour for Entire Intersection Begins at 04:45 PM

05:30 PM	5	1	6	0	12	10	167	0	0	177	0	1	3	0	4	4	116	1	0	121	314
Total Volume	11	3	20	0	34	34	746	2	1	783	1	4	17	0	22	17	484	5	0	506	1345
% App. Total	32.4	8.8	58.8	0		4.3	95.3	0.3	0.1		4.5	18.2	77.3	0		3.4	95.7	1	0		
PHF	.550	.750	.556	.000	.708	.850	.942	.250	.250	.955	.250	.500	.607	.000	.688	.708	.945	.625	.000	.944	.966
Vehicles	11	3	20	0	34	33	743	1	1	778	1	4	17	0	22	17	483	5	0	505	1339
% Vehicles	100	100	100	0	100	97.1	99.6	50.0	100	99.4	100	100	100	0	100	100	99.8	100	0	99.8	99.6
Trucks	0	0	0	0	0	1	3	1	0	5	0	0	0	0	0	0	1	0	0	1	6
% Trucks	0	0	0	0	0	2.9	0.4	50.0	0	0.6	0	0	0	0	0	0	0.2	0	0	0.2	0.4
