FAULTMETER - JOINTS

PCC Joint Faulting Measurements at the MnROAD Project

HISTORY OF THE FAULT MEASUREMENTS AT MnROAD

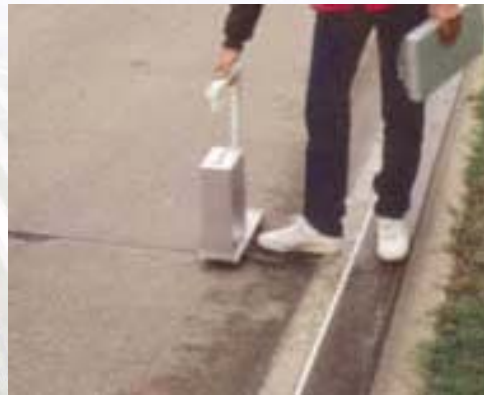
An electronic digital faultmeter used to measure transverse joint faults. The transverse contraction joints in concrete pavement eventually wear out with repeated heavy vehicle loading. One symptom of this wear is the presence of “stepping” at the joints, also called “faulting.”

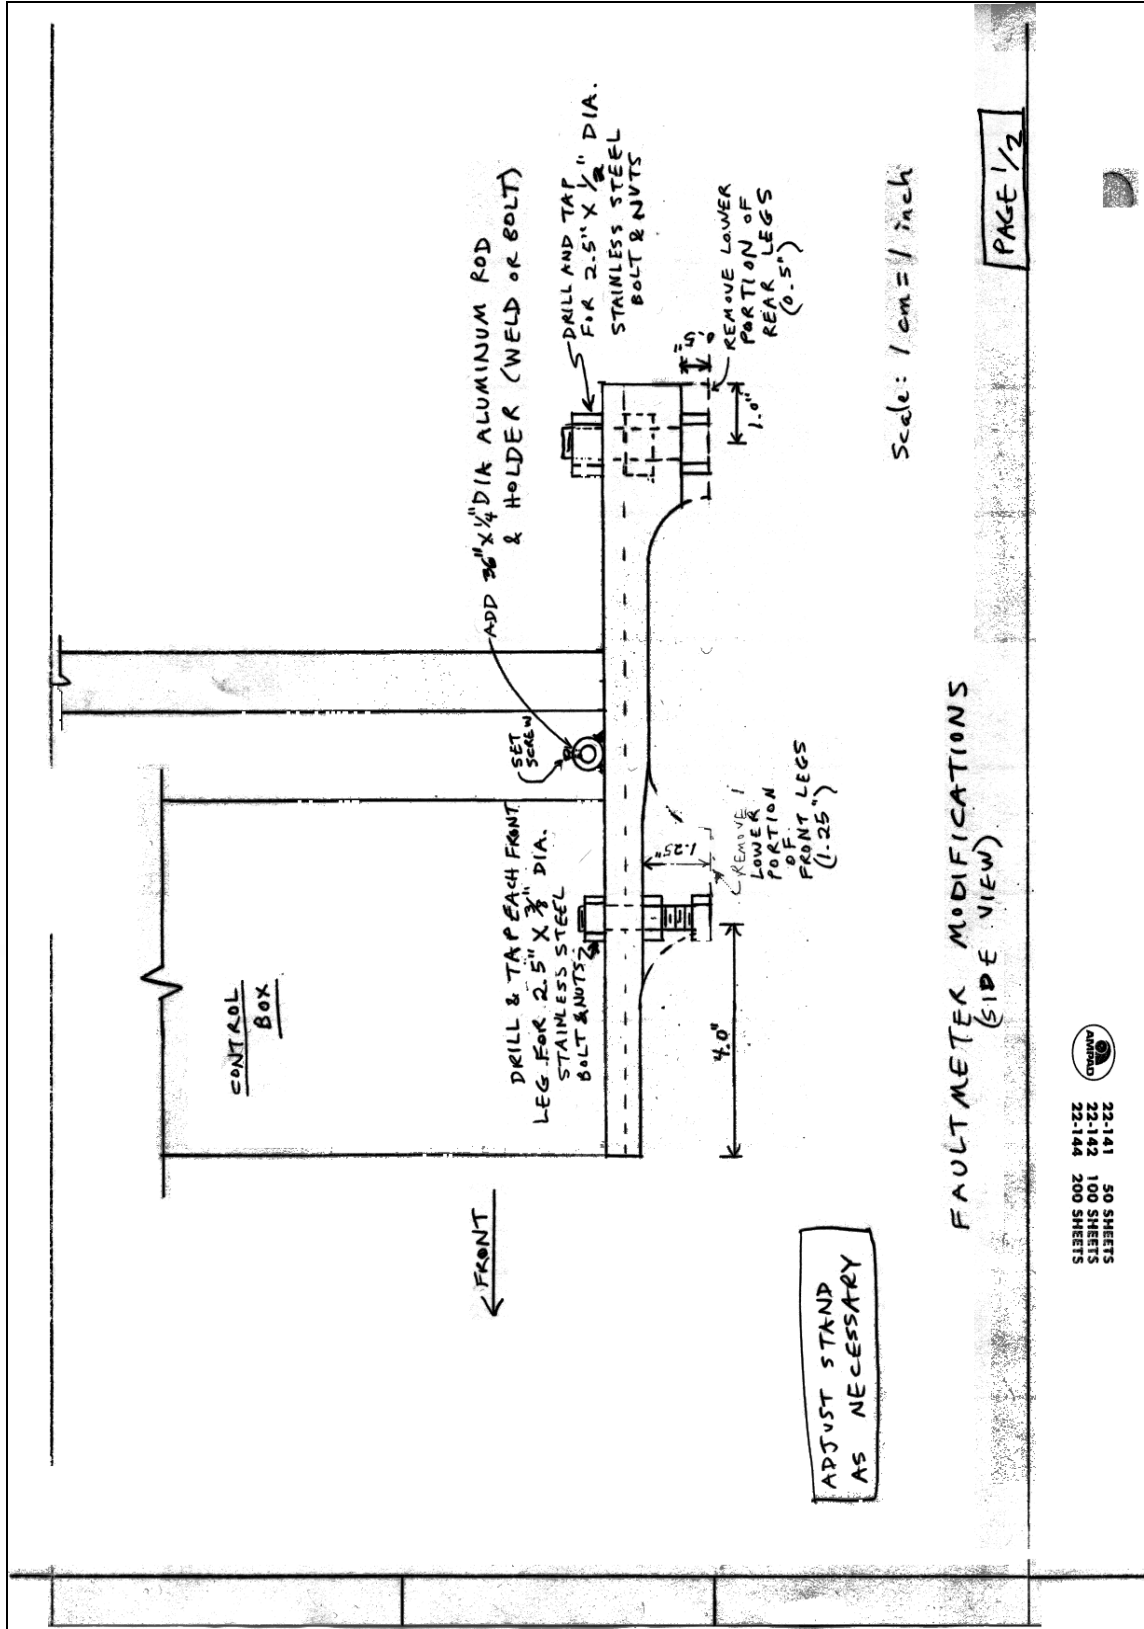
Figures 1 and 2 show dimensions and layout of the new three point foot system. Also shown in the figures is the addition of an offset rod, used to increase the speed of measurements. The rod can be used as a guide to quickly place the device relative to the outside edge of the fogline painted on the test sections. Allen head anchor screws allow quick and easy adjustment, as well as removal, of the rod.

Mn/DOT's faultmeter was originally constructed to Georgia DOT specifications by Mn/DOT's Maplewood Laboratory shop personnel. Modifications to the device were designed by the author and made by the shop in the winter of 2001-2002, to enhance the repeatability of the measurements. The principle change was the replacement of the four point "long feet" system, with a three point "bolt feet" system. Due to surface irregularities in the concrete pavement slabs, the four point long foot system commonly resulted in the operator having to move the device several times to avoid rocking of the base, which often led to non-repeatable measurements. By installing the three point "bolt head" feet, the device could simply be set down for a quick, stable and repeatable measurement.
