TECHNICAL SUMMARY

Preventing Bridge Scour with Matrix Riprap

This Technical Summary pertains to LRRB-produced Report 2015-15, “Matrix (Partially Grouted) Riprap Lab Flume Study,” published April 2015. The full report can be accessed at mndot.gov/research/TS/2015/201515.pdf.

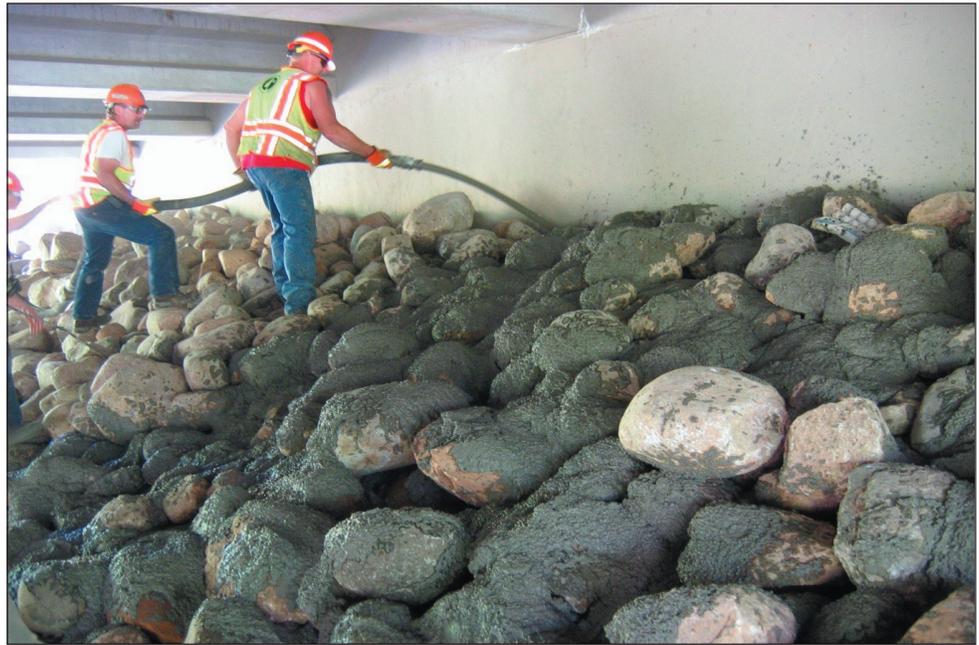
Grout was applied to riprap underneath a bridge in Milaca, Minnesota, creating a stronger scour countermeasure with more rounded rocks than typical riprap.

An alternative to larger riprap involves cementing smaller rocks together with grout, expanding the availability of riprap sources. This matrix riprap, also called partially grouted riprap, uses enough grout to bond rocks to each other without completely sealing the gaps between them, providing drainage and allowing the riprap to move and “self-heal” after floods. Matrix riprap is particularly promising for protecting spill-through abutments—abutments that are set back from the channel with an embankment that slopes down to the river. While the effectiveness of matrix riprap has been studied for bridge piers, it has not been studied for bridge abutments.
