TECHNICAL SUMMARY

Pavement Markings: Epoxy Paints and Thick Coats Perform Best on Challenging Asphalt Surfaces

This Technical Summary pertains to Report 2016-08, “Evaluation of Pavement Markings on Challenging Surfaces,” published March 2016. The full report can be accessed at mndot.gov/research/TS/2016/201608.pdf.

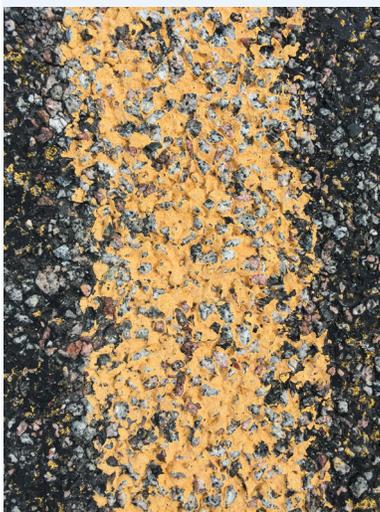
On coarse asphalt surfaces, one winter is enough to wear away even well-painted centerlines.

Both of these surface types offer a similar challenge for pavement marking performance: surface gaps into which fresh paint sinks. In less than one year, road use and snowplowing can scrape paint off the higher aggregate surfaces, leaving behind sunk-in paint that drivers see as faded lines.

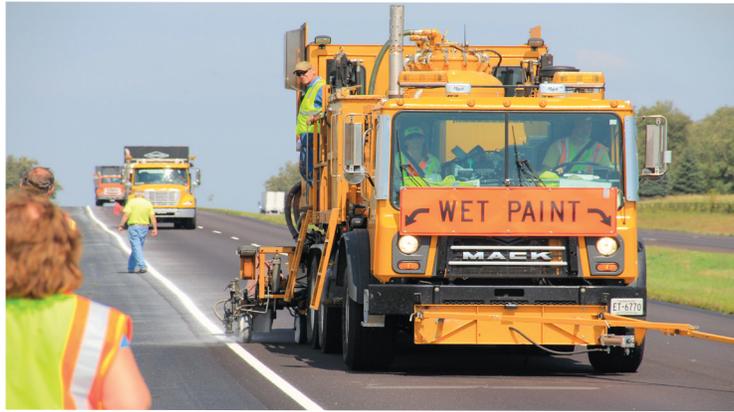
Painting long-lasting edge lines and centerlines on challenging, porous asphalt surfaces requires thickly painted stripes or the use of epoxy paint.
