Implementation and Evaluation of a Low-Cost Weigh-In-Motion System

Minnesota
Department of
Transportation

Taek M. Kwon, Principal Investigator
Department of Electrical Engineering
University of Minnesota Duluth

Research Project
Final Report 2016-10

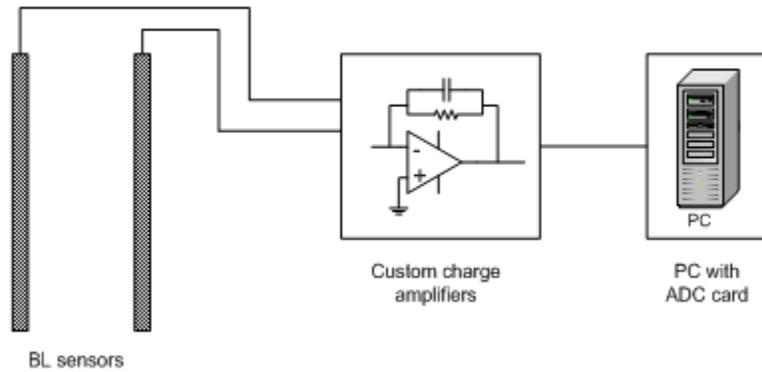
Figure 1.1: Proposed low-cost WIM system

Since loop detectors can detect metal body of vehicles, they are integrated to WIM systems to detect the length of vehicle body and the corresponding axle signals that belong to that vehicle. More specifically, loop signals are used to identify the end and beginning of each vehicle from a continuous stream of axle signals. In the low-cost WIM system, axle signals are analyzed based on known axle spacing patterns of vehicles, and then an algorithm determines the start and ending axles of a vehicle without using loop signals. Since loops are not used, it saves loop installation and detector card costs, as well as its maintenance costs. A block diagram of the final low-cost WIM system is depicted in Figure 1.1. Each lane uses two BL sensor strips, and the PC can accommodate WIM data collection up to four simultaneous lanes. Since the ADC card has 16 channels but it currently only uses 8 channels, four more lanes could be added by simply connecting charge amplifiers to the additional channels. Adding one more ADC card would be able to handle up to 16 simultaneous lanes.

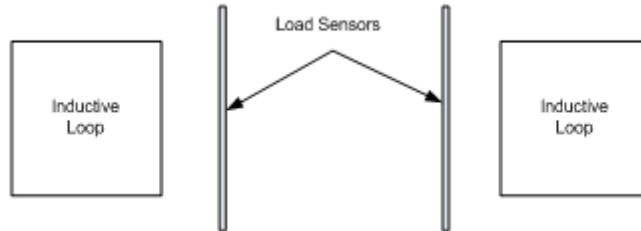
Figure 2.1 WIM sensor configuration per lane

The basic WIM sensor configuration which was used at WIM #30 consists of two loop detectors and two load sensor strips per lane as shown in Figure 2.1. The loop detectors are used for vehicle end detection, i.e., it determines the first and last axle of a vehicle. One of the main features of the new WIM controller is that it automatically detects malfunctioning sensors and optimizes WIM data computation based on availability of functioning sensors. More specifically, if one of the loops does not work, the software automatically detects the malfunctioning loop and then uses the remaining loop for vehicle end detection. If both loops fail simultaneously, it then automatically switches to an axle-signals-only mode in which vehicle end detection is achieved solely using an axle-spacing-based algorithm. The reason for using a pair of load sensor strips is to measure the vehicle speed. If one of the load sensor strips fails, speed cannot be computed and thus the weight cannot be calculated. In this case, the speed is estimated through the speed of an adjacent lane, i.e., the user specifies which adjacent lane to use along with an adjustment factor (percent of adjacent lane speed) for each lane. For example, if one of the driving lane sensor strips is not working but the pair in the passing lane are working, the speed of driving lane is estimated using the passing lane by reducing the speed at a certain percent set by the user. If the load sensor strips in both its own and adjacent lane are broken, the system then gives up weight

computation. Errors are reported in the vehicle record if any of the sensors in the basic configuration (Figure 2.1) fails, but all WIM data are still computed.

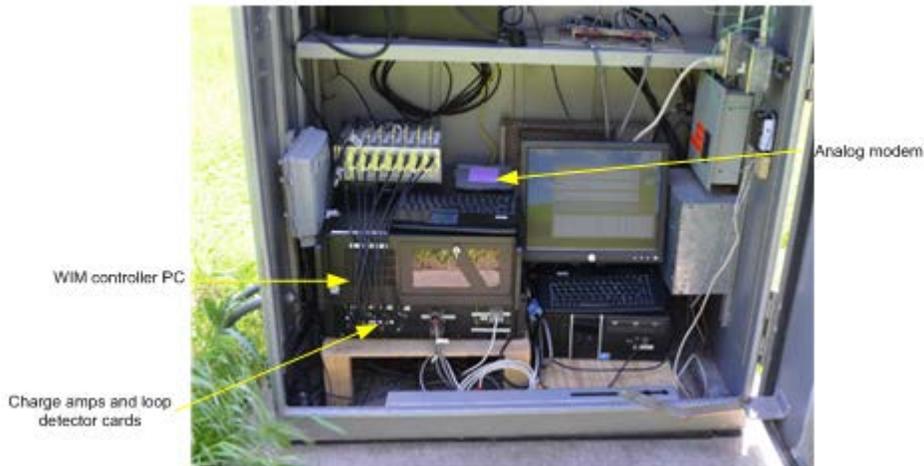
Figure 2.2: WIM #30 Cabinet

Figure 2.2 shows inside of the WIM #30 site cabinet. In addition to a WIM controller which is basically an industrial PC with a data acquisition board, there is another enclosure that houses charge amplifiers and loop detector cards. It is also equipped with an analog modem for remote control and data downloads but later it was replaced with a wireless modem (provided by Verizon). The system also includes a thermocouple for collecting pavement temperature data. The controller produces a daily data file that contains individual vehicle records, and the file is automatically downloaded to lab.

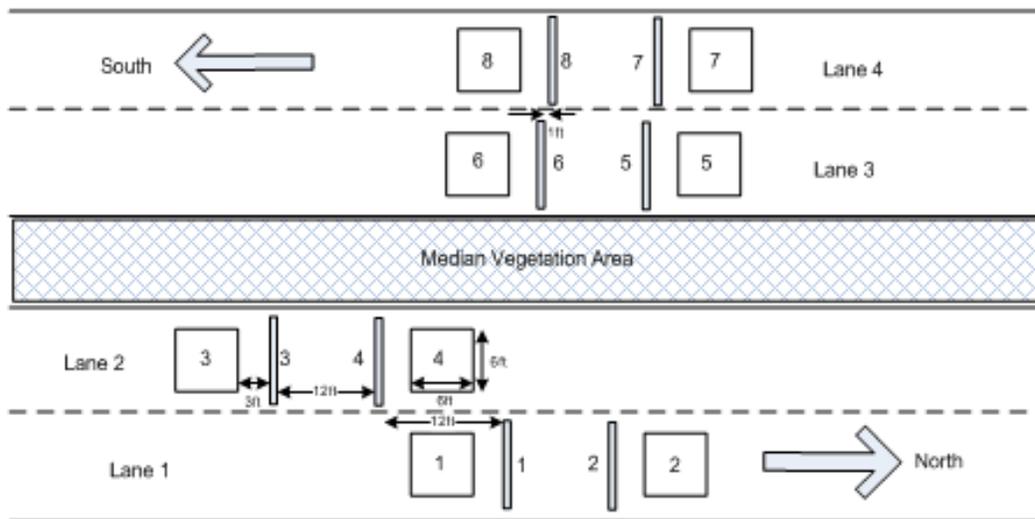
Figure 2.3: WIM #213 sensor configuration

For WIM axle sensors, eight RoadTrax BL Piezo Sensors (11 feet in sensor length and 200 feet in lead coaxial cable length) were installed. Sensor installation was completed by a contractor on October 10, 2013, and the configuration diagram is shown in Figure 2.3. All loops were configured as a 6×6 feet square, and axle sensors in each lane were spaced 12 feet. Loop to axle sensor or axle sensor to loop distances were all spaced at 3 feet. Axle sensor spacing between adjacent lanes for Lanes 1 and 2 was 12 feet while it was only 1 feet between Lanes 3 and 4. This close spacing of adjacent-lane sensors often generated false axle signals when vibration from the adjacent lane is spilled over or tire steps both lanes. In the future, spacing of at least 12 feet between adjacent lane axle sensors is recommended, i.e., the northbound setup in Figure 2.3 is recommended.

The length of coaxial lead cable required to run from Lane 4 sensors (Sensors #7 and #8 from Figure 2.3) to the instrument cabinet well exceeds 200 feet that came with the sensors. Thus, extending cable length through splicing was required. Unfortunately, the sensor installation contractor extended the coaxial cables using simple butt splices. There are two major issues with butt splicing of coaxial cables. The first issue is shield leak in the splice, which introduces noise to the line. The second issue is the short circuit created when it is submerged under water. Since all cables cross the highway through underground conduits, splices are placed in a manhole which is likely filled with water. Indeed, resistance measurement of Sensors #7 and #8 showed zero ohm, and water submerge was confirmed.

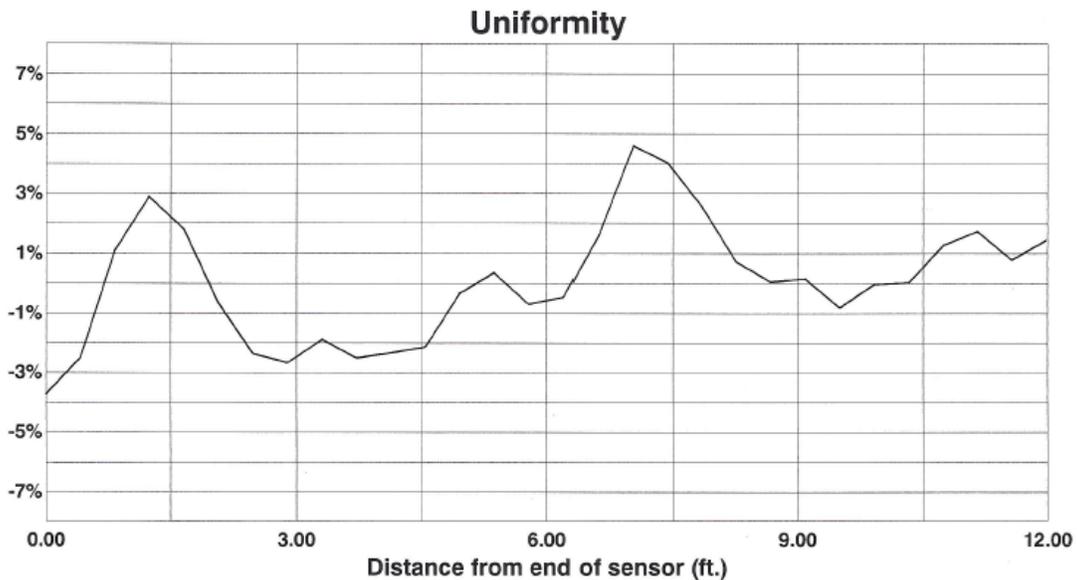
Figure 2.4: Uniformity of BL sensor (Source: Measurement Specialties Inc.)

Another important characteristic regarding BL sensors is that sensor material is not uniform with respect to the distance from the end of sensor. Figure 2.4 is a data sheet on uniformity of a BL sensor strip that comes with when a sensor strip is purchased. This graph shows that the sensor reading of vehicle weights can be different up to about 10 percent, depending on which part of the sensor strip was driven even if everything else is the same. This uniformity characteristic of BL sensors is one of the limiting factors of the sensor's accuracy.

Serial #: JBL168163	
Sensor Length: 12 ft.	
Cable Length: 200 ft.	
Capacitance: 12.11 nF	
Dissipation: 0.0085	
Average Sensitivity: 53 pC/N	
BL Traffic Sensor

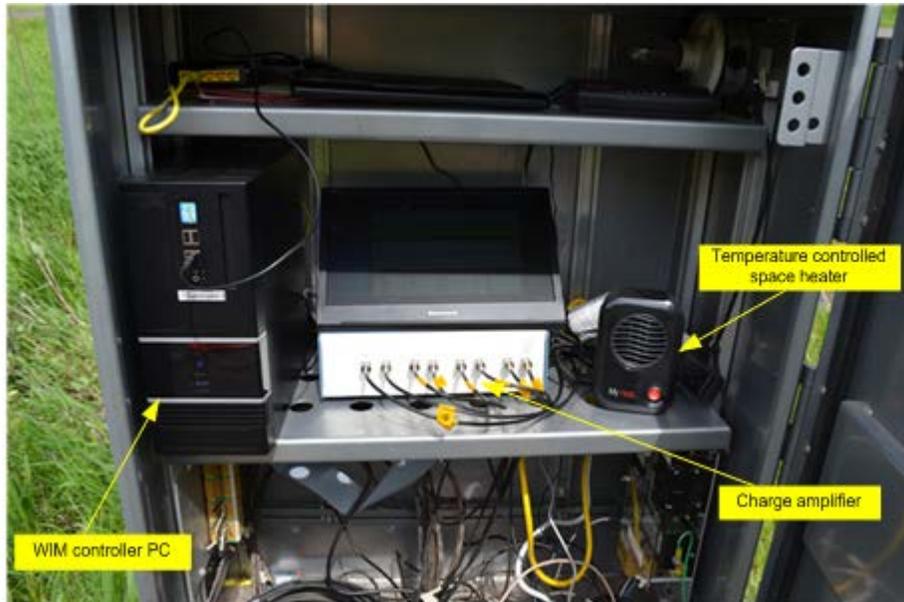
Figure 2.5: WIM #213 instrument cabinet

Figure 2.5 shows the instrument cabinet of the WIM #213 site after installation. A small footprint PC equipped with a data acquisition board is connected to an enclosure that contains charge amplifiers. The axle load sensor outputs are directly connected to inputs of charge amplifiers. For the PC display, a USB monitor was used. This USB monitor is normally not plugged in, and it is only used when operator wishes to see the screen. The equipment in the cabinet includes an analog modem (V.92) for remote access and a temperature controlled heater to cope with Minnesota winter. In addition, a K-type thermocouple was installed and records pavement temperature data. Although inductive loops were wired as shown in Figure 2.3, the system does not use them in this study. This is because if loops are not used, tens of thousands of dollars of installation and instrumentation costs can be saved. Since the main objective of this project was to develop and evaluate a low-cost WIM system, the decision was made towards cutting cost. The controller software was the same version used in WIM #30, which was an in-house developed version by the current author. The WIM PC was configured as an ftp server to provide remote downloading of WIM data. The system was also set as a Remote Desktop host to

allow Remote Desktop connections from a remote computer and remote control of the instrument PC.

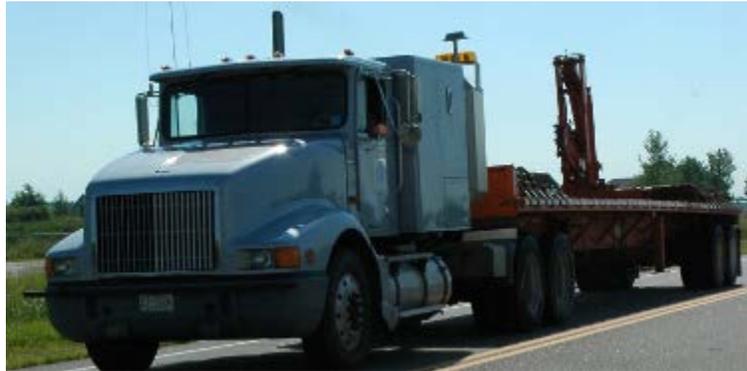
Figure 2.6: MnRoad calibration truck

Both sites were calibrated using the MnRoad class-9 truck (shown in Figure 2.6) on June 18, 2014. This truck has been used for WIM site calibrations at MnDOT for many years, and its axle weights are evenly distributed for stability. Gross vehicle weight (GVW) of this vehicle was 79.8 kips, and its axle weights were from steer to the last axle, 12, 16.7, 18.1, 17.1, and 15.9 kips. On the calibration day, the low, high, and mean temperatures were 55, 66, and 60°F, respectively. During the calibration which took place between 10:30 to 12:30 AM, the temperature was in the range of 62 to 63°F, and wind speed was between 16 and 26 mph. This data was confirmed through www.wunderground.com.

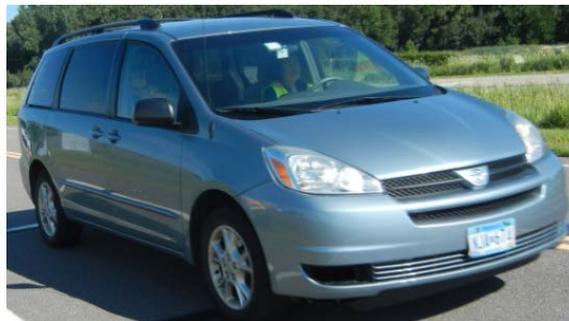
Figure 2.7: Test vehicle used for axle signal strength test

This section analyzes uniformity of signal strengths between sensor pairs and between lanes for the WIM #213 site. The signal strength comparison would provide information on the depth of the sensor strips buried in the pavement. Axle signals are recorded from each sensor strip driven by the same test vehicle. A picture of this test vehicle is shown in Figure 2.7, which is a 2005 Toyota Sienna van. This vehicle was driven at close to 65 mph for all lanes.

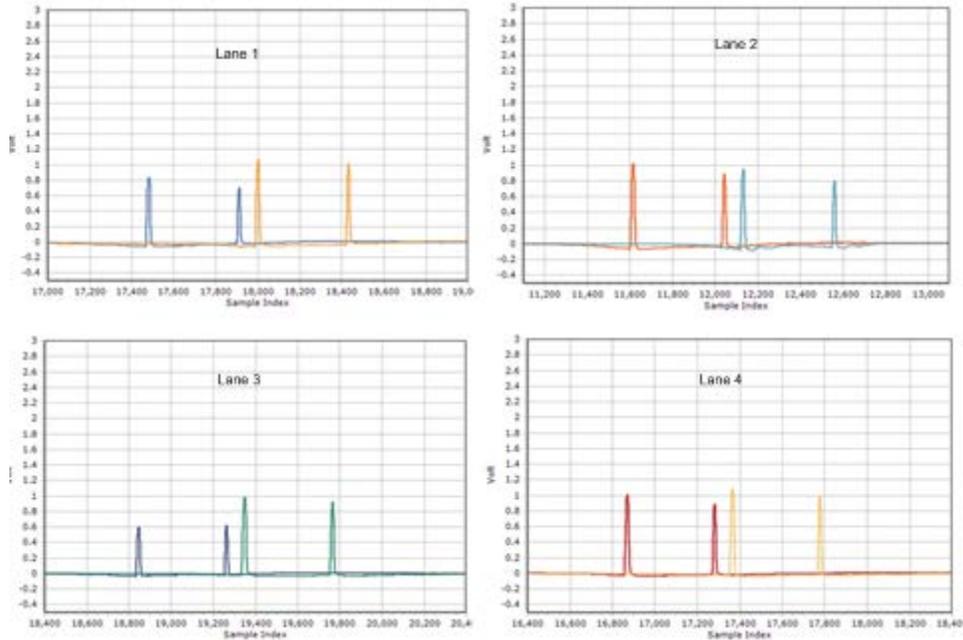
Figure 2.8: Signal strength comparison of axle sensors

Since the WIM #213 site has four lanes, a total of eight sensor strips were installed. In Figure 2.8, plots of axle signals from Lanes 1 through 4 are shown. The first two spikes with the same color in each lane shows the front and rear axle signals of the vehicle from the upstream sensor, and the next pair are the downstream front and rear axle signals. Among signals, notice that Lane-3 upstream signals show the least strengths, implying that the sensor strips are buried deeper than other sensor strips. Also, the signal strengths between upstream and downstream sensors are not same, except for the signals at Lane 4, but the differences are small, which indicates similar sensor depth and/or uniformity of sensor material.

Another application of signal strength analysis is that this information is used for setting up the signal threshold of each sensor strip for detection of axles. After observing axle signals of the test vehicle, it is clear that the threshold level of the Lane-3 upstream sensor should be set lower than other sensors.

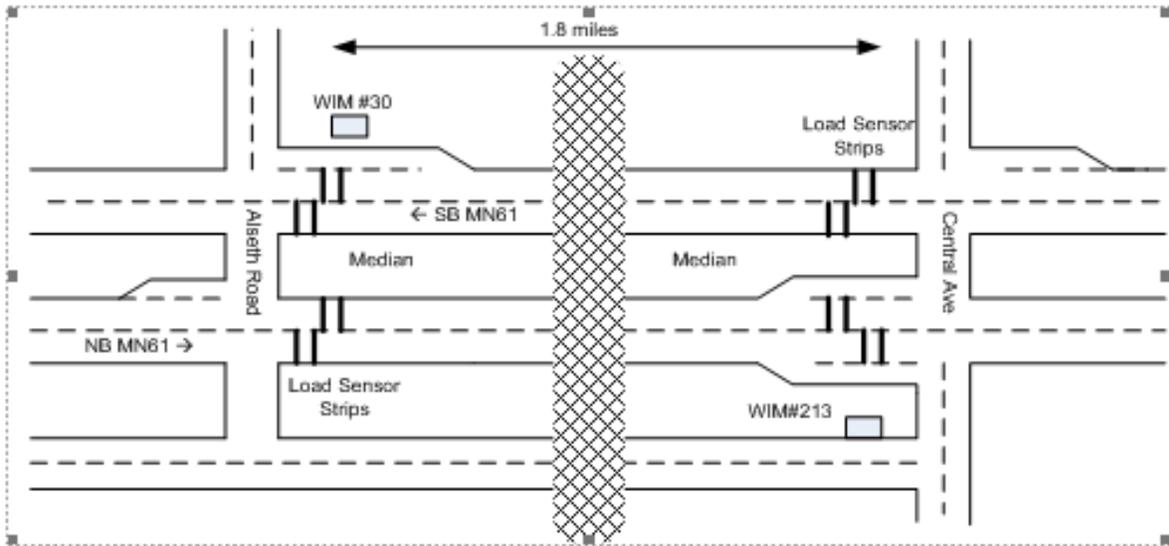
Figure 3.1: WIM #30 and #213 sites and exit lanes

Daily volume counts are compared between WIM #30 and #213 in terms of directional and total volumes. Figure 3.1 shows configuration of lanes and exits around both sites. Notice that there are three exits where vehicles bypass the WIM sensors: two exits are in northbound lanes near WIM #213 and one exit is in the southbound lane near WIM #30. Because of these three exits, volume counts on both sites cannot be identical, but it should be similar since exit volumes are relatively a small amount.

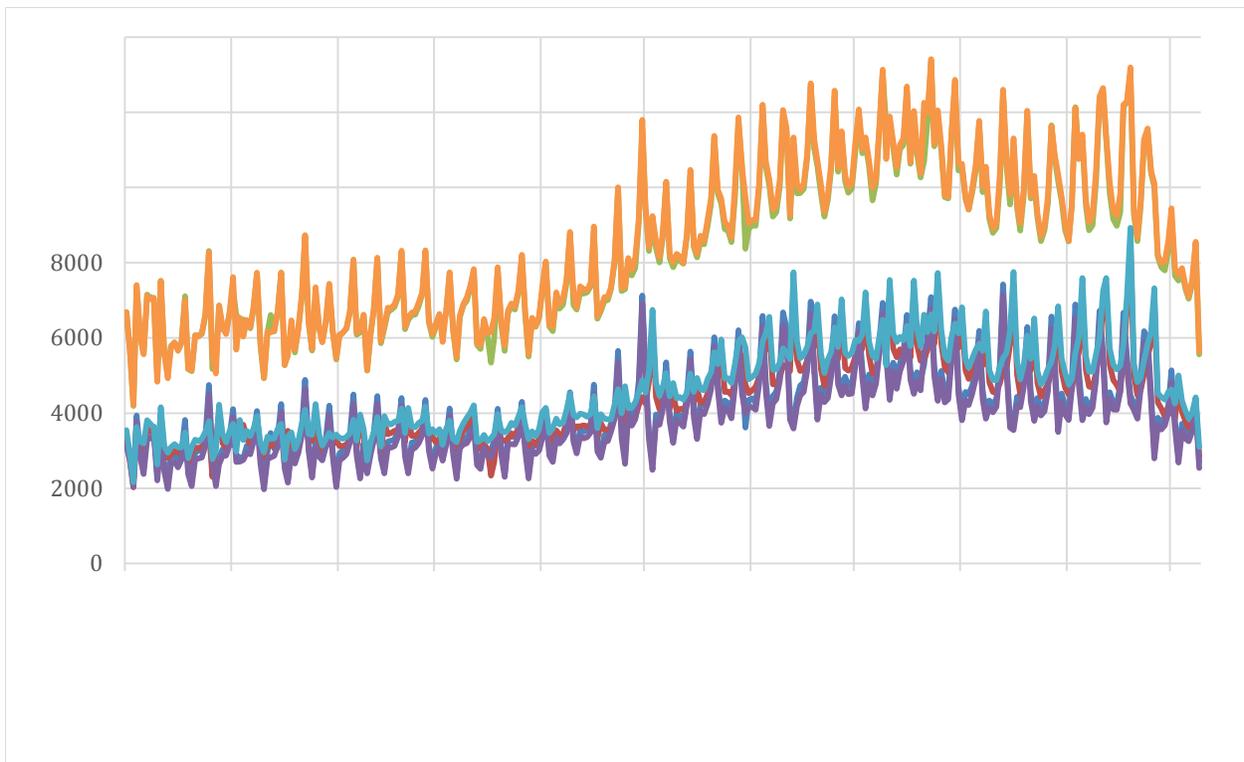
Figure 3.2: Daily directional and total volumes of WIM #30 and #213 sites

A graph of daily volumes, which was plotted over 10 months from 12/23/2014 to 10/31/2015, is shown in Figure 3.2. The top two lines show total volumes of the two sites. Both lines are mostly overlapped, indicating similar traffic counts. The bottom four lines show directional volumes of the two test sites. Again, directional volume curves are mostly overlapped, indicating similar volume counts. It is also interesting to notice seasonal differences that January (winter) daily volumes are around 6,000 and then the volume increases to nearly 1,200 in July (summer).

Root Mean Square Error (RMSE) of daily volumes computed over 10 months (from 12/23/2014 to 10/31/2015) was 94 vehicles per day which is about 1.47% of the WIM #30 average volume. Given that there are three exits between the two WIM sites of the highway, these daily volume differences are considered minimal, implying that both BL and Lineas sensors made no differences in volume counts. Table 3.1 shows a sample of daily directional volume data for 15 days, from 11/9/2014 to 11/23/2014, which shows typical volume differences between two sites.

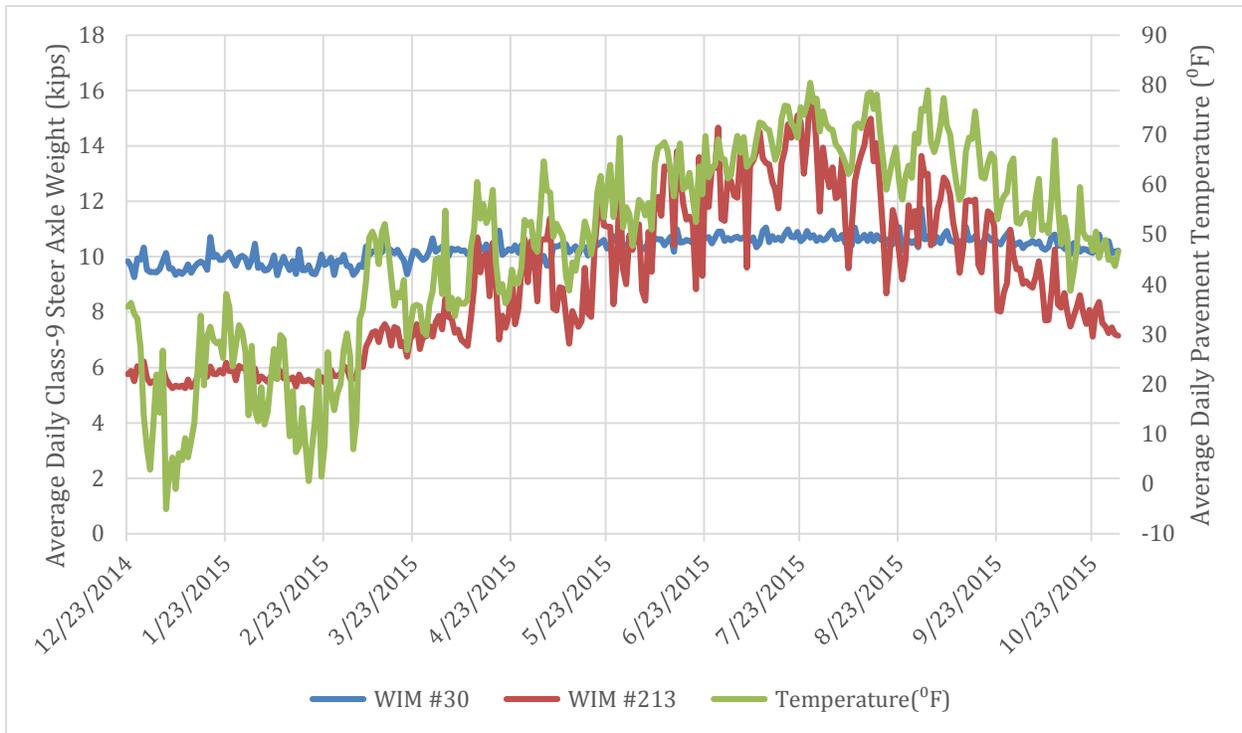
Figure 3.3: Daily averages of class-9 steer axle weights and pavement temperatures

Figure 3.3 shows daily average pavement temperatures (olive-green, right axis) and daily averages of steer axle weights measured by BL sensors (dark-red) and Lineas sensors (royal-

blue). Notice that daily average temperature swings widely but the trend remains firm, rising from about -6°F in January to 80°F in July. The steer axle weights measured by BL sensors in WIM #213 is clearly following the temperature trends while averages measured by Lineas sensors do not. This data indicates that BL sensors have a high temperature sensitivity, i.e., it rose from 6 kips to 15 kips or 250% when temperature increased from -6°F to 80°F . This temperature sensitivity was the reason that PVDF piezoelectric films (base material of BL sensor) are often used for temperature sensing, i.e., BL sensors use the same materials used for temperature sensing.

The original daily-average plot shown in Figure 3.3 was redrawn after temperature-based calibration, and it is shown in Figure 3.15. After calibration, notice that both Lineas and BL sensor data no longer follows daily temperature trends, which indicates removal or minimization of temperature dependency.

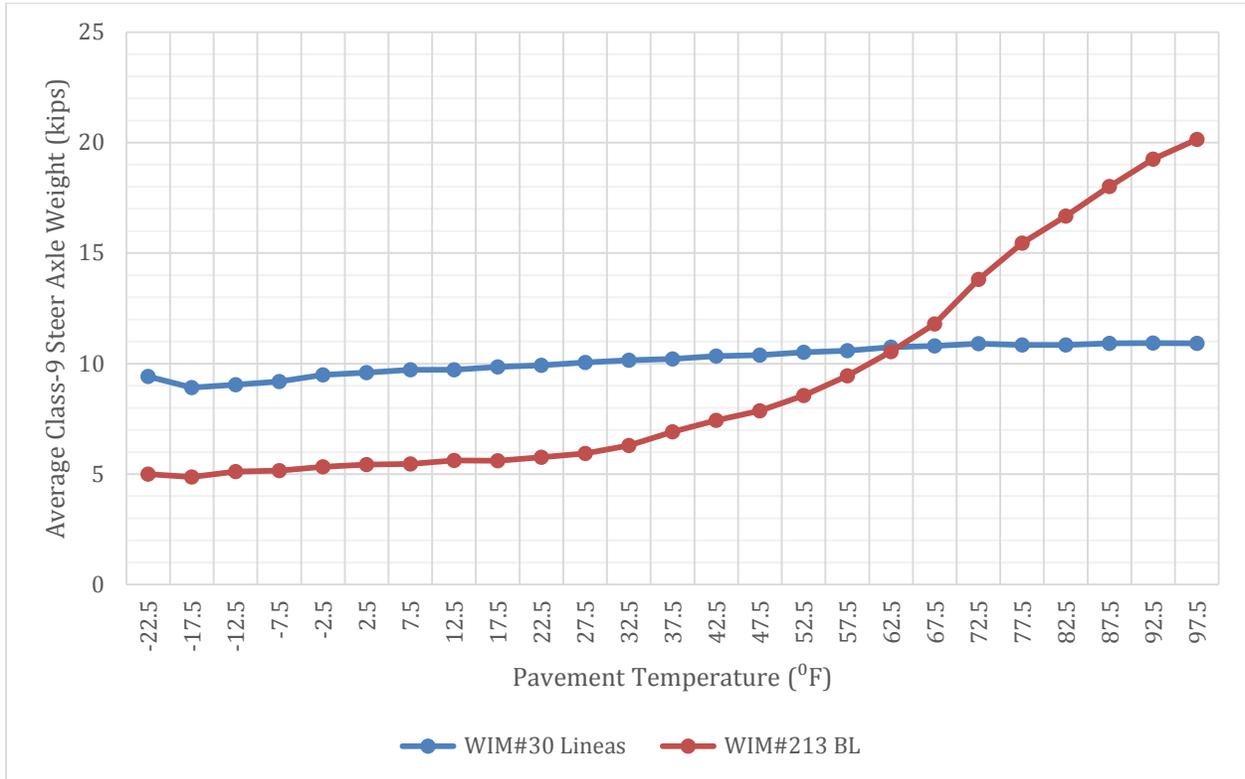
Figure 3.4: Averages of the class-9 steer axle weighs in 5°F temperature bins

In order to more accurately evaluate thermal effects, 10 months of class-9 steer axle weight data were first binned for 5°F increments in the range from -25°F to 100°F , i.e., the bins are -25 to 20 , -20 to -15 , ..., 95 to 100°F . Each temperature bin contains all of the class-9 steer axle weights collected over 10 months in the assigned temperature range. The average of each bin was plotted for both BL and Lineas sensors, and it is shown in Figure 3.4. The horizontal axis shows the mid value of each bin. Standard Deviation (SD) of each bin is also shown in Figure 3.5. Data shows

that weights measured by BL sensors change from 5 kips at -22.5°F to 20.7 kips at 97.5°F. This is about 314% increase, which clearly indicates a large error of weights caused by temperature. On the other hand, Lineas sensors increased only a small amount over the same temperature range, i.e. 9.0 to 11.2 kips or 24%. For BL sensors, SD increased along with temperature as well (see Figure 3.5).

In Figure 3.4, the weight averages of class-9 steer axles over 5°F incremental bins in the temperature ranges from -25°F to 100°F were plotted. This plot was redrawn after temperature-based calibration and shown in Figure 3.13. Notice that steer axle weights are now near 10 kips on all temperature ranges for both BL and Lineas sensors. This demonstrates that temperature-based calibration can correct the deviation caused by temperature. Figure 3.14 shows SD after calibration and it shows that SD is also reduced and consistent over the measured temperature range.

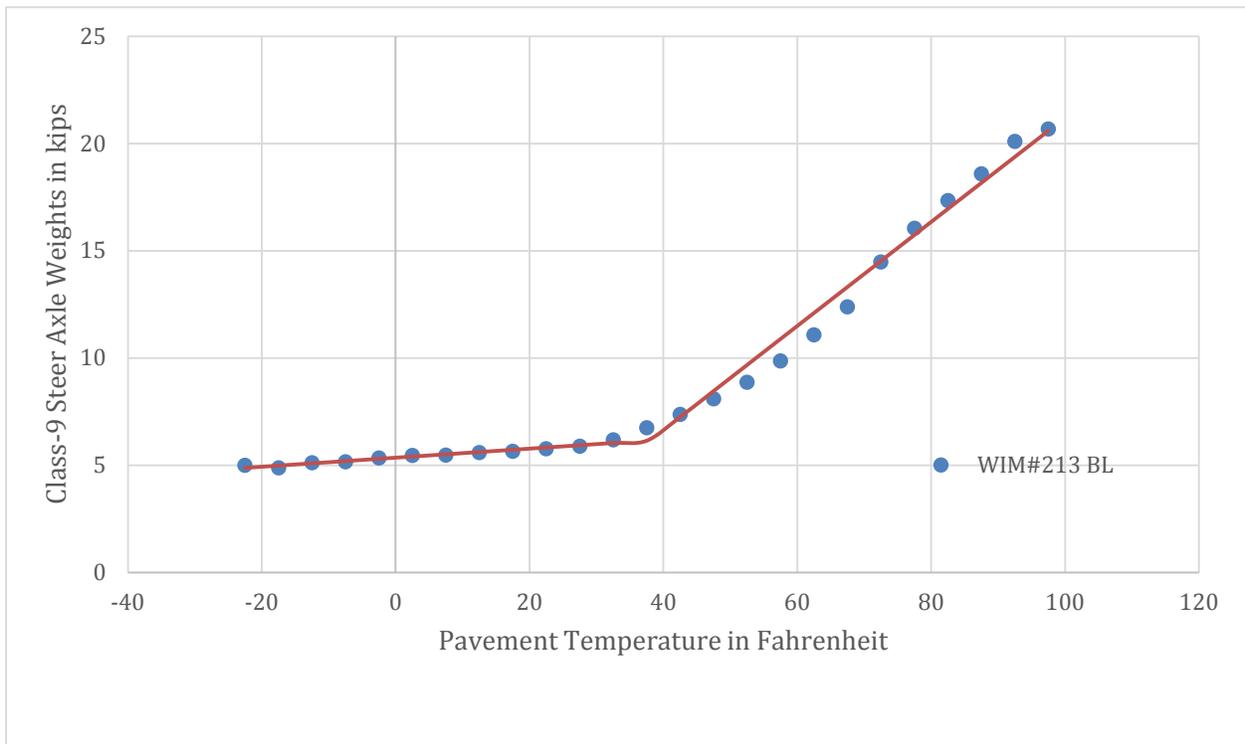
Figure 3.6: Linear modeling of BL sensor temperature sensitivity

Therefore, finding Equation (1) using the observed data is critical and should be the first step. First approach considered is modeling of the function using linear regression, and the result is shown in Figure 3.6. It can be observed that the slope of BL sensor measurements changes around 32°F (blue dots in the graph). When the two sections are separately linearly modeled, its crossing point occurs at 38°F, and the combined model is expressed as

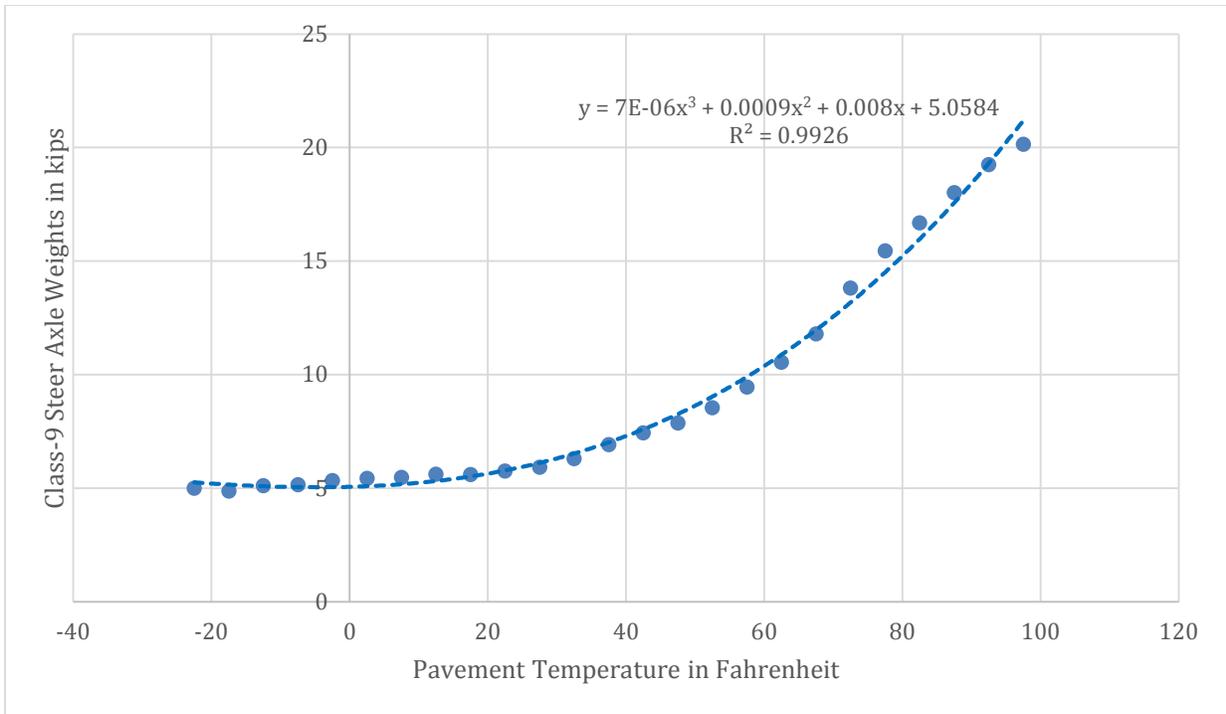
Figure 3.7: Polynomial function modeling of BL sensor temperature sensitivity

A more precise fit can be achieved using a polynomial function. Figure 3.6 shows a 3-rd degree polynomial function:

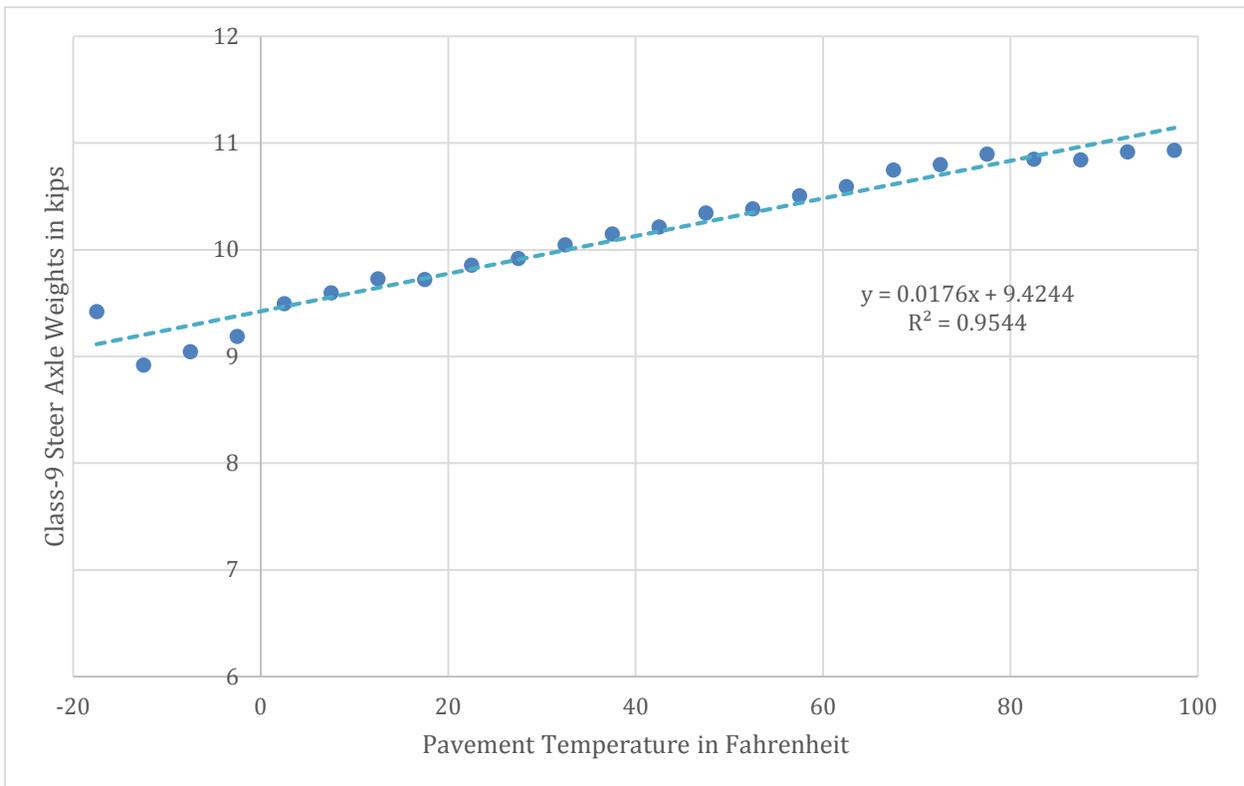
Figure 3.8: Linear modeling of Lineas sensor temperature sensitivity

In contrast, the slope of Lineas sensor measurements do not significantly vary, i.e., it only increased about 2 kips when temperature changed from -22.5°F to 97.5°F. Consequently, it is linearly modeled. The computed linear model with respect to temperature x in Fahrenheit is shown in Figure 3.8 and the equation is given by

$$y = 0.0176*x + 9.4244 \quad (6)$$

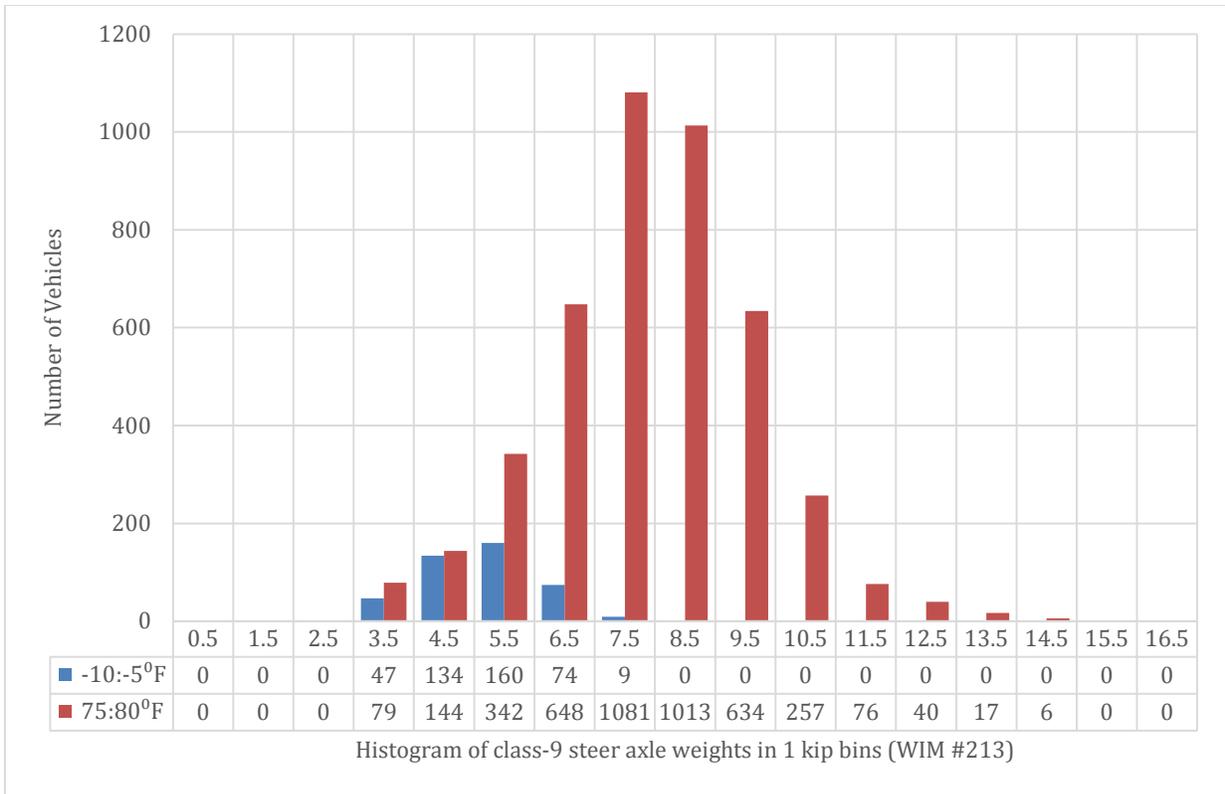
Figure 3.9: Histogram of class-9 steer axle weights of WIM #213 site in two different temperature ranges: before calibration

Figure 3.9 shows the histogram (distribution) of steer axle weights of BL sensors on two selected temperature ranges before calibration. The bin size of this histogram was 1 kip and the horizontal axis shows the mid value of each bin. Notice that the averages of the steer axle weights were shifted from 5.5 to 7.5 kips, when the temperature ranges increased from $(-10: -5)^{\circ}\text{F}$ to $(75: 80)^{\circ}\text{F}$. This data clearly shows that weights increase with respect to temperature for BL sensors. Notice also that there is a much higher population in the temperature range, $(75: 80)^{\circ}\text{F}$, which simply means that more class-9 vehicles traveled through Highway 61 in summer.

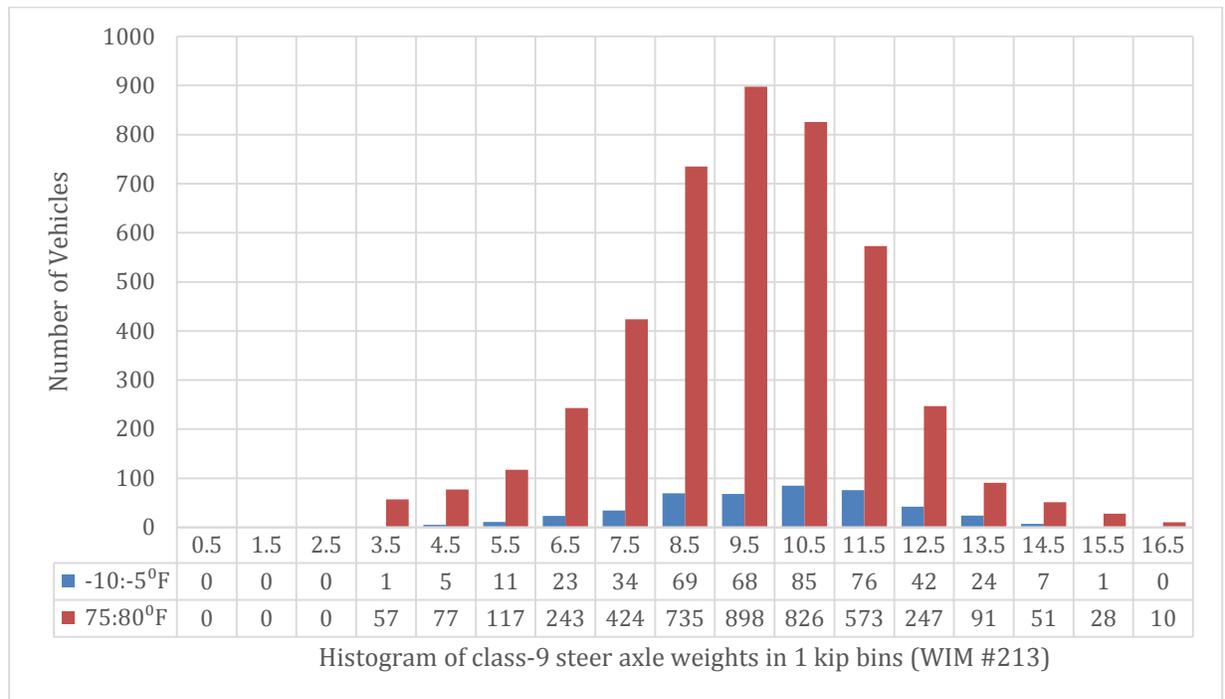
Figure 3.10: Histogram of class-9 steer axle weights of WIM #213 site in two different temperature ranges, after temperature-based calibration

The objective of temperature calibration is to move the class-9 steer axle weight distribution to approximately the same expected value (10 kips was chosen). The axle weights were calibrated using Eq. (3) based on the calibration model in Eq. (5). The weight distribution of after calibration is shown in Figure 3.10. Notice that the distribution centers are now moved to near 10 kips for both temperature ranges. Notice also that the support area of the distribution in the range, $(-10: -5)^{\circ}\text{F}$ widened after calibration, and it would have matched with $(75: 80)^{\circ}\text{F}$ range if more population of data are available. This indicates that temperature sensitivity can be calibrated to correct its measurement deviation.

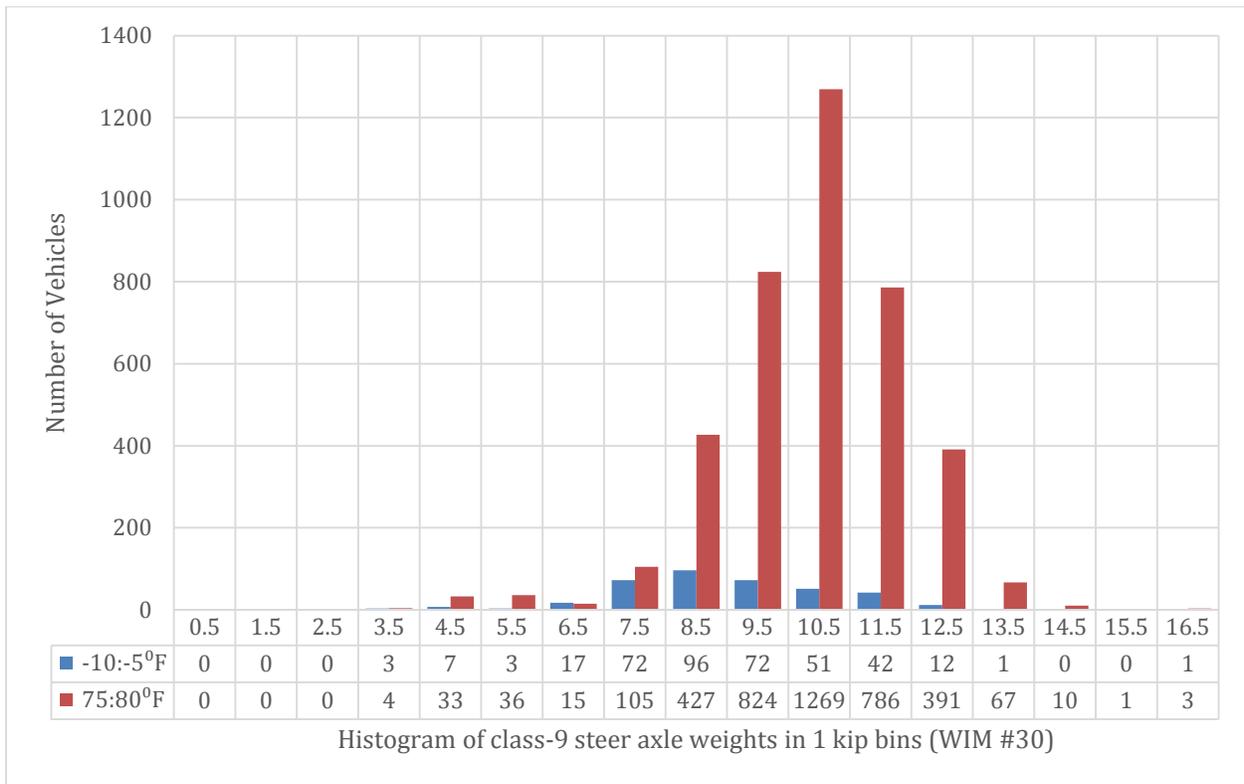
Figure 3.11: Histogram of class-9 steer axle weights of WIM #30 site in two different temperature ranges: before calibration

A similar computation was done for the Lineas sensors (WIM #30) and plotted, i.e., histograms of class-9 steer-axle weights for temperature ranges (-10: -5)^oF and (75: 80)^oF. This plot is shown in Figure 3.11. Notice that the weight averages of two temperature ranges were increased from 8.5 to 10.5 kips, indicating about 20% increase of temperature influence.

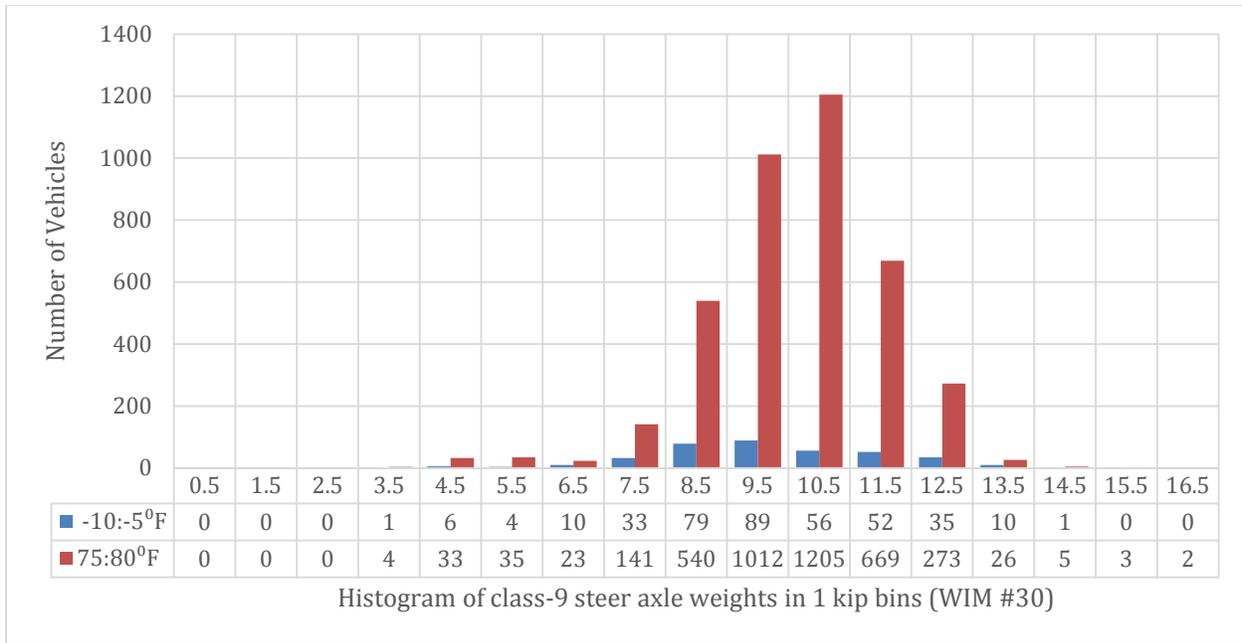
Figure 3.12: Histogram of class-9 steer axle weights of WIM #30 site in two different temperature ranges, after temperature-based calibration

For calibration, the linear mode in Eq. (6) was used for Lineas sensors (WIM #30). After calibration, the histogram was plotted again and is shown in Figure 3.12. Notice that the distribution centers are now near 10 kips for both selected temperature ranges.

Another characteristic that can be observed is that the dispersion of BL measurements is wider than that of Lineas sensors. This means that Lineas sensors would provide more consistent measurements.

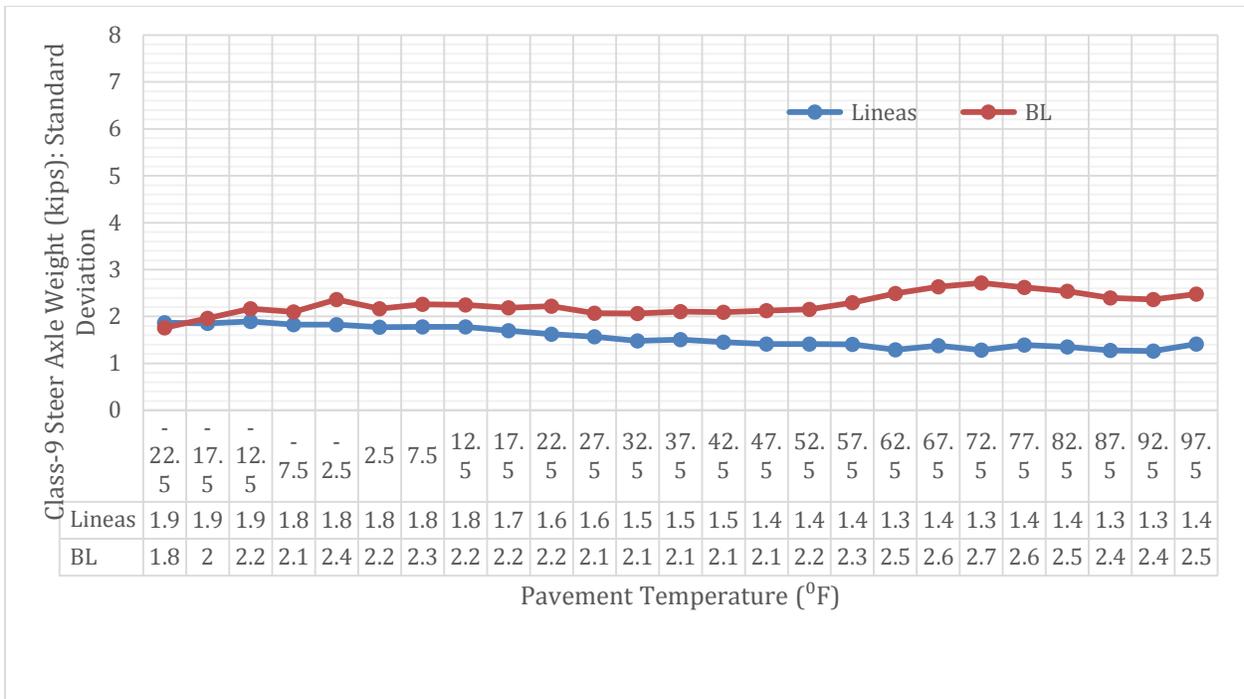
Figure 3.14: Standard deviation of class-9 steer axle weights in 5°F temperature bins after temperature-based calibration

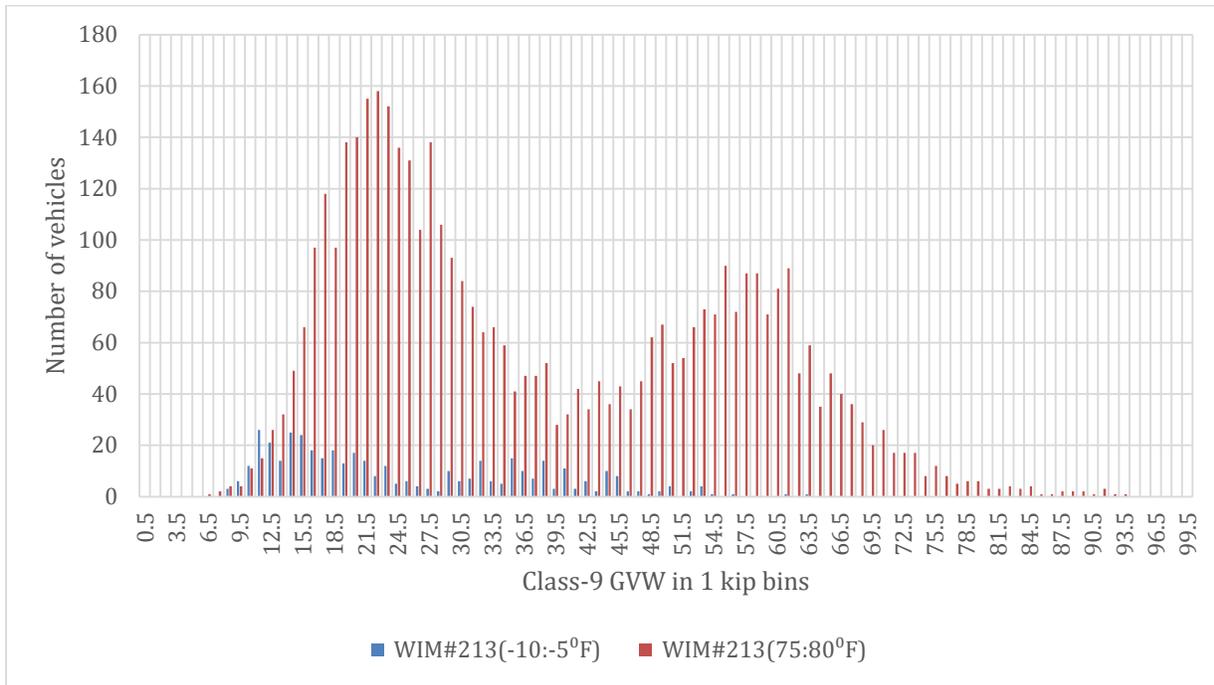
Figure 3.16: Histogram of GVW at WIM #213 in two different temperature ranges, before calibration

Similarly to class-9 steer axle analyses in Figure 3.9-15, GVW data in two temperature ranges, $(-10: -5)^{\circ}\text{F}$ and $(75: 80)^{\circ}\text{F}$ are analyzed. There were 424 class-9 vehicles in the range $(-10: -5)^{\circ}\text{F}$ and 4,336 vehicles in $(75: 80)^{\circ}\text{F}$ for WIM #213. Histogram of each temperature range was computed for 1 kip bin size and its plot is shown in Figure 3.16. Blue bars show the histogram of the temperature range $(-10: -5)^{\circ}\text{F}$ and red bars show the histogram of the temperature range $(75: 80)^{\circ}\text{F}$. Notice that GVW distribution appears as a distribution of two bell curves, consisting of two peaks and one valley. This is a typical shape of class-9 GVW distribution, in that the first bell curve shows distribution of unloaded vehicles and the second bell curve shows distribution of loaded vehicles. The valley of the curve occurs around 27.5 kips in the temperature range $(-10: -5)^{\circ}\text{F}$ and 40 kips in the temperature range $(75: 80)^{\circ}\text{F}$. It clearly shows that the valley moves to a higher kips value as temperature rises. Moreover, the distribution is not only shifted to higher weights but also spread wider in the higher temperature range.

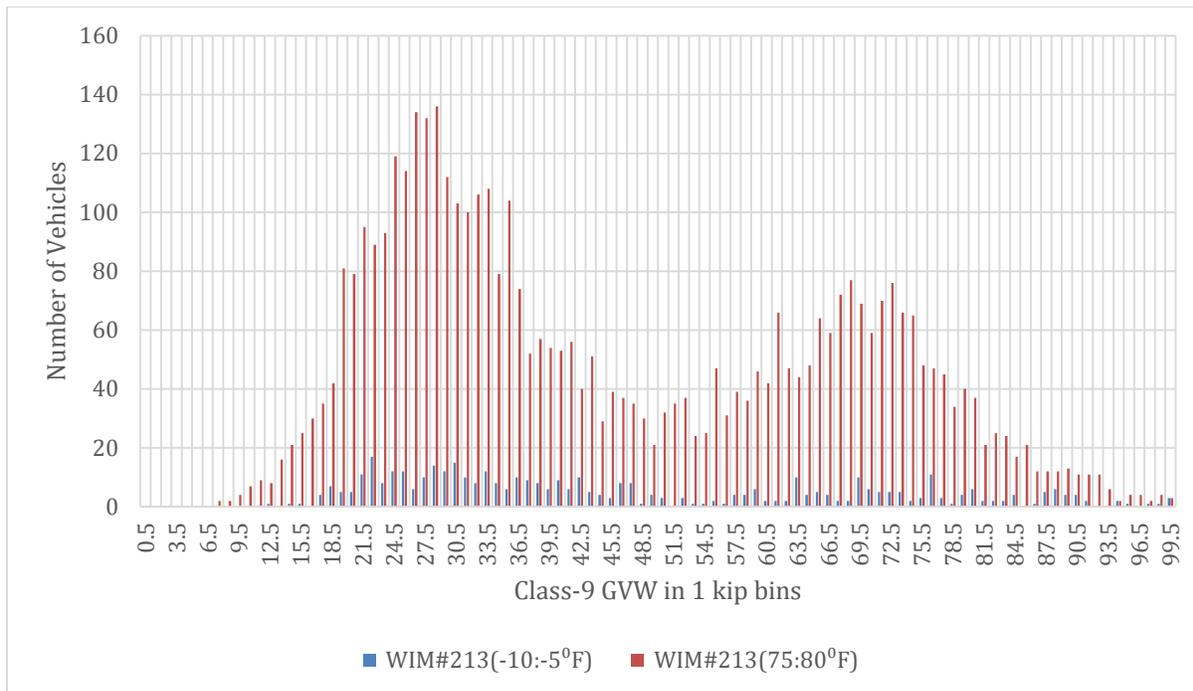
Figure 3.17: Histogram of GVW at WIM #213 after temperature-based weight calibration

GVW distribution after temperature-based calibration using Eq. (5) is shown in Figure 3.17. It can be clearly seen that bell curve peaks and valleys are more in synchronous, indicating removal of temperature dependency.

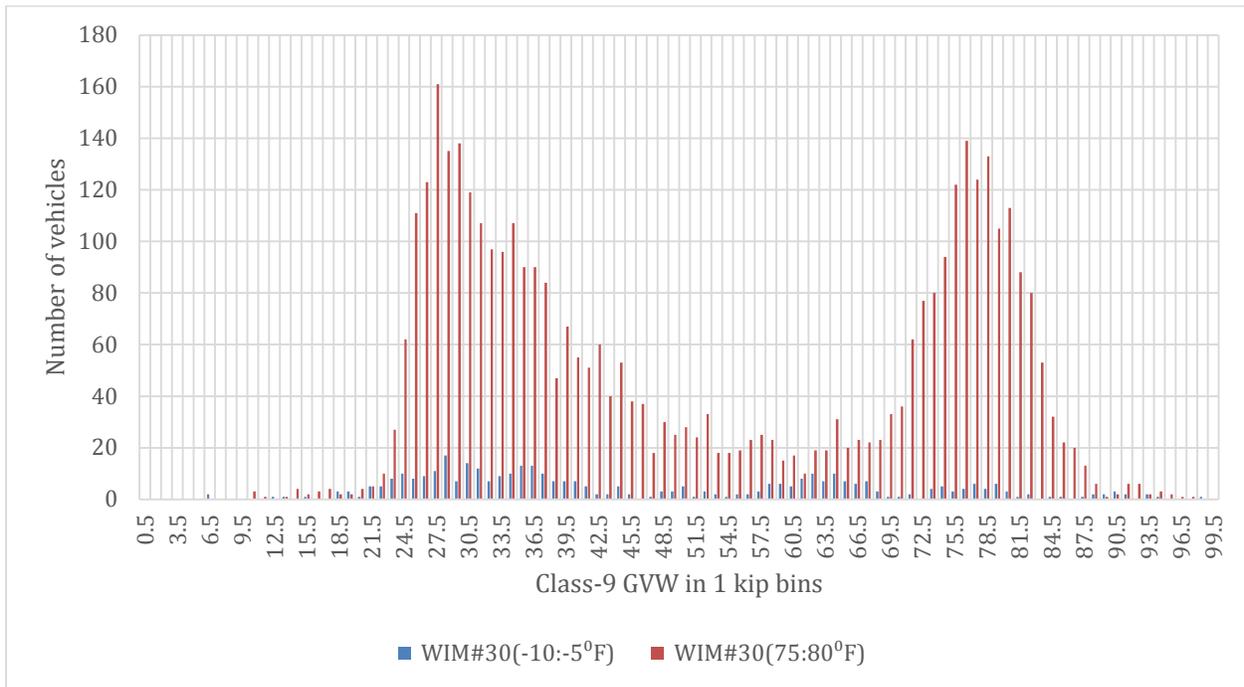
Figure 3.18: Histogram of GVW at WIM #30 site in two different temperature ranges: before temperature calibration

For WIM #30 Lineas sensors, histograms of two temperature ranges were computed and plotted similarly to the WIM #213 data, and it is shown in Figure 3.18. The major difference from WIM #213 data is that weights are distributed in a similar range for both temperature ranges, i.e., (-10: -5)^oF and (75: 80)^oF. The valley formed by two bell curves was around 45 kips in the temperature range (-10: -5)^oF and 58 kips in the temperature range (75: 80)^oF.
