Implementation and Evaluation of a Low-Cost Weigh-In-Motion System

Minnesota
Department of
Transportation

Taek M. Kwon, Principal Investigator
Department of Electrical Engineering
University of Minnesota Duluth

Research Project
Final Report 2016-10

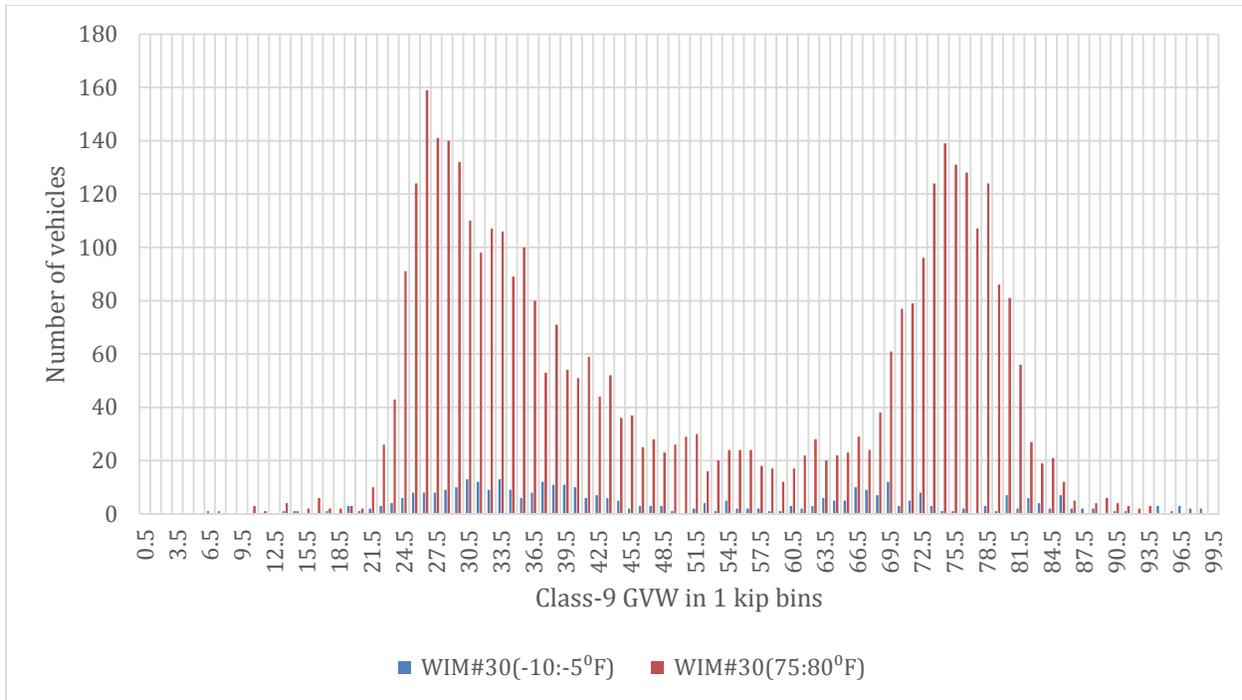
Figure 3.19: Histogram of GVW at the WIM #30 site after temperature-based weight calibration

Distribution recomputed after temperature-based calibration using the Eq. (6) is shown in 3.19. Notice that the difference is not as significant as WIM #213 data, but the peaks and valleys are shifted to reduce temperature dependency. This shows that it is a small amount of improvement but temperature dependency of Lineas sensor was also reduced after a temperature-based calibration.

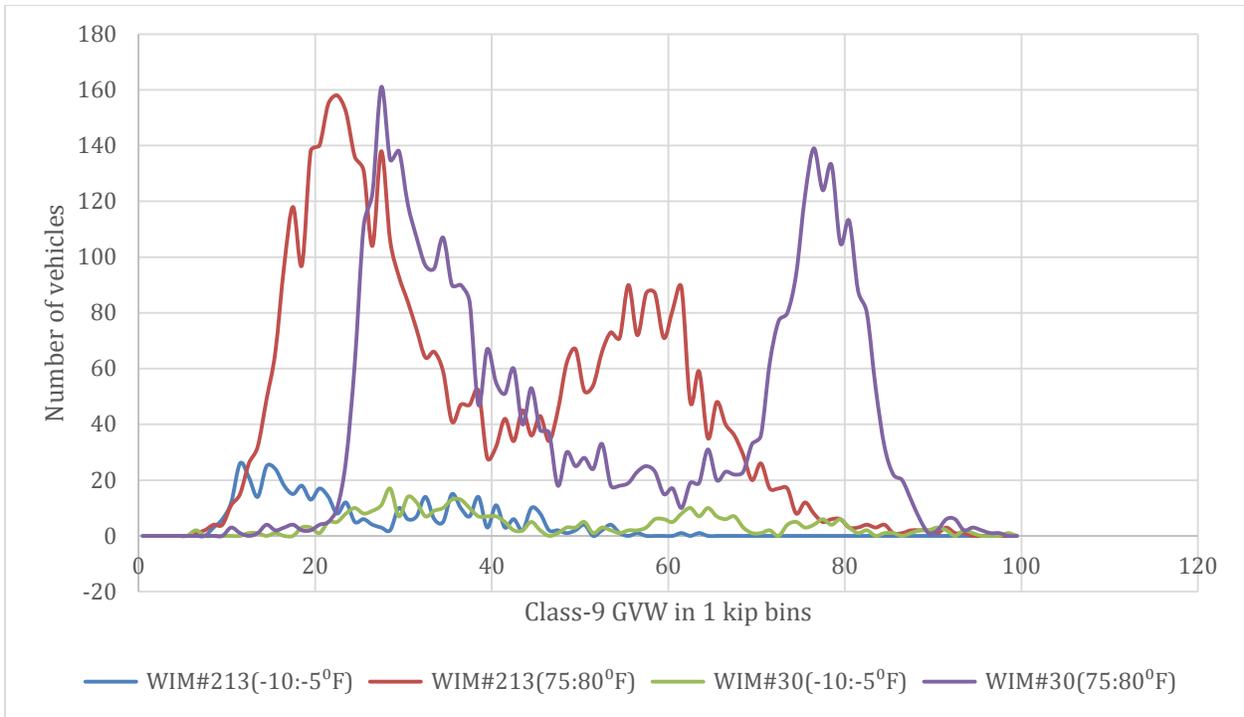
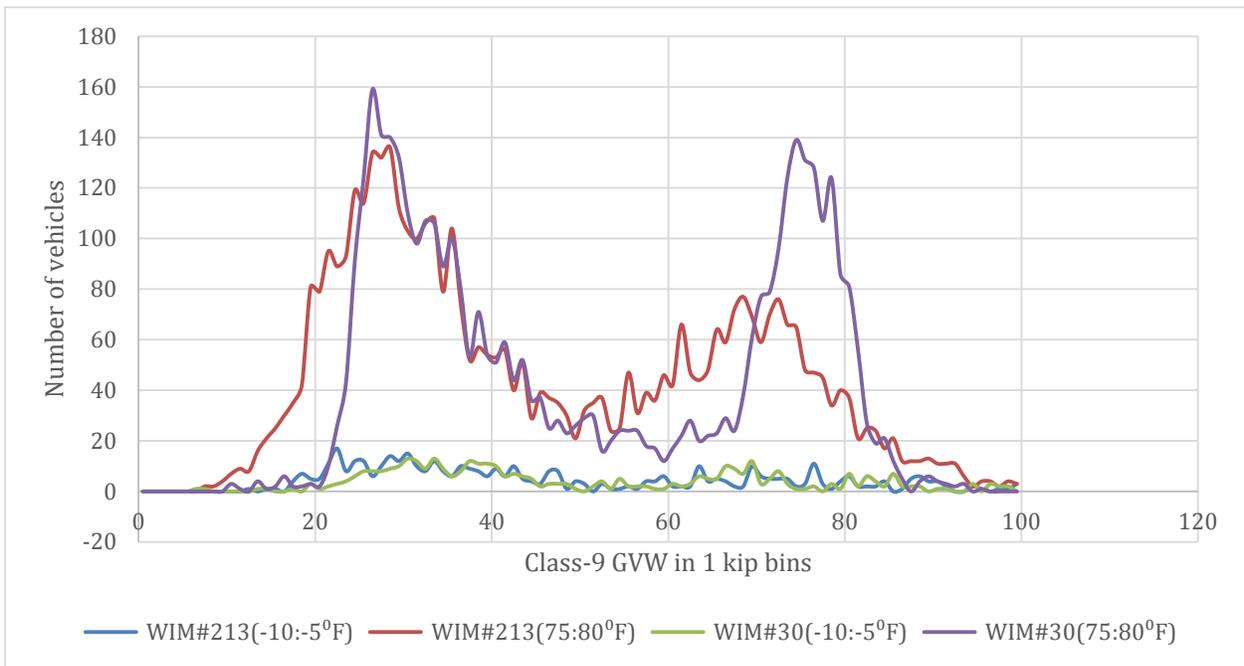
Next, in order to observe the differences between GVW measurements by Lineas (WIM #30) and BL (WIM #213) sensors in relation to before-and-after temperature-based calibration, distribution of both sensor data are plotted in the same graph in Figure 3.20, and after temperature-based calibration in Figure 3.21. Before calibration, distribution of WIM #213 data is more skewed to lower GVW and severe displacement of curves was observed, i.e., the curves are not aligned and chaotic. After calibration, the weight distribution curves are more closely aligned together (see Figure 3.21). Especially, GVW distributions of the temperature range, (-10: -5)^oF, at both sites are now closely aligned in a similar spread range. However, it can be also observed that Lineas data has a narrower distribution than BL data in the temperature range (75: 80)^oF. This indicates that Lineas sensors are more consistent than BL sensors even after temperature-based calibration. Notice from Figure 3.21 that the loaded class-9 vehicles of WIM # 213 has a much wider width and lower height distribution than that of WIM #30. This difference is not observable from the temperature range, (-10: -5)^oF. This shows that SD is smaller on lower temperature ranges and larger on higher temperature ranges for BL sensors.
