## TECHNICAL SUMMARY

# Improved Specifications for Tightening Anchor Bolts on Signs, Luminaires and Traffic Signals

*This Technical Summary pertains to Report 2018-27, “Re-Tightening the Large Anchor Bolts of Support Structures for Signs and Luminaires,” published August 2018. The full report can be accessed at [mndot.gov/research/reports/2018/201827.pdf](http://mndot.gov/research/reports/2018/201827.pdf).*

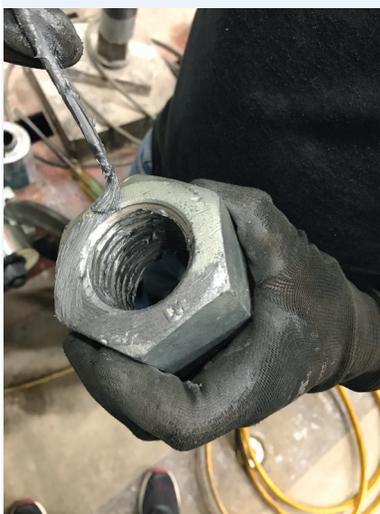
Proper lubrication is one of several critical steps in properly tightening anchor bolts and nuts.

Researchers revised the specifications to require bolt lubrication, establish torque levels for snug-tight and specify turn-of-nut rotation after snug-tight for a range of MnDOT materials:

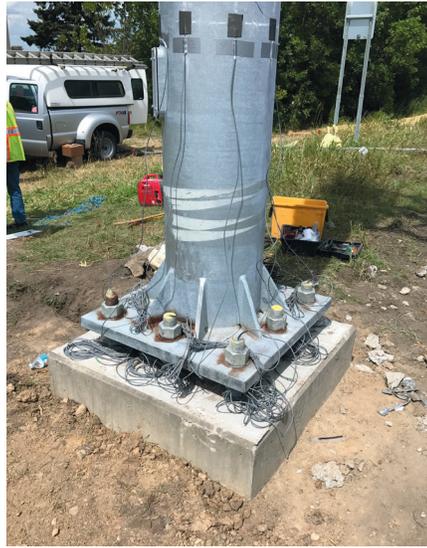
Researchers attached strain gages to the bolts and the mast of a new overhead sign. Installers followed new procedures and specifications to tighten the bolts so that investigators could evaluate the effectiveness of the new standards.

To determine the impact of environmental and structural strain on bolt tightness, researchers monitored sign structures in the field and in the lab. They attached strain gages to the bolts and post of an overhead sign near Minneapolis-St. Paul and installed a wind monitor, camera and data logging unit nearby to collect strain and environmental data for four months. In the lab, they instrumented a post and baseplate mounted in concrete to compare current and proposed tightening specifications and practices.
