Bridge 2440

Third Avenue Bridge

Summary Engineering Report

March 5, 2015

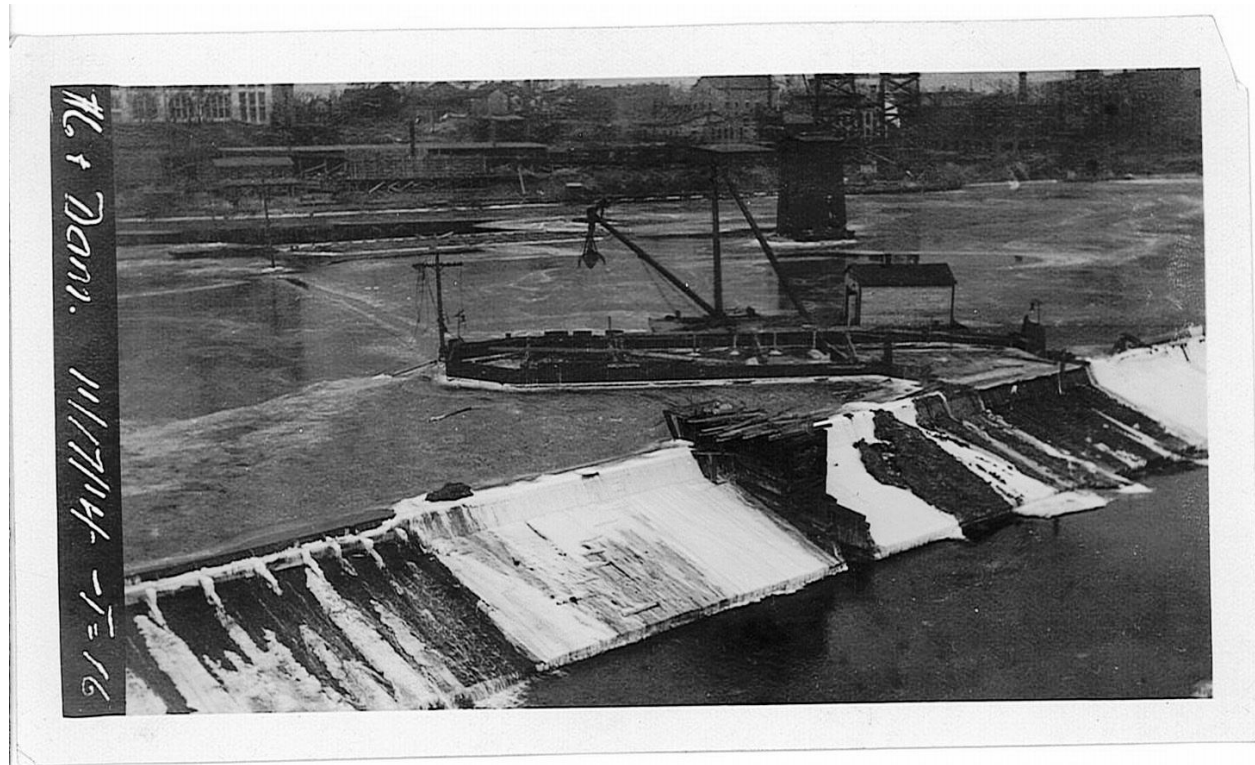
In 1837 a treaty was established between the Dakota and U.S. government which allowed development of the east bank (north side of the river in this area). In order to direct the logs to the east bank, a rock filled timber crib structure was constructed upstream into the river in 1849. This is now the north side of the horseshoe dam. The south half of the dam was added in 1856 [3]. With the construction of the south side of the horseshoe dam, a large number of grain milling operations established near and beyond the current lock location. The 1800's era rock filled timber dam was eventually capped with concrete and the original structure remains largely in place (Figures 5 & 6). The downstream edge of Pier 5's concrete footing seal lies immediately adjacent the horseshoe dam (Figure 7).

Figure 7: Pier 5 cofferdam and horseshoe dam.

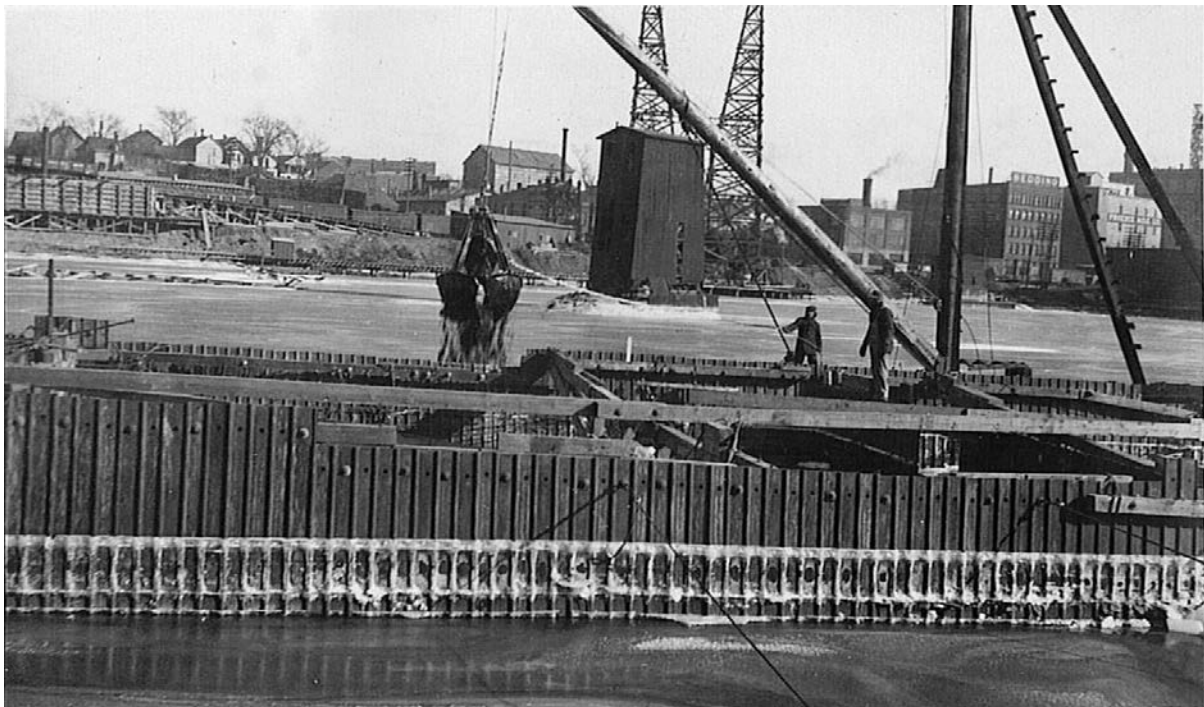
Sediment was removed mechanically from within the cofferdam through the use of orange-peel buckets (Figures 17 & 18). Photos show laborers cleaning out cofferdams with hand shovels as well. Evidence suggests that removing the sediment from within the cofferdam was not completed effectively. Figure 19 identifies concrete erosion of Pier 4 soon after construction which is likely related to foreign deleterious material mixing with the concrete at the time of casting.

Figure 18: Pier 5 cofferdam being cleared of debris and silt.

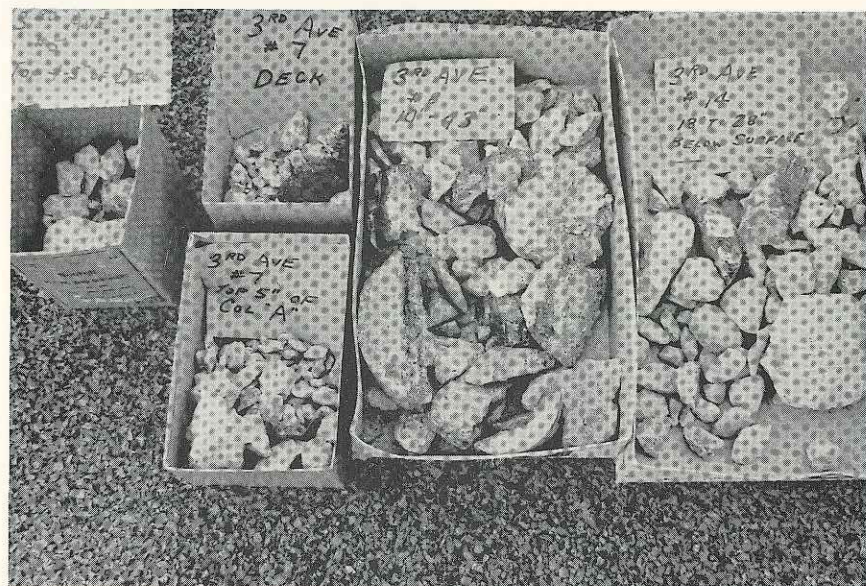
Core 1 (arch rib) was drilled down 9 inches but the sample recovered was 4 1/2 inches long which is too short for testing. Core 2 (arch rib) was drilled down 12 inches and recovered as 11 inches of sound concrete. Core 3 (barrel arch) was drilled down 12 inches and recovered as 10 inches of good

11-33. Cores as recovered from all coring operations.

concrete. Core 4 (deck to spandrel column) consisted of 8 inches of asphalt, 4 inches of sand/gravel fill, 11 1/2 inches of concrete deck, and 16 1/2 inches of concrete spandrel column (reinforcement hit at 5 1/2 inches). The 11 1/2 inch deck core was suitable for testing. Core 5 (deck to spandrel column)

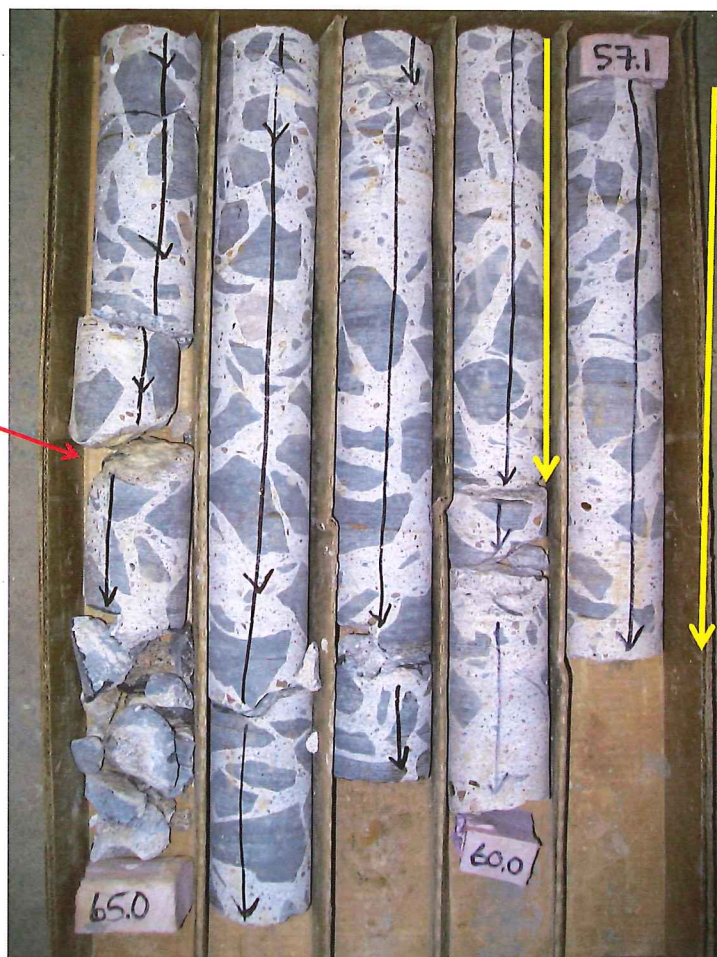
Core run 57.1 ft. to 65 ft.

Piece of
sandstone

100% coring water
return from 57.1 ft.
to 59.2 ft.

0% coring water
Return below 59.2 ft.

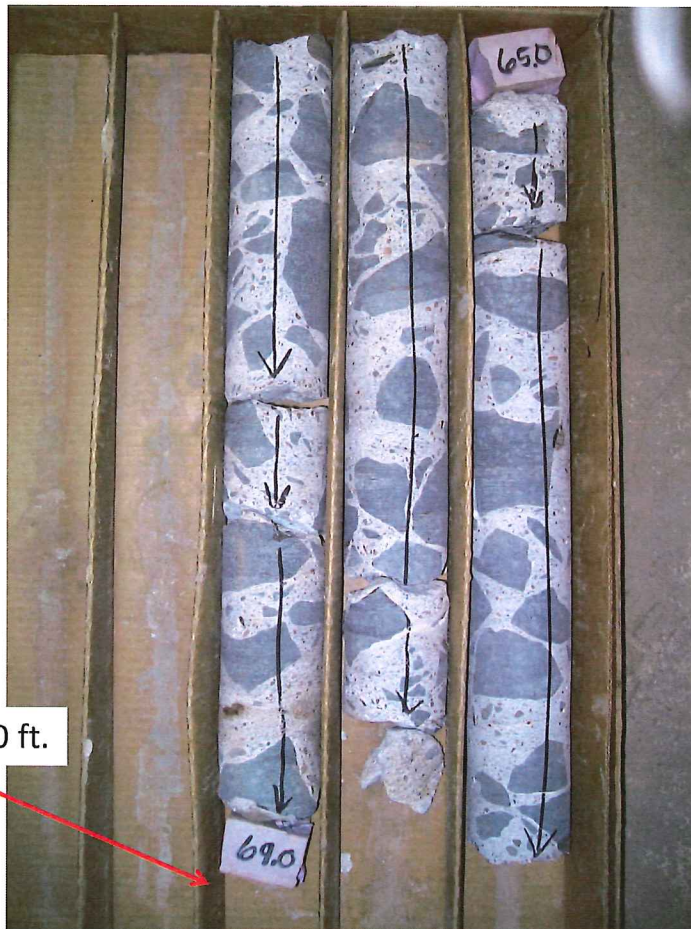
Core run 65ft. to 70 ft.

Void from 69 ft. to 70 ft.

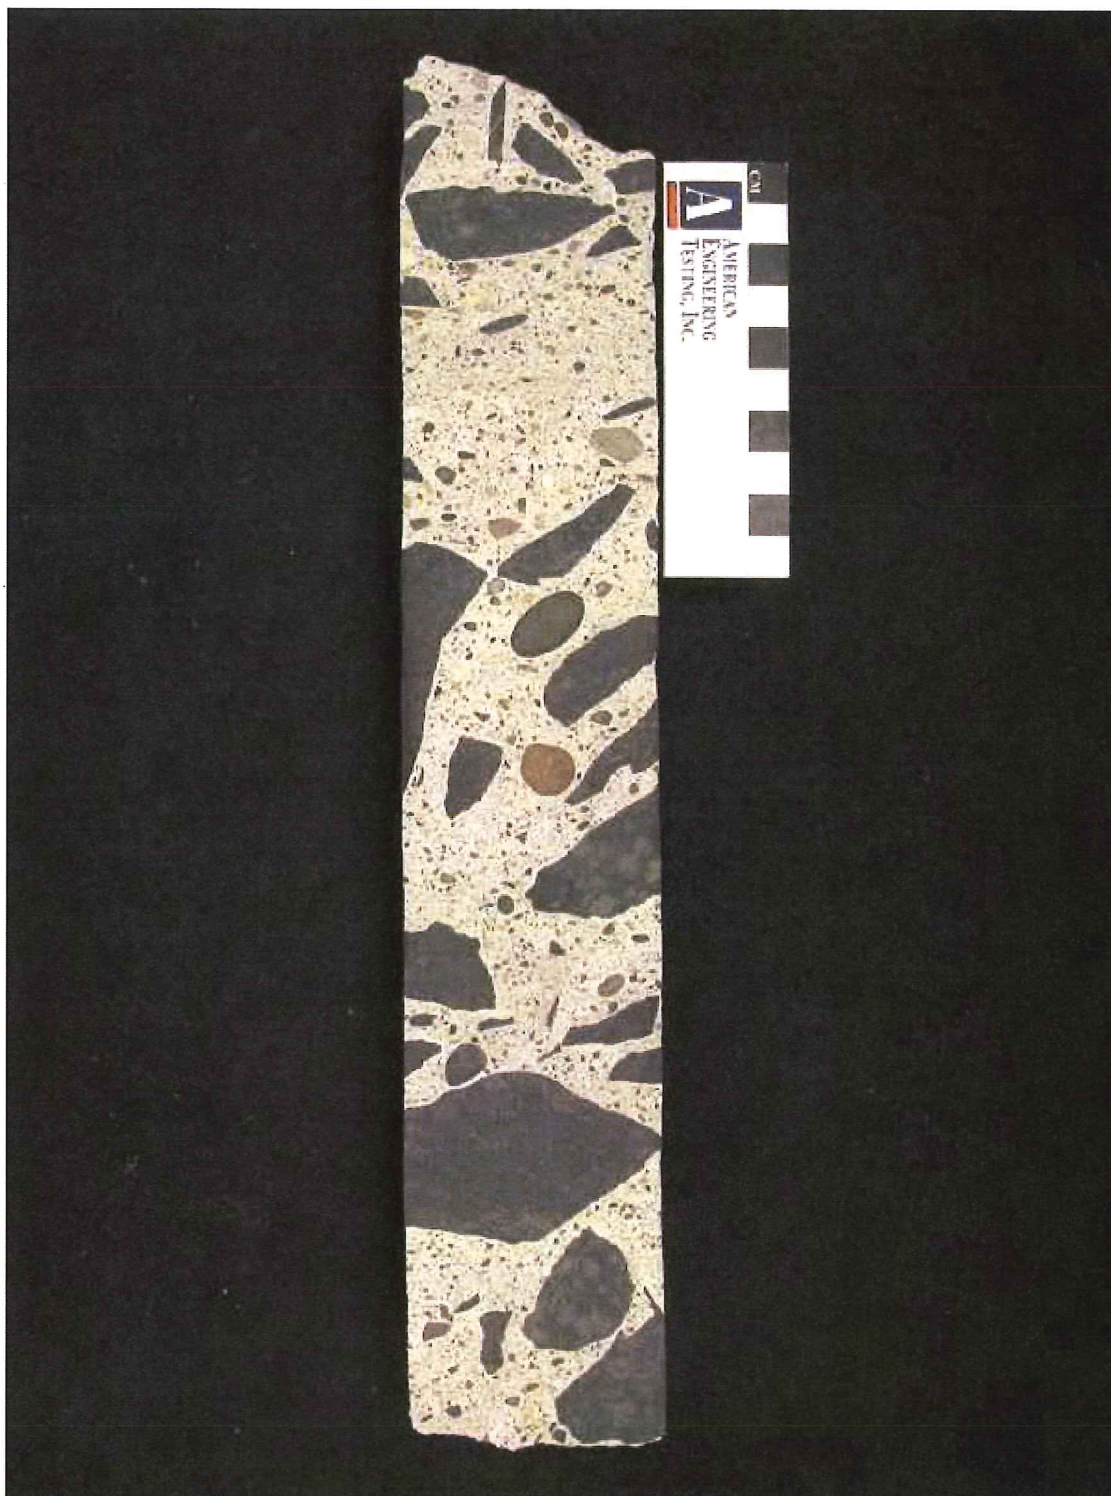
PHOTO: 3

SAMPLE ID: B1 **DESCRIPTION:** Sawcut and lapped cross section of core. Note the relatively large crushed coarse aggregate and a zone of aggregate segregation proximate to the top of the core.

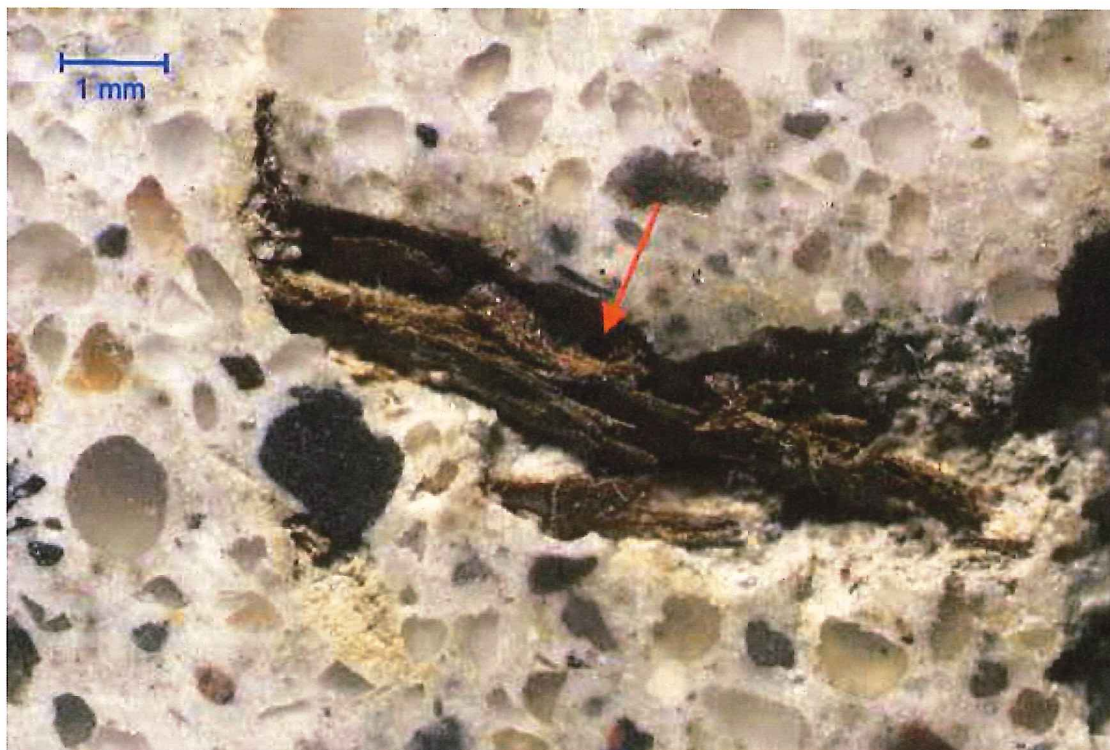
PHOTO: 6

DESCRIPTION: Fragment of plant material or wood (red arrow) along the cored edge of the sample.
