Winona Bridge Work Package #5

Bridge No. 5900 (Existing Bridge) Rehabilitation and Reconstruction

Q&A #2

This report documents the findings of the routine and fracture critical inspection of Mn/DOT Bridge No. 5900, TH 43 over the Mississippi River, Railroad and City Streets. **The inspection started on June 2, 2008 and was completed on June 5, 2008.**

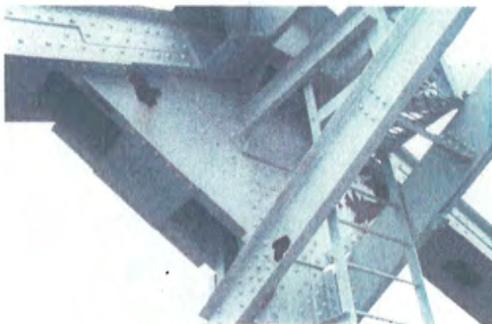
Picture 1: Span 19 East Truss U10
Inside Plate

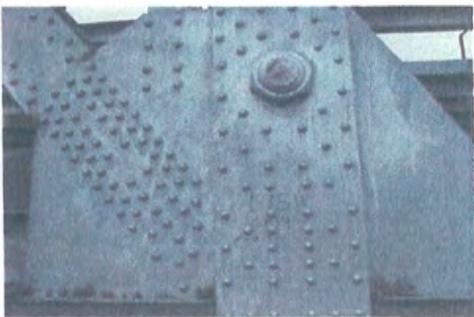
Picture 2: Span 19 West Truss L15
Outside Plate

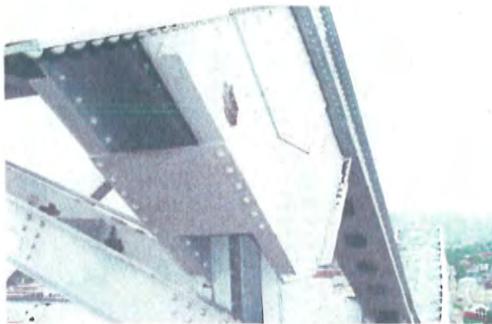
Picture 3: Span 19 East Truss U10'
Outside Plate

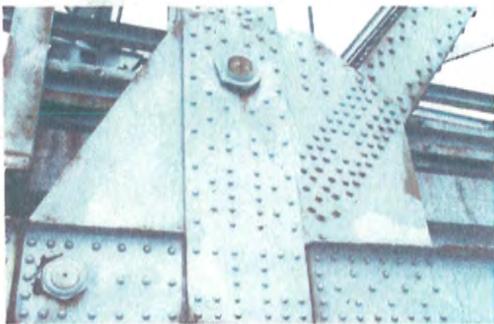
Picture 4: Span 19 East Truss L15'
Outside Plate

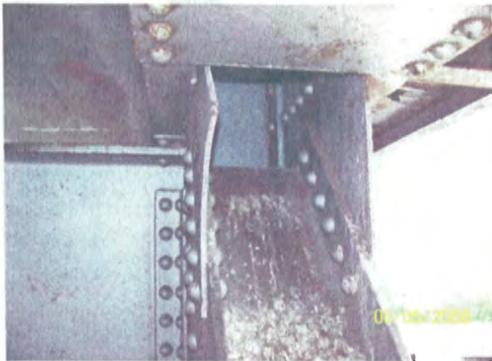
Picture 5: Span 16 East Truss U3 South Edge

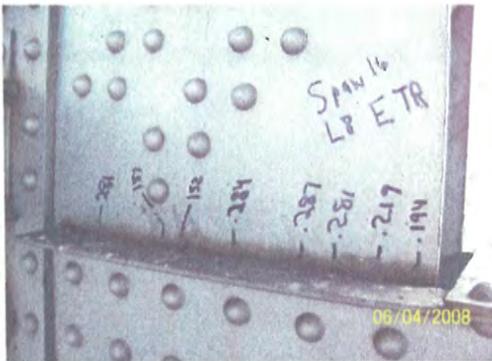
Picture 6: Span 16 East Truss L8
Inside Plate Shear Zone - 38% Loss

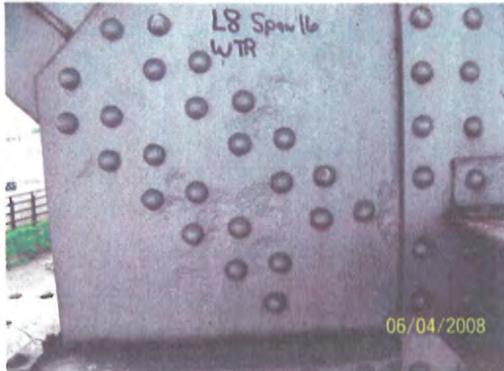
Picture 7: Span 16 West Truss L8
Inside Plate Localized Pit - 75% Loss

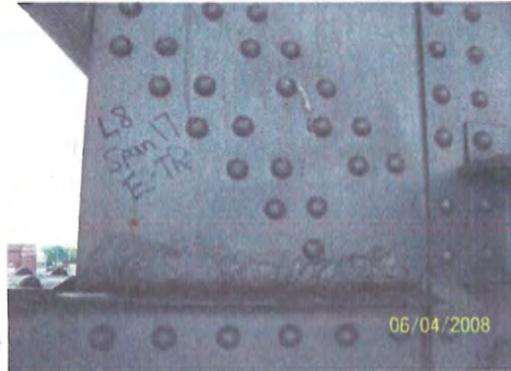
Picture 8: Span 17 East Truss L8
Inside Plate Shear Zone - 42% Loss

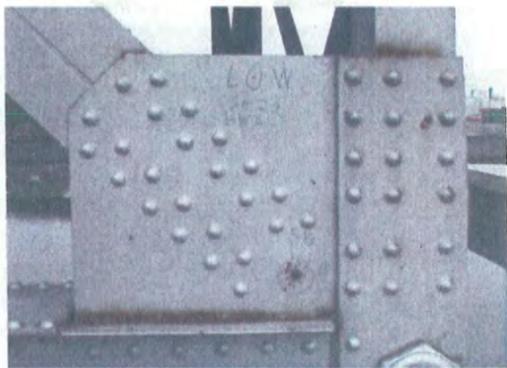
Picture 16: Span 22 West Truss L0 Outside Plate Hole

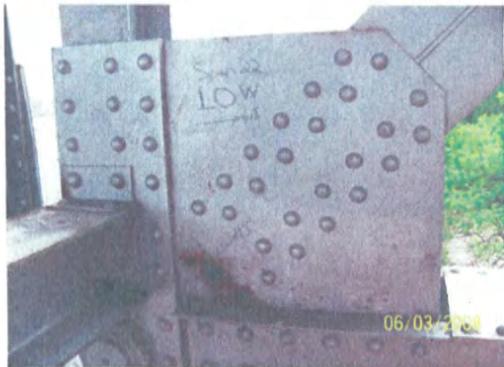
Picture 17: Span 22 West Truss L0 Inside Plate Hole

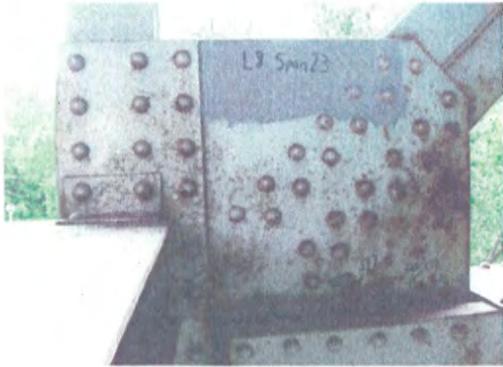
Picture 18: Span 23 East Truss L8 Inside Plate Shear Zone - 44% Loss

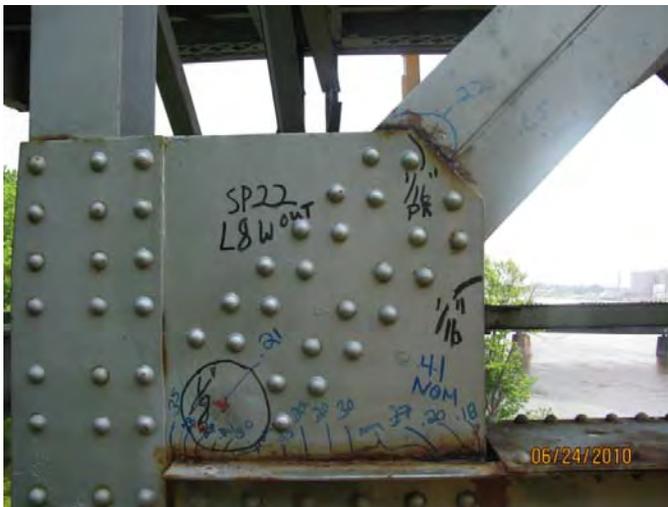
Photo 1: Span 22 L8W Exterior Gusset

- Exterior Gusset (Photo 1): 40% loss measured on the horizontal shear zone. There is also a 1/8” bulge out in the compression zone.
- Interior Gusset (Photo 2): 30% loss measured on the horizontal shear zone. There is also a 1/8” bulge out in the compression zone and 3/8” bow out on the vertical free edge.

The NBI superstructure rating has been adjusted to 2 by the Mn/DOT Bridge Office based on the needed gusset repair. It will be re-adjusted to a 3 once repairs are made to the gusset plates.

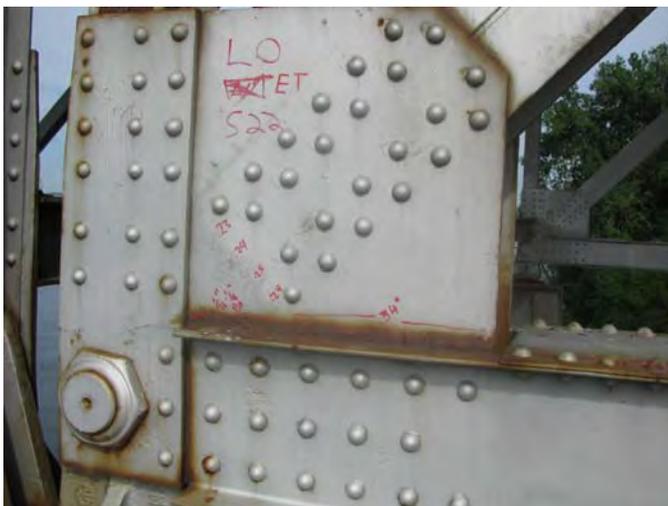
Photo 3: Span 21 L0E Exterior Gusset Plate

- Exterior Gusset (Photo 3): 20% loss measured in the horizontal shear zone. 37% loss measured in the compression zone at the end of the diagonal.
- Interior Gusset (Photo 4): No notable loss in the horizontal shear zone. 30% loss measured in the compression zone at the end of the diagonal.

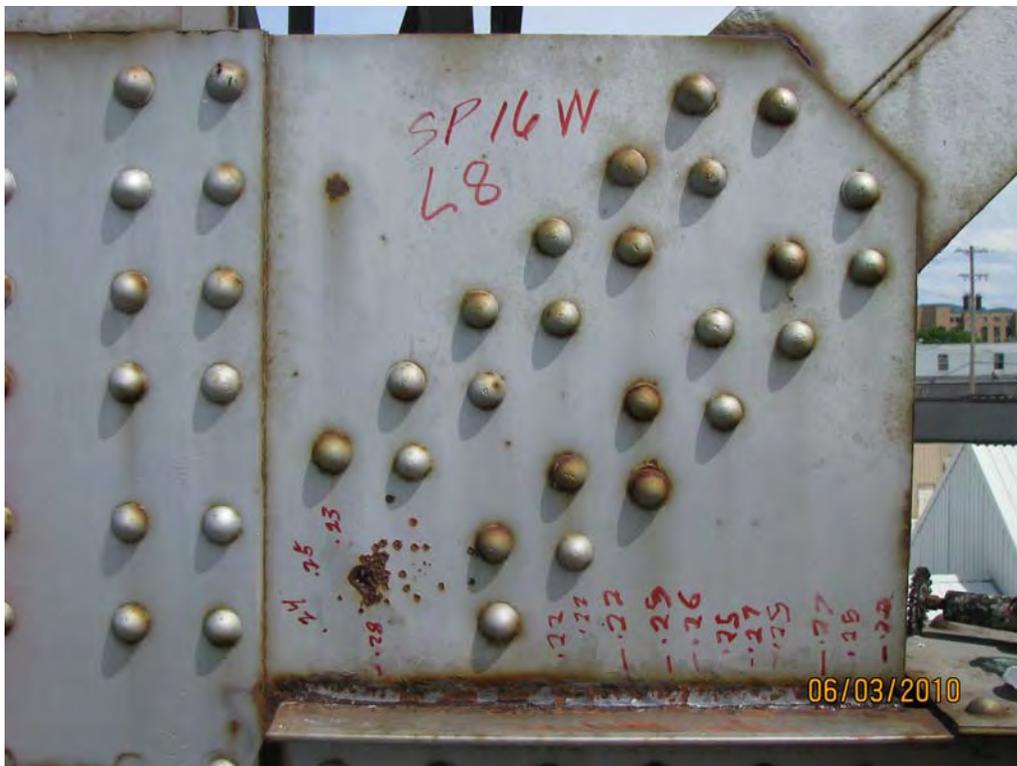
Photo 1: Span 16 L8W Exterior Gusset Plate

As a result of the load rating analysis findings, the Mn/DOT Bridge Office affirms that the bridge should be posted at legal loads, or 40 tons, and to conduct repairs to the Span 16 L8W panel point exterior plate per the 2008 Wiss, Janney, Elstner Associates, Inc. gusset plate repair plans.

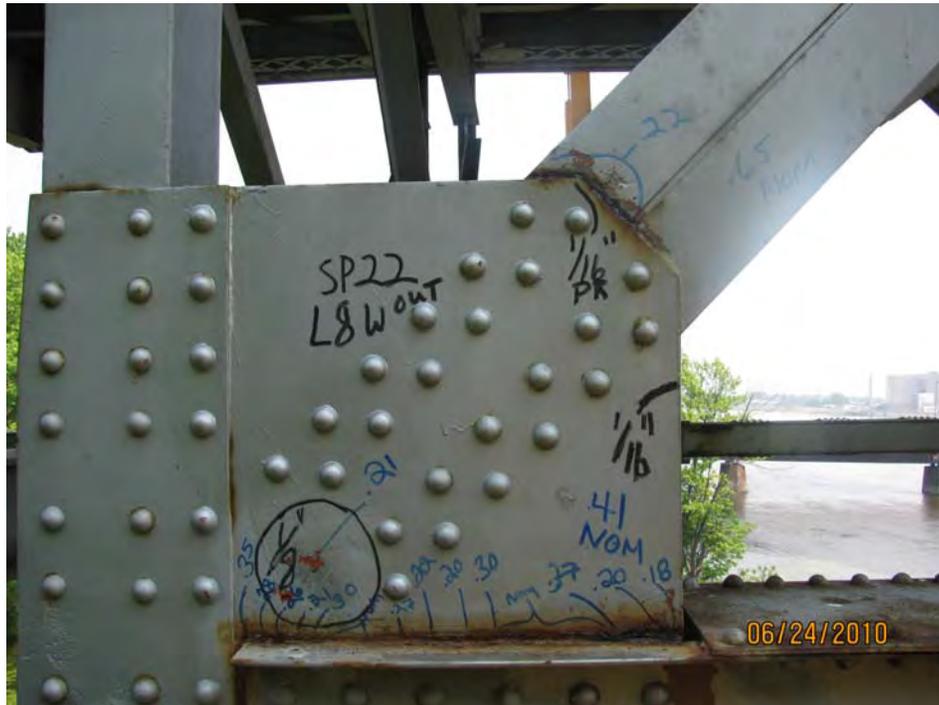
Photo 1: Span 22 L8W Exterior Gusset

- Exterior Gusset (Photo 1): 40% loss measured on the horizontal shear zone. There is also a 1/8" bulge out in the compression zone.
- Interior Gusset (Photo 2): 30% loss measured on the horizontal shear zone. There is also a 1/8" bulge out in the compression zone and 3/8" bow out on the vertical free edge.

The NBI superstructure rating has been adjusted to 2 by the Mn/DOT Bridge Office based on the needed gusset repair. It will be re-adjusted to a 3 once critical repairs are made to these gusset plates. A number of additional

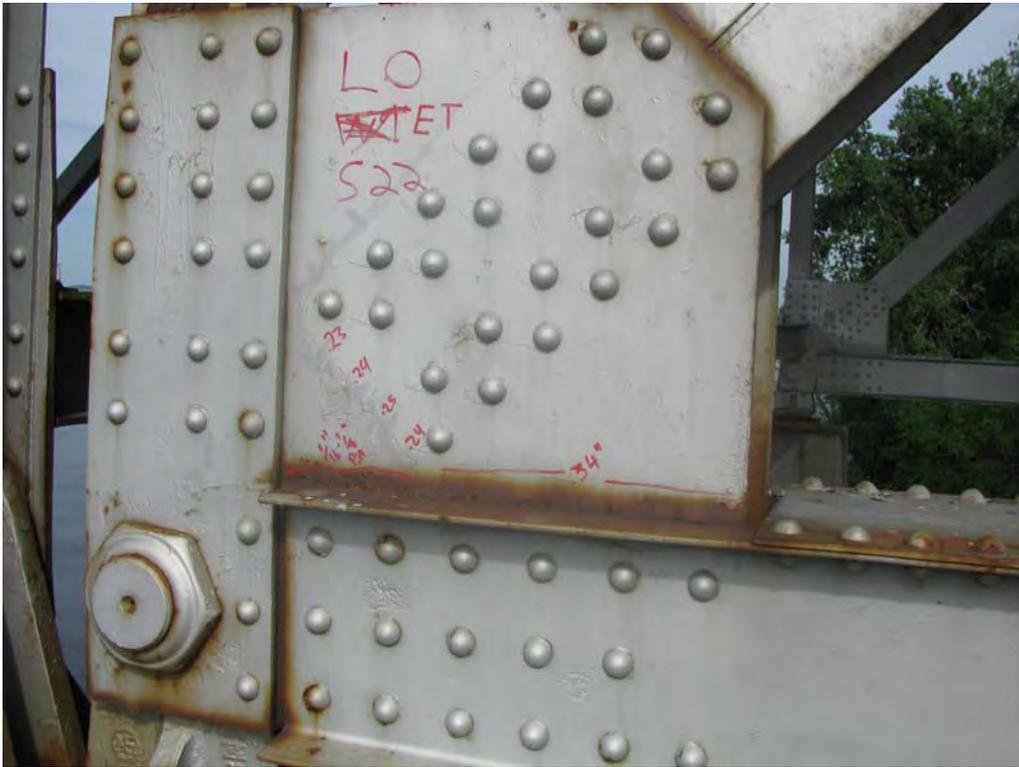
Photo 3: Span 21 LOE Exterior Gusset Plate

- Exterior Gusset (Photo 3): 20% loss measured in the horizontal shear zone. 37% loss measured in the compression zone at the end of the diagonal.
 - Interior Gusset (Photo 4): No notable loss in the horizontal shear zone. 30% loss measured in the compression zone at the end of the diagonal.
-

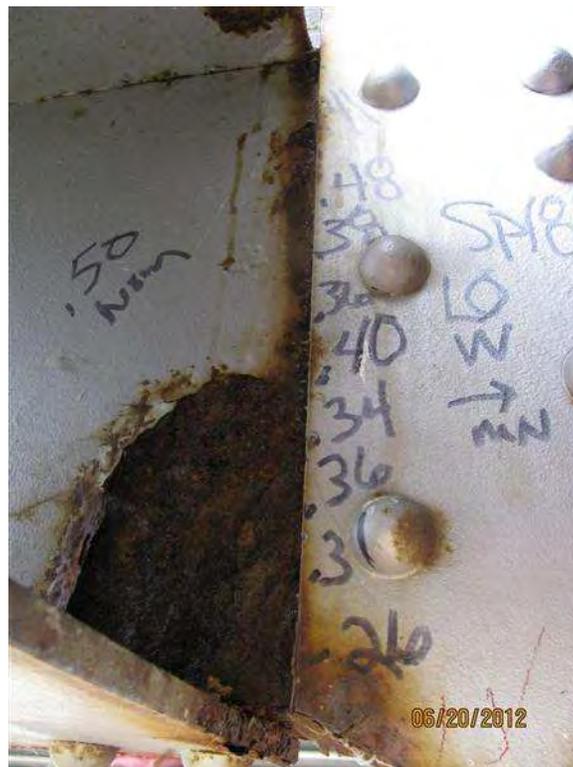
Photo 2 - Span 18 LOW Inside Channel Losses at LOW

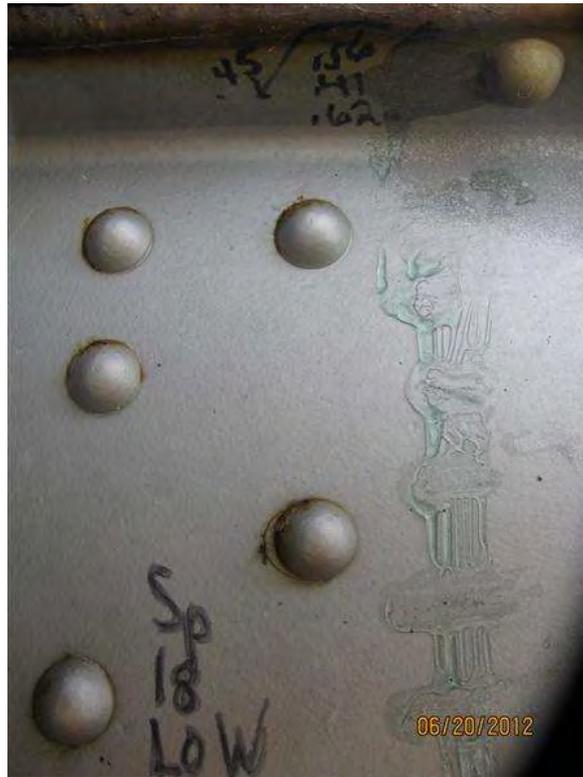
Photo 3 - Span 18 LOW Inside Channel Top Flange Losses at LOW

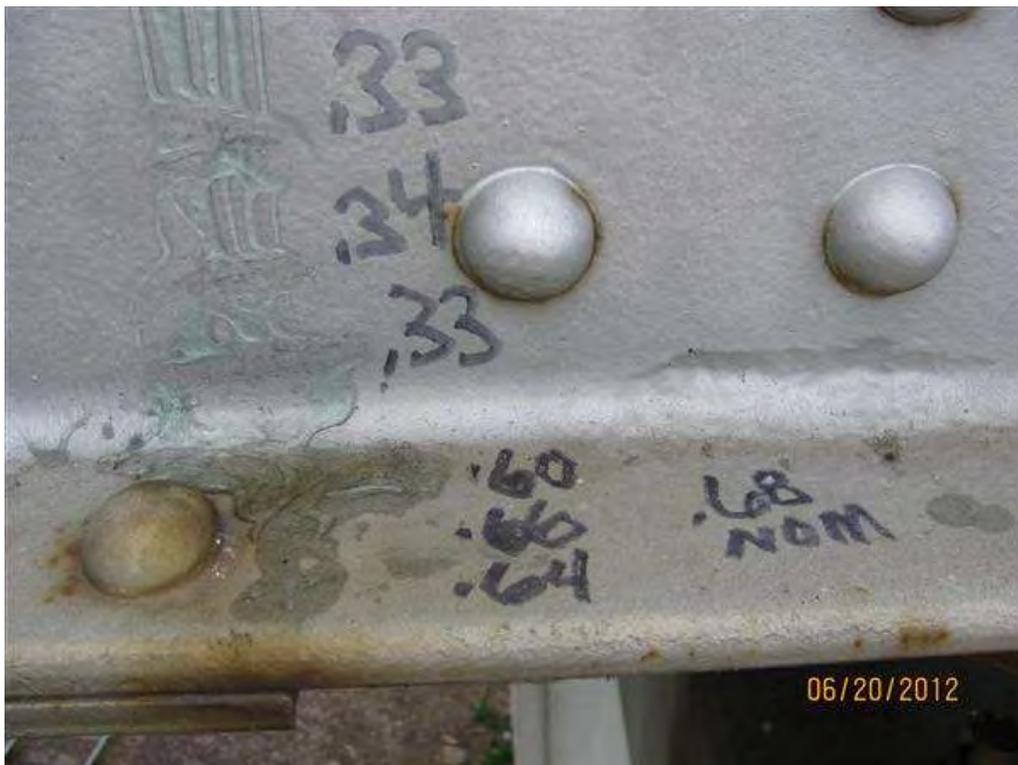
Photo 4 - Span 18 LOW Outside Channel Bottom Flange Losses

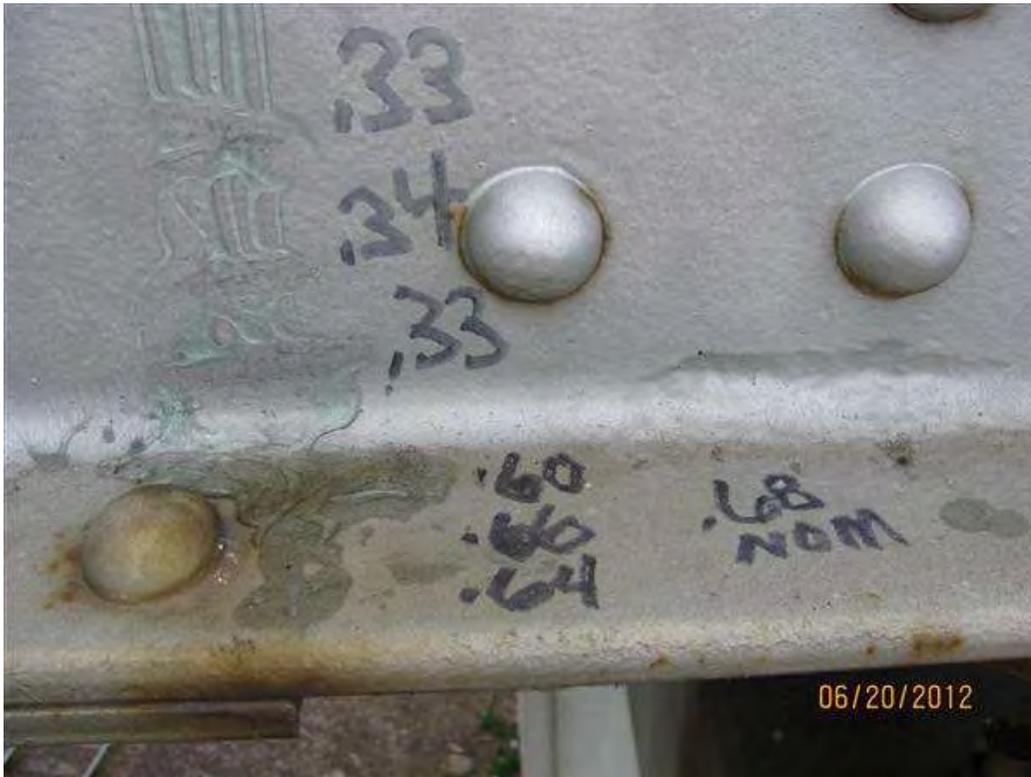
Photo 5 - Span 18 LOW Outside Channel Bottom Flange Losses

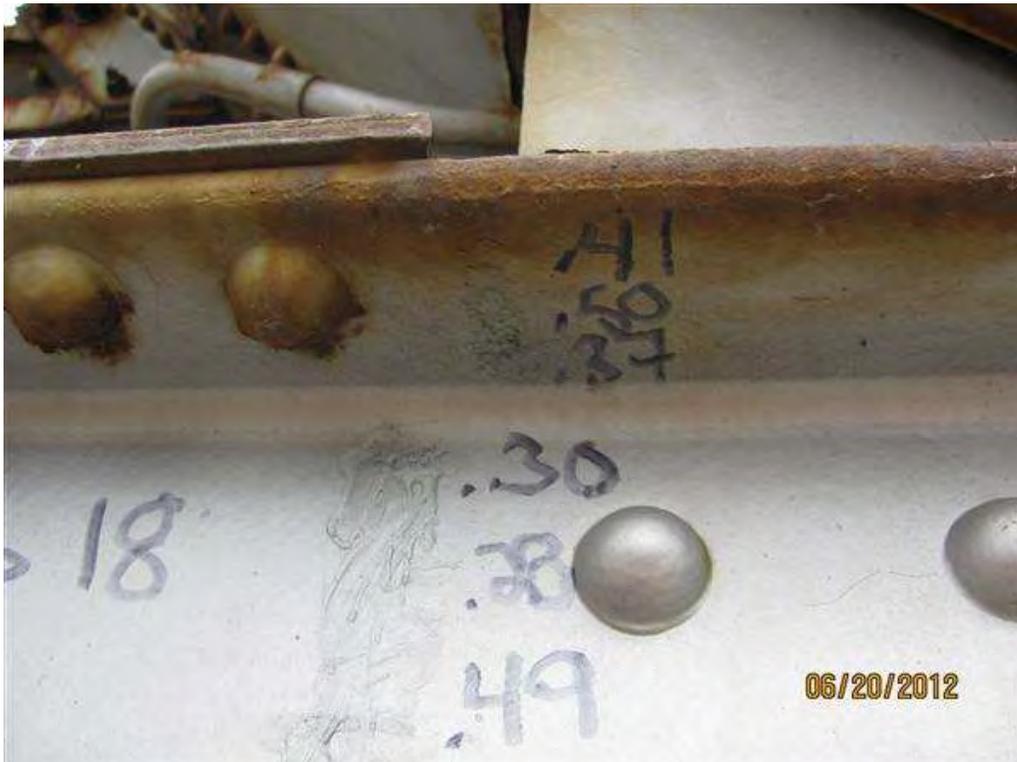
Photo 6 - Span 18 LOW Outside Channel Top Flange Loss

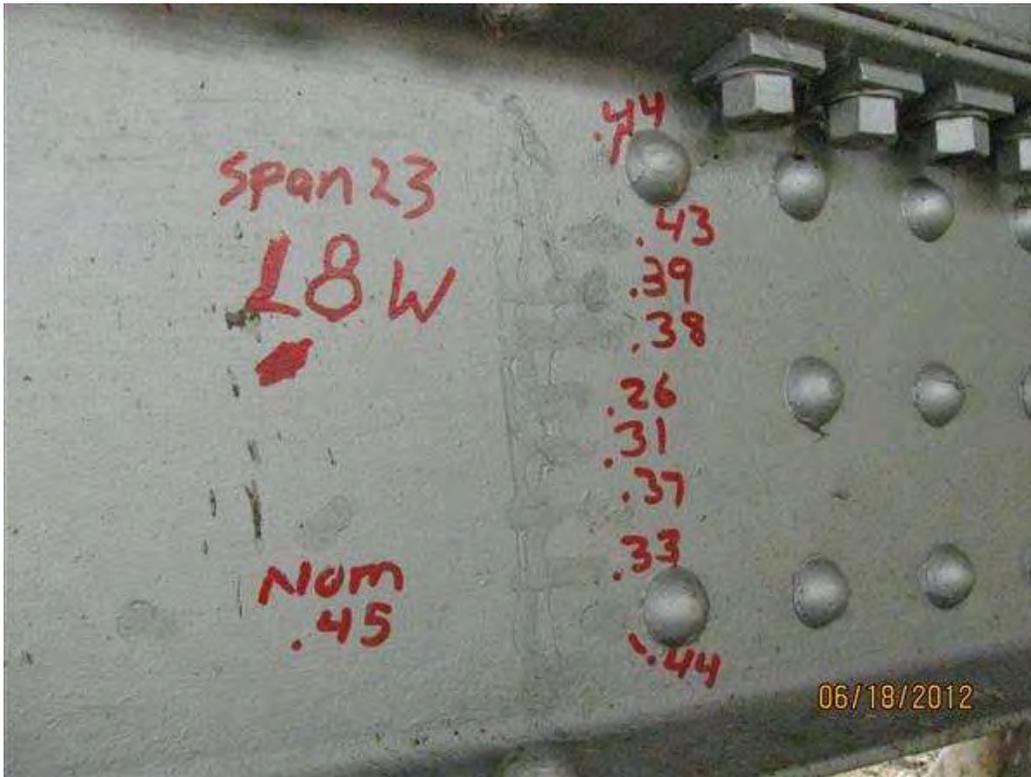
Photo 9 - Span 23 SL @L8 Int Web

3.Span 23 Deck Truss – L8W Bottom Chord Interface to Gusset (Photo 9):

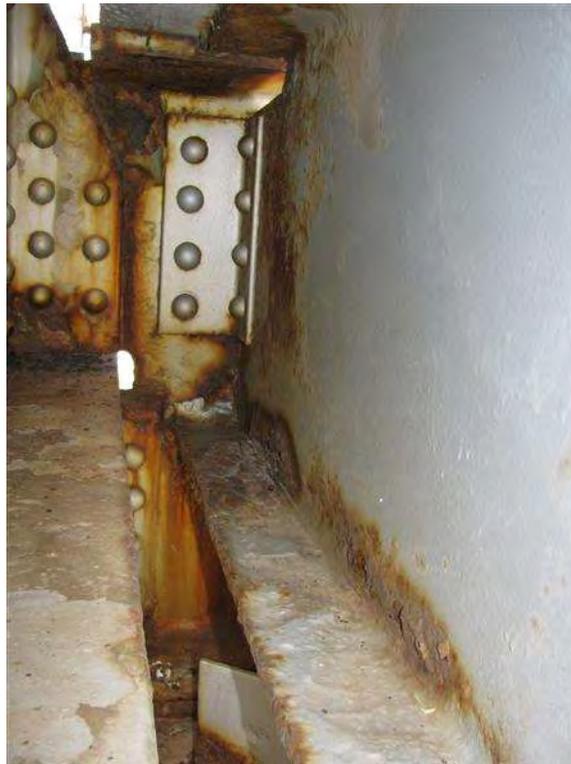
1. Span 19 Stringer 1 at Floorbeam 12 West web continues to show increased through-corrosion (Photo 102). No web crushing is evident. Other areas of web through corrosion have developed in other stringers in the through truss spans: Span 18 Stringer 1 L8W, Span 18 Stringer 6 L8E, Span 19 Stringer 2 FB11, and Span 19 Stringer 5 L18'E. Add 8 more feet to CS5. No web crushing; therefore, structural analysis is not needed at this time since the stringer load rating factors are high. Fascia stringers along Spans 18-20 are heavily corroded along the bottom flange at the floorbeam connections up to 3/8" loss. Surface corrosion is present along entire length of fascia stringers. The Bridge Office analyzed these locations on 6/22/2012, and the rating factors remain very high despite the loss.

Photo 102 - 102 Span 19 Stringer 1 at L12W

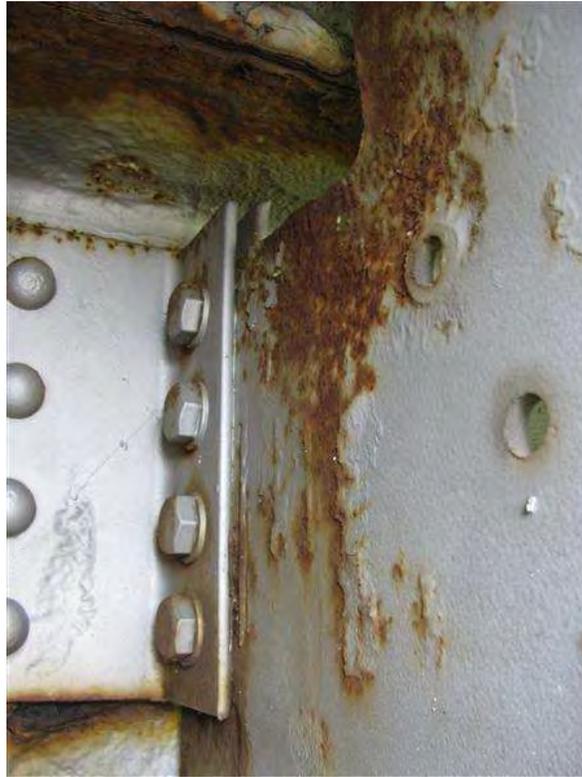
Photo 5 - Span 18 Stringer 1 at L8W Connection West Face

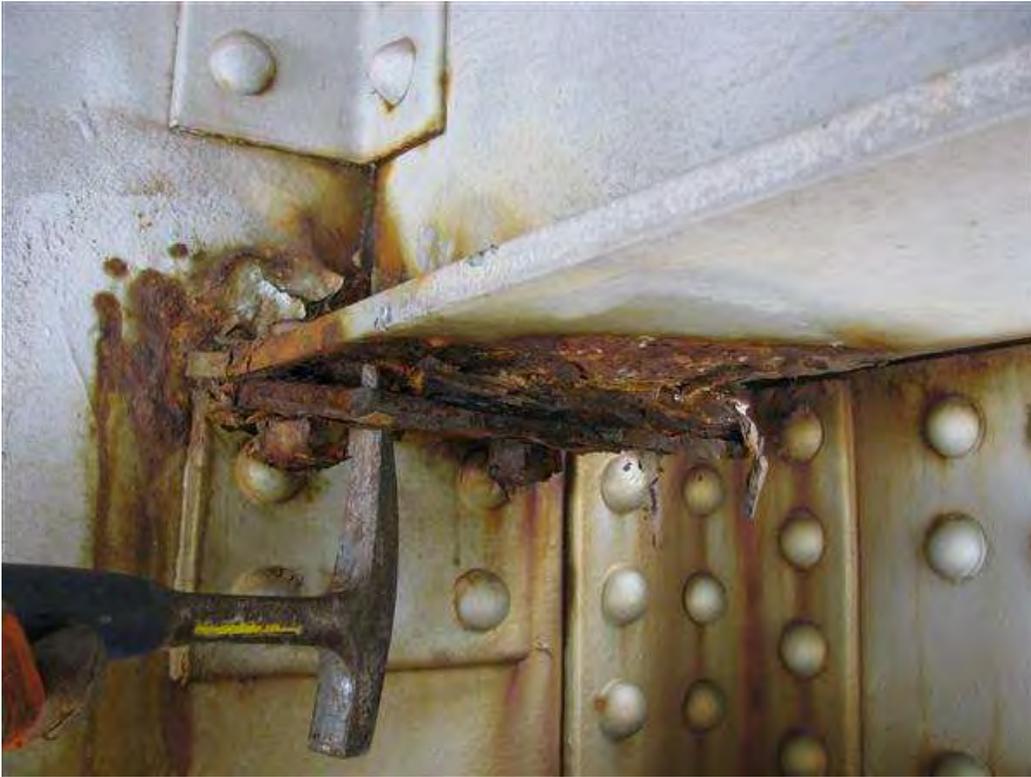
ELEMENT #113: [2014] Span 19 Stringer 1 at Floorbeam 12 West web continues to show increased through-corrosion (Photos 1-2). No web crushing is evident. Other areas of web through corrosion have developed in other stringers in the through truss spans - Span 18 Stringer 1 L8W, Span 18 Stringer 6 L8E, Span 19 Stringer 2 FB11, and Span 19 Stringer 5 L18'E (Photos 3-10) - add 8 more feet to CS5. No web crushing; therefore, structural analysis is not needed at this time since the stringer load rating factors are high. Fascia stringers along Spans 18-20 are heavily corroded along the bottom flange at the floorbeam connections up to 3/8" loss (Photos 11-12). Surface corrosion is present along entire length of fascia stringers (Photo 13).

Photo 11 - Span 19 FB19 Stringer 1 Bottom Flange Losses

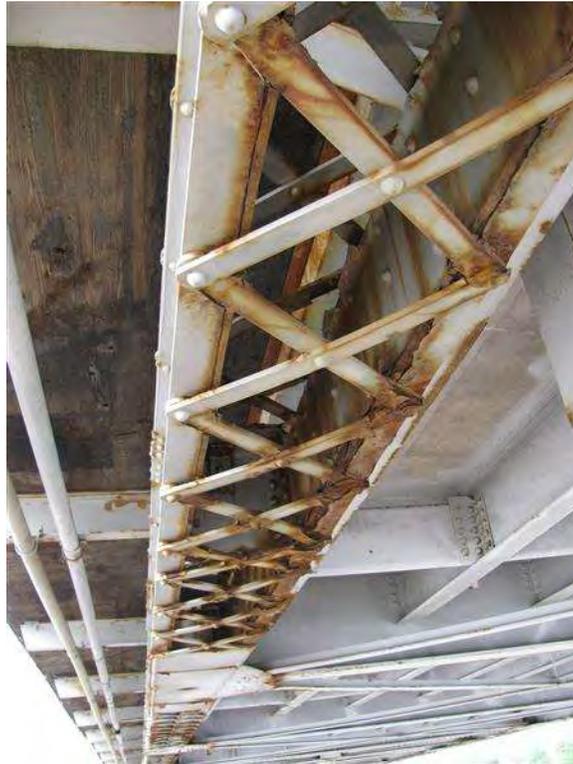
Photo 14 - Span 19 L17-L18E

ELEMENT #121: [2014] Entire lower chord of main truss spans 18-20 up through the splash zone is CS4 due to extensive flaking and pack rust with notable loss of section mainly near gusset plate locations (Photos 14-17). Many batten plates and lacing bars have through corrosion (Photo 18). Notable locations of loss recorded include: Span 19 L15-L16E at L16SE (Photos 19-20) up to 30% web loss and up to 20% flange loss but with likely an overall section of loss equal to less than 20% (typical for more of the bottom chord members of this type); Span 19 L12'-L13'W 15.3% overall loss (Photos 21-23). Analysis was completed by the MnDOT Bridge Office for these locations - L15-L16 can take losses up to 40-50% overall before affecting the current posting; L12-L13 is approaching the threshold of a posting revisions and/or repair. Close monitoring of these locations during each inspection must be noted and reported to the Bridge Office immediately if additional losses are incurred. These entire chord sections (6 segments total) are rated CS5. Losses noted at the locations in 2012 have not changed significantly, but quantity will remain in CS5.

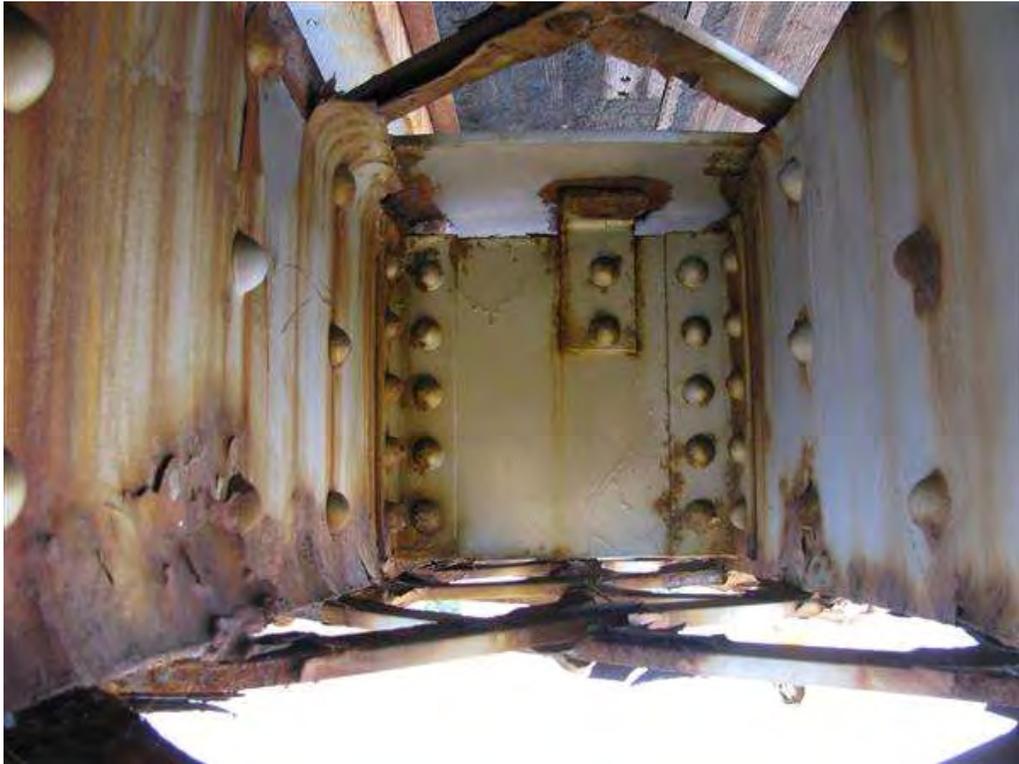
Photo 16 - Span 19 L17-L18E Looking North

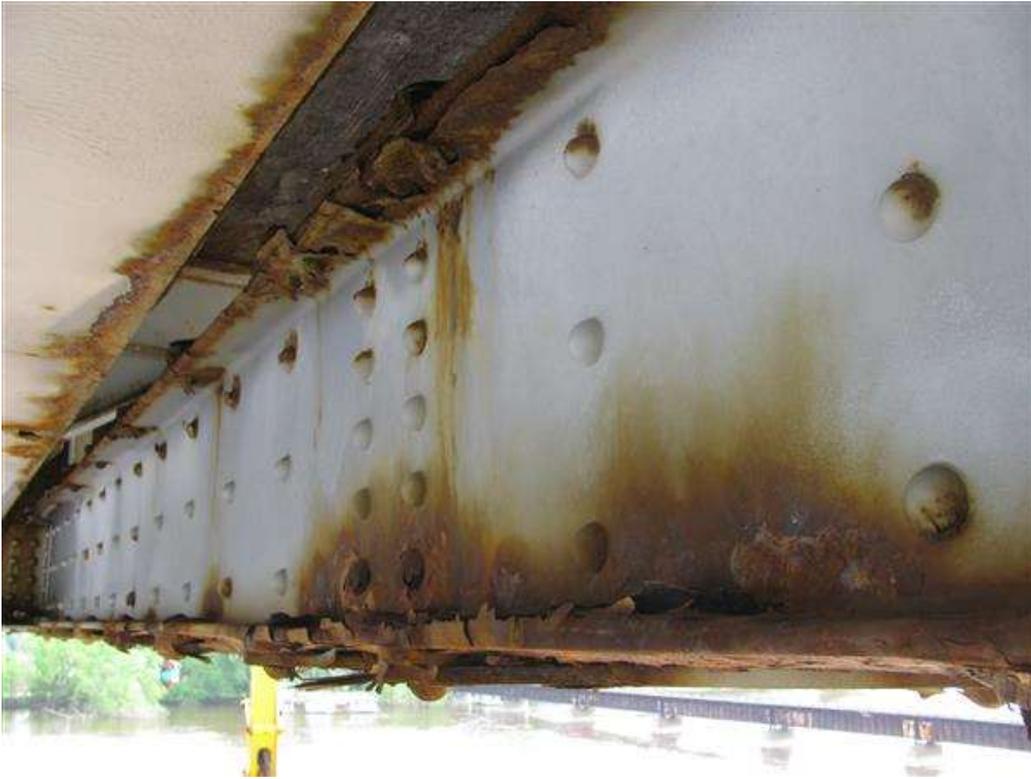
Photo 17 - Span 19 L17-L18E Looking North

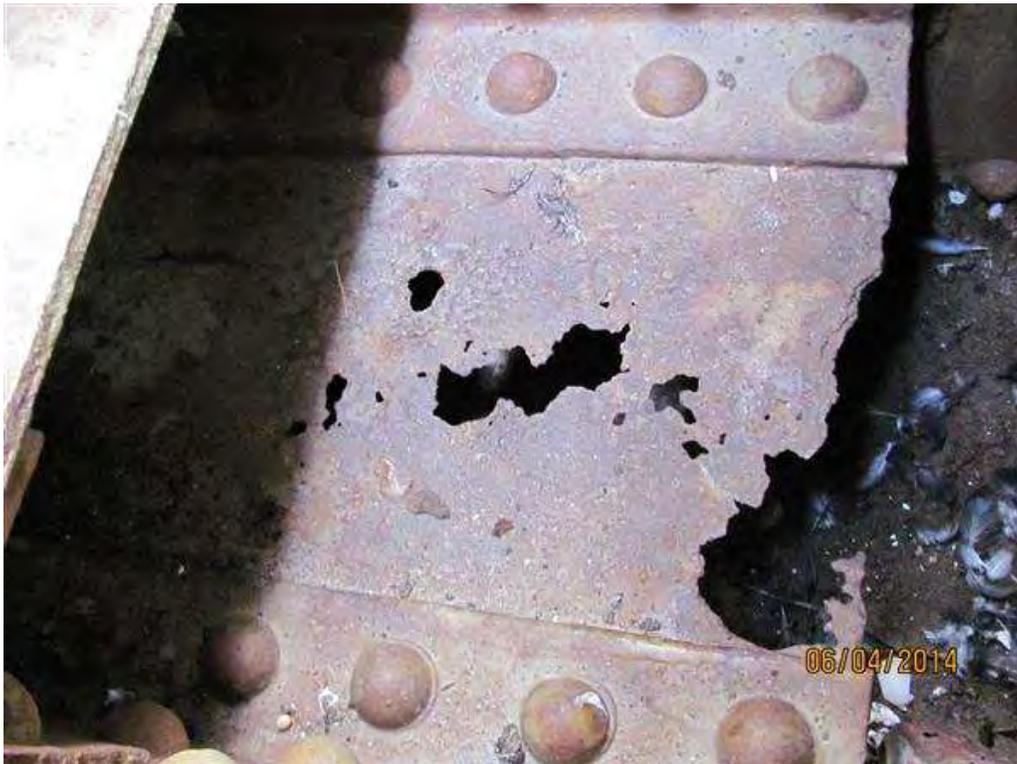
Photo 18 - Span 19 L12'E Interior Chord Shelf Plate Typical

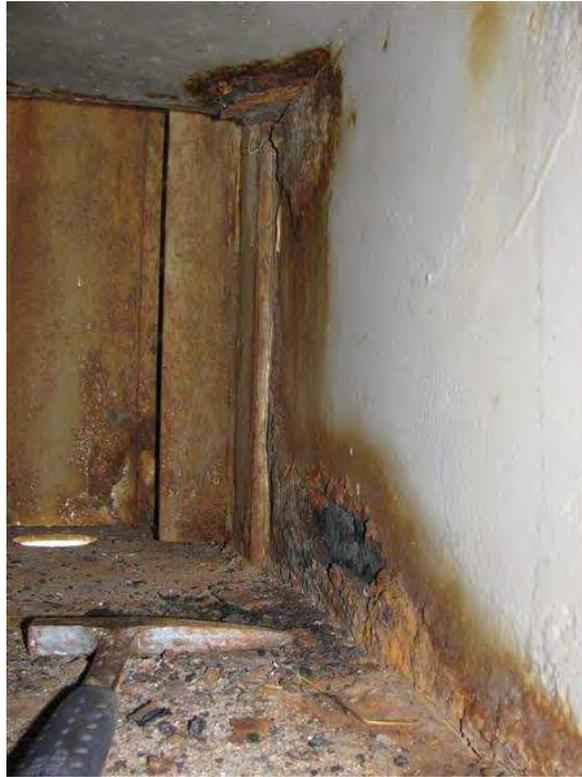
Photo 19 - Span 19 L15-L16E Losses

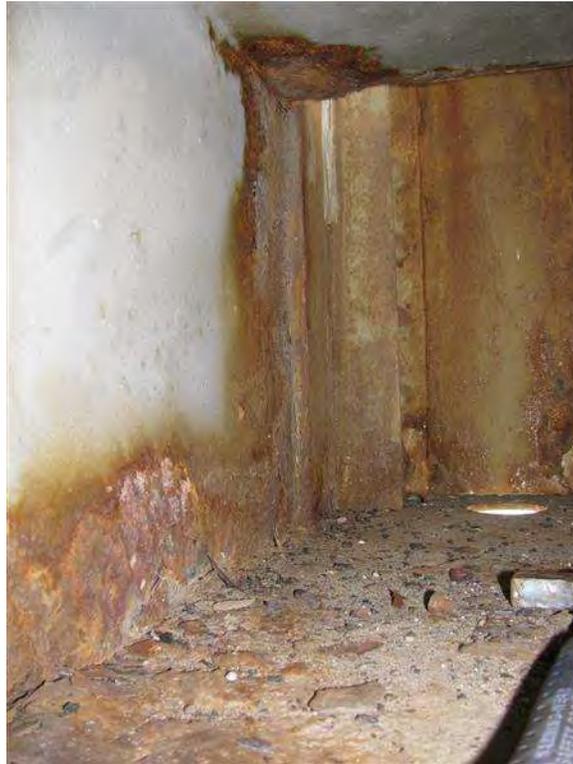
Photo 20 - Span 19 L15-L16E Losses

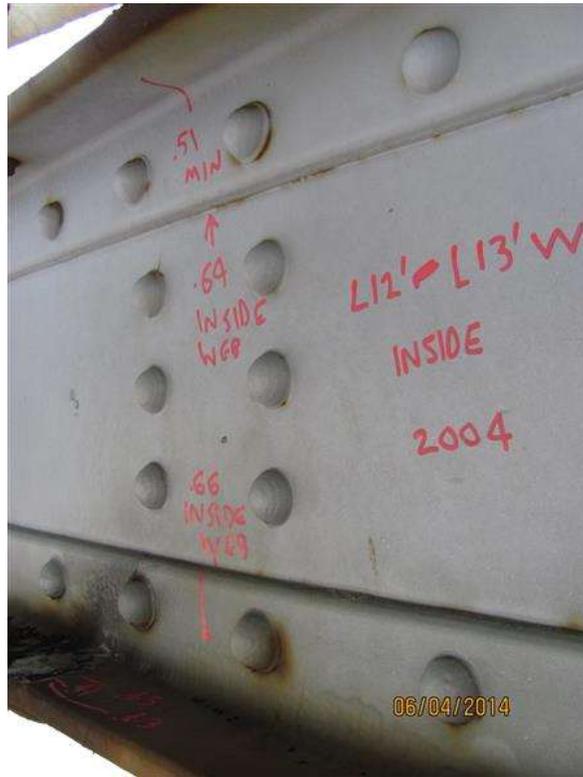
Photo 21 - Span19 L12'W-L13'W UT Readings of Chord SL Inner

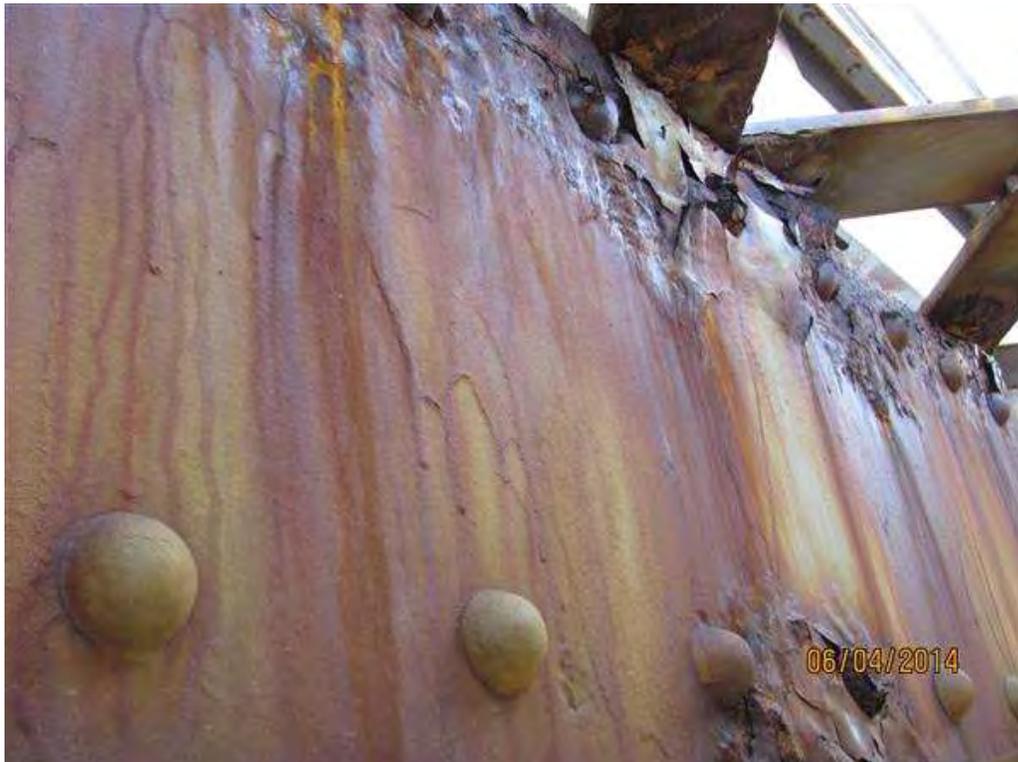
Photo 22 - Span19 L12'W-L13'W TYP Interior Web Pitting & PR

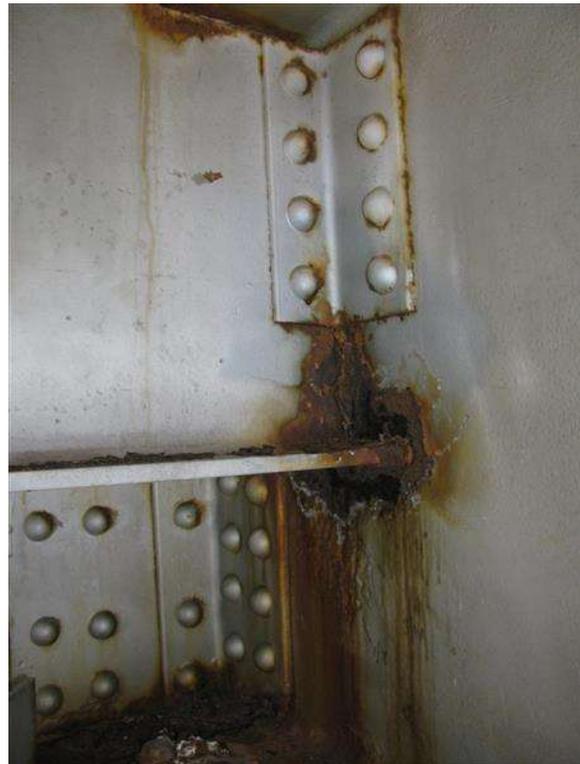
Photo 26 - Span 19 FB12SW Web Losses

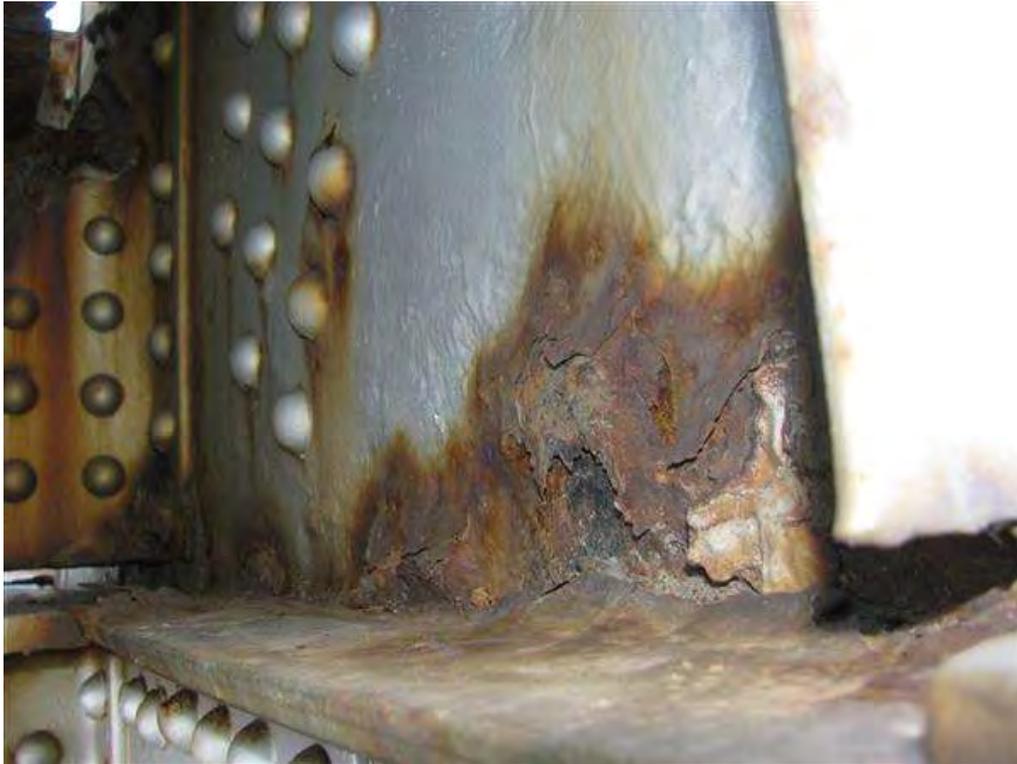
Photo 34 - Span 19 L12W Interior Plate North

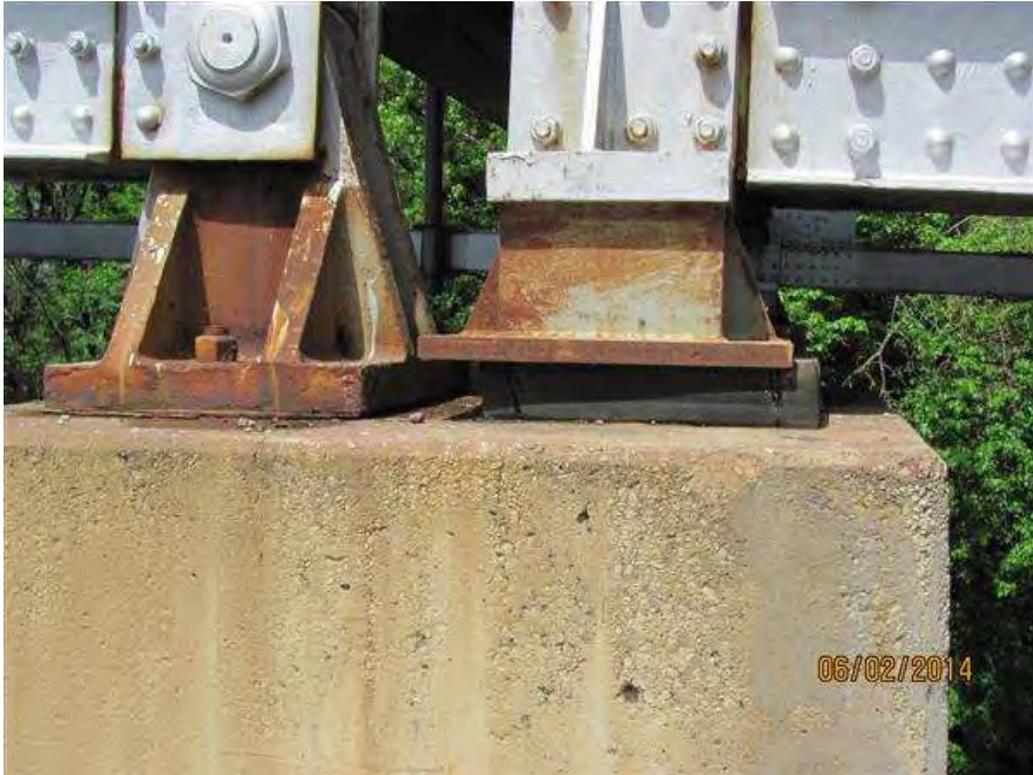
[2014] Pier 22 bearings have crept out further (Photo 35). The Winona bridge crew installed retainers at this location during this inspection. The elastomeric bearing under the prestressed concrete beam is walking out on Pier 14, and that will be reset at some point in the late summer or early fall of 2014. Condition states for these 3 bearings is CS2.

Photo 35 - Span23 L0E Shifted Bearing Pad
